Flood Investigation Report

Packington

18th September 2023

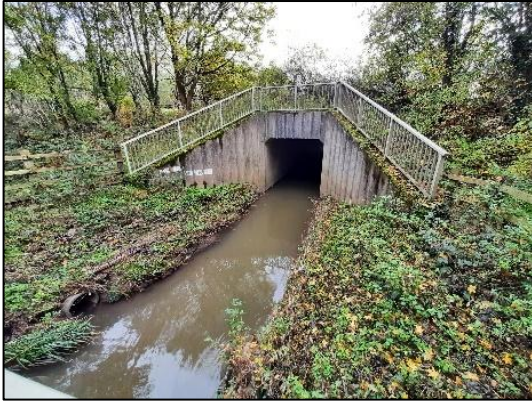
Photograph 1: Upstream of A42 showing bridge inlet and incoming drainage pipe

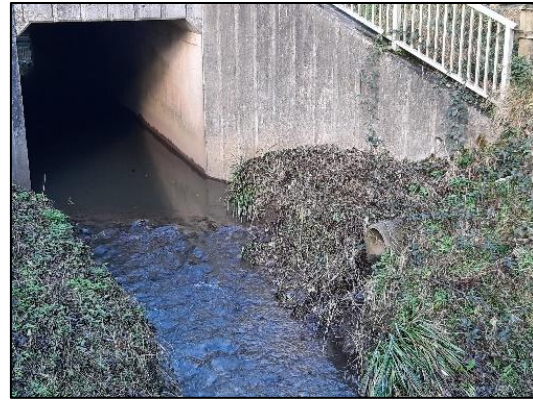
Photograph 2: Downstream of the A42 also showing a 300mm national highways outfall

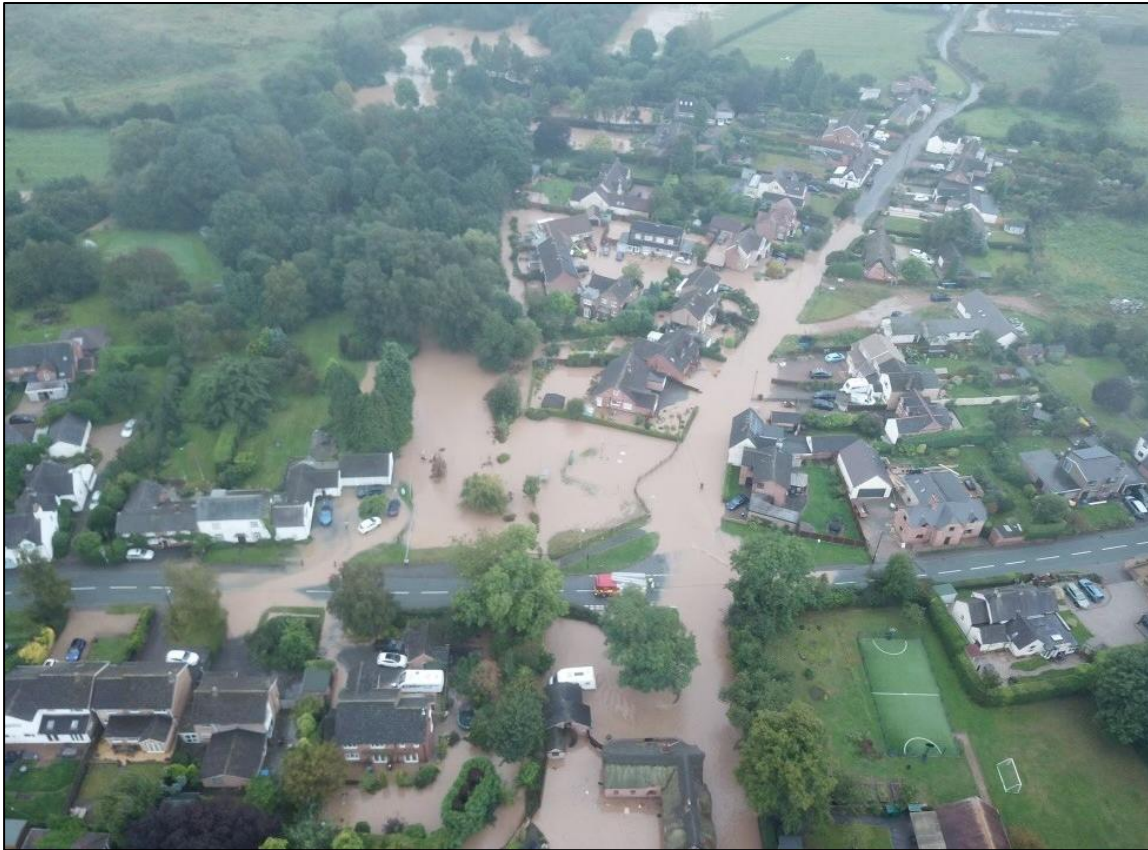
Photograph 3: Drone footage of the flooding in Packington on 18/09/2023, looking southwards towards the bridge junction around Mill St, Bridge St, Measham Rd, Babelake St. By kind permission of G. Saunt

The flooding occurred suddenly, with the brook level rising quickly from its normal level of 1.2m Above Local Datum (ALD) to a peak of 2.251m ALD within 2 hours. The maximum recorded level of 2.118m is the highest recorded depth of the brook since the flow gauge was installed in 2001. The previous peak was 2.1m, recorded at 5.30am on 16th February 2020.

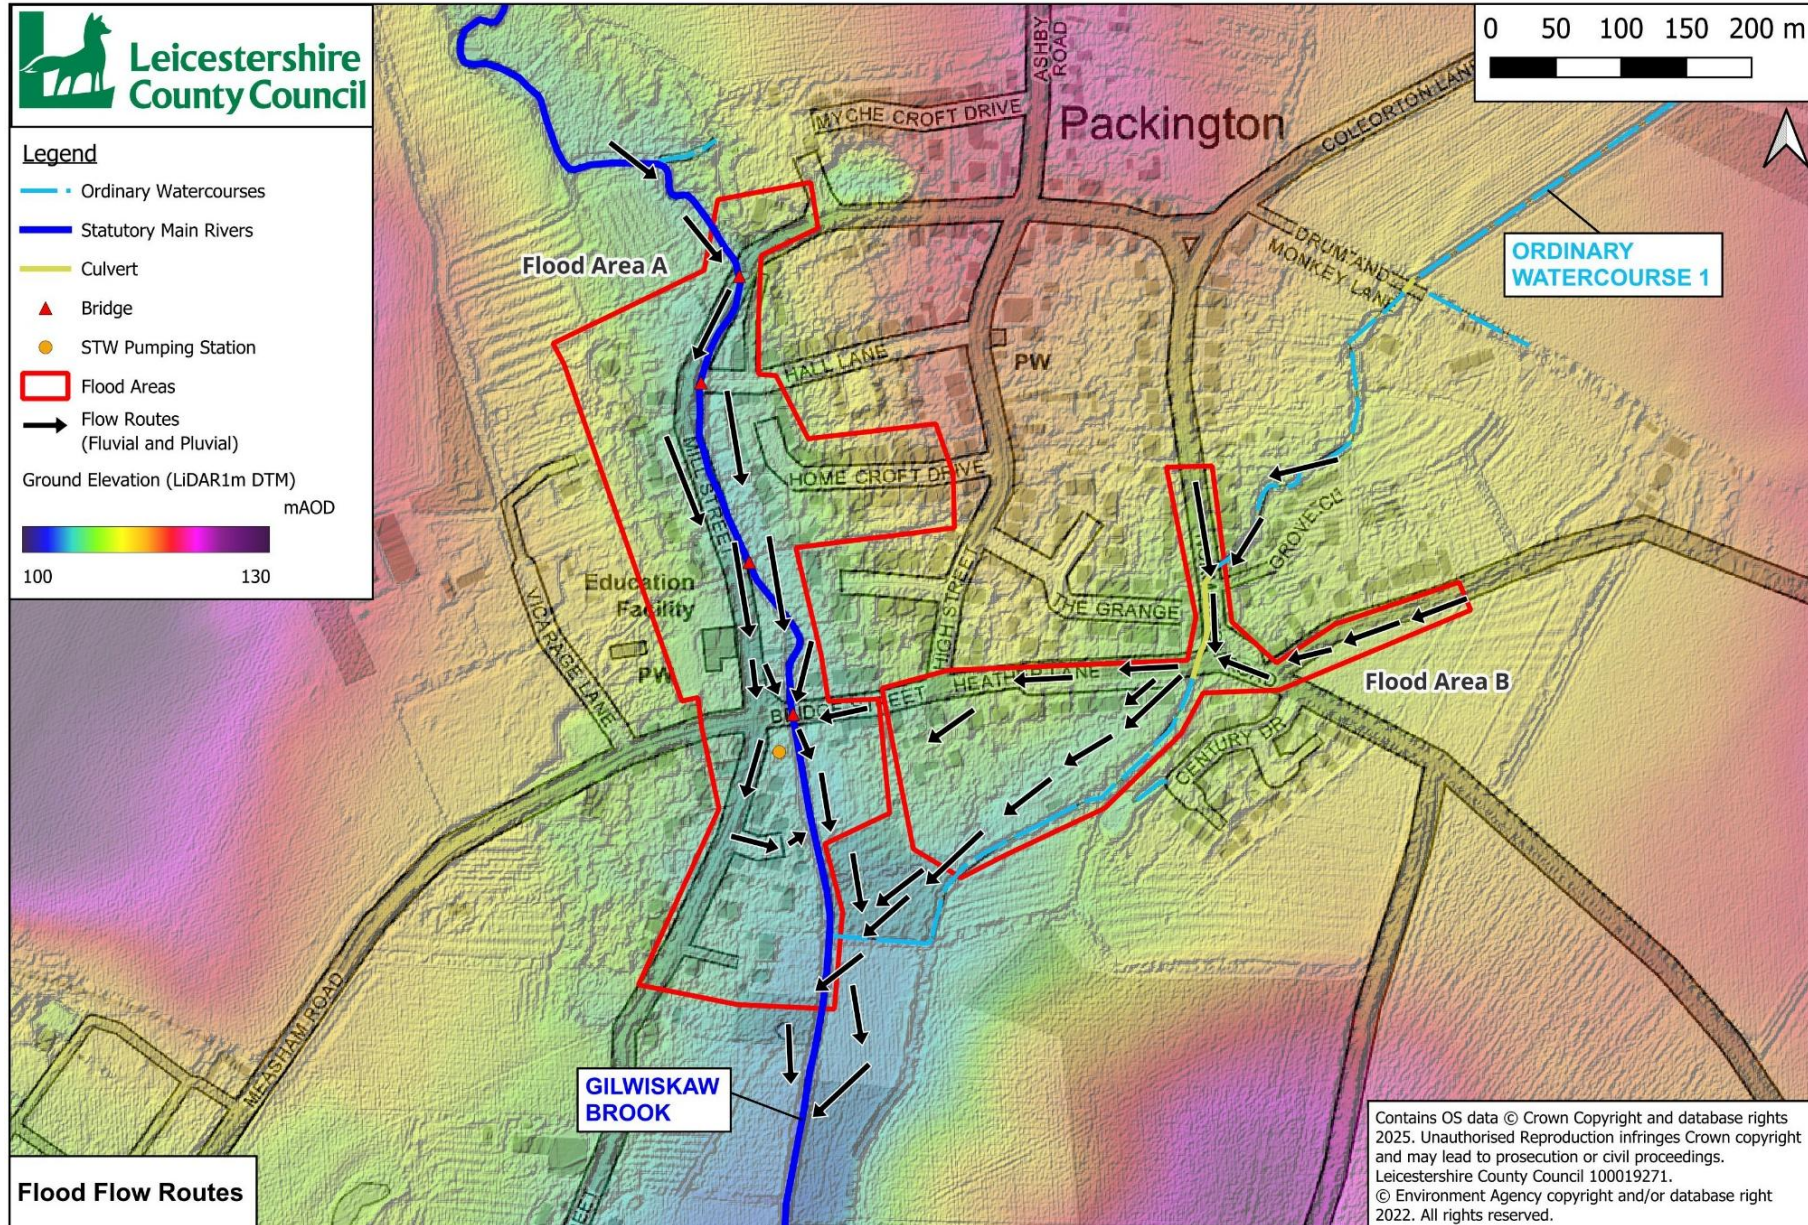
Figure 3: Topography and Flow Pat

The ordinary watercourse reportedly flooded onto the highway upstream of the culvert beneath Normanton Road and Heather Lane. A manhole cover on the pavement immediately above the culvert inlet also lifted, contributing additional overland flow onto the highway. Flood water was described as flowing down Normanton Road in a southward direction, accumulating at the junction with Heather Lane. Additional flows were anecdotally reported from Spring Lane, where surface water reportedly flowed off agricultural land onto the highway and down to the junction of Normanton Road and Heather Lane.

Flood water accumulated at the junction of Normanton Road and Heather Lane before subsequently flowing down onto the Heather Lane slip road. The flood water overtopped kerbs on the southern side of the highway initially causing external property flooding to the frontage of several properties. Three residential properties on Heather Lane reported internal flooding from the front but also from the rear as the ordinary watercourse overtopped its banks behind the properties. An additional three residential properties reported external property flooding from this source also. Two residential properties on Normanton Road also reported external property flooding, as a result of the ordinary watercourse overflowing into rear gardens upstream of the junction at Heather Lane and Normanton Road.

On Spring Lane, one residential property reported external property flooding, and one reported internal property flooding. This was anecdotally caused by surface water flows from adjacent agricultural land.

All flow paths are illustrated on Figure 3.

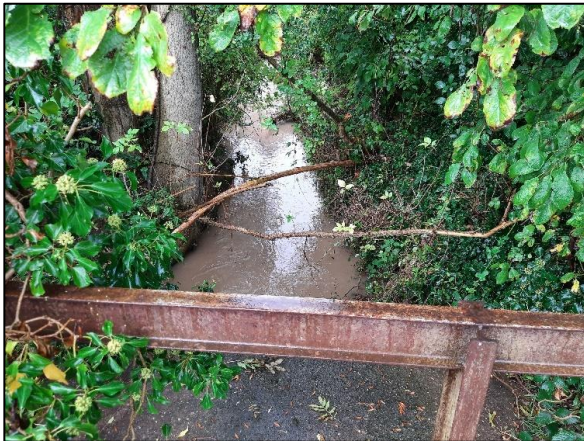
Anecdotal evidence suggests that, prior to the flood event on 18th September 2023, land in the upstream reaches of ordinary watercourse 1 had recently been ploughed. This practice, particularly when carried out without appropriate soil conservation measures, can significantly increase surface runoff and sediment transport during heavy rainfall. The exposed soil is more susceptible to erosion, resulting in silt and debris being washed into downstream channels and structures. This influx of material can reduce channel capacity, block culverts, and accelerate flow velocities, compounding flood risk. Photograph 4 illustrates the silty water and Photograph 5 illustrates visible scouring of the ploughed field following the event. Traditional agricultural practices in sensitive catchments like Gilwiskaw Brook can therefore exacerbate flooding by altering natural drainage patterns and increasing sediment loads. These impacts highlight the importance of catchment sensitive farming practices.

Photograph 4: View looking downstream of agricultural fields where ordinary watercourse 1 then flows through residential gardens

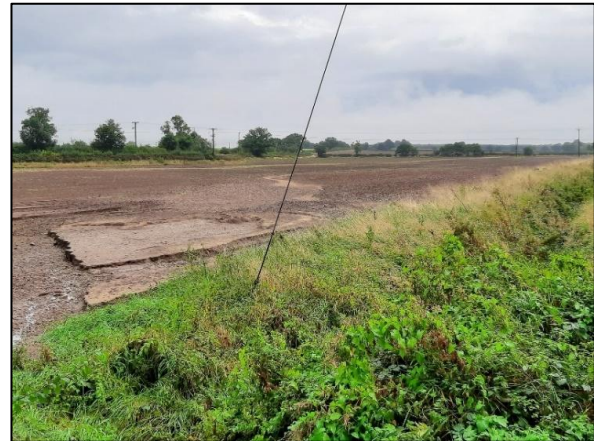
Photograph 5: Taken after the flood event on site visit of 26th September 2023 illustrating scour across land and ploughed fields adjacent to ordinary watercourse 1 upstream of residential dwellings

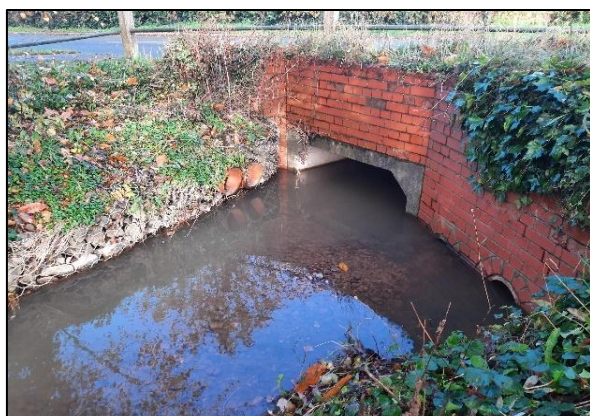
Significant debris accumulation was identified immediately downstream of the culvert outlet after the event, just upstream of an informal footbridge located in the rear garden of 1 Heather Lane (see Photograph 6). Water was reported to be surcharging from highway inspection chambers at the junction during the event, indicating the local drainage system was overwhelmed as no blockages were identified.

It is most likely that the debris at the culvert inlet originated from upstream field scouring during the flood event. The Council undertook silt and debris clearance from ordinary watercourse 1 in April 2024, removing a substantial volume of material from the downstream section beneath the highway.

Photograph 6: deposits from upstream in ordinary watercourse 1 downstream of outlet adjacent to 1 Heather Lane

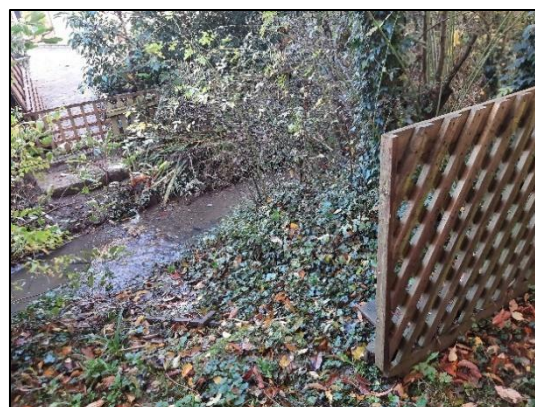
Ordinary watercourse 1 runs through the rear gardens of the properties along Heather Lane. During a post-flood site visit on 10th November 2023, it became clear that before the flooding, an informal foot bridge existed across the watercourse within the back garden of 1 Heather Lane (remains as illustrated in Photograph 7). This footbridge was described as having washed away during the flood event. No evidence of consent for the works was identified by the LLFA. Any works within or in proximity to an ordinary watercourse require consent under the Land Drainage Act (1991). This allows the LLFA to permit works on ordinary watercourses that do not increase flood risk. Due to the size of the flood event and in the absence of detailed flood modelling or details around the size of the structure, it is not known to what extent this informal footbridge may have impacted the flooding around Heather Lane. It is likely to have exacerbated the backing up of water before the structure was eventually washed away.

Photograph 7: Remains of the informal footbridge crossing from 1 Heather Lane

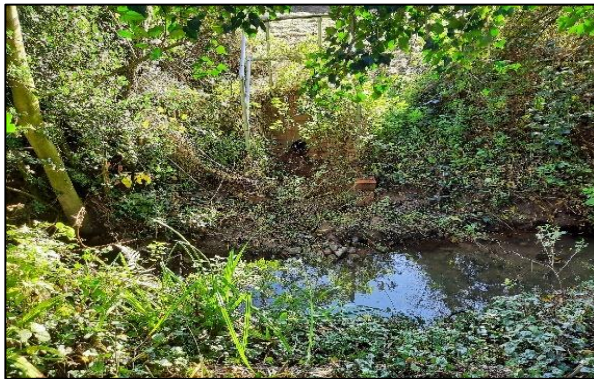
Residents drew attention to a discharge point into ordinary watercourse 1 (at the rear of 2 Heather Lane, Photograph 8) at the time of the site walkover on 10th November 2023. No concerns have been identified with this outfall. The outfall appeared to be discharging freely at the time. The discharge details of which were agreed and approved by the planning process at the time approval was given for the development.

It is likely that this outfall would have been unable to discharge during the flood event as ordinary watercourse 1 would have resulted in the outfall becoming submerged. No flood concerns were raised within the development that it serves.

Photograph 8: Outfall into watercourse from estate. Located to the rear of 3 Heather Lane

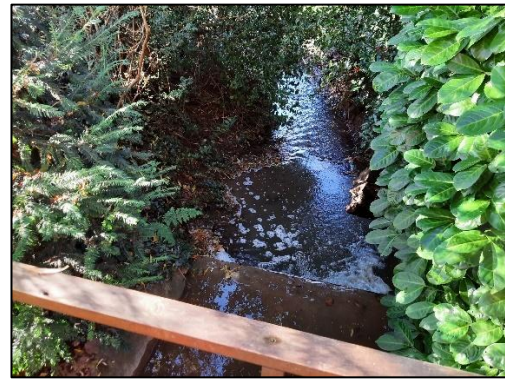
Photograph 9: Unconsented weir to rear of 4 Heather Lane

- The unconsented obstructions identified on ordinary watercourse 1 may have exacerbated local flooding to Heather Lane, however in the absence of river modelling it is not known to what extent. Due to the speed of flooding it is unlikely that this would have caused the flooding but it may have increased the extent. The wooden footbridge was washed away during the event and the weir has been logged as unconsented and the landowner informed.

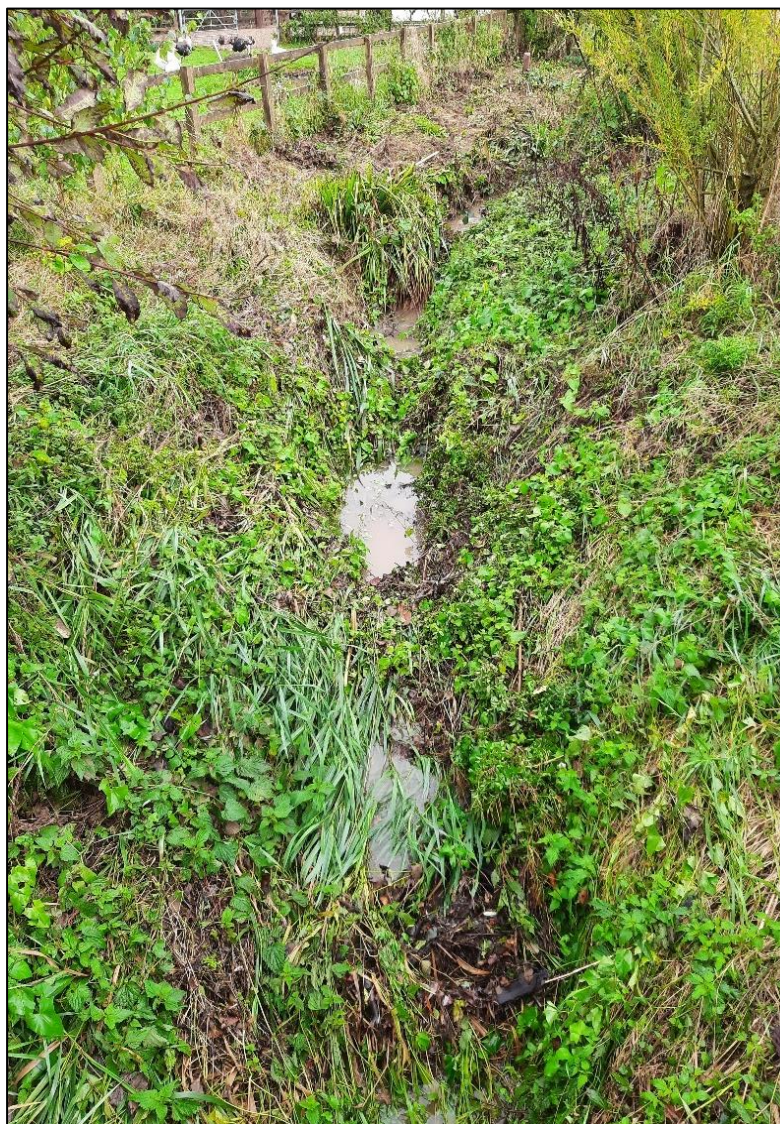
Photograph 10: Ordinary watercourse 1 downstream of land to the rear of properties in Heather Lane

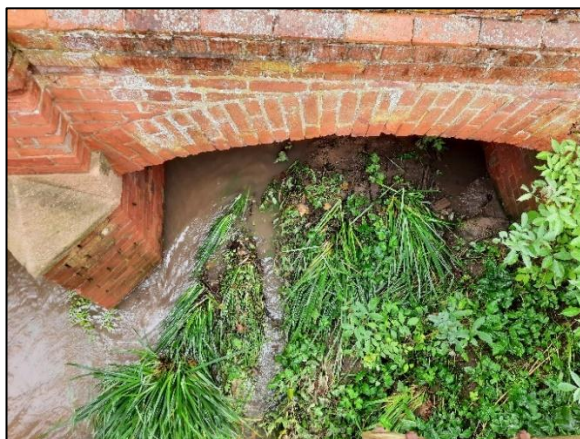
Anecdotal reports suggested that the Gilwiskaw Brook bridge at Bridge Street was obstructed, causing water to back up and exacerbate flooding upstream. A post-event inspection (see Photograph 11) confirmed debris accumulation beneath one of the twin arches, including silt, sand, and organic material likely deposited during the flood and over time. Water was observed flowing over and around the obstruction, while this may have contributed to localised slowdown of flow immediately upstream, the watercourse narrows downstream of the bridge (Photograph 12), which would have naturally limited flow regardless of the obstruction.

The EA has undertaken an analysis of the Gilwiskaw Brook in the vicinity of Packington, the results of this analysis suggests that at Bridge Street the channel is over-wide and silt naturally deposits here as the flow slows down. The Bridge Street spans are larger than those upstream. Flooding conditions in the channel actually start further upstream at the Old Water Mill and then flows down Mill Street rather than being caused directly by backing up from Bridge Street.

Given that water continued to pass through the structure and the second arch remained largely unobstructed, it is unlikely that the condition of the blocked arch alone had a significant impact on the overall extent of flooding. The restriction downstream would have been the dominant control on flow capacity during the event.

Photograph 11: Taken immediately after the event illustrating one of the twin arch bridges were partially obstructed (junction of Bridge Street and Mill Street)

The EA's current position is that *"dredging/ de-silting projects undertaken by the EA can be extremely costly, which, alongside not having any tangible benefits (in this case), is part of the reason why we would not be carrying out de-silting of the bridge at this time."* The EA will however, monitor the level of silt at this bridge and review it regularly.

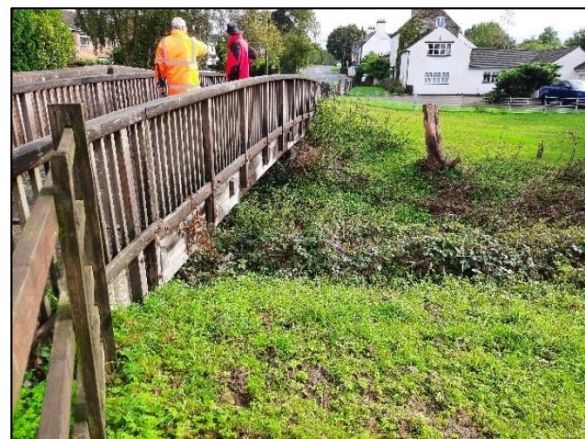
Photograph 12: Illustrating the channel width just downstream of the twin arch bridge

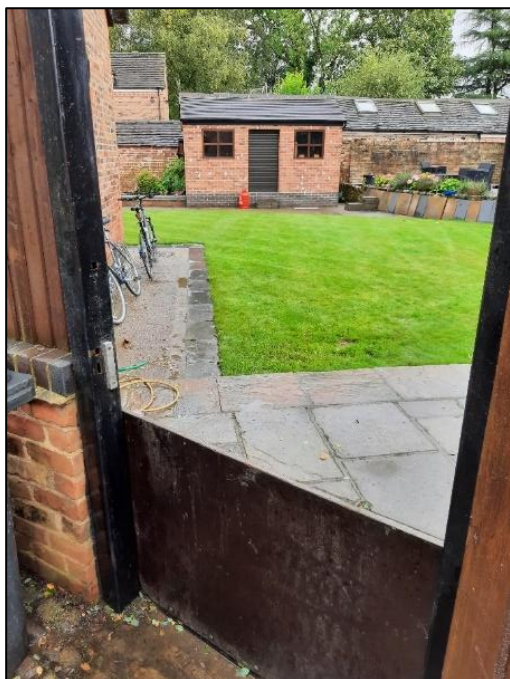
As mentioned previously, some residents had already installed their own measures to try to prevent water ingress, but deployment of some measures was not possible due to the speed in which the flooding occurred (refer to Photograph 13 and Photograph 14).

Photograph 13: Makeshift barrier to rear of 53, Mill Street

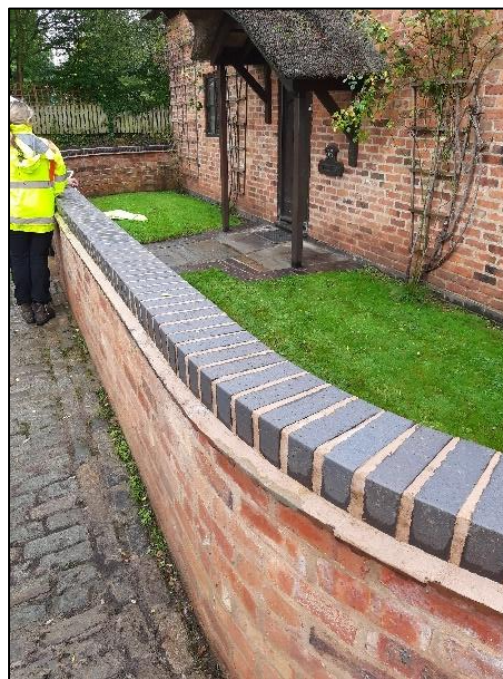
Photograph 14: Flood wall installed around 55, Mill Street
