# **Flood Investigation Report**

Oadby & Wigston  
22<sup>nd</sup> June 2023

Version	Published Date	Author	Approved By
Final 001	17/12/2025	Helen Burton, Consultant Senior Flood Risk Engineer	Victoria Coombes, Flood Risk Manager

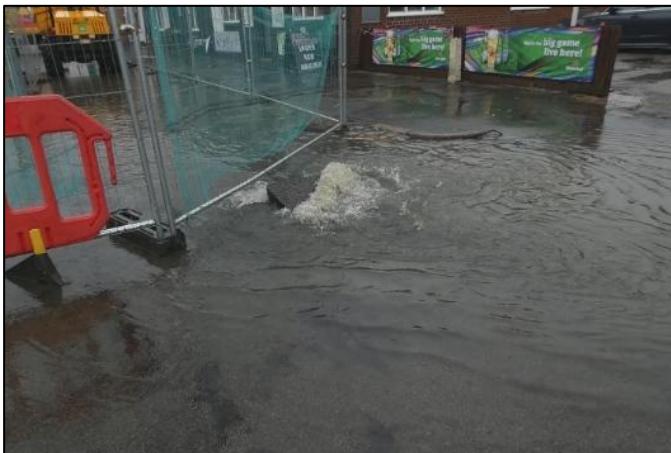
**Photograph 2: Flooding along London Road at junction with The Morwoods**

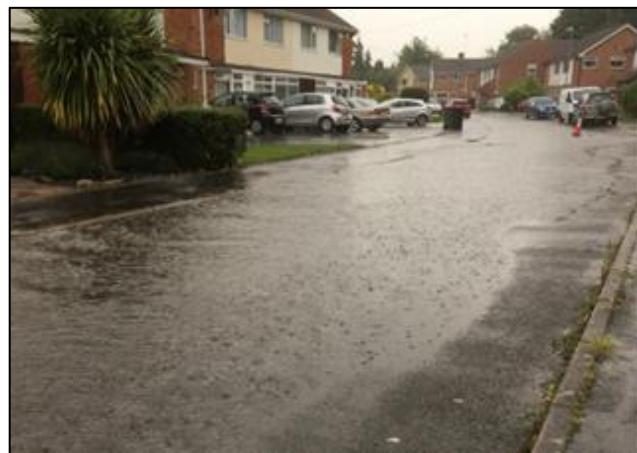
The resulting floodwater accumulated on the highway to a depth that quickly overtopped kerbs on both sides (Photograph 3 and Photograph 4). This led to initial flooding of driveways and gardens of residential properties on the northern and southern sides of the highway (Photograph 5). External property flooding was reported at nine properties along The Morwoods.

**Photograph 3: Flooding along The Morwoods**

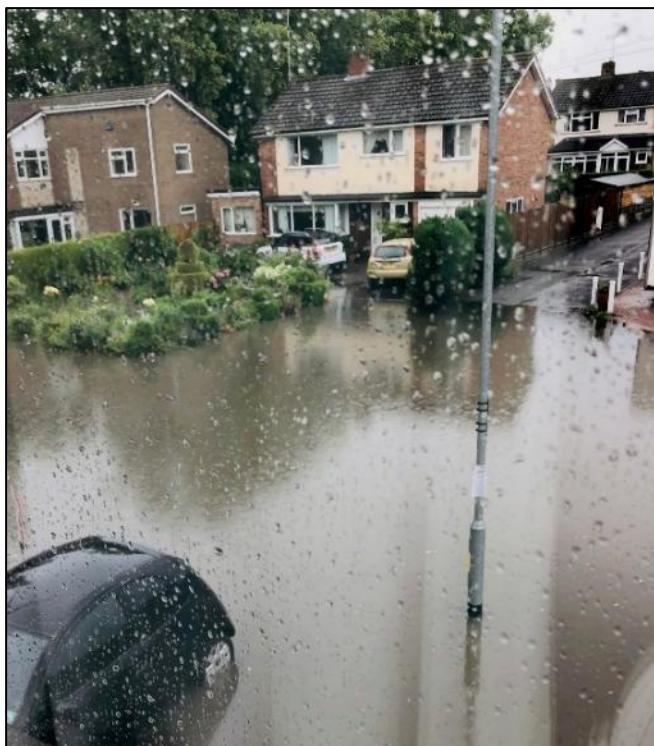
**Photograph 4: Flooding along The Morwoods**

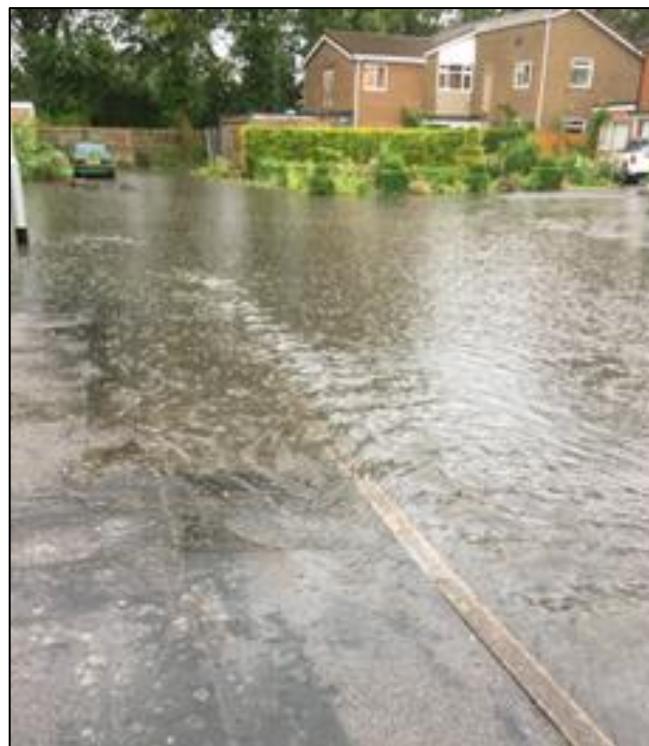
**Photograph 5: Flooding along The Morwoods**

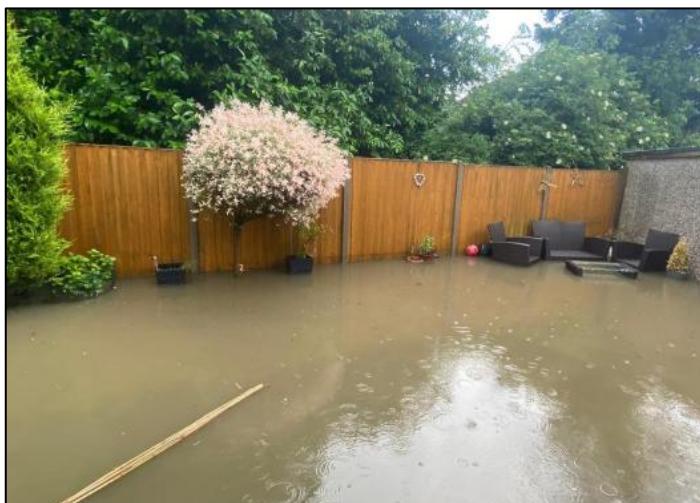
**Photograph 6: Flooding to rear garden along The Morwoods**

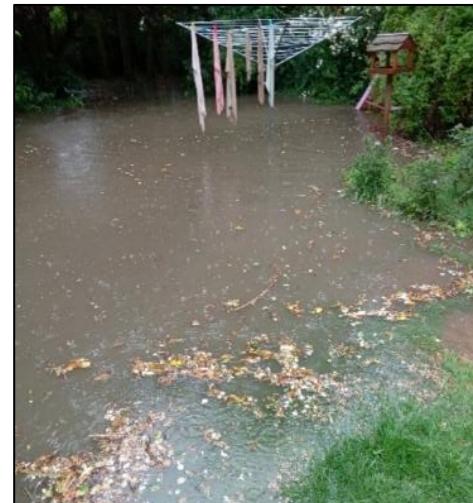
**Photograph 7: Flooding to rear garden along Greenbank Drive**

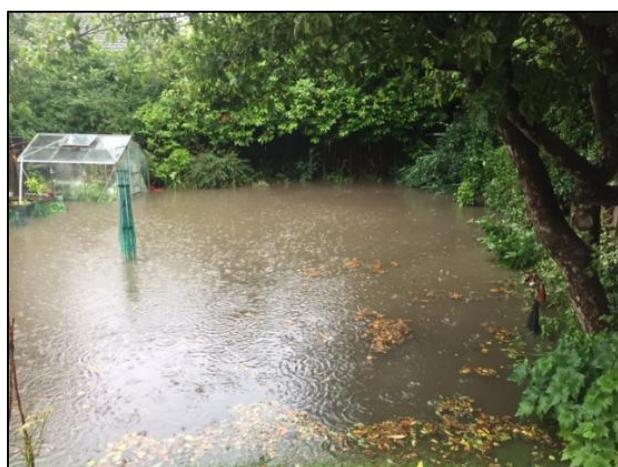
Flood water continued to flow downhill southwards through these properties and their rear gardens towards Wash Brook. Here, Wash Brook flows generally from east to west. It was reported that Wash Brook also overtopped its banks flooding the rear of back gardens along The Morwoods (Photograph 6) and within six rear gardens of properties along Greenbank Drive (Photograph 7 and Photograph 8) located adjacent to the south bank of Wash Brook.

**Photograph 8: Flooding to rear garden along Greenbank Drive**

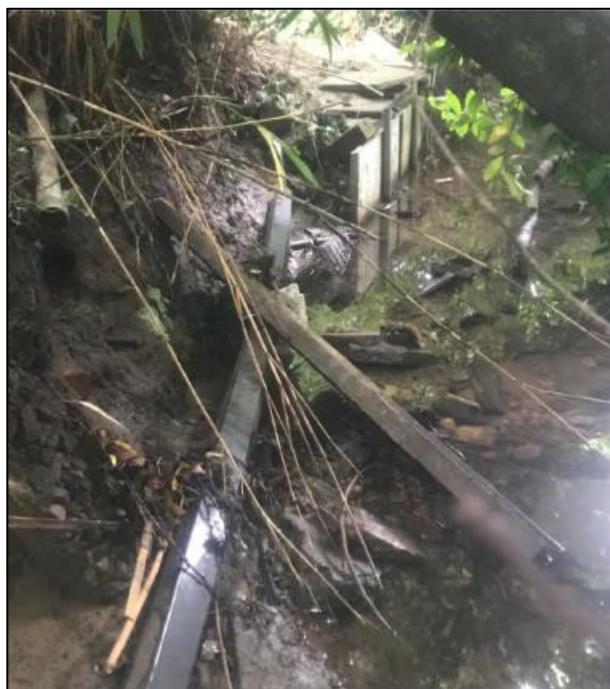
Several riparian owned reaches of Wash Brook were reported and found to have been overgrown and at the upstream end of The Morwoods, was obstructed with concrete posts (Photograph 9), a canoe washed down from a garden (Photograph 10), and a discarded bath (Photograph 11). Some vegetation debris had also accumulated behind a pipe crossing over Wash Brook, further obstructing flows at the upstream end of The Morwoods (Photograph 12). As such, Wash Brook had a reduced capacity than what would be considered optimal to convey flow during the event.

**Photograph 9: Discarded concrete posts in the Wash Brook at the upstream extent of The Morwoods**

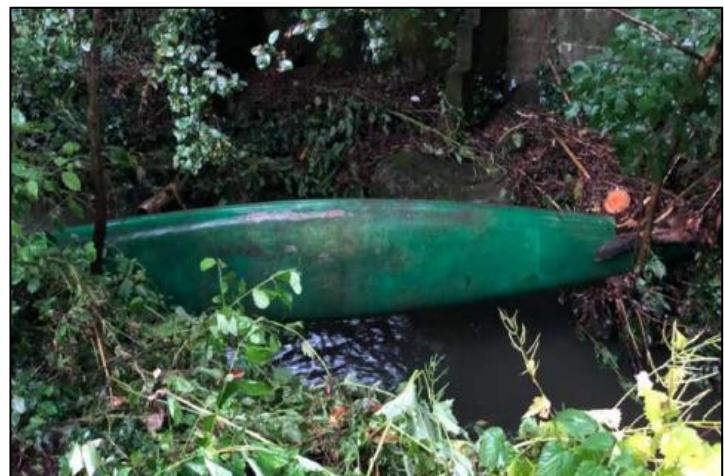
**Photograph 10: Canoe washed downstream along Wash Brook at the upstream extent of The Morwoods**

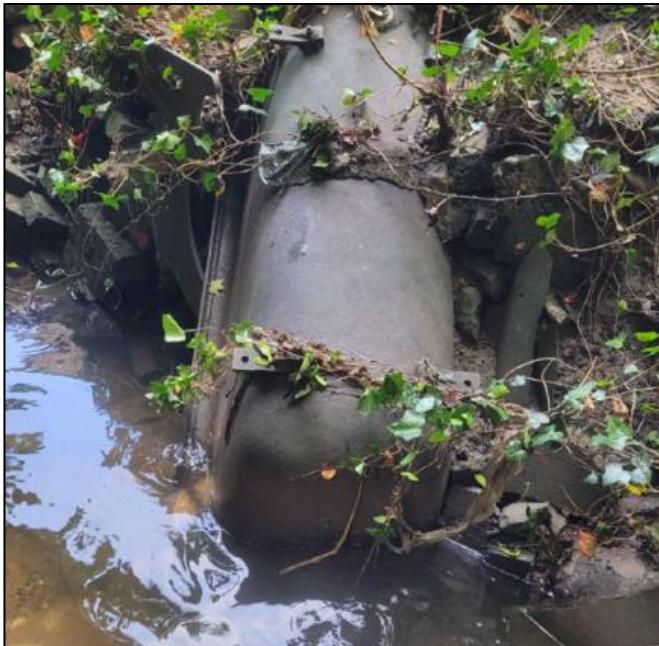
**Photograph 11: Discarded bath along Wash Brook at the upstream extent of The Morwoods**

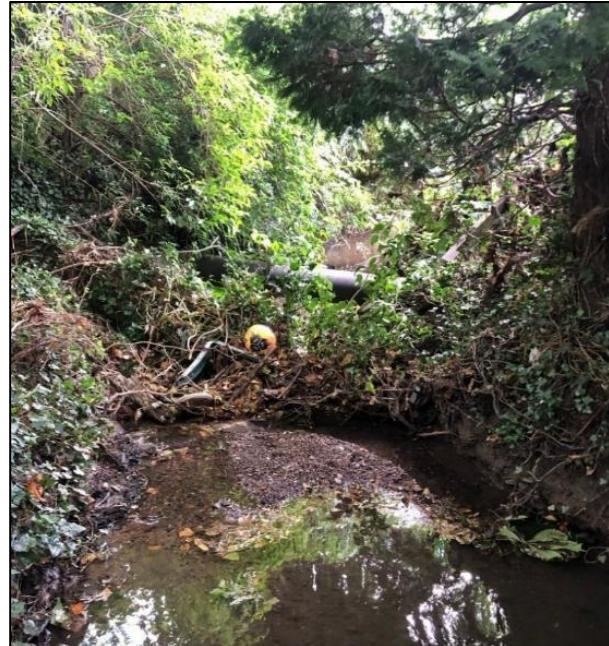
**Photograph 12: Blockage at pipe crossing over Wash Brook alongside The Morwoods**

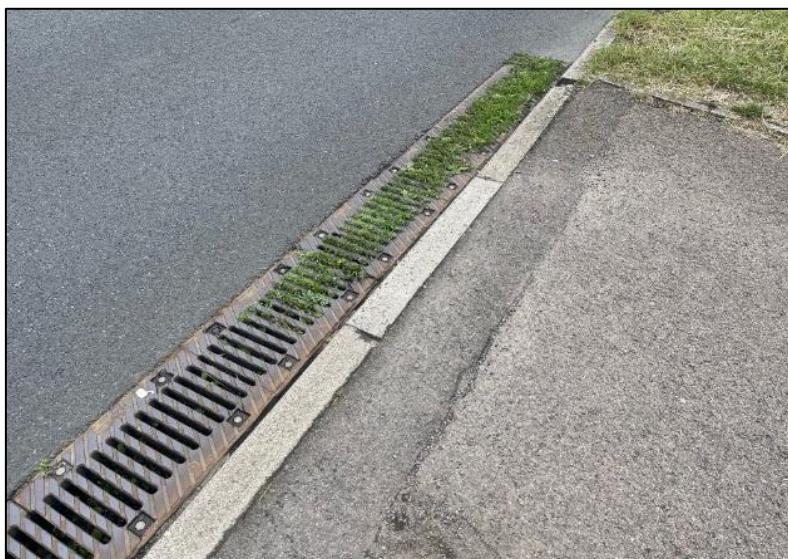
Internal flooding was reported at seven residential properties and one business property on Wigston Road directly from Wash Brook after depths exceeded property thresholds and entered through air bricks into basements. It was also anecdotally reported that because of the drainage network being overwhelmed, flood water flowed off Wigston Road into the front gardens/driveways of these properties. Several of these driveways slope down towards the properties, exacerbating the surface water flow routing. Anecdotal reports were made of partial blockages to highway drains (including a concrete dished channel) by weeds (Photograph 13).

**Photograph 13: Partially blocked concrete dished channel drain along Wigston Road**

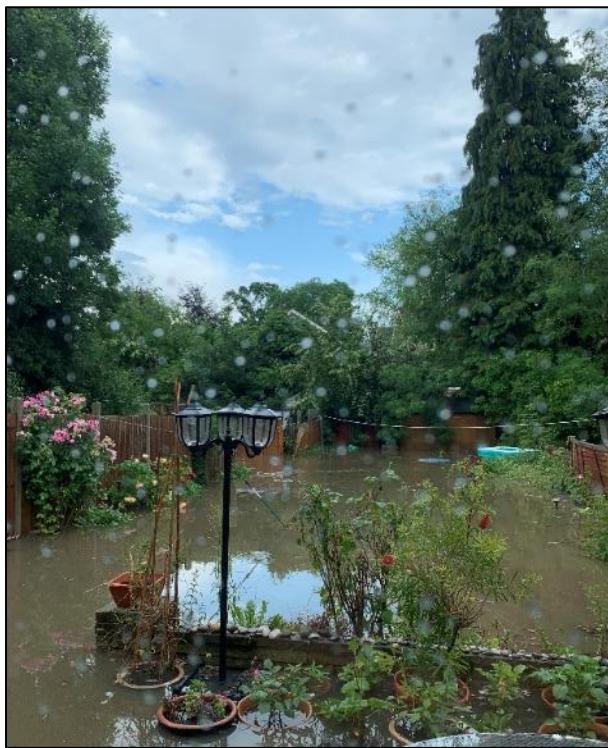
Floodwater continued to flow south-west through the rear of gardens of properties situated along Wigston Road and Brambling Way. Evidence of this is depicted in Photograph 14 and Photograph 15 respectively, resulting in external property flooding being reported at a further eight properties along Wigston Road, and four properties along Brambling Way. These properties did not flood internally due to them having longer rear gardens which exhibit gradients that provided some informal storage.

**Photograph 14: Flooding in rear garden along Wigston Road**

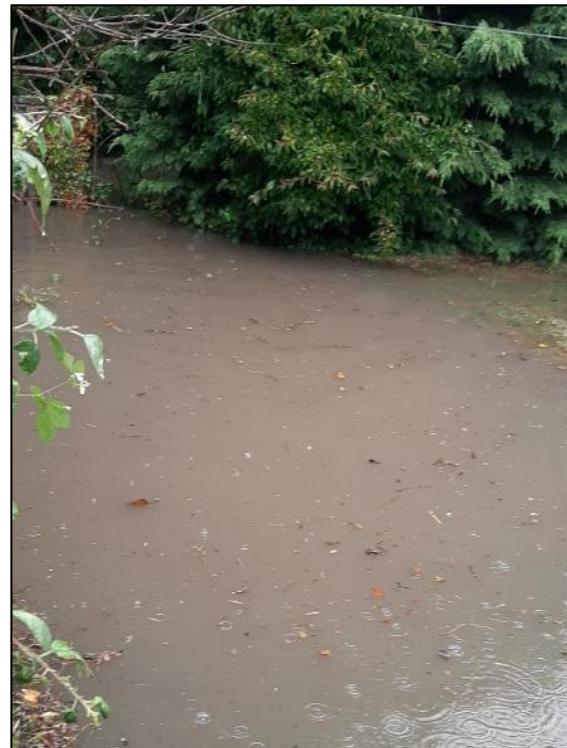
**Photograph 15: Flooding in rear garden along Brambling Way**

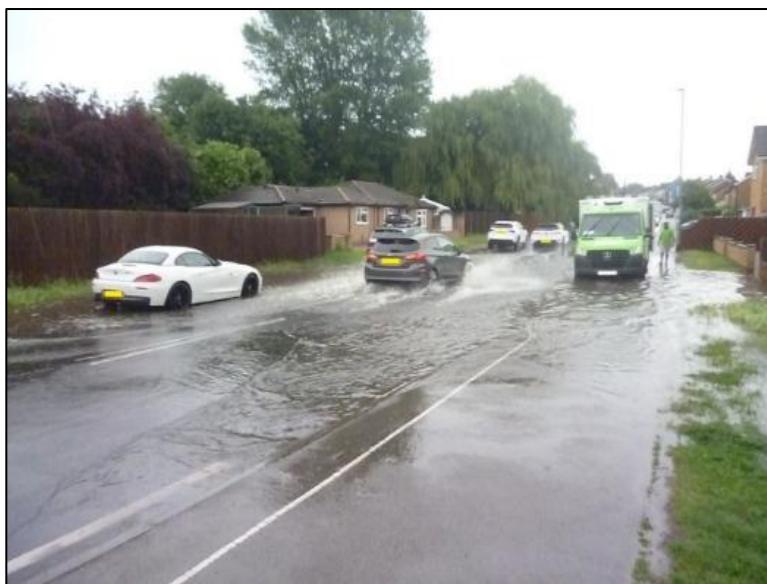
Photograph 16: Flooding along Rosemead Drive

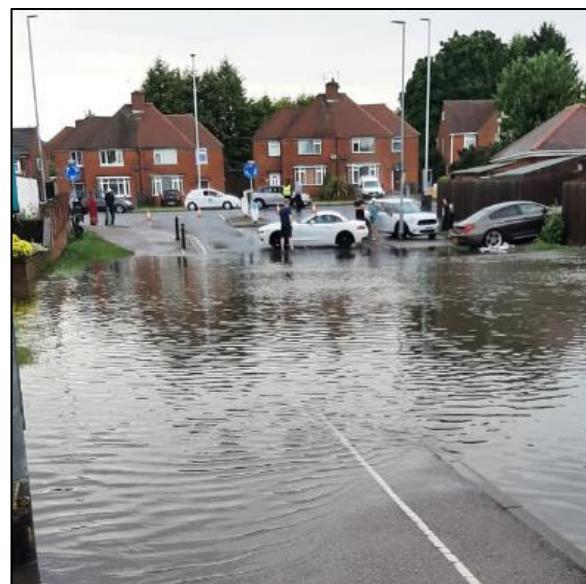
Photograph 17: Flooding along Rosemead Drive

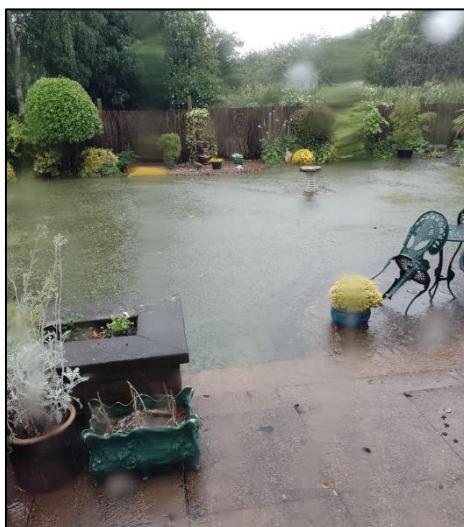
**Photograph 18: Flooding in rear garden along Foxhunter Drive**

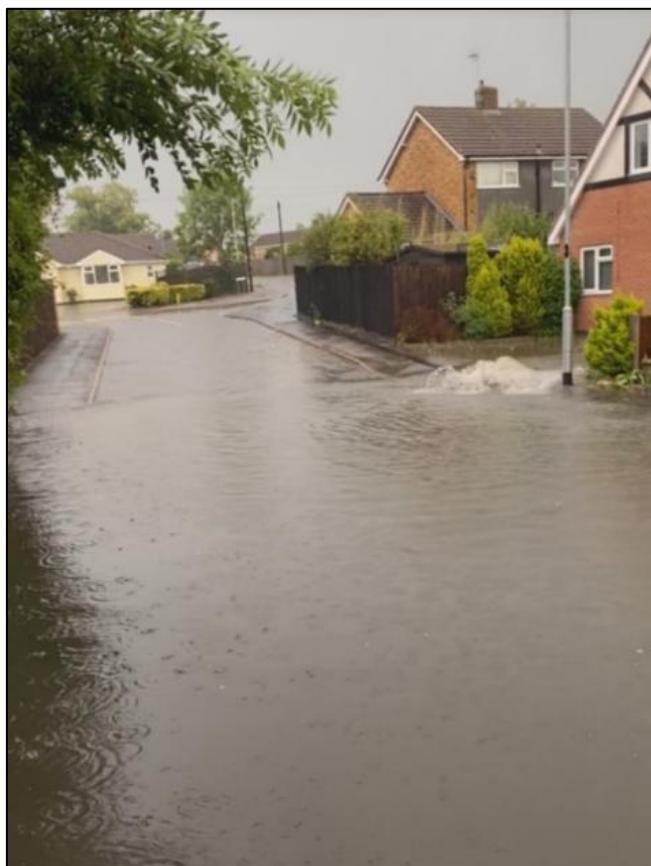
**Photograph 19: Flooding and surcharged surface water network gully, Badgers Holt**

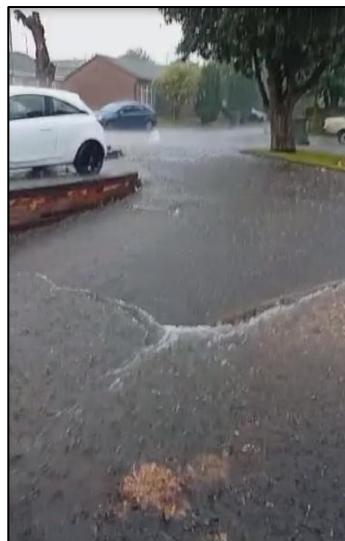
This initially resulted in external flooding to driveways and gardens on residential properties, as depicted in Photograph 20. This also resulted in internal property flooding at two properties on the northern side of the highway, where property thresholds were lower than the highway. Internal water levels were described as reaching the top of skirting boards.

**Photograph 20: Flooding along Wheatland Close**

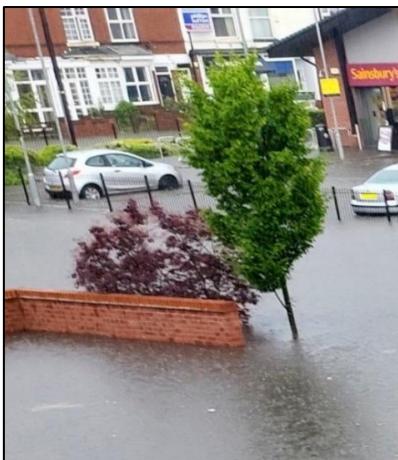
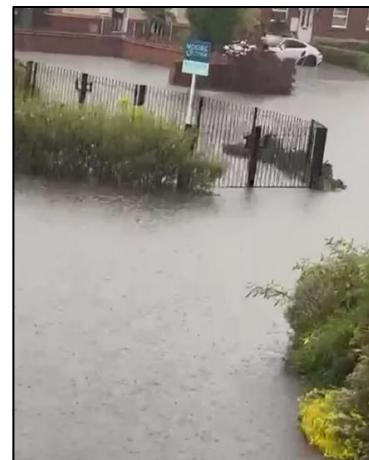
Photograph 21: Flooding at Peacock Place    Photograph 22: Flooding at Peacock Place

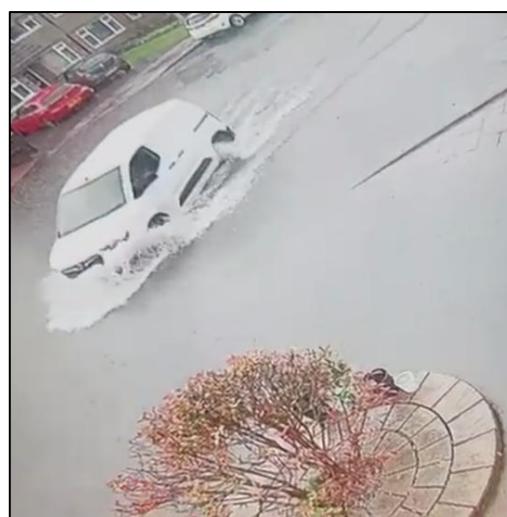
Photograph 23: Flooding at Seaton Road

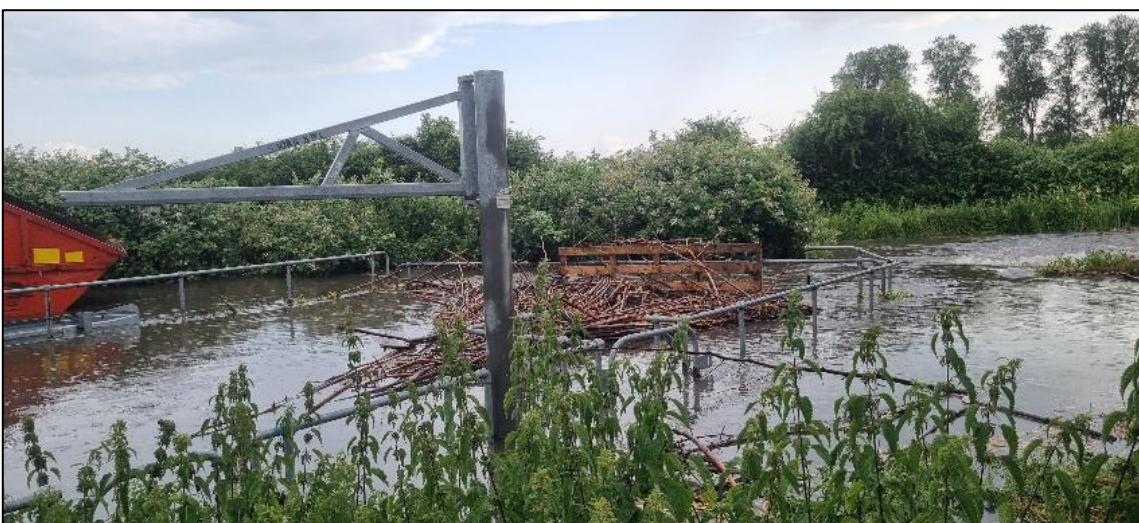
STW regularly inspect this screen and remove identified blockages. A site inspection confirm it was clear at the end of May 2023. Another site inspection conducted by STW shortly after the event identified a significant amount of new vegetation and urban debris mobilised by the floodwater blinding the screen, causing a partial/full blockage of the siphon inlet (Photograph 24). This caused raised water levels upstream of the screen as it reduced the capacity of the culvert inlet impacting the hydraulic performance of the culvert and slowed down the flow of water. High water levels observed around the River Sense confluence shortly downstream also overwhelmed this storm drain as water was unable to discharge. Subsequently, fluvial flooding was incurred to rear gardens along Narrow Boat Close due to overtopping of the east bank (illustrated by the blue flow arrows in Figure 11).

**Photograph 24: Blinded screen on storm drain south east of Narrow Boat Close**

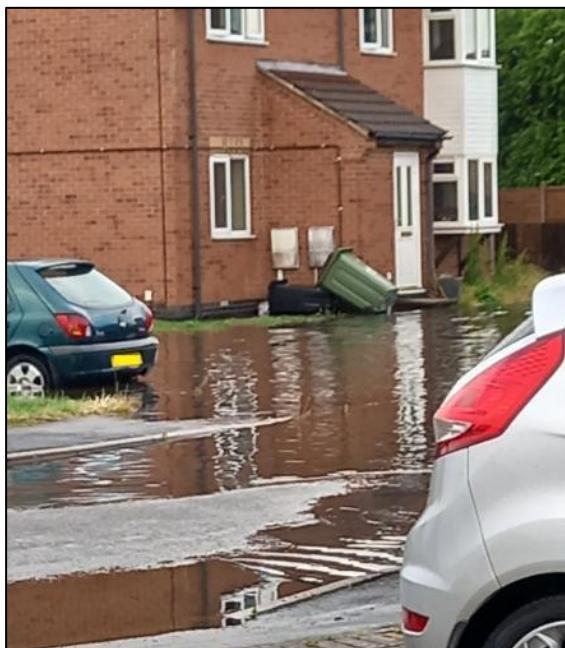
**Photograph 25: Flooding along Narrow Boat Close**

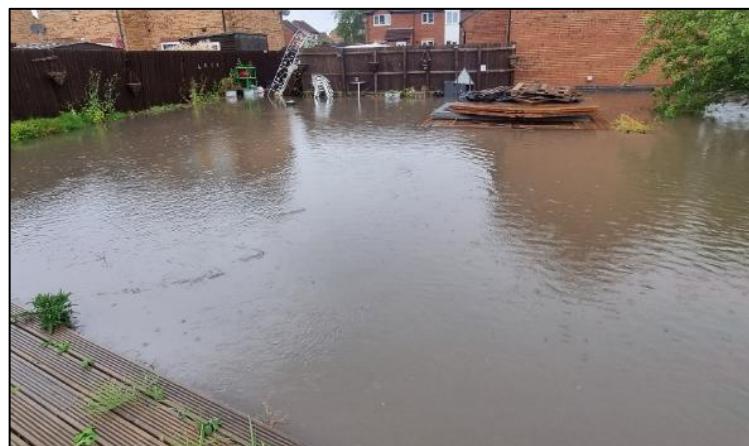
**Photograph 26: Flooding to rear garden along Narrow Boat Close**

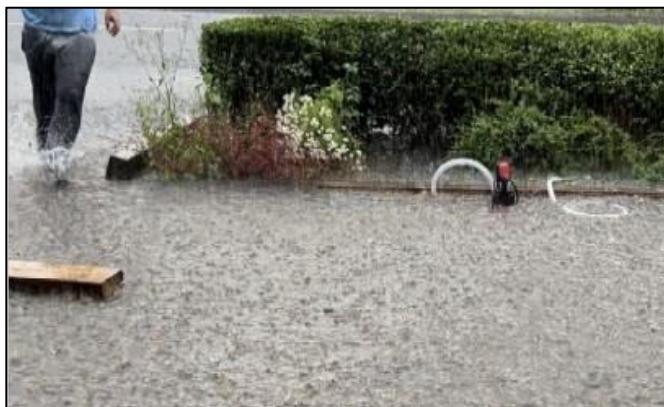
**Photograph 27: Flooding in front garden along Aylestone Lane**

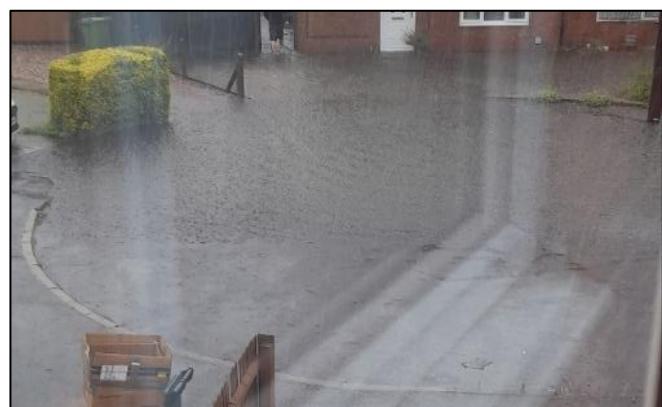
**Photograph 28: Flooding along Dukes Close**

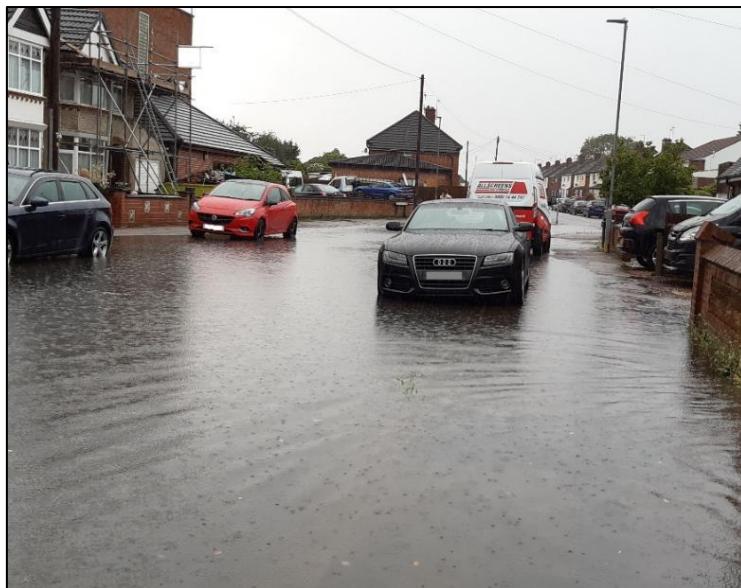
This resulted in excess surface water accumulating and pooling in the road close to the junction with Barnby Avenue to ankle depths as depicted in Photograph 29. It then overtopped the kerbs spilling into the driveways and gardens of four residential properties flooding them externally, and exceeding the thresholds of an additional five properties, flooding those internally.

**Photograph 29: Flooding along Burleigh Avenue**

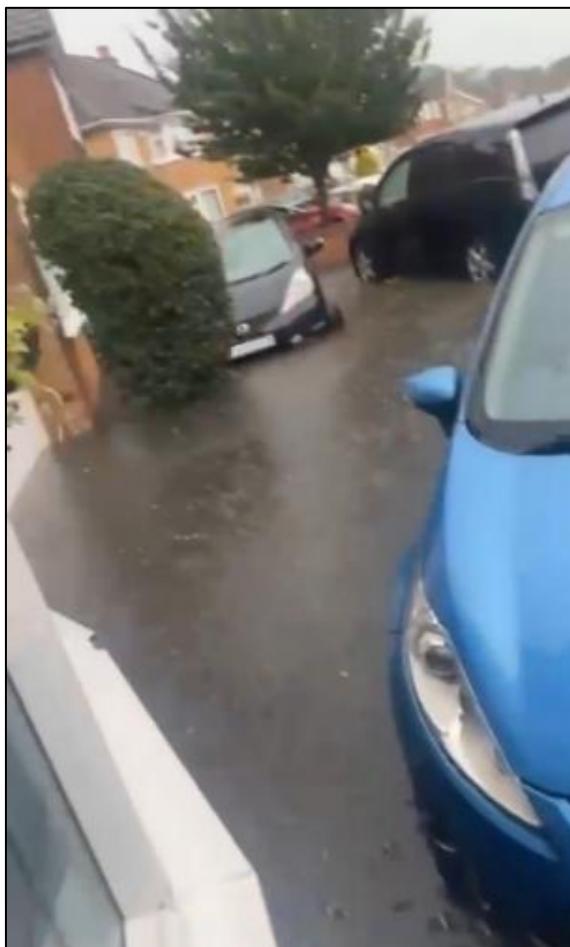
**Photograph 30: Flooding along Ruskington Drive**
