Flood Investigation Report

Storm Henk

2nd January 2024

Asfordby and Asfordby Valley

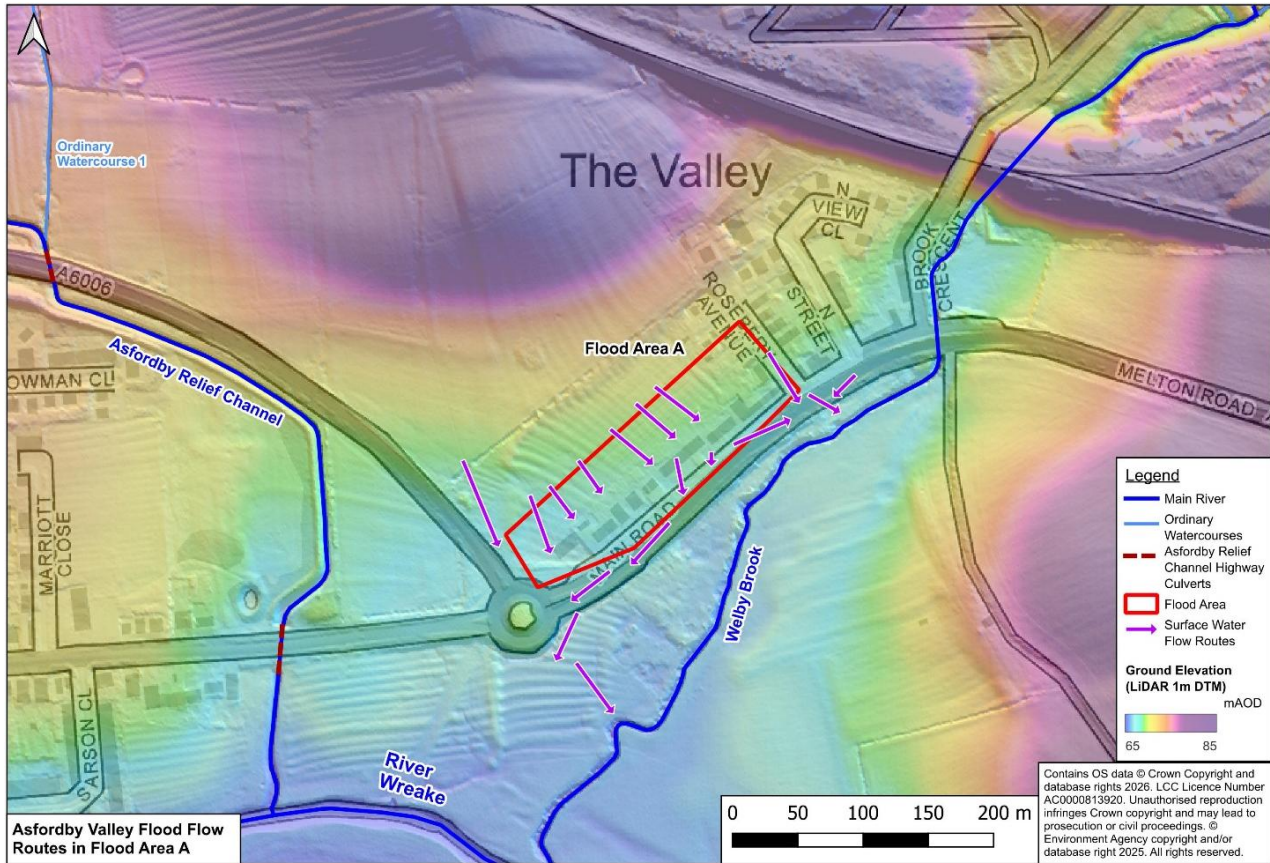
Figure 12-2: Asfordby Valley Flow Routes through Flood Area A (INSET 5)

The two affected properties along the A6006, the Valley reported surface water flowing over the fields in a southerly directly towards the rear of their properties and then onto the A6006. It is therefore understood that the primary source of flooding here was not from Welby Brook Main River, but was a result of intense rainfall generating a large volume of overland flow of surface water runoff within fields to the north of the A6006 that followed the local ground levels downhill towards the brook (Figure 12-1). It was reported that floodwater entered one property from the rear via air bricks causing internal flooding. The second property reported that they experienced external property flooding to the rear.

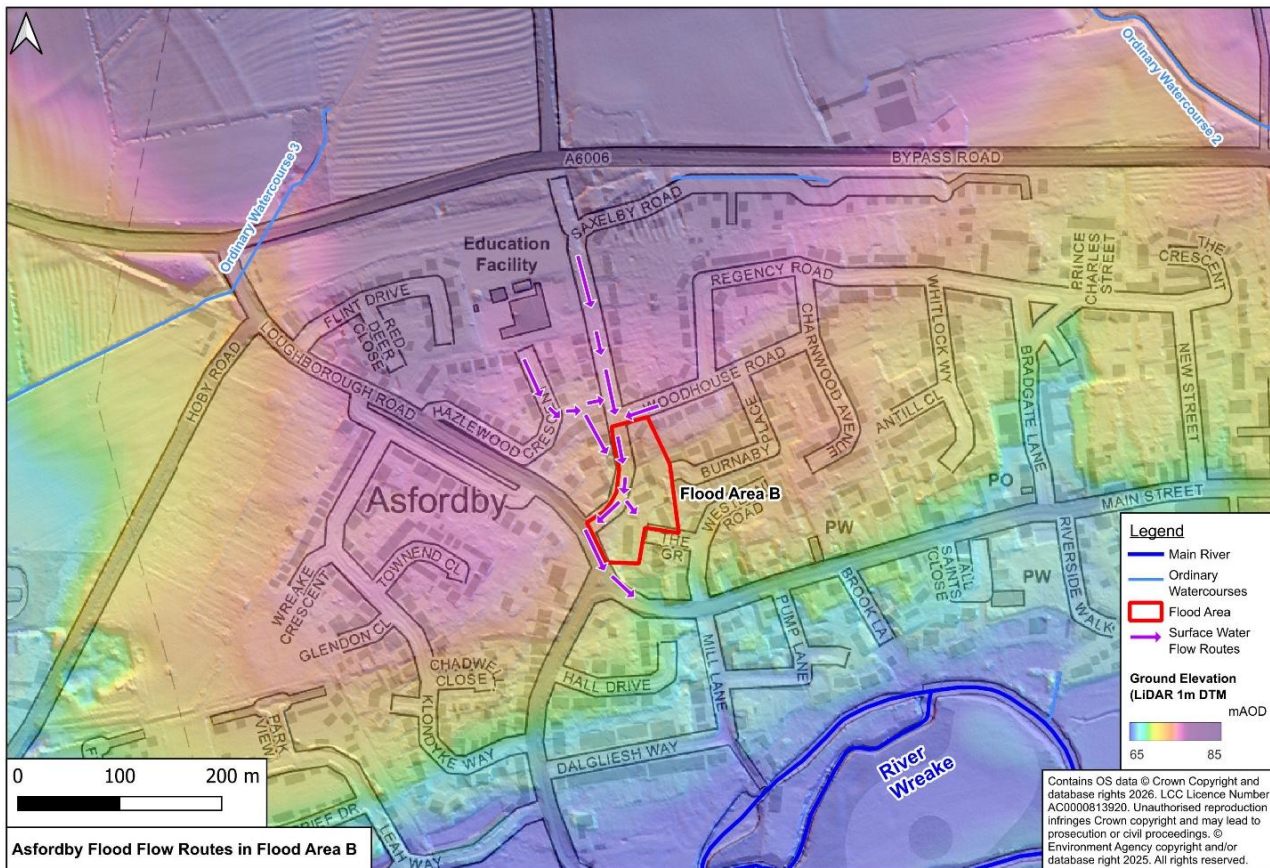
Figure 12-3: Asfordby Flow Routes through Flood Area B (INSET 5)

Internal flooding was reported at one property and external flooding at two properties on Saxelby Road during the Storm Henk event.

As part of the investigation, a report was received of blocked highway drainage on Saxelby Road. A review of the drainage in this area has identified a 225mm diameter (dia) STW public surface water sewer and a 150mm dia STW public surface water sewer draining Saxelby Road in Flood Area B. These surface water sewers join and proceed southwards beneath Main Street and Mill Lane before out-falling into the River Wreake at OSNGR SK 70575 18757. A small number of highway gullies are present along Saxelby Road, south of the A6006 Bypass Road, including two at the junction of Saxelby Road with Woodhouse Road which connect in the STW public surface water sewer.

A site visit by Leicestershire County Council (LCC) Local Highways Authority (LHA) was undertaken after Storm Henk to verify the presence or source of any blockages. A highway gully was confirmed to be blocked and required cleansing at the southern extent of Saxelby Road. However, anecdotal reports were received that residents had already unblocked this gully during the event which reportedly managed to limit the impact from the flood event.

It is therefore concluded that the intense rainfall event generated a large volume of overland flow of surface water on the highway that followed the local ground levels downhill southwards along the easiest route of the highway (as illustrated in Figure 12-1). It then ponded at the bottom of the hill where the limited highway drainage was overwhelmed, a gully became blocked, and was unable to drain the water away sufficiently. Ponded floodwater then accumulated and exceeded the threshold of one adjacent property, located at a low point, via their driveway flooding it internally. Two additional properties also flooded externally as a result of water flowing down Saxelby Road. The location of these coincides with the area at high risk along Saxelby Road identified in the RoFSW map (Figure 12-5).

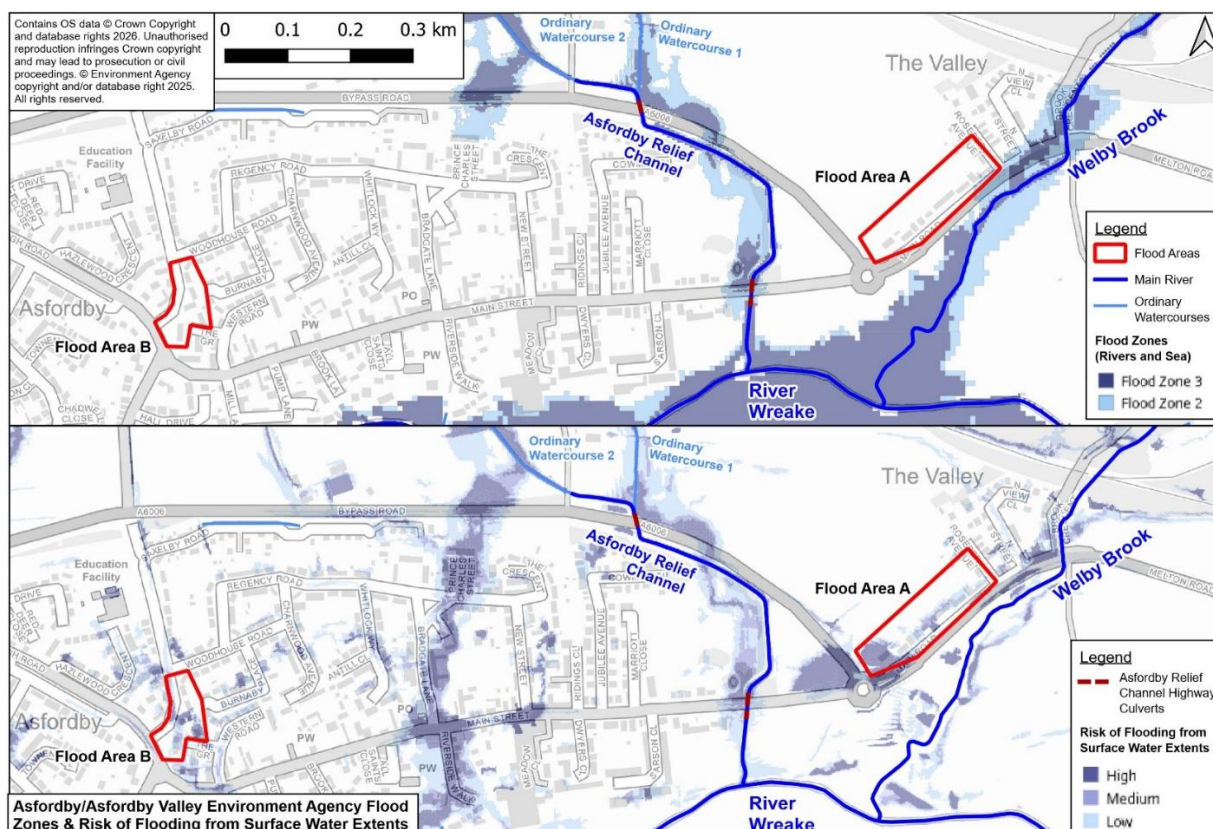
Figure 12-5: Asfordby and Asfordby Valley EA Flood Map for Planning Flood Zones³ and Risk of Flooding from Surface Water Extents⁴ in Flood Areas (INSET 5)

Flood Area A north of Main Road is entirely located within Flood Zone 1 (low risk of river flooding) from Welby Brook. However, the central and south-western extent of Flood Area A is located within an area identified as being at medium to high risk of surface water flooding.

Flood Area B at Saxelby Road is located within Flood Zone 1 from the River Wreake (low risk) of river flooding and within an area identified as being partially at a low, medium and high risk of surface water flooding, and within as illustrated in Figure 12-5.

During the high-intensity rainfall event on 2nd January 2024, the land drainage quickly became overwhelmed. Pre-existing soil saturation within agricultural land rapidly reduced infiltration capacity, resulting in accelerated surface runoff towards the River Wreake. The flooding which occurred in Flood Areas A and B closely matches the predicted outlines of the EA's RoFSW mapping, as shown in Figure 12-5.
