# **Flood Investigation Report**

Storm Henk

2<sup>nd</sup> January 2024

**Fleckney**

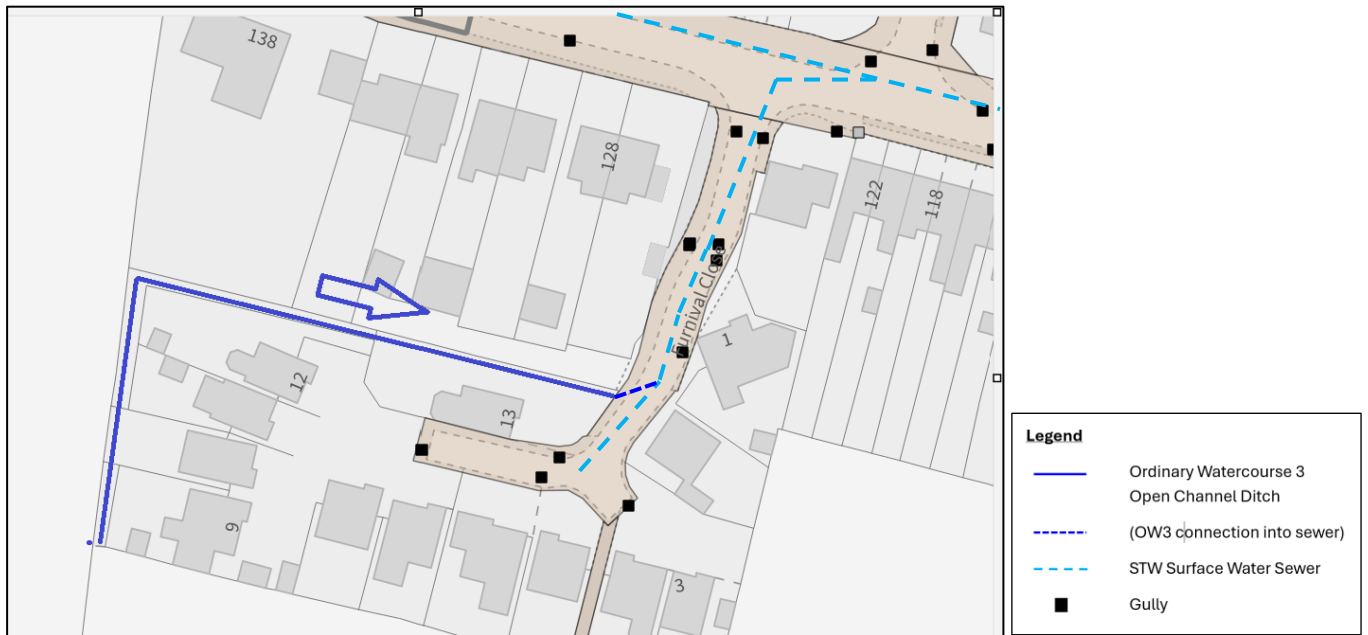
**Figure 15-3: Ordinary Watercourse 3 at Furnival Close**

described to enter Ordinary Watercourse 3, then proceed towards the culvert inlet to the STW public sewer system on Furnival Close, as illustrated in Figure 15-3.

Water was described to overwhelm the watercourse and overtop onto the 'jitty' (a privately owned access track to garages for properties on Kilby Road, adjacent to Furnival Close). Flooding continued towards Furnival Close where it pooled and flowed to the natural low point around a residential property. This property was surrounded and flooded internally from both the front and rear as the garden is walled and so it is likely that this stopped the water from flowing on further and increased the depth of flooding.

Anecdotal reports stated that in Furnival Close, highway drainage was originally taking water away but then they backed up and water rose (surcharged) out of gullies during the event. The highway drainage system connects onto the STW public sewer system at this location. Typically, road drainage networks are designed to accommodate limited rainfall event on the contributing area of highway itself, but not for any additional volumes of overland flow originating from land adjacent to the highways, or overtopping onto them from watercourses, as occurred here.

Following Storm Henk, STW conducted a camera survey of the public sewer network at this location and found it to be clogged with debris, this has since been jetted and cleared. It is highly likely that some of this material was mobilised and washed down during the flood event. No reports of any blockages were made to LCC or STW prior to Storm Henk. If the STW public sewer system became obstructed, then this could have impacted the gullies being able to effectively drain the highway and potential surcharging. A collapsed drain was also identified at the junction of Furnival Close and Kilby Road, this has since been rectified by STW but at the time could have also contributed to the flooding of the sewer network initially.

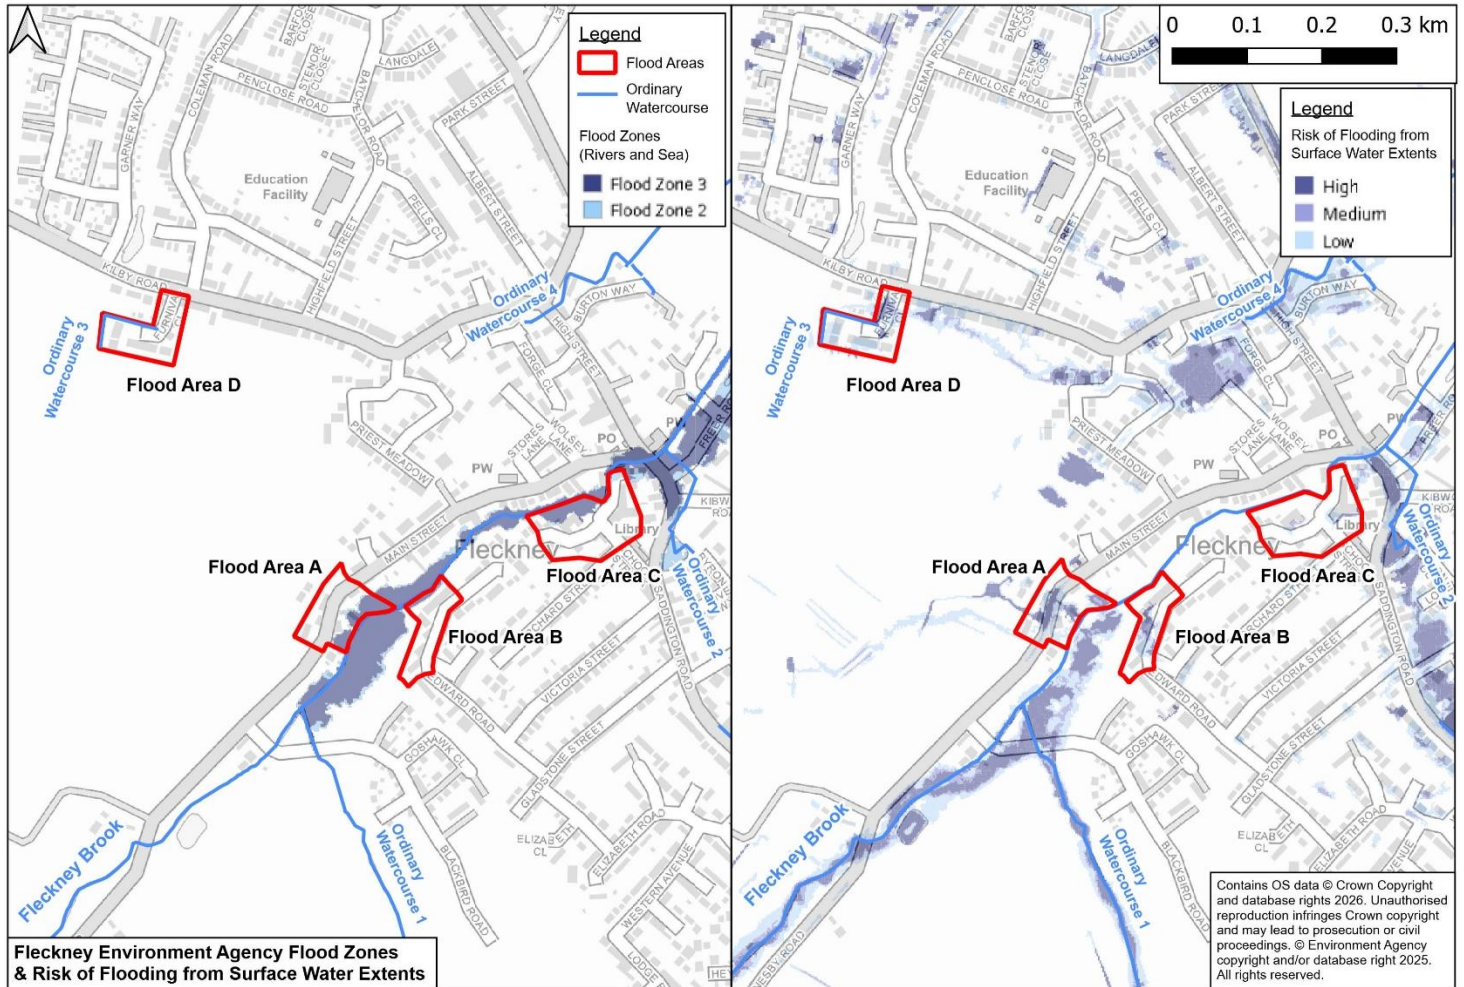
Figure 15-4: Fleckney EA Flood Map for Planning Flood Zones<sup>3</sup> and Risk of Flooding from Surface Water Extents<sup>4</sup> in Flood Areas (INSET 14)

Flood Area A, B and C are illustrated in Figure 15-4 as also being at low to high risk from surface water flooding. Surface water was reported to have originated off land to the north of Arnesby Road (some of which is ridge and furrow which would have exacerbated channelling of surface water towards the road), entered onto Main Street and headed towards Fleckney Brook (close to the Blackbird Road attenuation pond). One additional property on Main Street is believed to have been flooded internally from the rear due to runoff from the fields.

Regardless of any obstructions, the sheer volume of rainfall that fell during the event would have overwhelmed the entire drainage network including the public sewer network. The flooding at Furnival Close closely matches with the areas identified by the EA's surface water flood map (Figure 15-4) with properties and the highway in this area being identified as being at low, medium and high risk of surface water flooding.

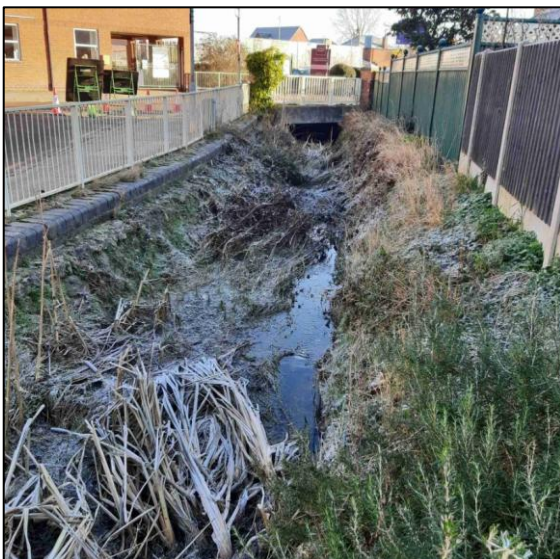
Anecdotal reports were made of overgrown vegetation within Fleckney Brook adjacent to the Baptist Church and also just downstream on the Howlett Road development site. No evidence has been found by Leicestershire County Council (LCC), the Lead Local Flood Authority (LLFA), to indicate that overgrown vegetation increased the number of properties that internally flooded, although it is possible it may have increased the extent of flooding locally.

**Photograph 15-1: Fleckney Brook alongside Main Street looking downstream (near the junction with High Street) before channel maintenance**

Recognising the heightened concerns of the community following the flood event (despite the section of watercourse being privately owned) as a gesture of goodwill, the Local Highways Authority (LHA) conducted some channel maintenance at this location on 25<sup>th</sup> October 2024 (see Photograph 15-1 before and Photograph 15-2 after maintenance was completed). This work was completed with the key aim of improving conveyance within the watercourse to allow the highway drainage to outfall more efficiently. Following Storm Henk, Fleckney Parish Council also undertook clearance works on Fleckney Brook to help improve conveyance and this includes sections alongside the development compound at Howlett Road.

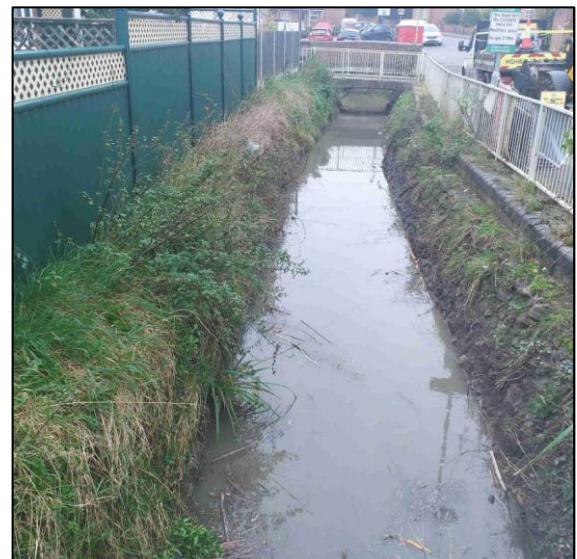
**Photograph 15-2: Fleckney Brook alongside Main Street looking upstream (near the junction with High Street) after channel maintenance**
