# **Flood Investigation Report**

Storm Henk

2<sup>nd</sup> January 2024

**Frisby on the Wreake**

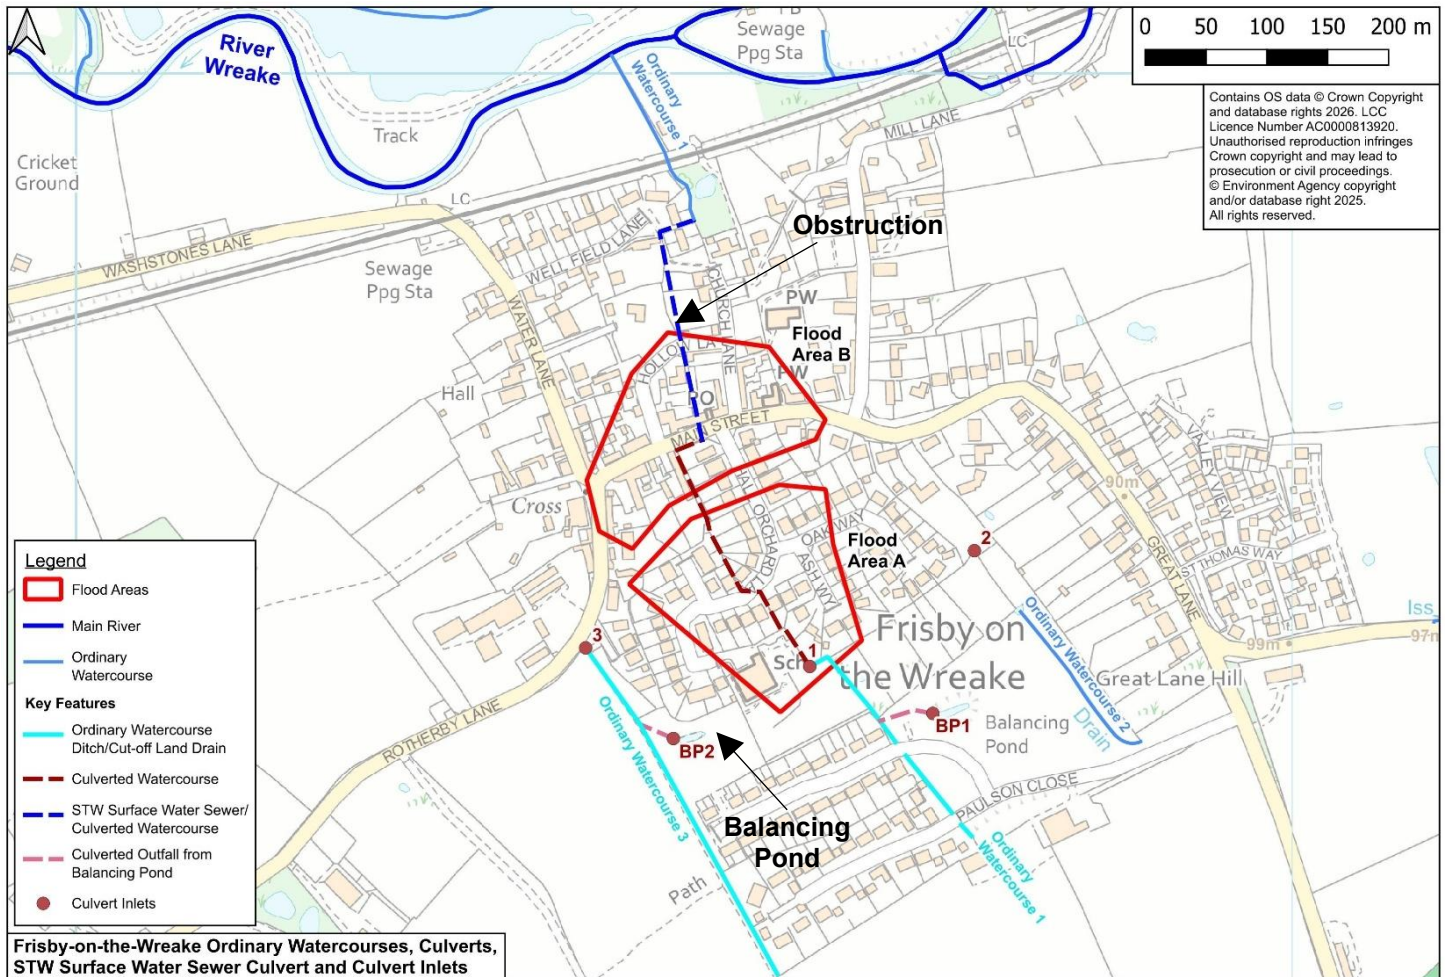
**Figure 6-2: Frisby on the Wreake locations of culverted watercourse and key features (culvert inlets, balancing pond (BP) outfalls and obstruction in public surface water sewer)**

Following the flood event, STW commissioned a camera and cleanse of the public sewer network in the village. This included the section of 600mm brick culvert flowing north from the centre of the village to its outfall. The survey could not be completed in its entirety due to a near complete obstruction of the 600mm brick culvert due to a root mass near Hollow Lane. This obstruction was later removed, with an access manhole installed in Hollow Lane to improve future maintenance access. STW were not aware of this obstruction prior to Storm Henk and had received no reports of any concerns relating to this culvert prior to the flood event. It is therefore not known how long the obstruction had been present or to what extent it covered the culvert before the flood event. No previous reports of flooding were made to either STW or LCC, suggesting there may not have been a complete obstruction.

It is believed that the obstruction in the 600mm brick culvert most likely caused the local drainage network upstream of this obstruction to surcharge, via existing manholes and the highway drainage system as the water could not get away quick enough. No evidence was found during the investigation of any further obstructions downstream and the outfall of the culvert was also found to be unimpeded.

ACTION	ACTION DETAIL	LEAD RMA	CURRENT STATUS
<b>Multi-agency Site Walkover</b>	Following Storm Henk, multi-agency site walkovers were undertaken on 5 <sup>th</sup> , 18 <sup>th</sup> , and 30 <sup>th</sup> January 2024 to witness the devastation and collect information to help identify actions to help mitigate future flooding.	RMAs	Complete
<b>Local Highway Network Maintenance</b>	Following the event, LCC, as the Local Highways Authority (LHA), completed a reactive cleanse of highway gulleys across the county, targeting affected areas and ensuring residual debris within catchments washed into the network was removed.  LCC LHA has raised gulleys on Water Lane and Well Field Lane from a Priority (P) 2 to a P1, the highest level of priority.	LCC LHA	Complete
<b>Public Sewer Asset Improvements</b>	STW surveyed the culvert running north from Main Street and found a significant root mass. This was removed after the event, the culvert lined and an additional manhole installed for improved maintenance access.	STW	Complete

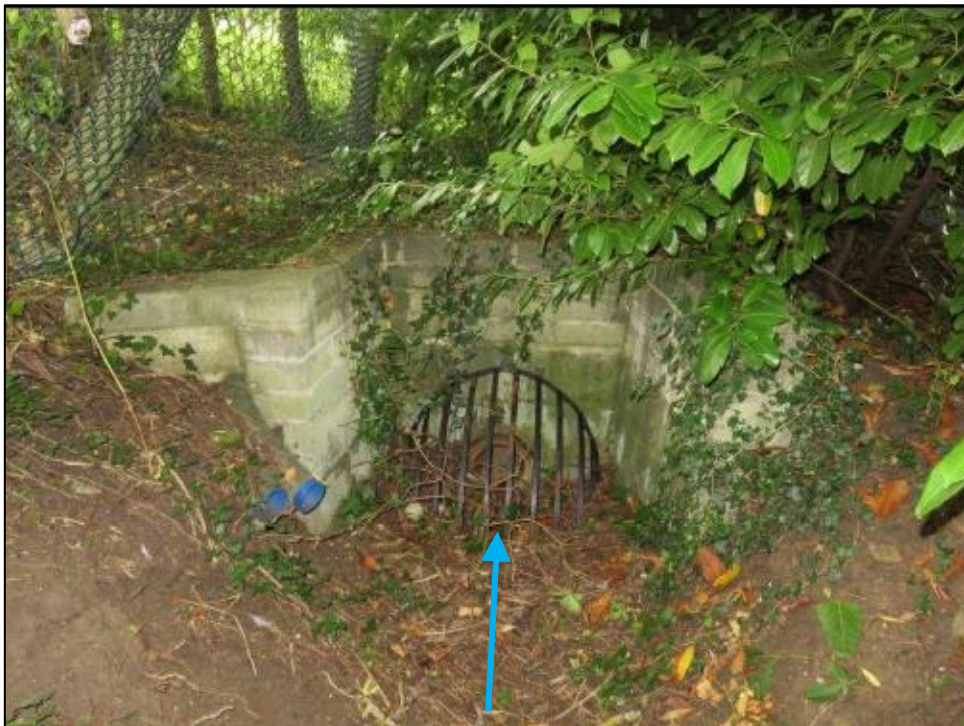
As it flows through the school land it then takes a 90 degree bend west before entering a 225 dia surface water culvert adjacent to the rear of gardens of properties along Ash Way (at OSNGR SK 69602 17512) (identified as Inlet 1 on Figure 6-2 and depicted in Photograph 6-1). The inlet to the culverted section is protected by an informal trash screen which is owned and maintained by Frisby C of E Junior School and the riparian landowner.

**Photograph 6-1: Culvert Inlet 1 at Downstream Extent of Ordinary Watercourse 1 at Frisby Church of England Junior School**

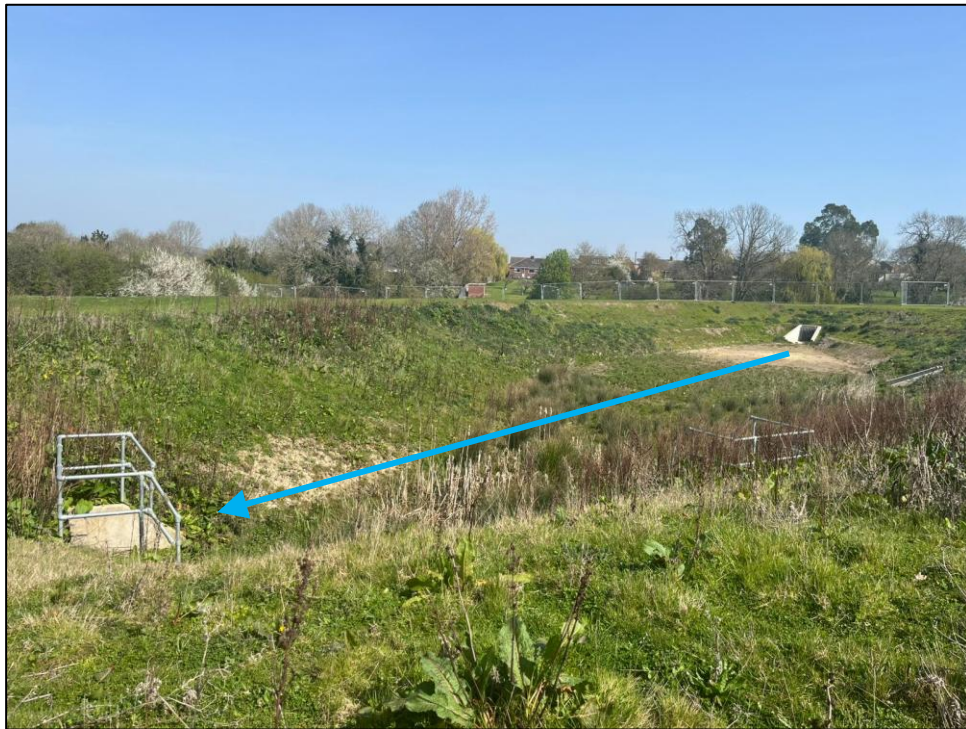
Surface water runoff collected from the Rotherby Manor development is directed into two balancing ponds where flows are attenuated. The eastern balancing pond (Photograph 6-2) discharges via an approved flow control chamber (identified as BP1 in Figure 6-2) (through a 375mm dia pipe into a HydroBrake followed by a 225mm dia pipe). This outfalls into Ordinary Watercourse 1 at the south east corner of the Frisby C o E Junior School playing field (at OSNGR SK 69666 17472).

**Photograph 6-2: Rotherby Manor Eastern Balancing Pond and Out-fall Headwall into Ordinary Watercourse 1**

Anecdotal reports were received by LCC LLFA stating that the development contributed towards the flooding and that the balancing pond were not functioning correctly. No evidence has been found to verify that this was the case. The balancing pond were not reported to be overtopping, whilst these and the flow controls discharging to Ordinary Watercourse 1 and Ordinary Watercourse 3 were investigated by the LCC LLFA and MBC following the event and were found to be constructed as per the approved designs.

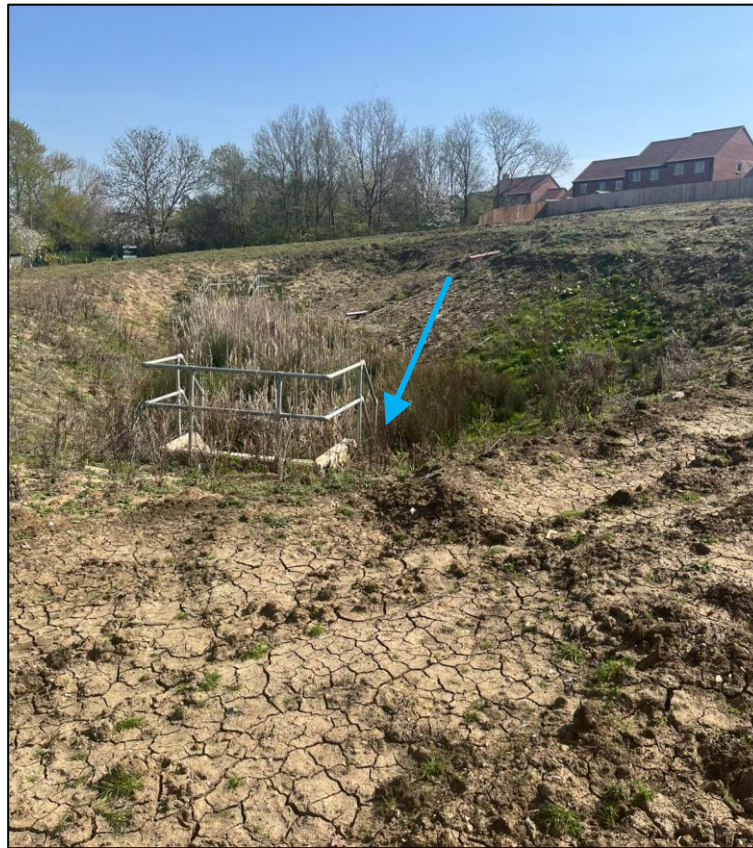
The western balancing pond (Photograph 6-3) discharges via an approved flow control chamber (identified as BP2 in Figure 6-2) (through a 450mm dia pipe into a HydroBrake followed by a 225mm dia pipe). This outfalls into Ordinary Watercourse 3 (described below) (at OSNGR SK 69461 17470) located to the west.

**Photograph 6-3: Rotherby Manor Western Balancing Pond and Outfall Headwall into Ordinary Watercourse 3**

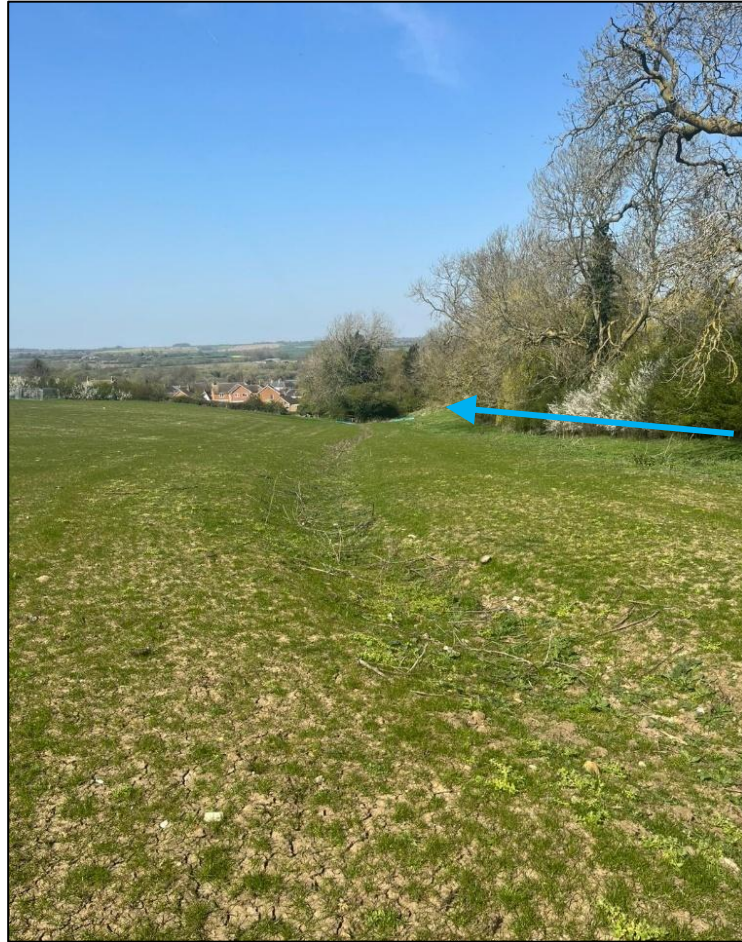
Unnamed Ordinary Watercourse 2 originates on the northern side of Robert Street as an open channel field ditch, as illustrated in Figure 6-2 and depicted in Photograph 6-4. Ordinary Watercourse 2 flows along the eastern perimeter of the Rotherby Manor estate before entering a pond where it is shown to cease in the OS mapping. It is understood however to proceed northwards, firstly via a continuation of the channel through the next field to the north, then into a 225 dia culvert located at the north-eastern corner of this field (identified as Inlet 2 in Figure 6-2 and depicted in Photograph 6-5). The inlet for this culvert has a trash screen. This culvert is understood to run beneath private gardens east of Oak Way towards Great Lane, along the course of the former natural channel as illustrated from historic mapping and as indicated by ground elevation data.

Photograph 6-4: Looking northwards towards Ordinary Watercourse 2

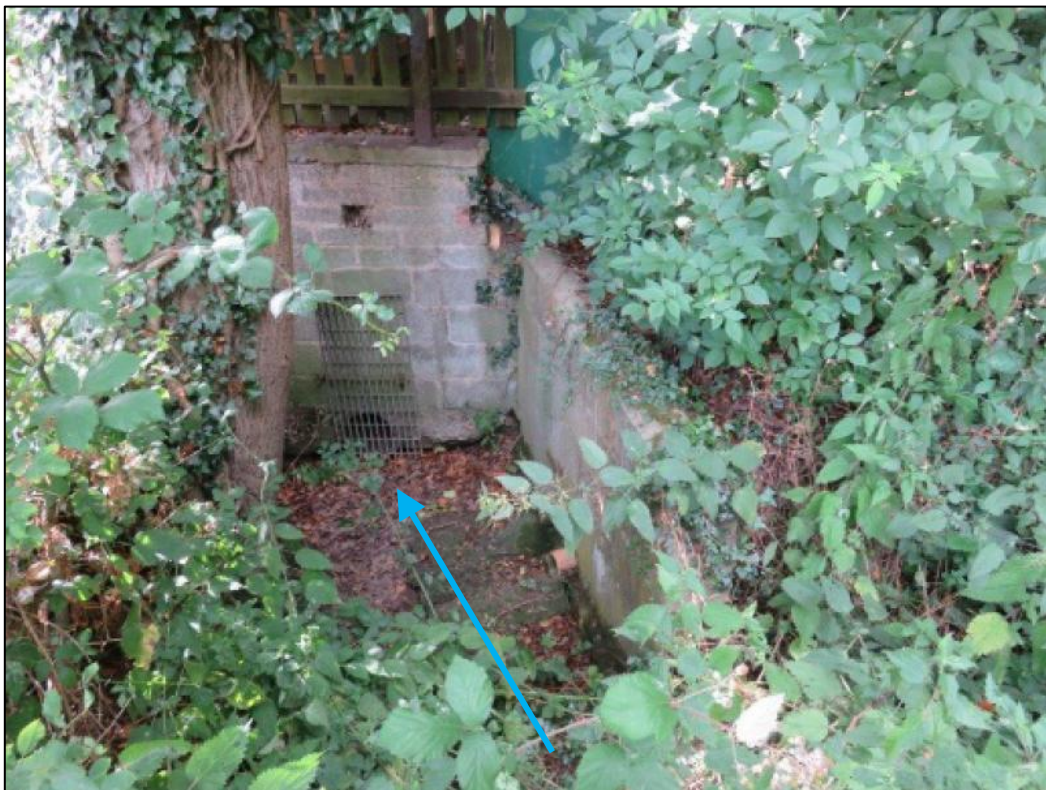
Photograph 6-5: Culvert Inlet 2 at Downstream Extent of Ordinary Watercourse 2

This culvert is believed to eventually connect into the STW 600mm dia brick arched surface water sewer in Main Street via a local culverted drainage network, but the exact alignment, condition and sizing of this is unknown so has not been illustrated on Figures within this report.

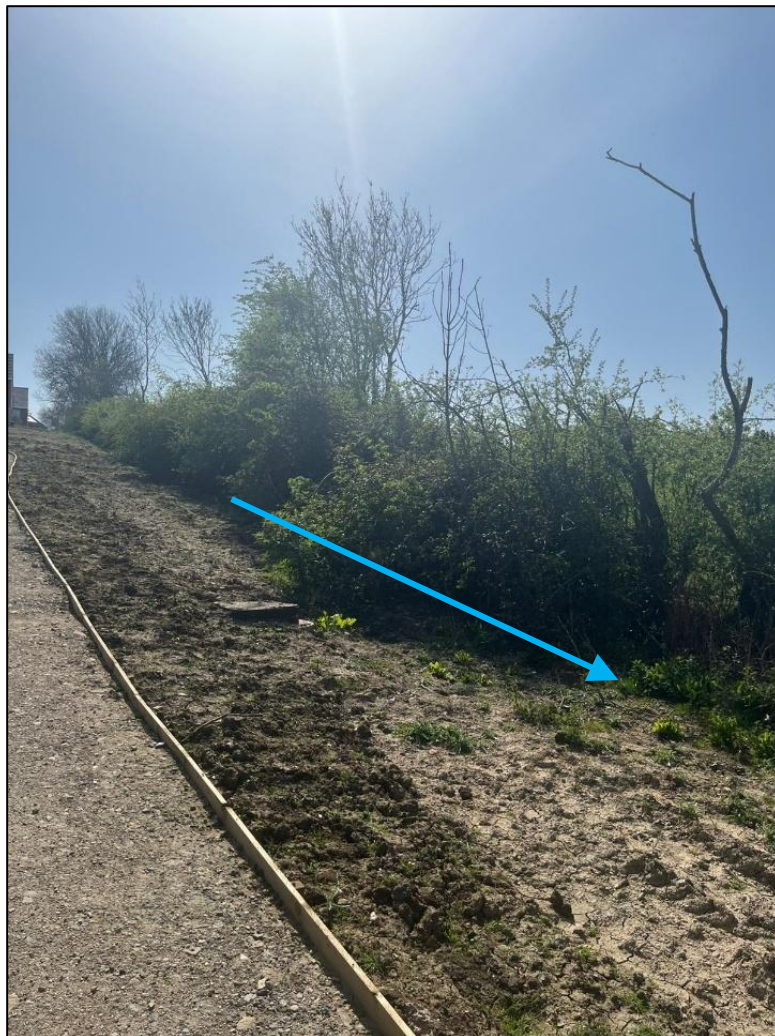
Unnamed Ordinary Watercourse 3 drains the agricultural fields to the west of Rotherby Manor, as illustrated in Figure 6-2 and Photograph 6-6. It comprises an open channel ditch which flows northwards and enters a piped highway drainage network beneath Rotherby Lane via a twin culvert inlet (one 150mm dia culvert and one 100mm dia culvert) with a trash screen, as illustrated in Photograph 6-7 (identified as Inlet 3 in Figure 6-2), at OSNGR 469424 317531 .

**Photograph 6-6: Looking southwards upstream along Ordinary Watercourse 3 from path south of Rotherby Lane**

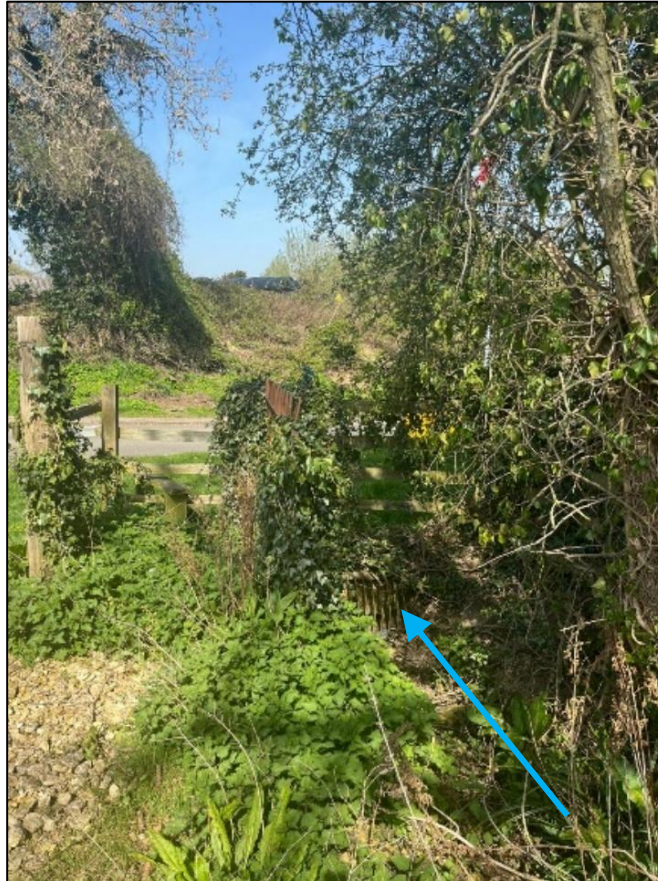
**Photograph 6-7: Twin Culvert Inlet at downstream extent of Ordinary Watercourse 3 on the southern side of Rotherby Lane looking northwards**

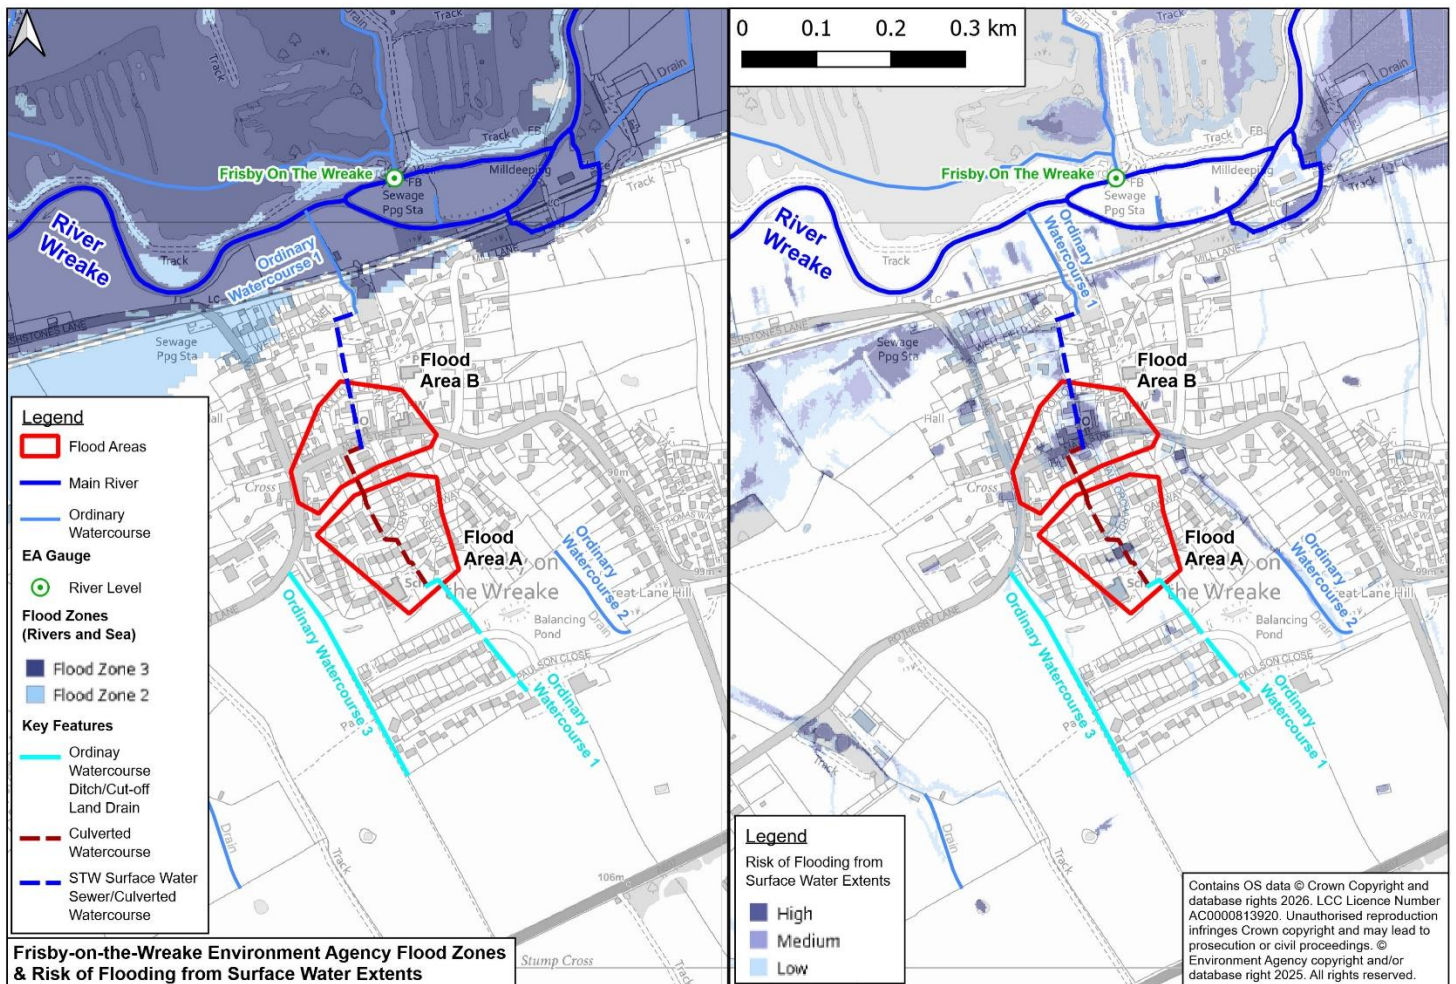
Figure 6-3: Frisby\_on the Wreake EA Flood Map for Planning Flood Zones<sup>5</sup> and Risk of Flooding from Surface Water<sup>6</sup> Extents in Flood Areas (INSET 4)

The flooding which occurred in Flood Area A closely matches the predicted surface water flooding as identified in the EA's RoFSW map illustrated in Figure 6-3.

The locations of internal flooding and flood extents which occurred in Flood Area B closely match the predicted surface water flooding as identified in the EA RoFSW, illustrated in Figure 6-3. The national RoFSW model (NaFRA2) does not provide detailed representation of below-ground drainage networks within the village, only an allowance for the losses for averaged infiltration rates they provide.
