Flood Investigation Report

Storm Henk

2nd January 2024

Glooston

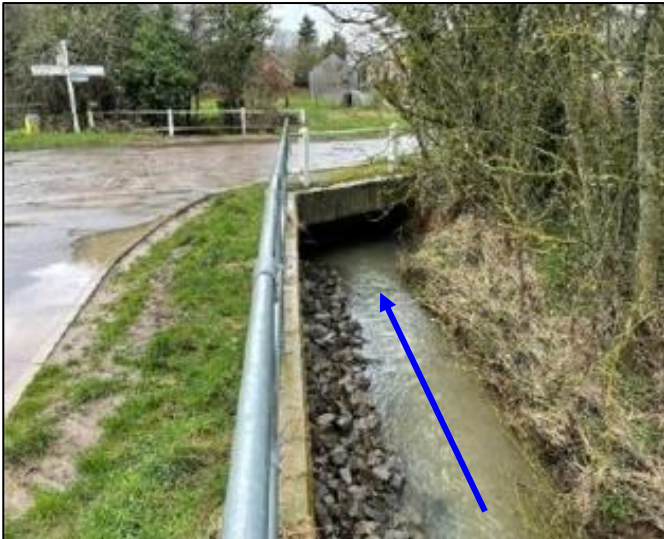
Photograph 7-1: Glooston Arm at the Harborough Road bridge culvert inlet looking downstream from Cranoe Road3

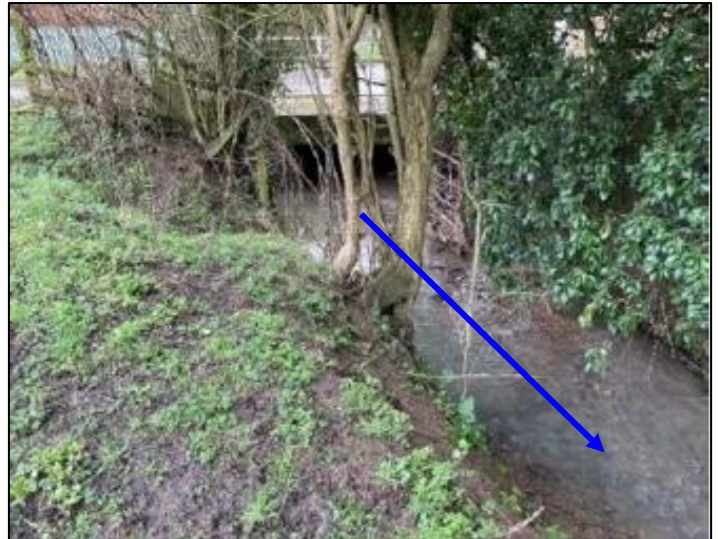
Photograph 7-2: Glooston Arm at the Harborough Road bridge culvert outlet looking upstream from Main Street3

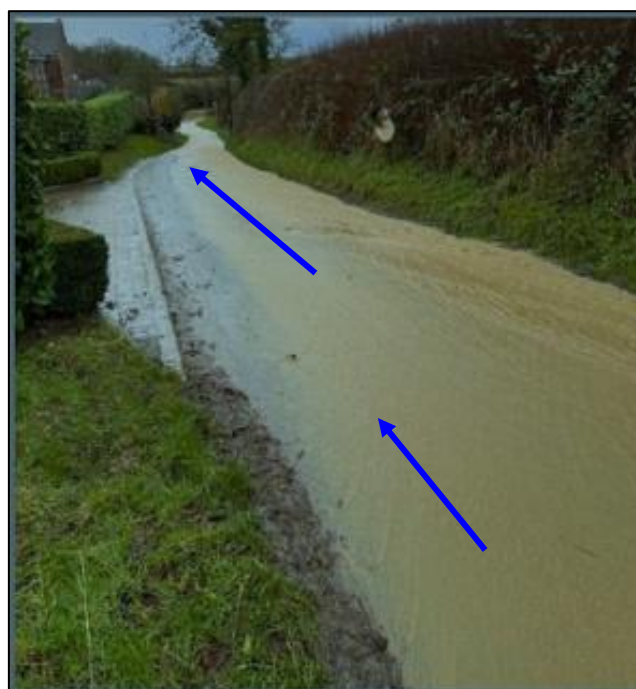
Surface water flowed off the fields in the surrounding agricultural catchment which exceeded the capacity of land drain ditches and tipped onto Goadby Road, Cranoe Road and Harborough Road. The capacity of drainage ditches running alongside these roads was also exceeded by the volumes of surface water runoff. These roads therefore acted as conduits for the flood water which headed towards the Harborough Road bridge as shown in Photograph 7-3. Properties along Goadby Road reported internal flood depths of approximately 350mm.

Photograph 7-3: Surface water flowing down Goadby Road towards Glooston village centre

ACTION	ACTION DETAIL	LEAD RMA	CURRENT STATUS
Highway Drainage Improvements	Install more grips on Goadby Road, Cranoe Road and Harborough Road to improve the efficiency of water removal from the highway during more frequent rainfall events.	LCC LHA	Complete – 23 rd September 2024 under job reference 666254: <ul style="list-style-type: none">Goadby Road – 4 grips north of 20th Godby Road

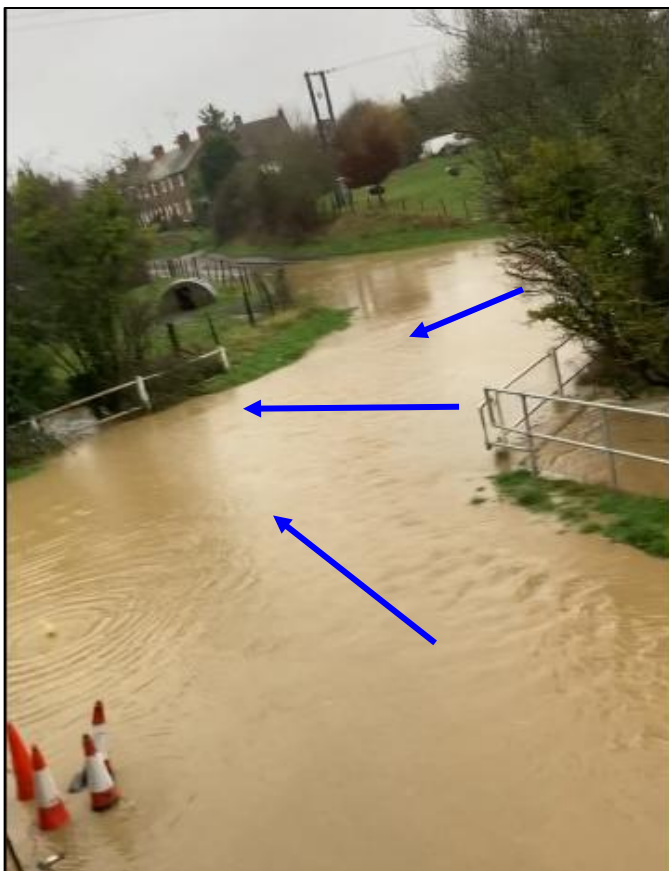
Out of bank flow, which had exceeded the capacity of the Glooston Arm channel and overtopped the bank thresholds, also progressed westwards down Cranoe Road towards the same location as shown on Photograph 7-4 and Photograph 7-5.

Photograph 7-4: View from Cranoe Road of Harborough Road bridge deck flooded looking downstream

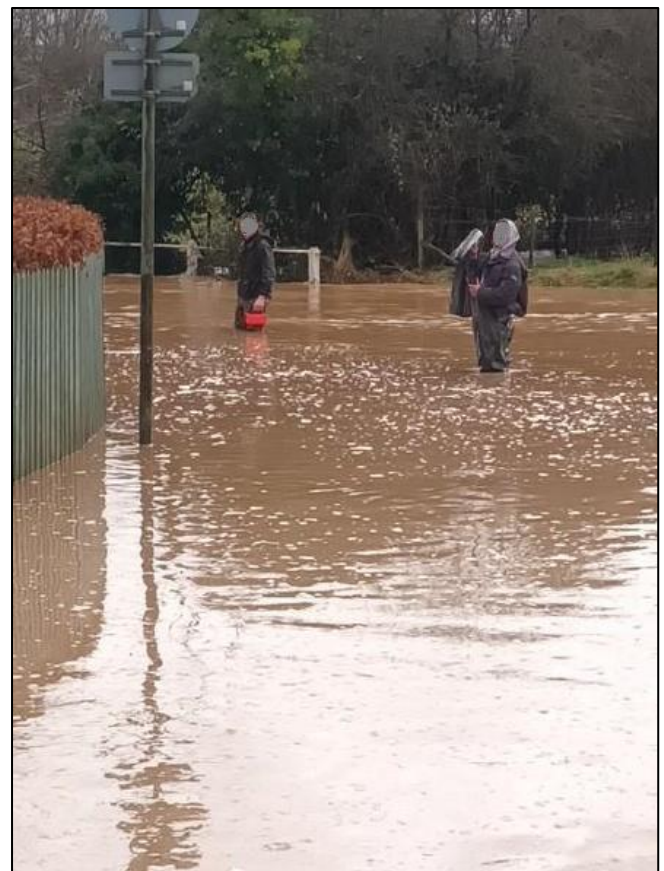
Photograph 7-5: Flooding at junction of Main Street and Goadby Road³

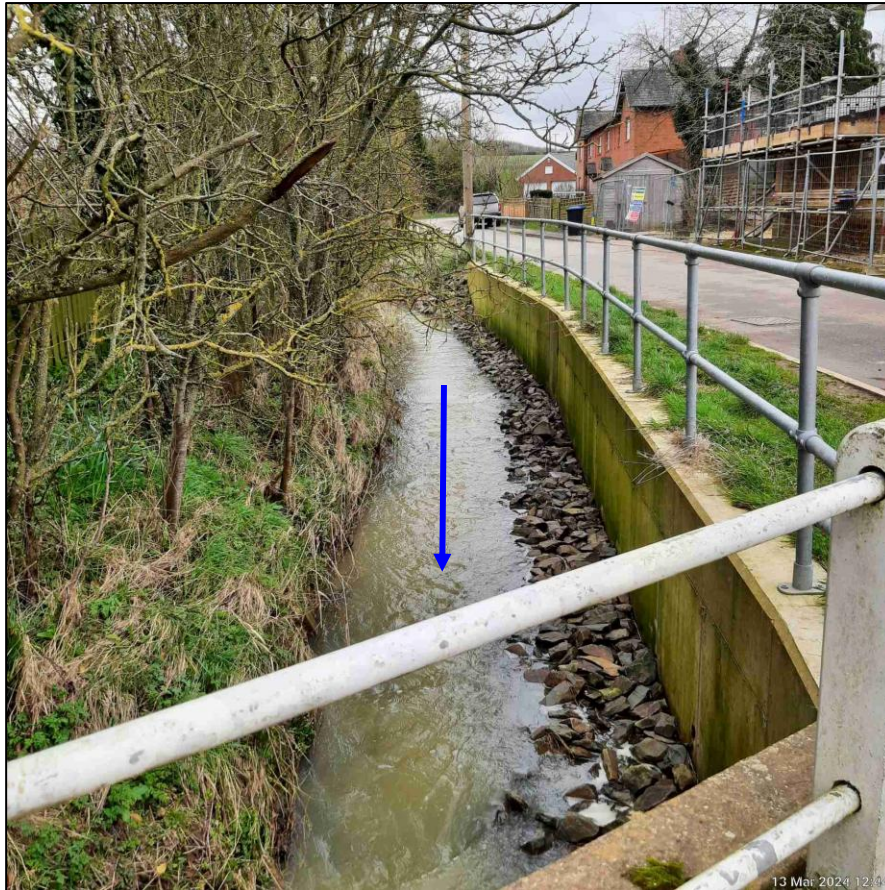
Historically, the bridge culvert was installed to replace an arched-bridge, and the south river bank (on the northern side of Cranoe Road) on approach to the bridge culvert was reinforced. A wall was installed with rip-rap (large rocks) (Photograph 7-6) to prevent erosion of the earth embankment that was exhibiting deterioration.

Photograph 7-6: Bank reinforcement upstream of Harbrough Road Bridge looking eastwards towards Cranoe Road

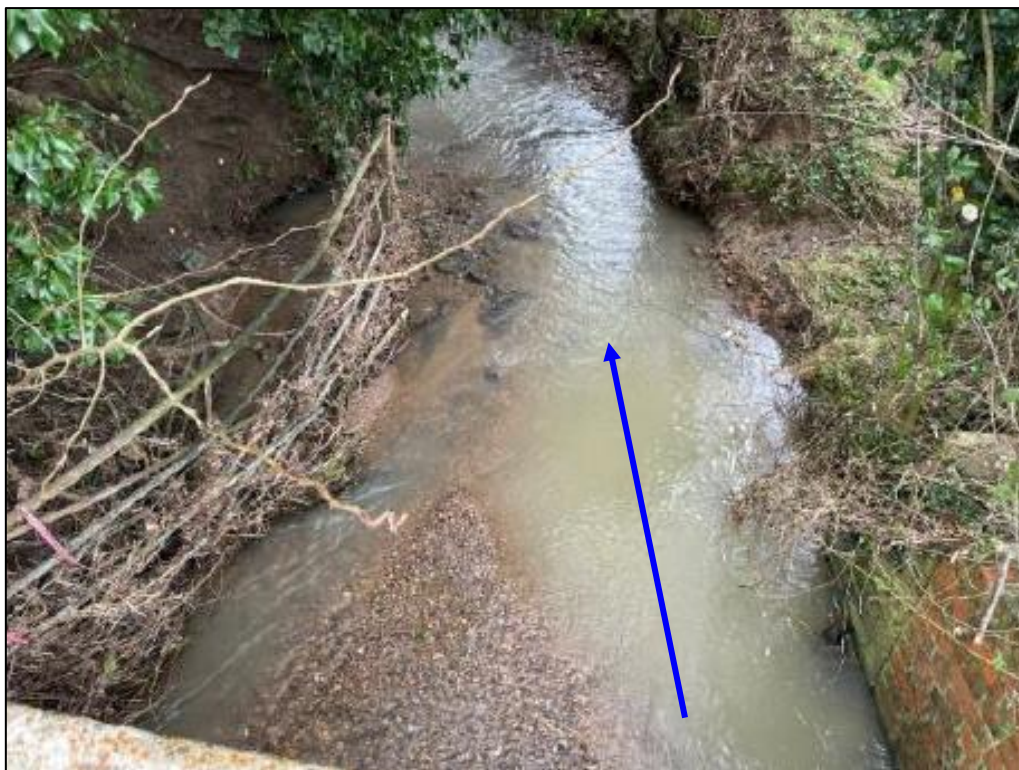
The Harborough Road bridge culvert itself, conveying the Glooston Arm, was observed during the flood event to be flowing at full capacity. The downstream extent of the bridge culvert was also observed to be significantly silted after the flood event (Photograph 7-7). A proportion of this may have been mobilised within the catchment, transported into the watercourse channel and deposited during the flood event as flow speed reduced. Leicestershire County Council (LCC), the Local Highways Authority (LHA), were not aware of any obstructions prior to the flood event.

Photograph 7-7: Silt deposition within the Glooston Arm on outlet of the Harbrough Road Bridge culvert looking downstream following the flood event³

ACTION	ACTION DETAIL	LEAD RMA	CURRENT STATUS
			<ul style="list-style-type: none"> • Cranoe Road – grips opposite Brookside Cottages and 3 more along approach into village. Main Street – 2 grips opposite Home Farm and concrete grip by finger post.
Riparian landowner engagement	Liaise with the riparian landowner of the channel immediately downstream of the culvert which runs under Harborough Road. Ensure any obstructions are removed to allow the culvert to convey its full design capacity.	LCC LLFA	Complete

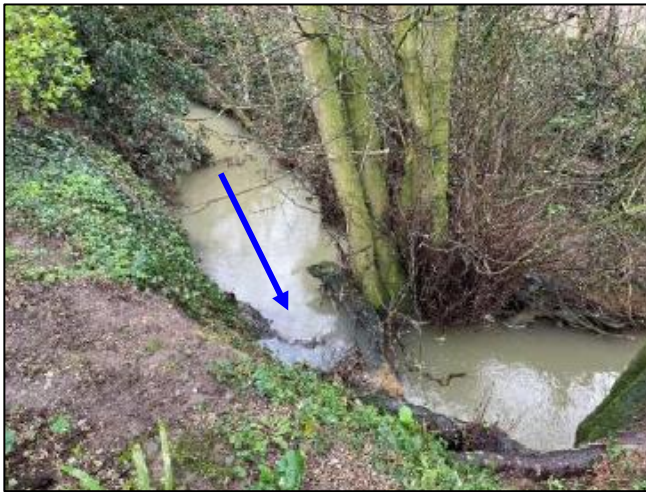
After the flood event, a site inspection in February 2024 identified minor vegetation and litter debris obstructions in the Glooston Arm channel exacerbated by tree roots on the bank sides (Photograph 7-8) and boundary fences that crossed the channel (Photograph 7-9). These likely reduced the channel conveyance capacity, locally raised water levels and re-routed flows in the immediate vicinity before they bypassed the obstruction and returned to the channel. These restrictions were not considered to be the primary cause of the flooding as the volume of runoff significantly exceeded the capacity of the drainage system. It is likely however that they exacerbated flooding close to their immediate location.

Photograph 7-8: Vegetation debris within Glooston Arm channel³

ACTION	ACTION DETAIL	LEAD RMA	CURRENT STATUS
Riparian landowner engagement	Inspect ditches adjacent to the highway with the respective landowners reminding them of their riparian responsibilities, to ensure that they are adequately maintained.	LCC LLFA	Ongoing
Ordinary Watercourse Conveyance Improvement Works	Ongoing engagement with riparian landowners to ensure proactive future maintenance to remove obstructions that may impede flows within the channel.	LCC LLFA	Complete

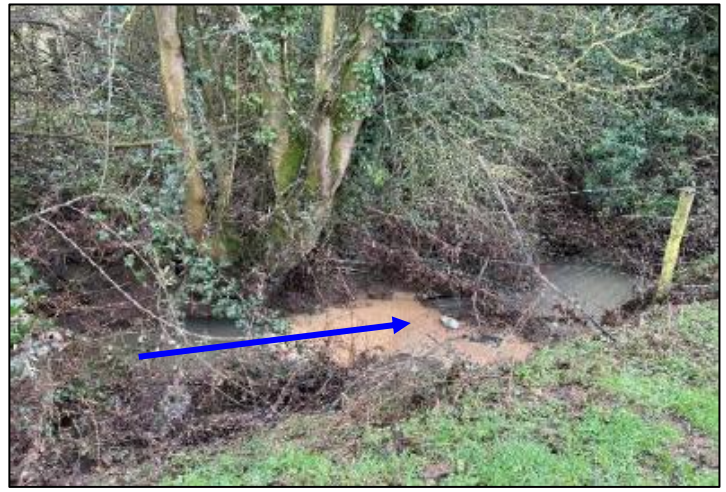
Photograph 7-9: Vegetation debris within Glooston Arm channel³

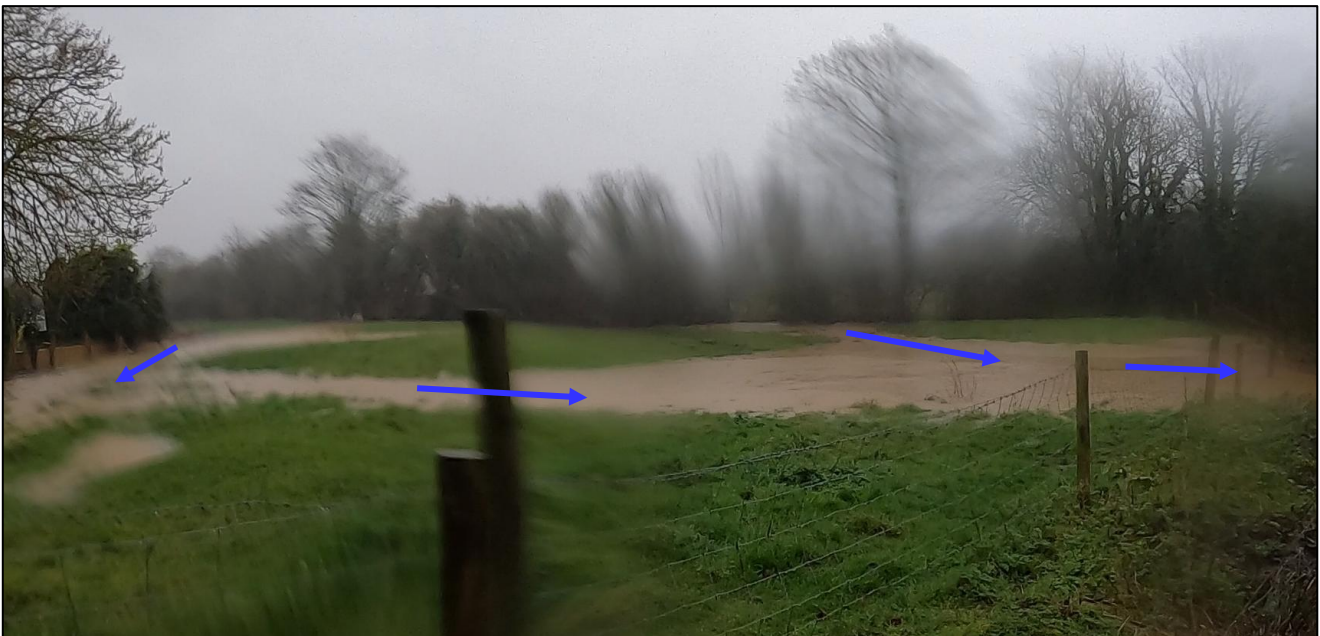
Just downstream of the Harborough Road bridge culvert, video footage taken during the Storm Henk event shows the flows from the Glooston Arm coming out of bank and flowing across a paddock, as depicted in Photograph 7-10. The fluvial flows appeared to be following a historic brook channel (paleochannel). The brook in this location appears to have been straightened when compared with other meandering sections nearby, and the historic channel is visible on LiDAR.

Photograph 7-10: Flooding of the Glooston Arm as overland flow across the paddock viewed from Bluebell Lane

ACTION	ACTION DETAIL	LEAD RMA	CURRENT STATUS
Natural Flood Management	Support with the community led opportunity for Natural Flood Management (NFM) measures in the upper catchments surrounding Glooston.	LCC LLFA, EA	Detailed design complete Consent application has been approved by LCC LLFA.
Flood Bund	Support with community-led proposals for a bund within the paddock area.	LCC LLFA	Ongoing

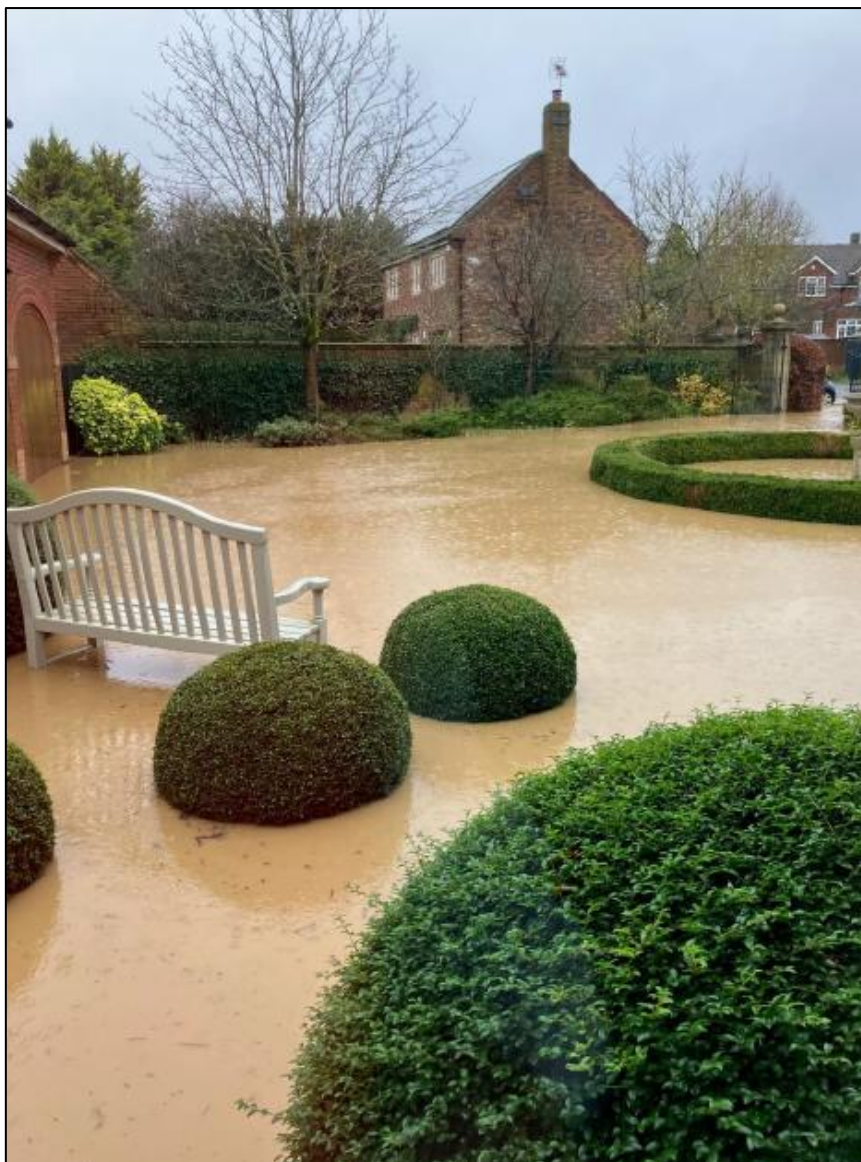
The volume of flood water was so significant that it submerged the southern extent of Bluebell Lane. These flow routes are consistent with the EA Flood Map and RoFSW map. These flows in combination with overland surface water flowing southwards down Bluebell Lane reportedly caused internal flooding to a further two properties after flooding exceeded the thresholds, and external flooding to one before flowing back into the Glooston Arm channel. One of the gardens that flooded along Bluebell Lane is depicted in Photograph 7-11.

Photograph 7-11: Garden flooding along Bluebell Lane
