Flood Investigation Report

Storm Henk

2nd January 2024

Loughborough

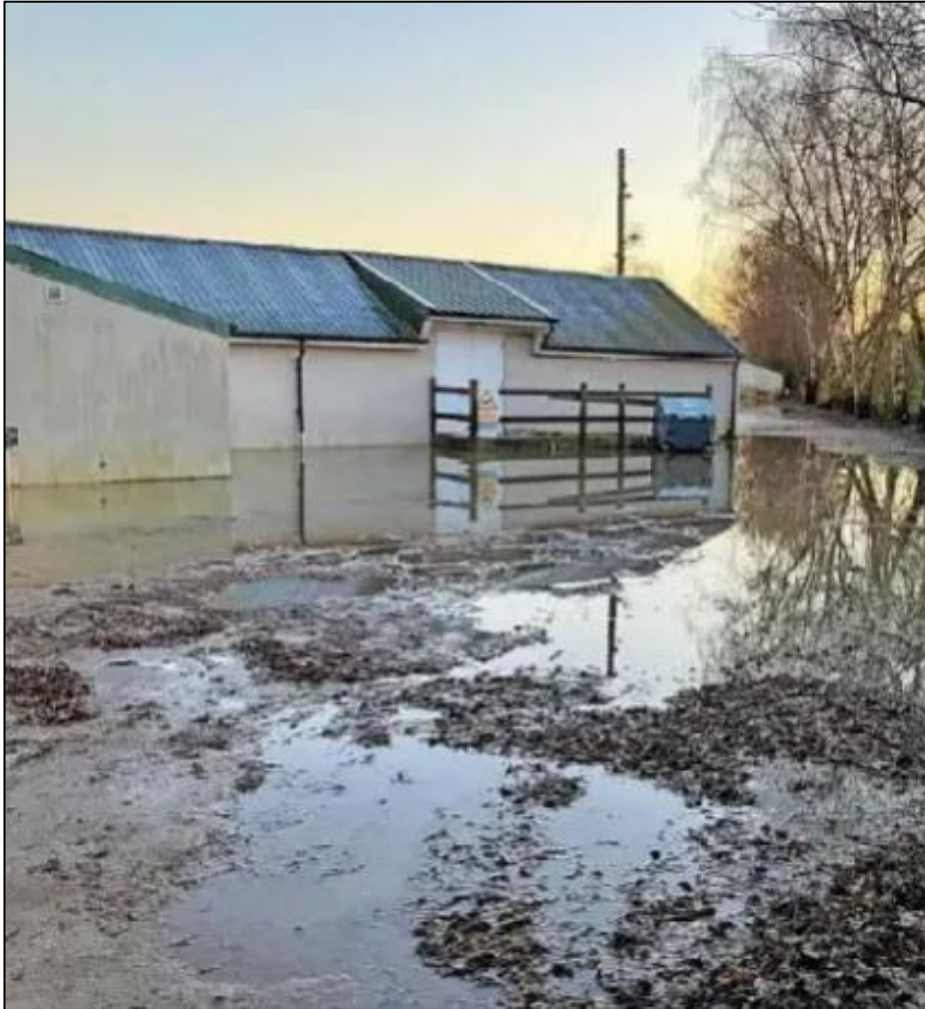
The times of flooding correspond with information of the River Soar peak. The area was reported to be inaccessible to vehicles other than tractors due to the depth of the flood water.

Photograph 8-2: Aftermath of flooding at Carillon Sports Club¹³

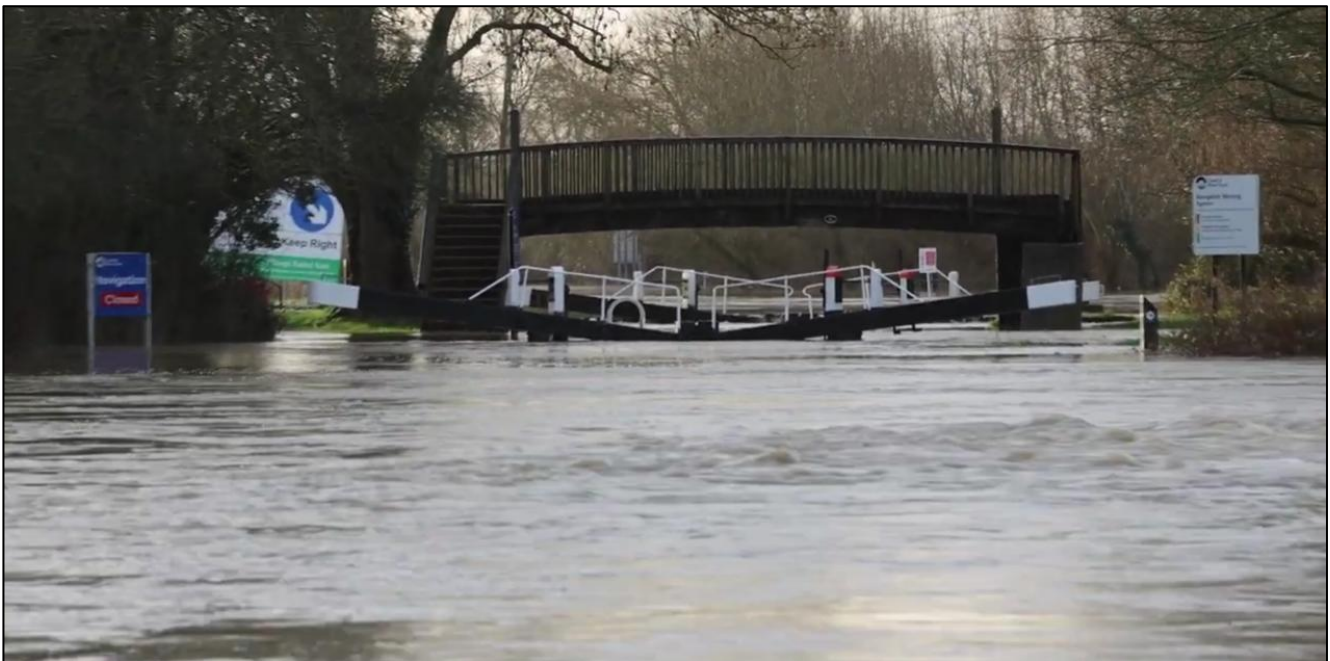
The EA has confirmed that Pillings Lock restricts flood flows entering the Canal in smaller scale flood events but not larger ones. Even if levels were raised at Pillings Lock, flood water can still enter the Canal from the surrounding floodplain, as it did during Storm Henk.

Flooding and damage to moored Canal boats was reported at nearby Pillings Lock Marina.

Photograph 8-3: Inundation of the Grand Union Canal at Pillings Lock on the Morning of Wednesday 3rd January 2024

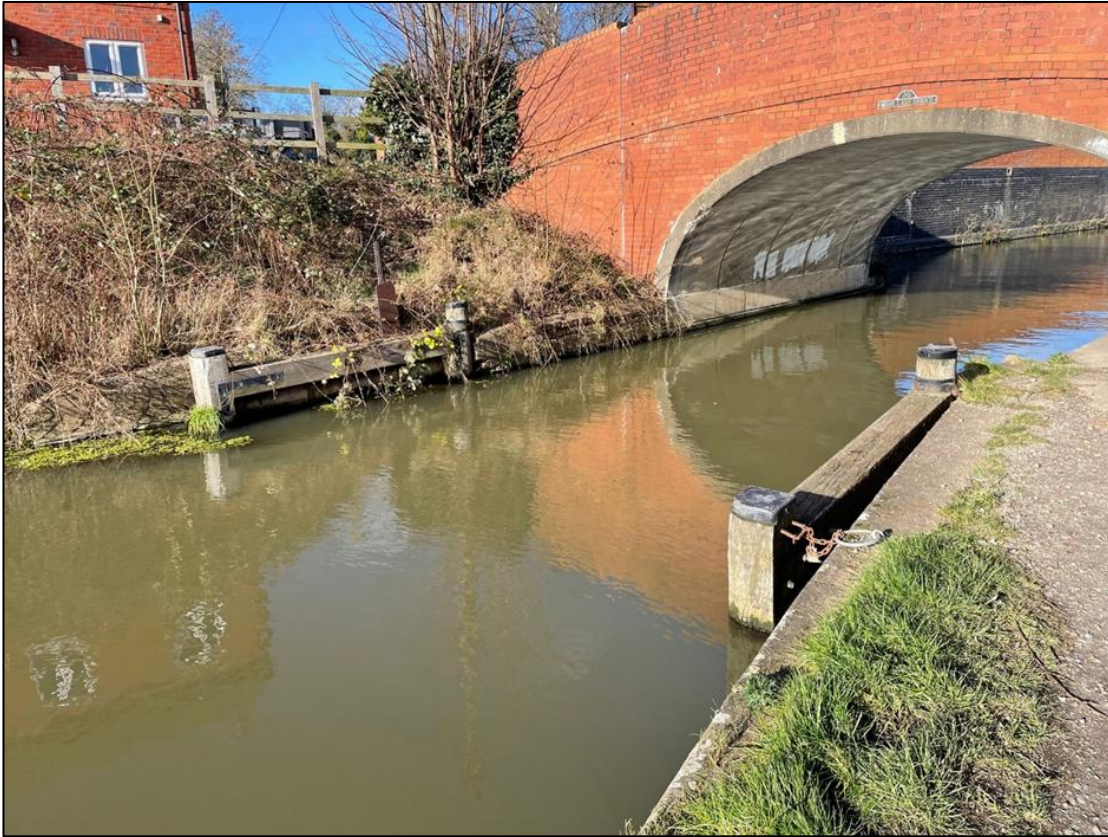
Photograph 8-4: Moor Lane Gates upstream of Moor Bridge on the Grand Union Canal¹⁷

- Prior to Storm Henk, the last principal inspection of the gates by CRT was in 2012; CRT assigned a condition grade B – 'good' condition.
- The EA last reviewed the Moor Lane Gates closure procedure in 2017, when CRT confirmed it was still agreeable. No changes to the procedure were made at this time or at any time between 2017 and Storm Henk. There is no recorded testing of the procedure.

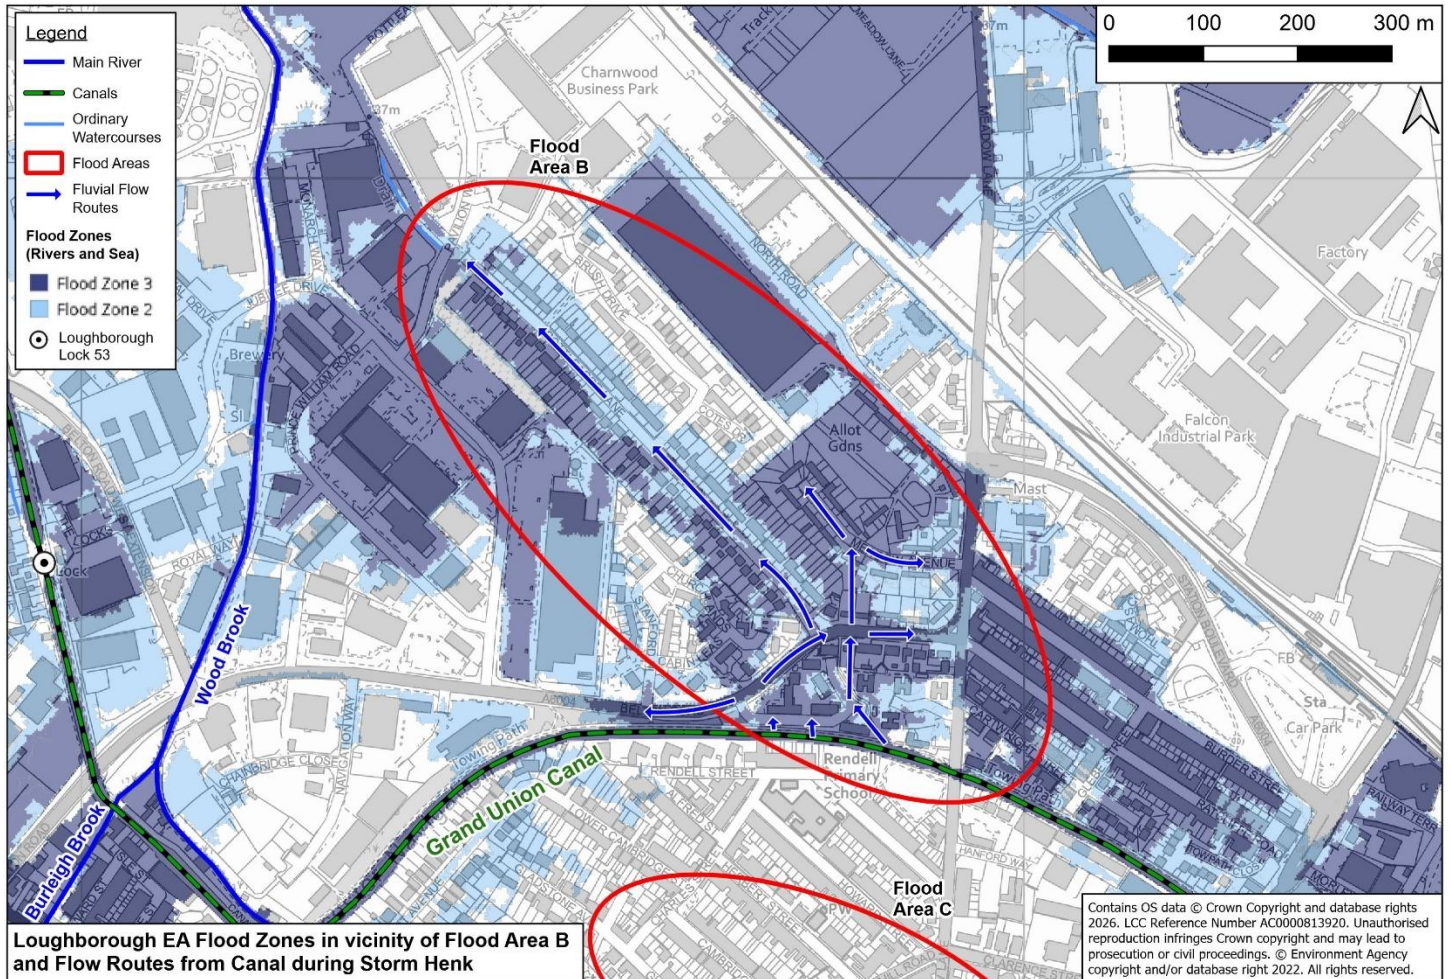
Figure 8-7: EA Flood Map for Planning Flood Zones and Fluvial Flow Paths from the Grand Union Canal during Storm Henk in Flood Area B

A summary of fluvial flow paths from the Canal is provided in Figure 8-7. The figure is recreated from a separate figure provided by the EA following their initial investigations after Storm Henk. Most properties which experienced internal flooding were located on Staveley Court, Waterside Close, Belton Road, Bottleacre Lane, and Meadow Avenue.

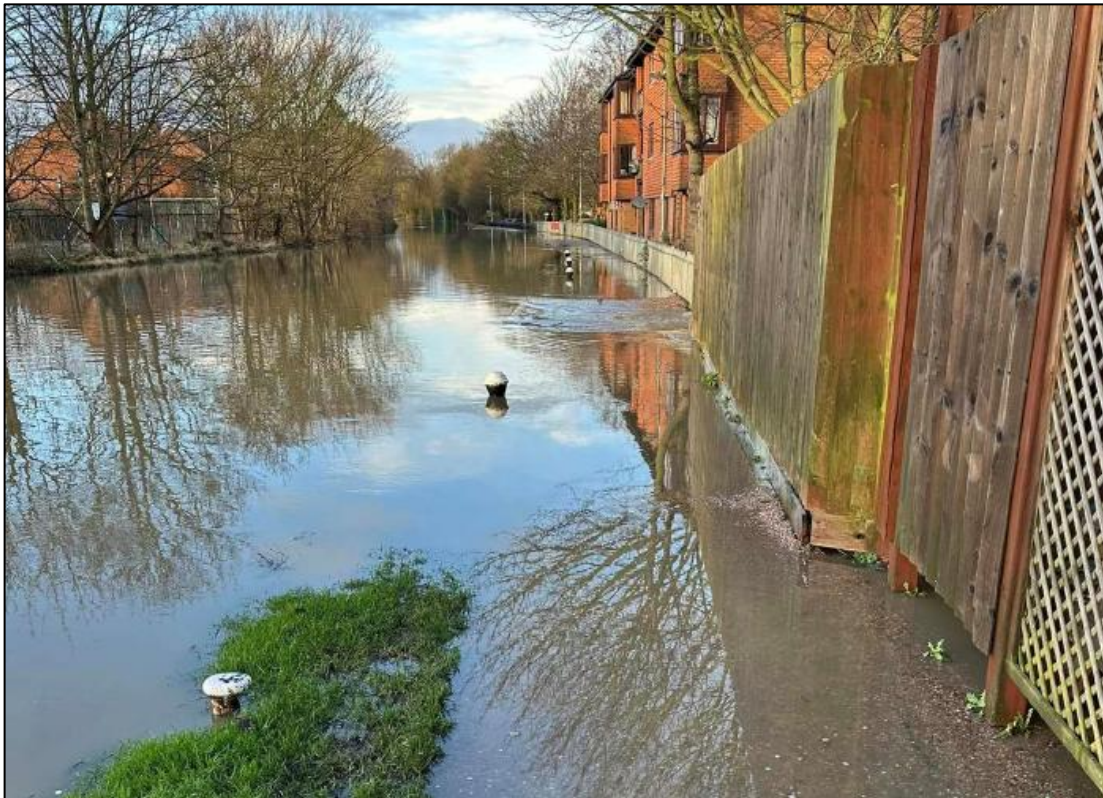
River flood flows within the Grand Union Canal overtopped the towpath adjacent to Staveley Court and Waterside Close, just west of the Boat Inn as depicted in Photograph 8-5 (OSNGR SK 53875 20388) from around 23:00hrs on the Tuesday evening. It overtopped in this location as it is a low point of the towpath. There is public video footage from Wednesday 3rd showing water coming over the towpath and into the Staveley Court car park, and public drone footage showing water coming over the towpath and along a footpath into Waterside Close adjacent to the Boat Inn.

Photograph 8-5: Fluvial flows overtopping the towpath out of the Grand Union Canal adjacent to Staveley Court and Waterside Close on 3rd January 2024. Looking west from The Boat Inn

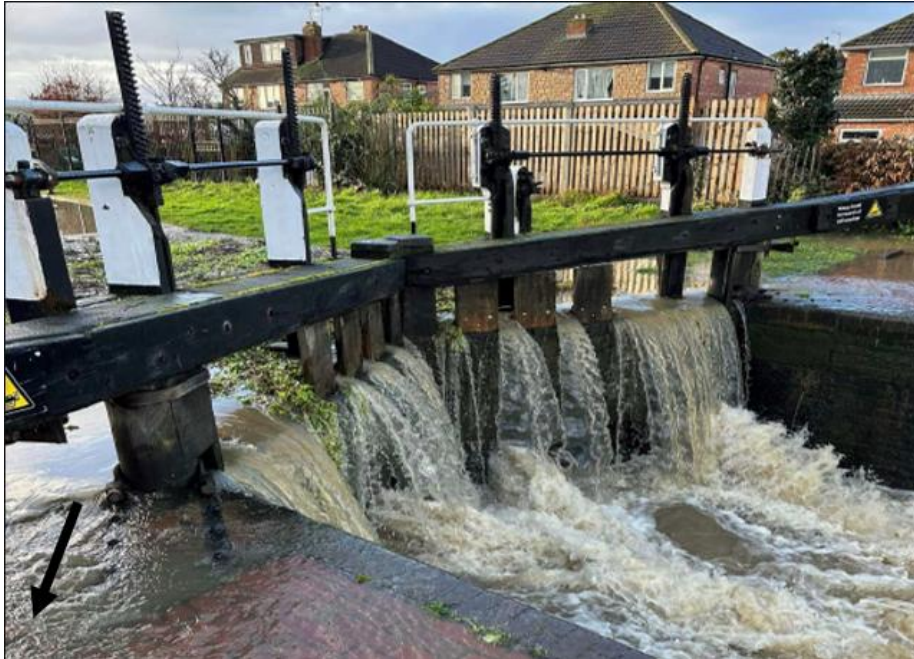
Around 800m to the west, there is also evidence that the Grand Union Canal was high at Lock 53 – Loughborough Lock, located adjacent to Kings Avenue at OSNGR SK 52963 20585; this potentially could have resulted in a flow path east along Belton Road towards Flood Area B, although limited evidence has been identified to support this. Photograph 8-6 shows river flows exceeding the capacity of the lock and overtopping out onto the towpath.

Photograph 8-6: Loughborough Lock 53. Fluvial flood flows exceeding capacity of the lock and overtopping onto towpath (see arrow).

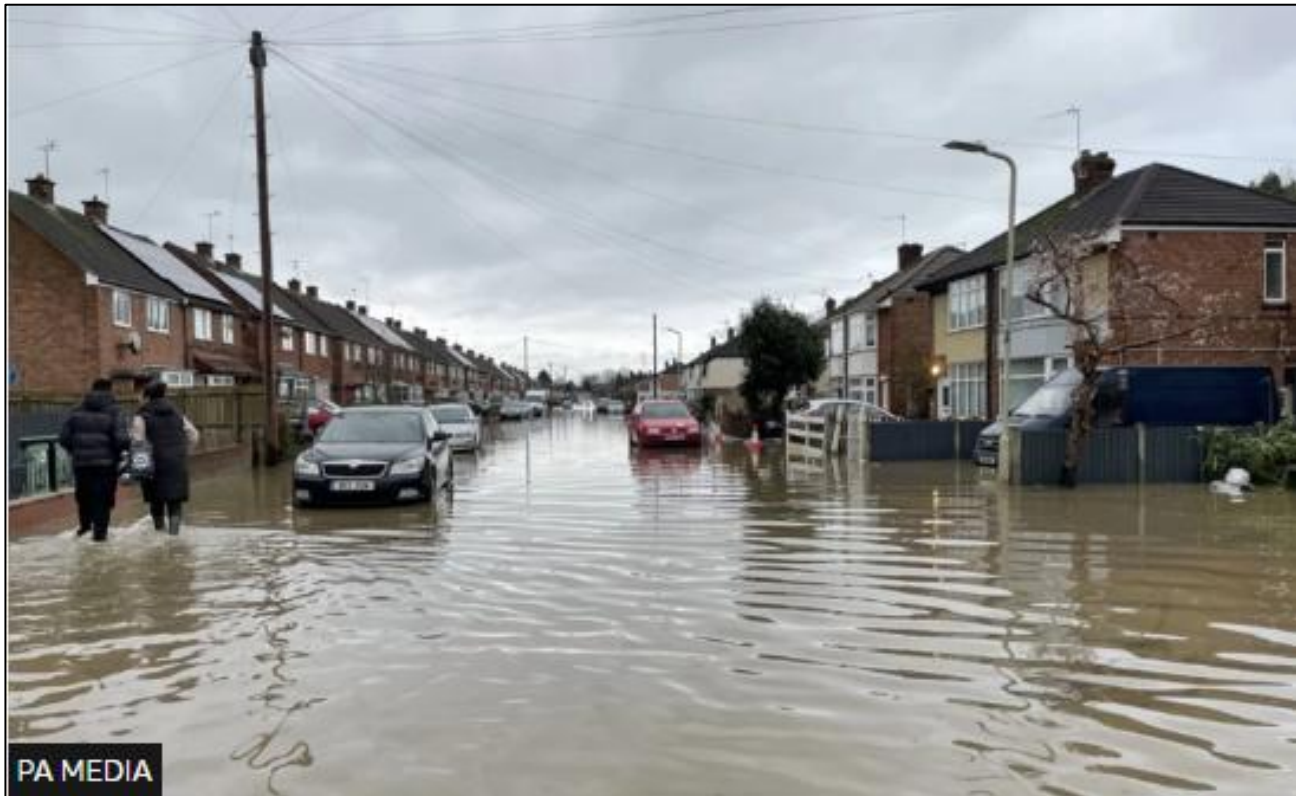
Flood water remained pooled at Bottleacre Lane for several days, as depicted in Photograph 8-7. The prolonged presence of the flood water exacerbated the impacts upon property owners.

Photograph 8-7: Flooding at Bottleacre Lane on the morning of Wednesday 3rd January²³

The highway drainage at this location discharges to the STW public sewer network. Road drainage networks are designed to accommodate rainfall events up to a certain magnitude on the contributing area of highway itself, and not to accommodate any other water such as that originating from the river. LCC, as Local Highways Authority (LHA), attended a couple of days after the event. They reported that gullies were not blocked although some gullies had become partially covered by flood debris which were subsequently cleared.

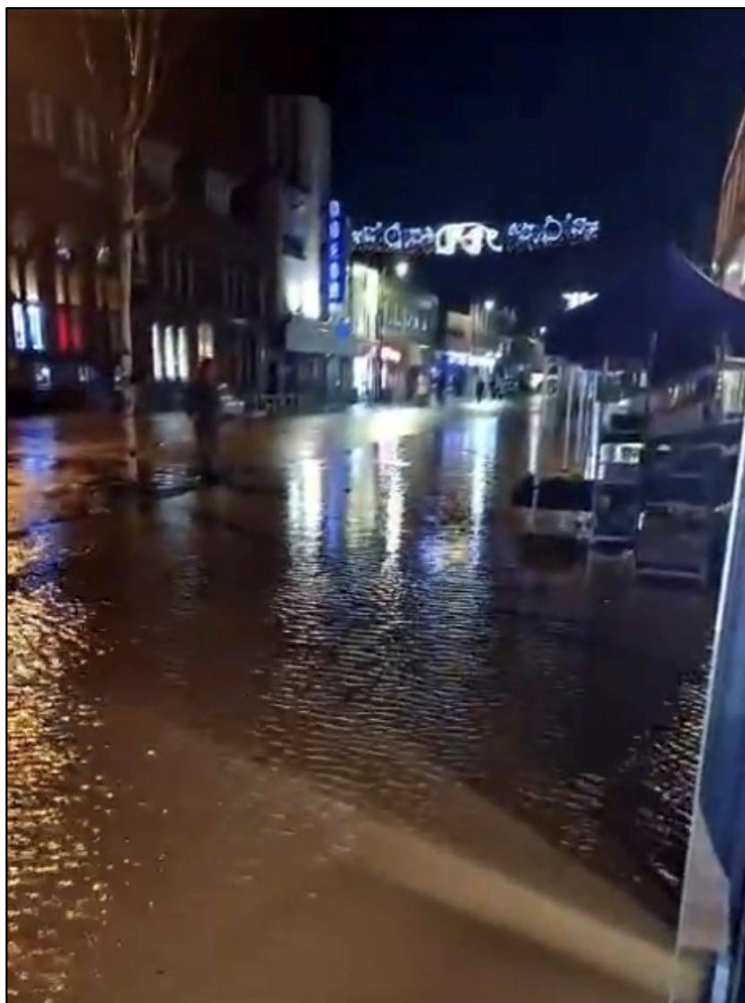
Photograph 8-8: Flooding of pedestrian area at Cattle Market' at around 17:00 - looking South towards junction with Granby Street

It is very likely that much of the flooding was caused by a combination of surface water which was not able to discharge through drainage networks into to Wood Brook due to its high-water levels, and potentially Wood Brook surcharging up through this drainage. The influence of Wood Brook is supported by the reports of flood water rapidly draining at the same time as levels in Wood Brook fell, and a lack of reports of flooding during more intense rainfall events when Wood Brook was not as high.

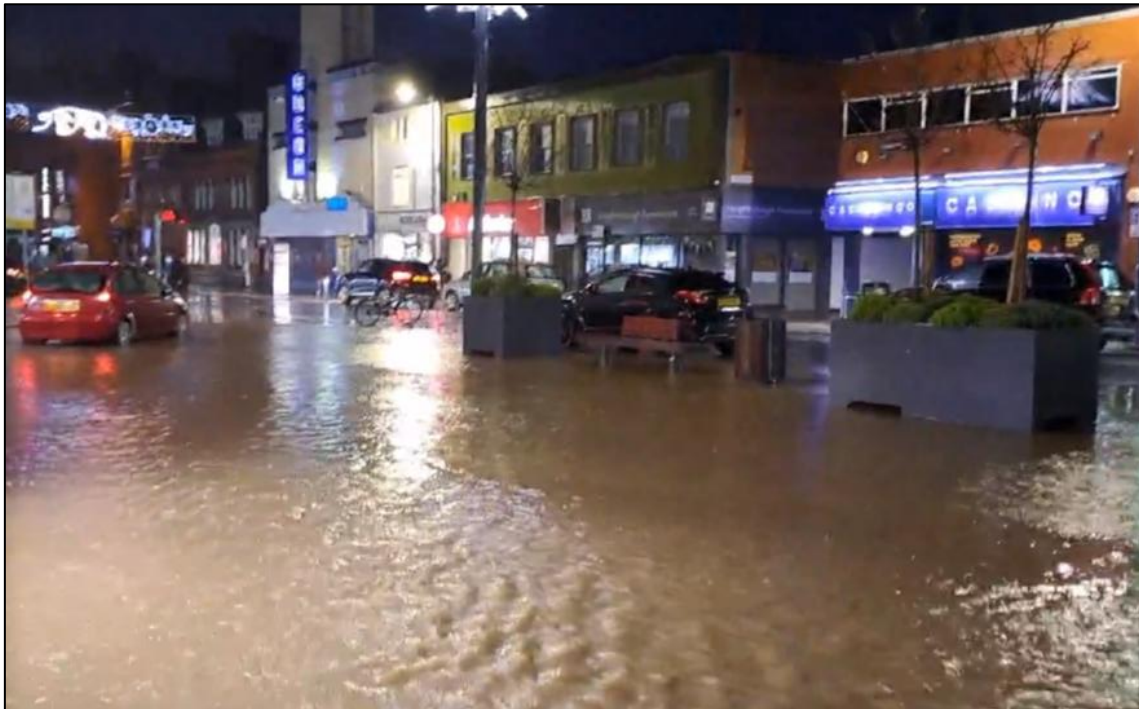
Photograph 8-9: Flooding at Devonshire Square, looking back towards the Cattle Market

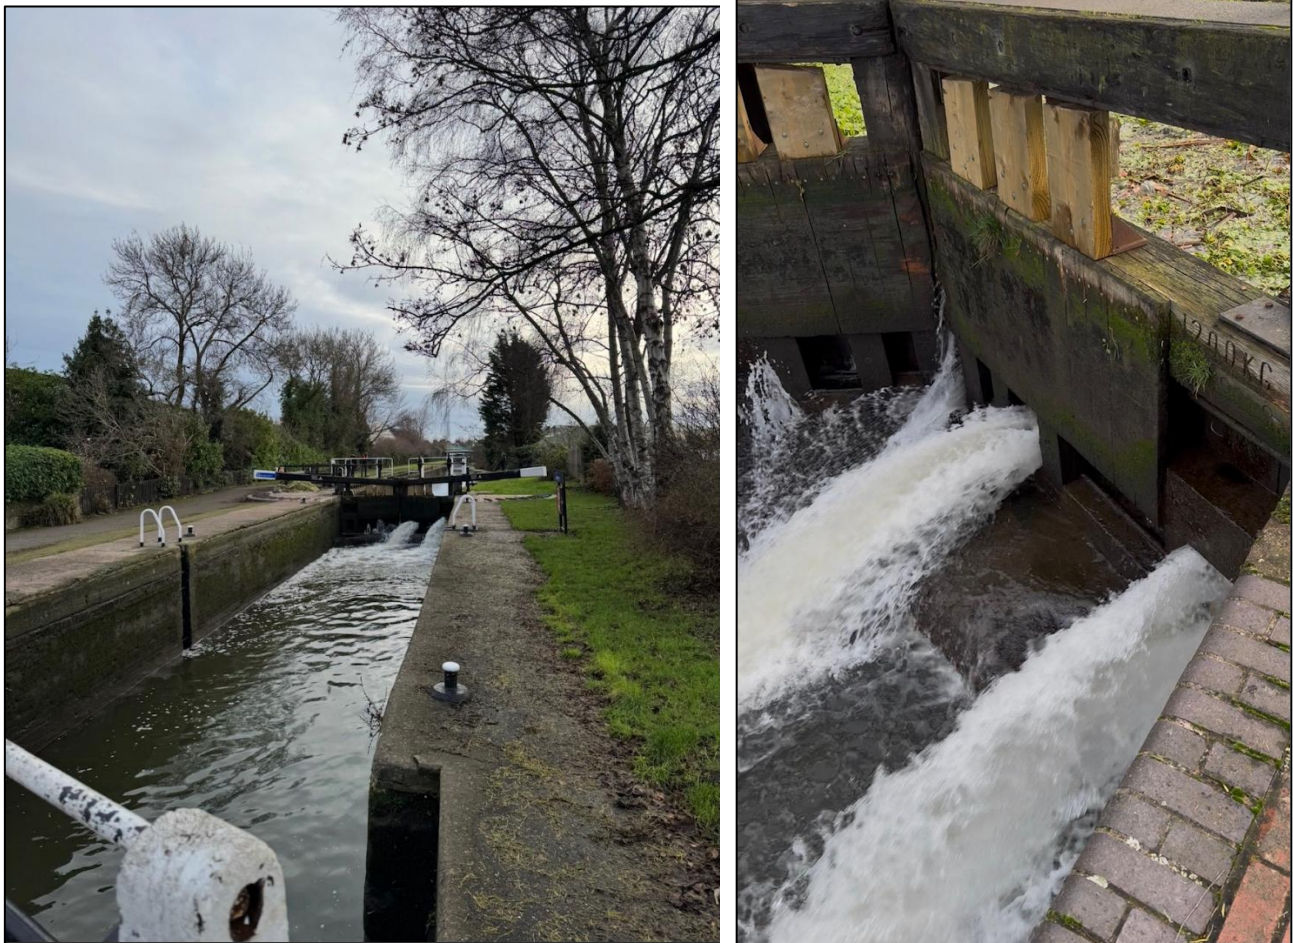
As mentioned in Section 8.2.2, CRT attempted to lower (drawdown) levels in the Canal **during** Storm Henk, by sluicing (opening) Loughborough Lock 53 (as depicted in Photograph 8-10, increasing the rate at which water flowed back to the River Soar.

Photograph 8-10: Loughborough Lock 53 drawdown procedure in progress by Canal and River Trust

Canal drawdown was again implemented by CRT on 6th January 2025, but **prior to** the flood peak, potentially reducing flooding impacts during this event. Formalising this procedure was then discussed. Following testing, the anticipatory drawdown of Canal levels has been formalised as a protocol and implemented internally by CRT on five occasions during winter 2025/26. Drawdown takes place upon receipt of the relevant Flood Alerts, which are usually issued by the EA in advance of Flood Warnings.
