Flood Investigation Report

Storm Henk

2nd January 2024

Quorn

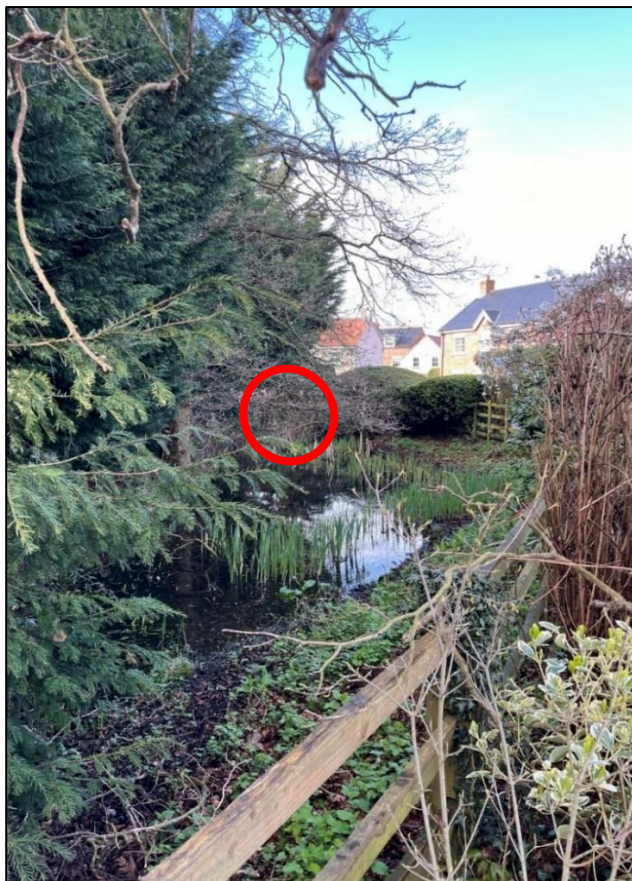
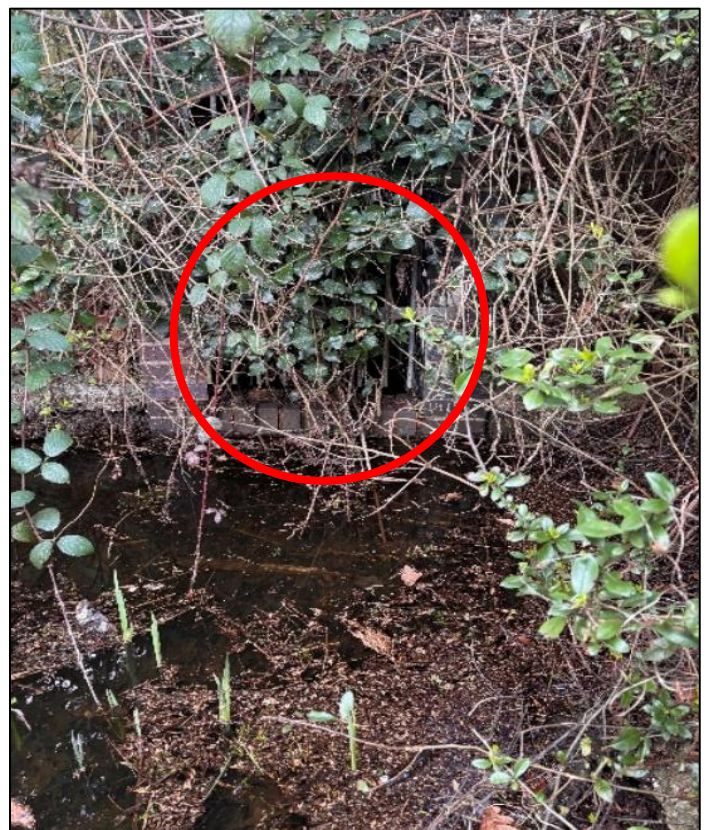
The watercourse was historically open channel, but it is now culverted through the Armston Road estate, under Loughborough Road and towards Wrights Mill and residential properties along School Lane. The exact alignment is not mapped however or fully understood. A trash screen exists at the culvert inlet within Quorn House Park upstream of Armston Road (illustrated within Photograph 9-1) situated next to an online attenuation pond.

*The location of the trash screen in red.
Credit: Simon Austin*

*Trash Screen on Culvert Inlet
Credit: Simon Austin*

Photograph 9-1: Views of Ordinary Watercourse 1 with attenuation pond within the Quorn House estate, and culvert inlet with trash screen upstream of Armston Road

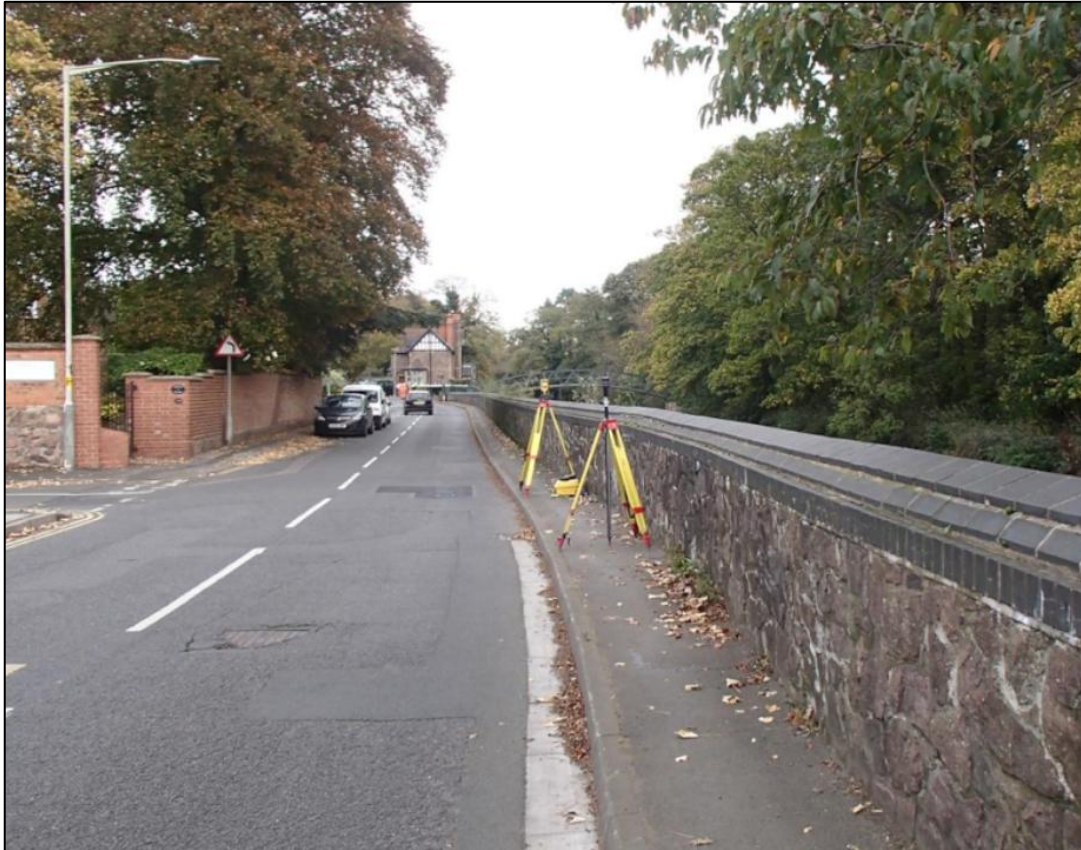
Photograph 9-2: River Soar Flood Wall alongside Soar Lane looking north eastwards downstream

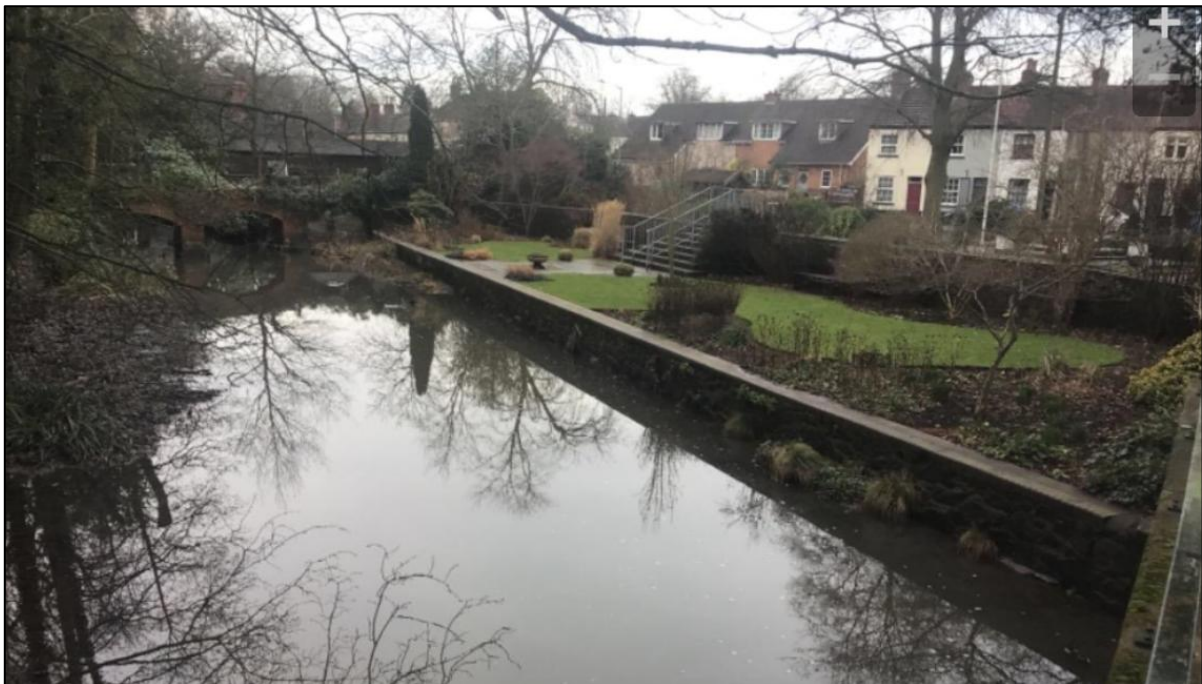
Photograph 9-3: Engineered high ground along Quorn Brook at the Memorial Gardens looking south westwards upstream

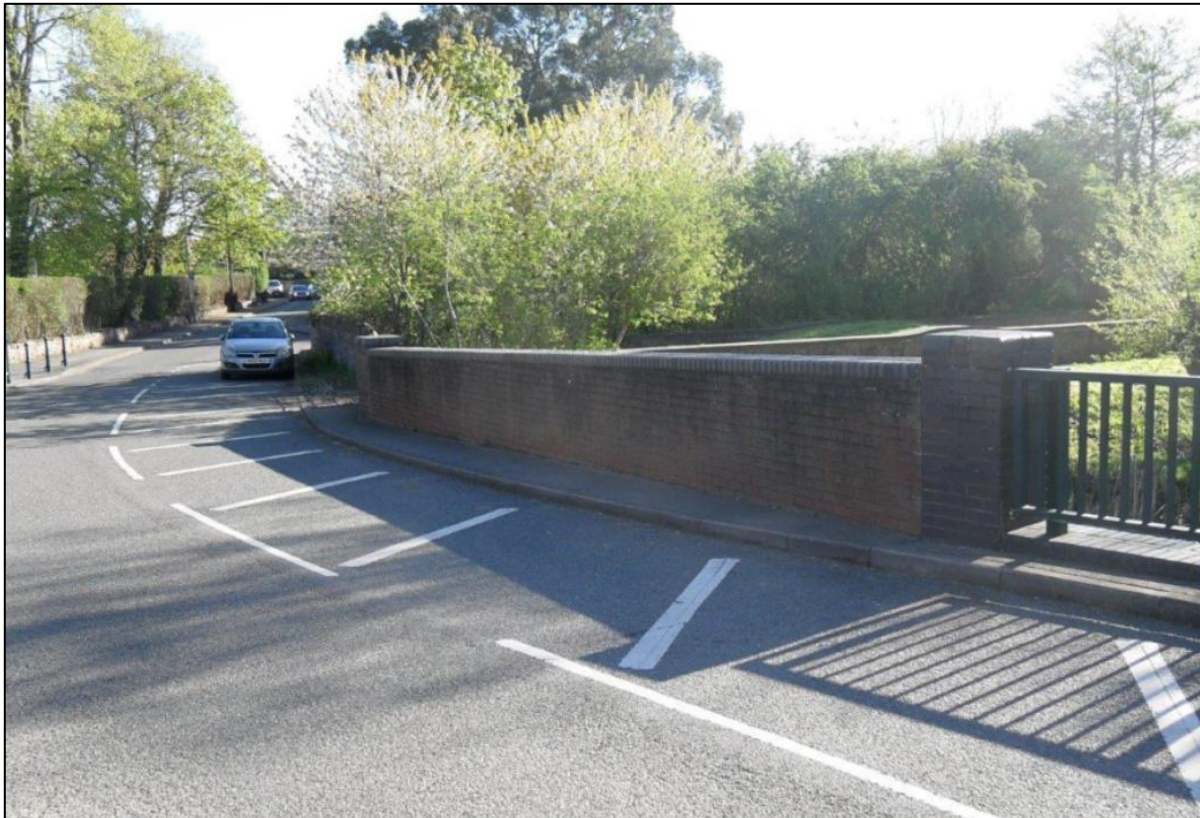
Photograph 9-4: Flood Wall and Embankments alongside Quorn Brook from School Lane looking north eastwards downstream

Following the event, the EA has identified issues with some assets in Quorn which became apparent during Storm Henk. For instance, the flood wall alongside the eastern edge of School Lane (AIMS ID: 38946) is below required condition and there was some reported leakage in Flood Area D (see later in the report). The EA reported however that flood defence assets generally performed effectively, with only minor leakage observed as a result of the exceptional volume and force of water experienced during the event.

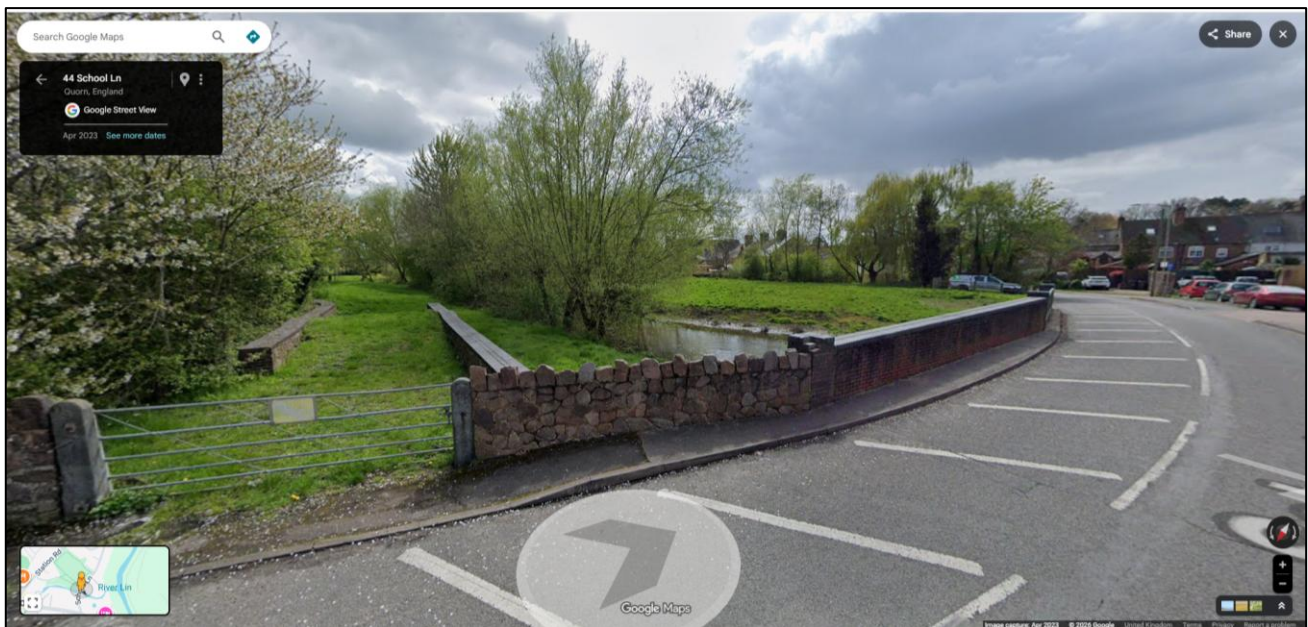
Photograph 9-5: Quorn Brook Flood Wall and Embankments from School Lane looking eastwards downstream

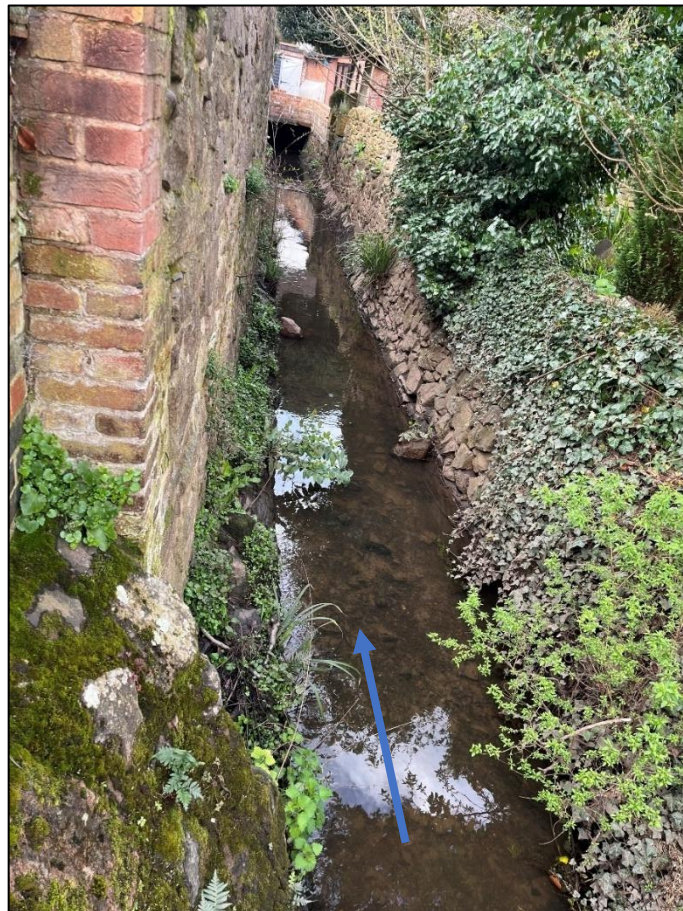
The force of the flood water is described to have caused part of this southern bank wall (at the entrance to the culvert, which conveys Poultney Brook under Meeting Street into Quorn Brook, see Photograph 9-6) to collapse during the event, allowing a substantial amount of water into the rear of a property along Meeting Street.

Photograph 9-6: View of Poultney Brook from the rear of adjacent property looking downstream south-east towards culvert inlet upstream of Meeting Street

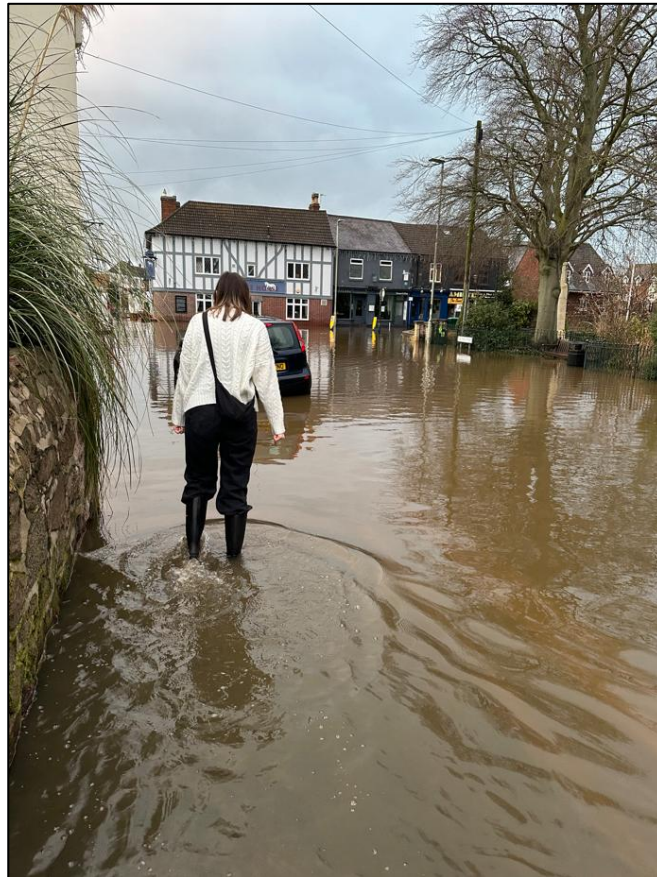
River water within Flood Area A was described to have converged with the surface water runoff and exceeded property thresholds of two properties along Meeting Street. The Parish Council described the flooding to be as deep as ‘at the shin’, as reflected in **Error! Reference source not found.**

Photograph 9-7: Flood Extents on Meeting Street looking towards Leicester Road

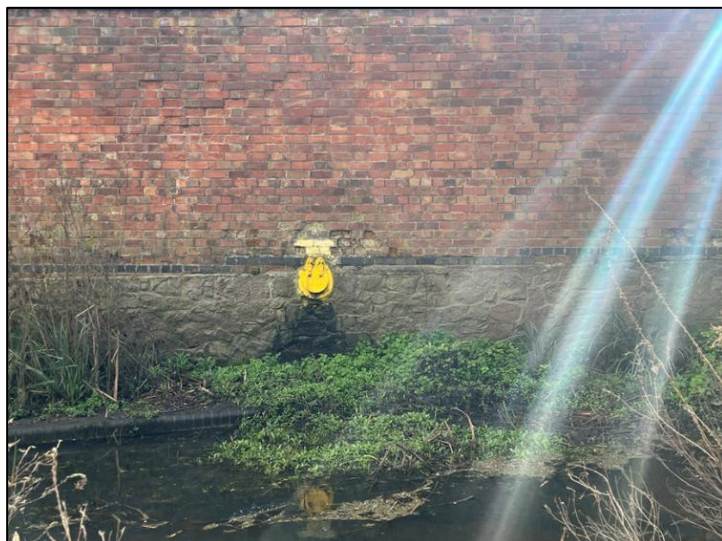
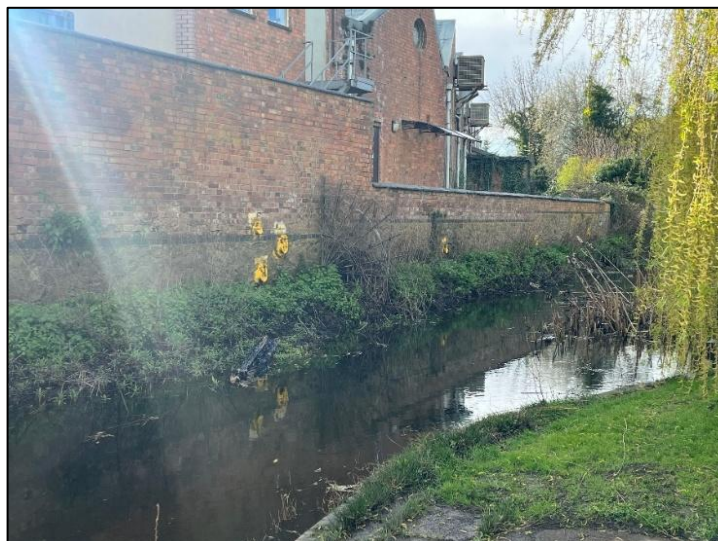
Anecdotal reports suggest that three non-return valve outfall flaps into Quorn Brook may have failed to seal completely (one in the Station Road car park (as illustrated in Photograph 9-8), and two in the Quorn War Memorial Gardens). Therefore, high water levels within Quorn Brook would also have likely backed up within the drainage network and surcharged at the surface here, adding river water to the flooding extents.

Photograph 9-8: Example flapped outfalls adjacent to Quorn Brook (yellow)

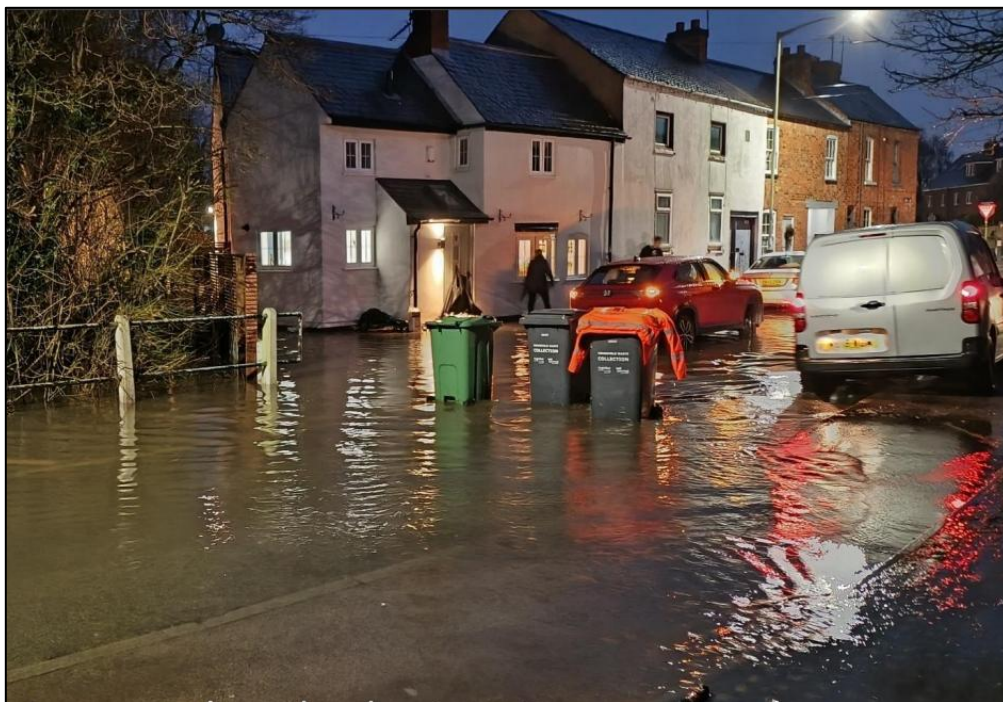
It is possible that Ordinary Watercourse 1 connects to this land drain. Regardless of this connection, during Storm Henk, the elevated water levels within the River Soar and Quorn Brook would have restricted the discharge of the land drain, thus likely causing surface water to accumulate and build up, and flow southwards towards the School Lane highway and affected property (see Photograph 9-9).

Photograph 9-9: Flooding impact during the Storm Henk flood event along School Lane, Quorn in Flood Area C
