# Flood Investigation Report

Storm Henk

2<sup>nd</sup> January 2024

**Sharnford**

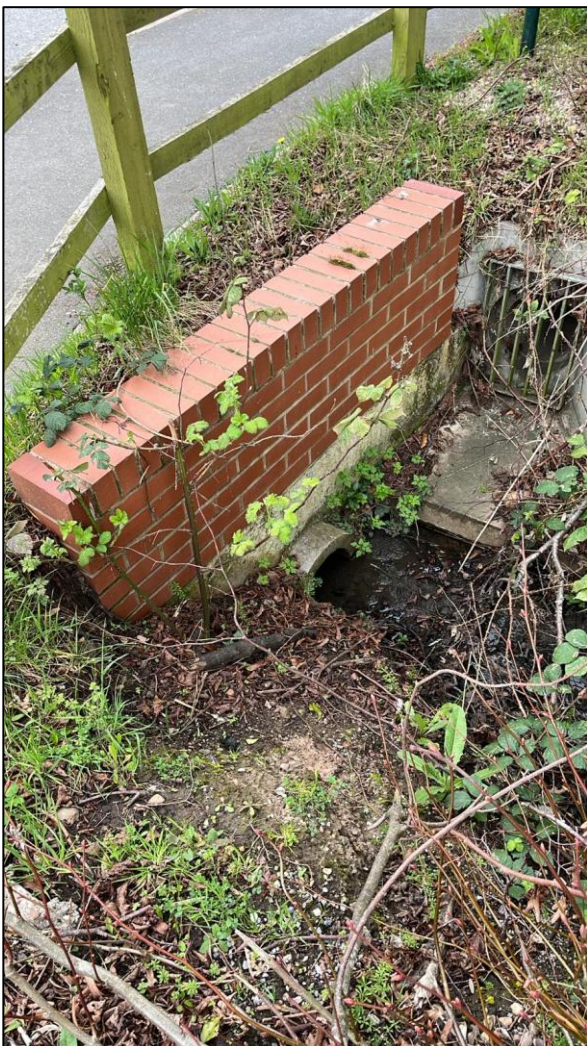
**Photograph 17-1: Culverted Ordinary Watercourse 2 Outfall on northern side of Butler Close (Location B)**

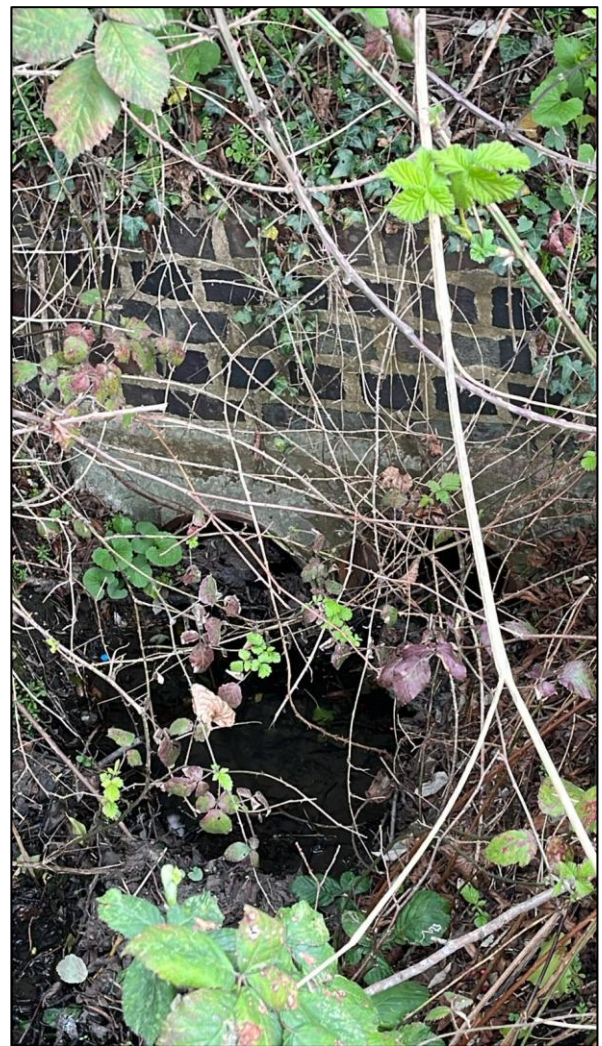
**Photograph 17-2: Culverted Ordinary Watercourse 2 Inlet west of B4114 Leicester Road (Location C)**

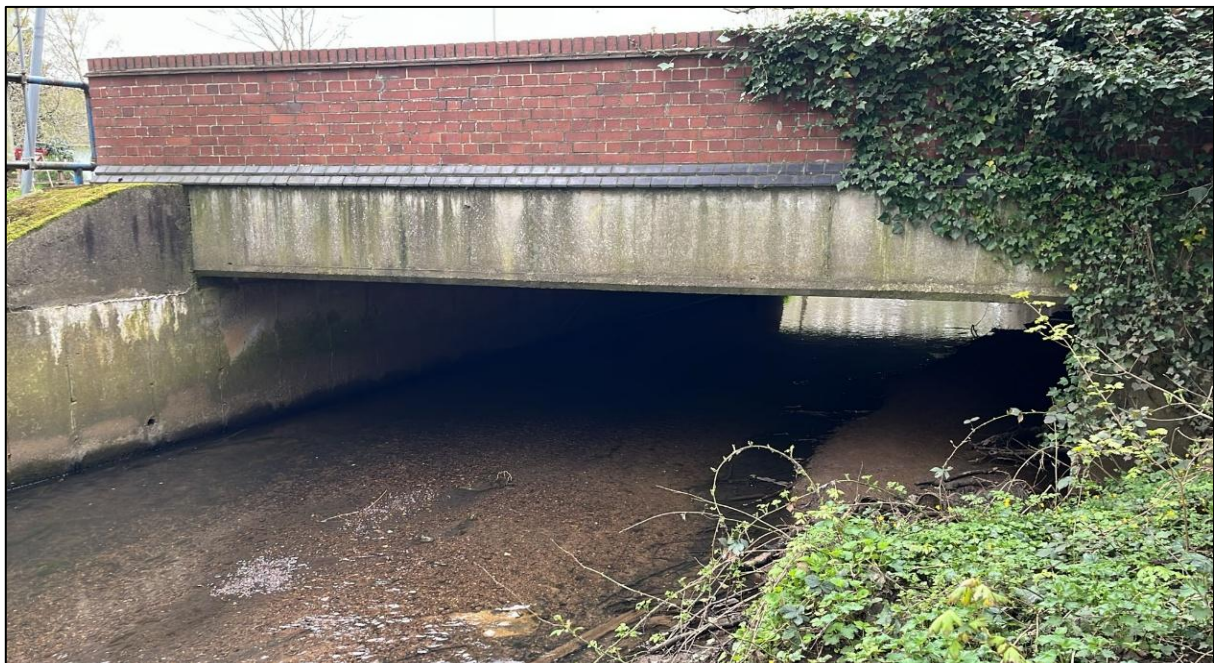
A hydraulically significant structure which crosses Soar Brook is the Aston Lane bridge as depicted in Photograph 17-3. This comprises a concrete rectangular bridge opening with brick parapet walls.

**Photograph 17-3: Soar Brook in Sharnford looking downstream towards the parapet wall of the Aston Lane bridge**

Preliminary investigations indicate that the water left the Soar Brook channel at the Aston Lane bridge due to capacity constraints under this structure (i.e. the structure struggles to convey the flow in significant flood conditions). Anecdotal reports suggest the flood depths on Aston Lane reached approximately 1 metre and impacted three businesses internally.

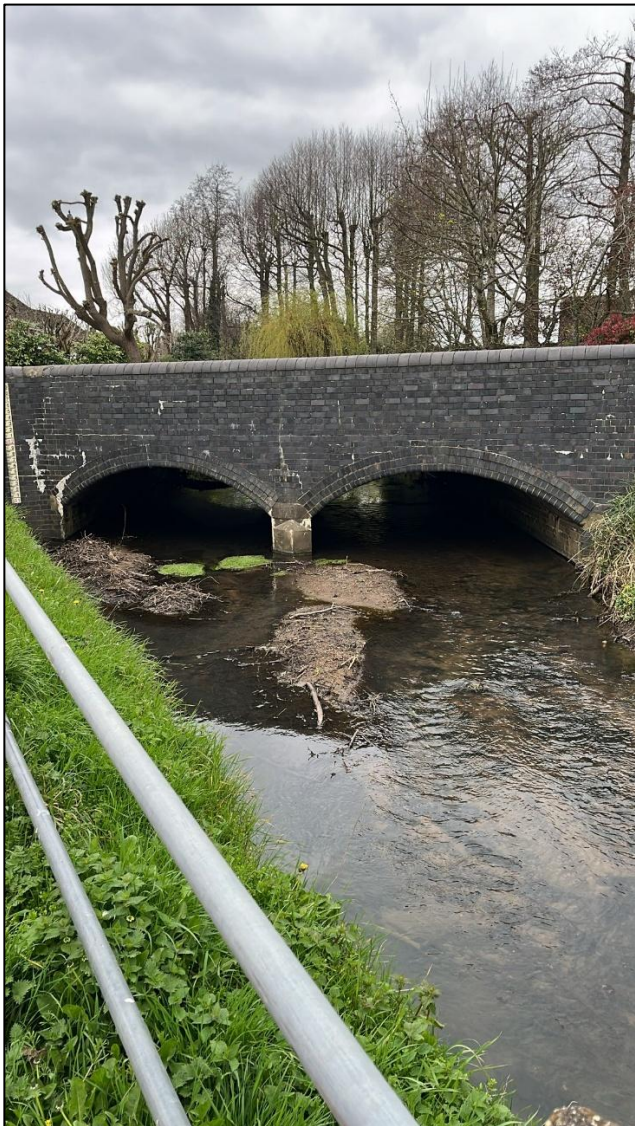
Another significant structure which crosses the Soar Brook is the Leicester Road (B4114) bridge, constructed circa 1910 and illustrated in Photograph 17-4. It is a twin arch bridge structure that replaced the ford, from which Sharnford is believed to have derived its name. Anecdotally, the relatively shallow (albeit large) arches of the bridge are historically believed to have worsened flooding within Sharnford, by restricting the conveyance of flows in Soar Brook and causing water to back up and rise out of the channel onto adjacent land.

**Photograph 17-4: Soar Brook in Sharnford looking upstream towards the downstream parapet wall of the B4114 Leicester Road bridge**

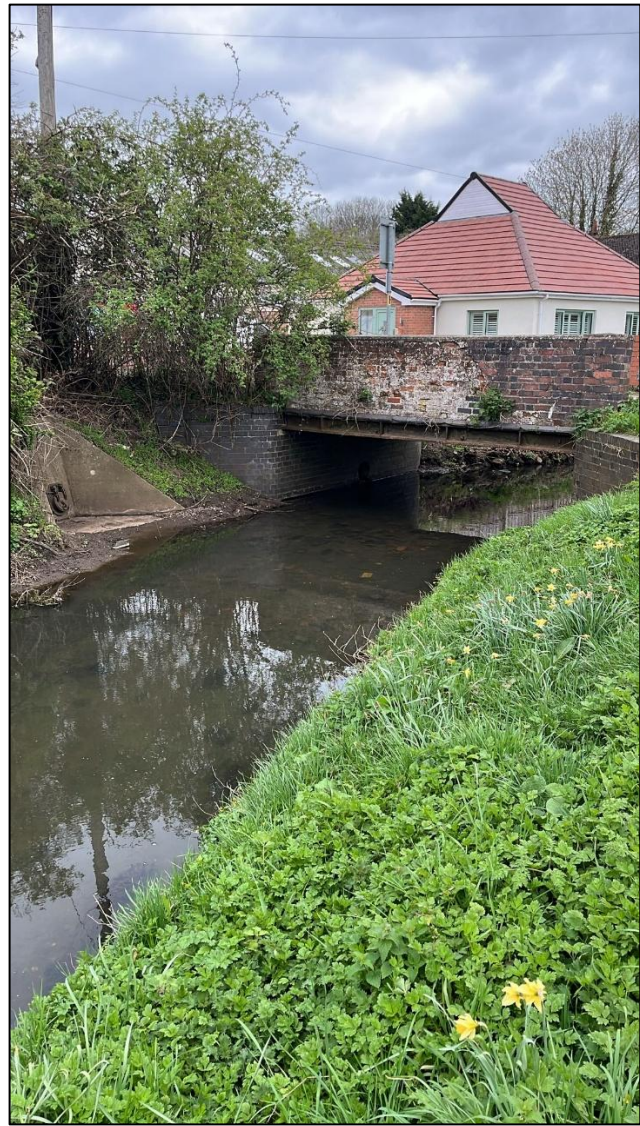
**Photograph 17-5: Soar Brook in Sharnford looking downstream towards the upstream parapet wall of the Chapel Street bridge and STW CSO outfall**

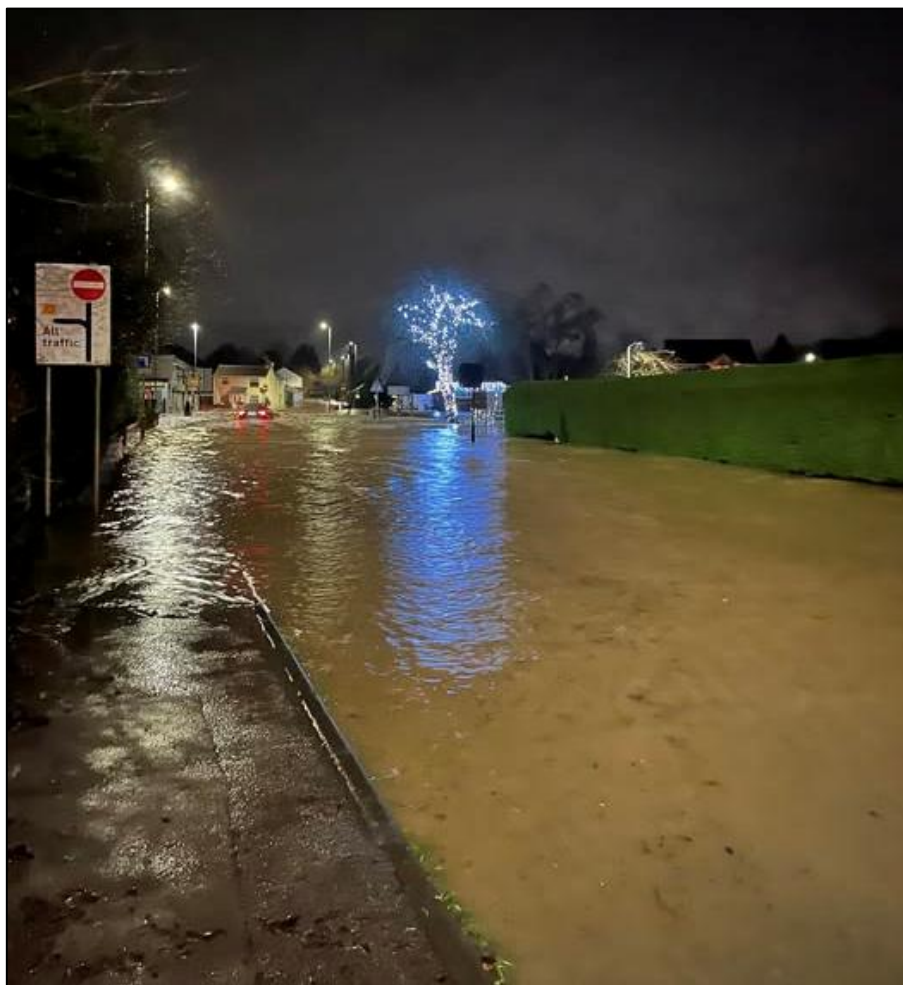
**Photograph 17-6: Highway flooding along Leicester Road looking westwards from north-eastern corner of Soar Brook Recreation Grounds<sup>7</sup>**

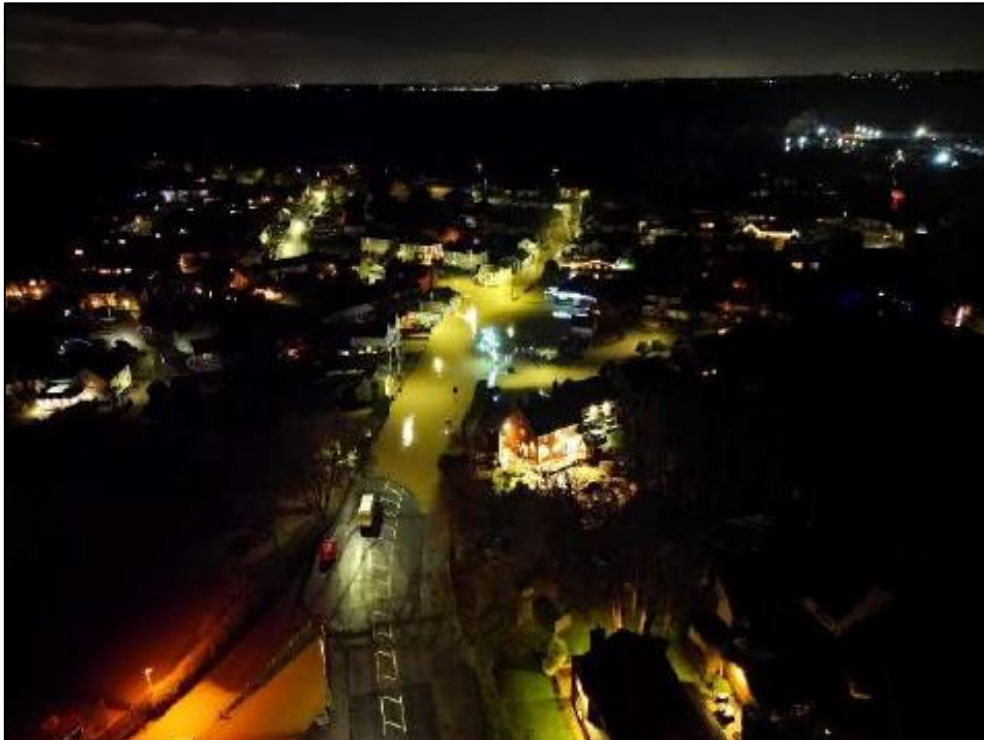
**Photograph 17-7: Drone Footage of Flooding in Sharnford Village Centre**

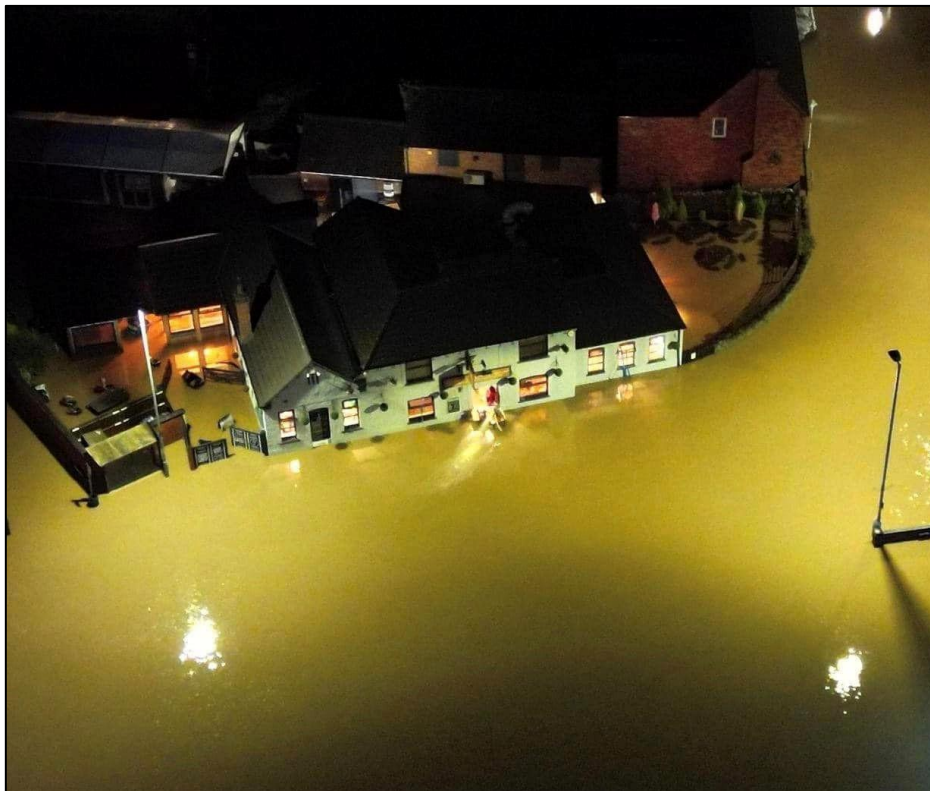
**Photograph 17-8: Aerial view of flooding in the vicinity of the Bricklayer Arms Public House, Leicester Road on 2<sup>nd</sup> January 2024<sup>8</sup>**
