Flood Investigation Report

Storm Henk

2nd January 2024

Twyford

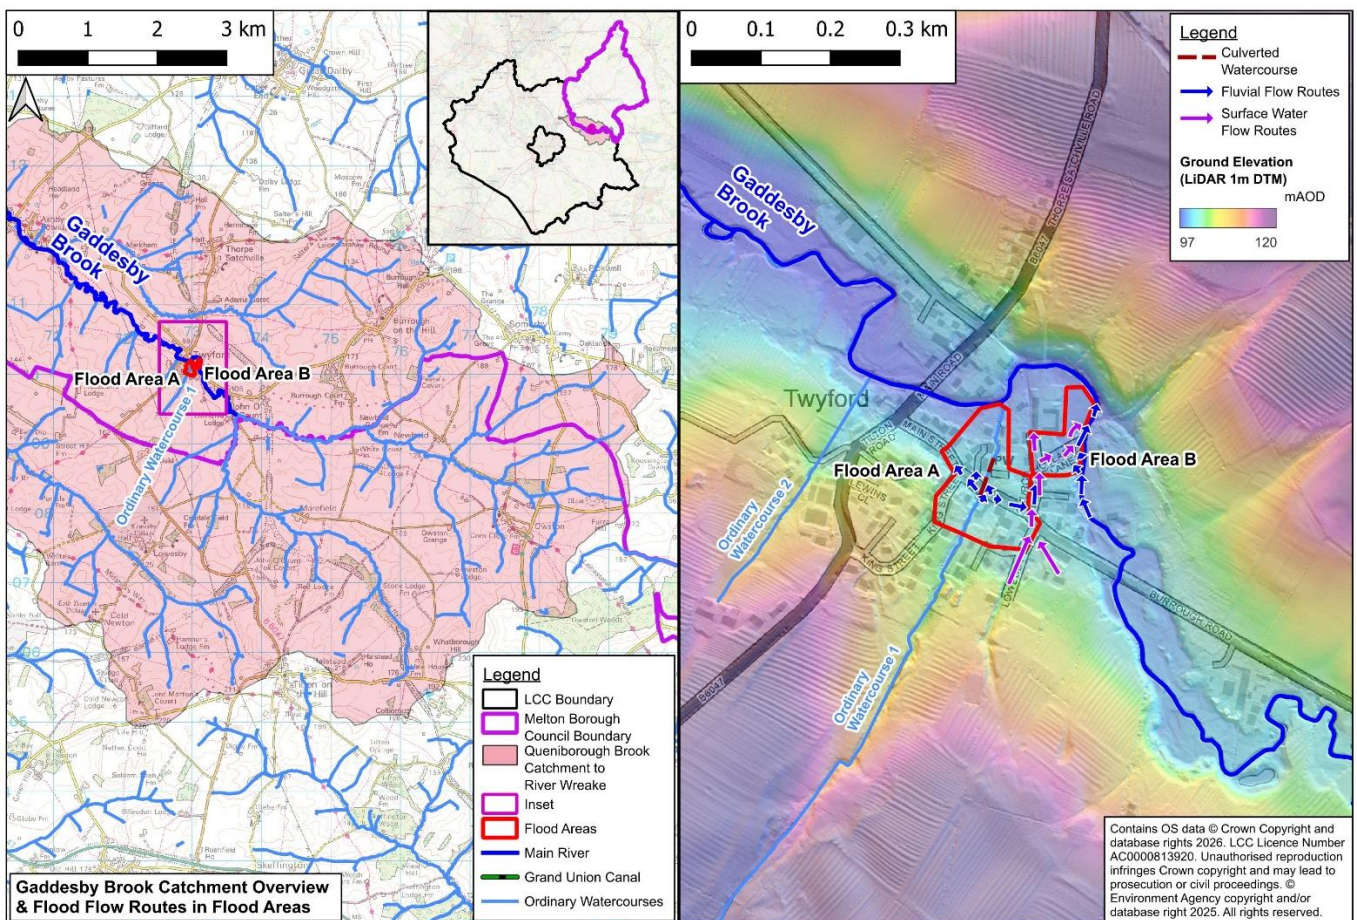
Figure 19-1: Twyford Location Plan, relevant Watercourse Catchment and Flow Routes through Flood Area (INSET 8)

A large volume of overland surface water runoff also flowed northwards through Flood Area A, primarily along Ordinary Watercourse 1 (illustrated in Figure 19-1). This watercourse exceeded the bank capacity on the southern side of Main Street where the watercourse is conveyed into a culvert inlet, and caused flooding to a single property along Main Street situated adjacent to the watercourse. As described in Section 19.1, this proceeds beneath Main Street to its outfall north of the church and continues towards Gaddesby Brook (see Figure 19-1). High water levels in Gaddesby Brook likely restricted the ability of this watercourse to discharge at the confluence. The capacity of the watercourse would have been exceeded, causing the culvert inlet to surcharge onto Main Street. Flooding was reported to have occurred from midday.

Areas of Church Lane and Hollands Lane (Flood Area B as illustrated in Figure 19-1) reportedly became impassible after being inundated by ponded floodwater. It is likely this was generated from intense rainfall that resulted in surface water runoff from higher ground to the south of Lowesby Lane proceeding northwards, in combination with the floodwater on Main Street from Ordinary Watercourse 1.

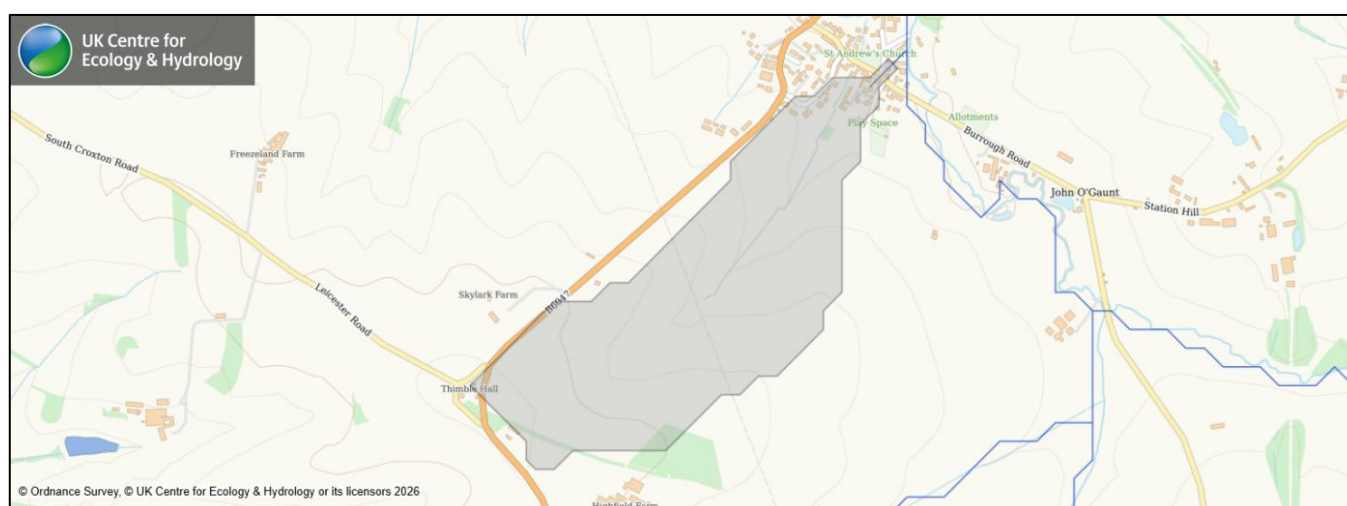
Figure 19-2: FEH Web Service Catchment of Ordinary Watercourse 1 Tributary of Gadddesby Brook at Twyford

The UK Centre for Ecology & Hydrology's Flood Estimate Handbook (FEH) Web Service¹ provides strategic level catchment mapping. Figure 19-3 defines the catchment for Ordinary Watercourse 1, a tributary of Gadddesby Brook, between King Street and Lowesby Lane. This identifies that the far downstream reach, north of Main Street, progresses down Church Lane and converges with Gadddesby Brook at the end of Hollows Lane.

However, site inspection and review of OS mapping and Severn Trent Water (STW) sewer records identified that the route of open channel ordinary watercourse actually progresses northwards beneath Main Street within a culverted watercourse (150mm diameter (dia) pipe) between Church View and St. Andrew's Church. This then outfalls into an open channel that converges with Gadddesby Brook at approximate Ordnance Survey National Grid Reference (OSNGR) SK 72992 10196, further downstream than is illustrated by the FEH Web Service. The responsible agency for this culverted watercourse is currently under investigation by Leicestershire County Council (LCC) Lead Local Flood Authority (LLFA) and STW.

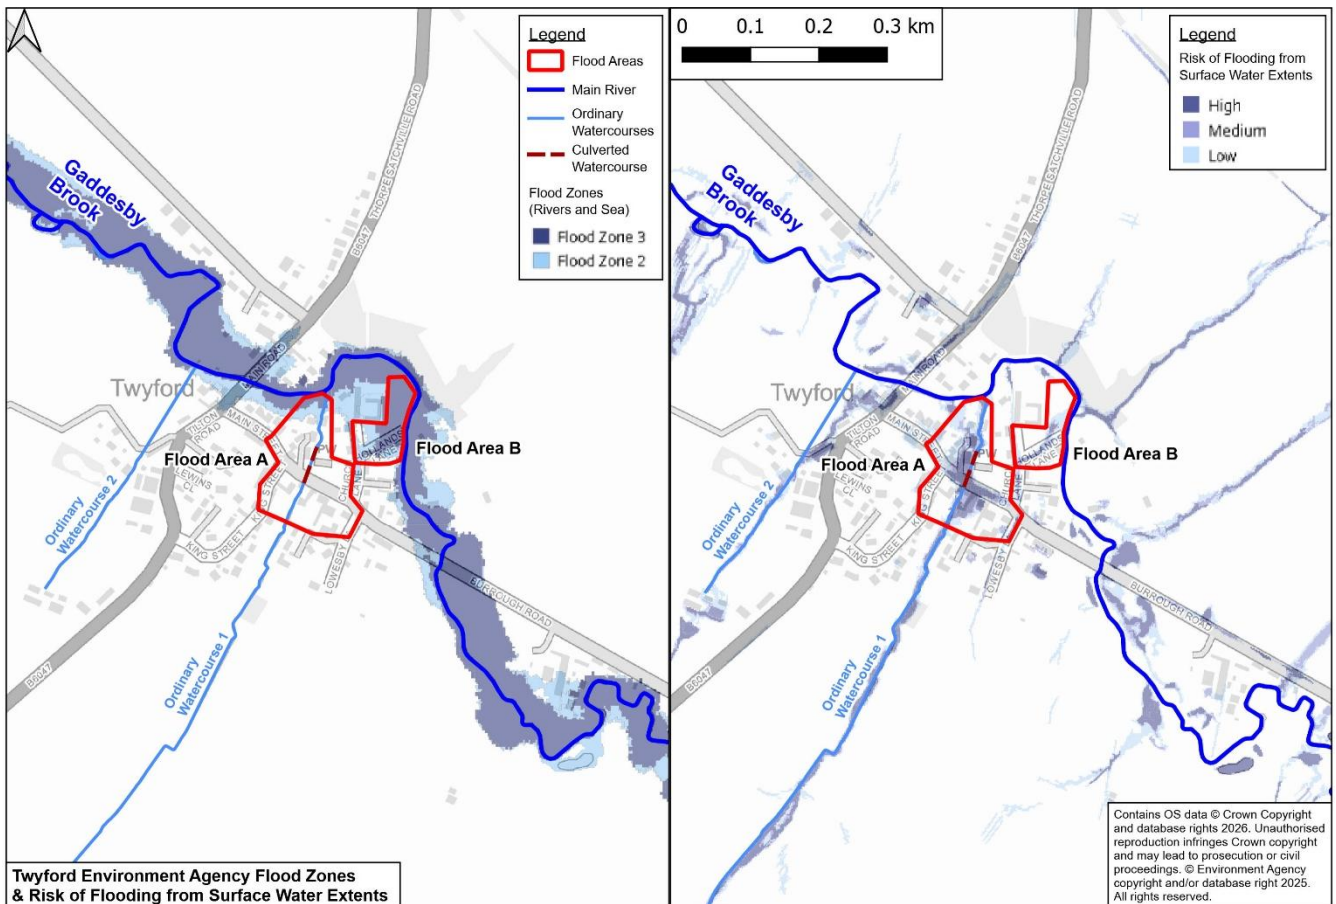
Figure 19-3: Twyford EA Flood Map for Planning Flood Zones³ and Risk of Flooding from Surface Water Extents⁴ in Flood Areas (INSET 8)

The EA provides flood risk mapping nationally for both rivers and surface water as detailed within Section 2.7.6 of the main Storm Henk report. The extents of the EA’s Flood Map for Planning (NaFRA2) Zones 2 and 3 associated with Gaddesby Brook through the village (medium and high risk of river flooding respectively) are illustrated in Figure 19-3. The northern extent of Flood Area A in open land and the northern extent of Flood Area B along Church Lane and Hollands Lane are most at risk from Gaddesby Brook.

Areas of the village are also identified as being at a high, medium and low risks of flooding in the national EA Risk of Flooding from Surface Water (RoFSW) (NaFRA2) are illustrated in Figure 19-3. The key surface water flow route through the village of interest for this summary report pass northwards through the centre of the village along the route of Ordinary Watercourse 1 and down Church Lane and Hollands Lane. Smaller routes follow Lowesby Lane northwards towards Church Lane and northwards along Ordinary Watercourse 2 that issues at Elms View Farm.
