Flood Investigation Report

Storm Henk

2nd January 2024

Wymondham

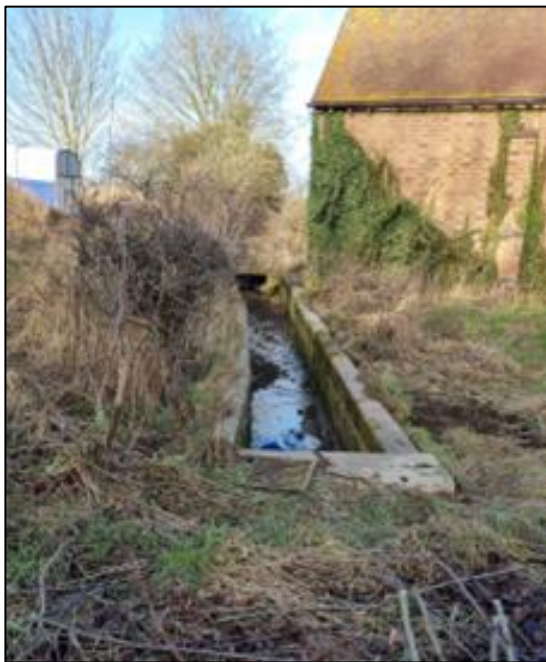
Flow within the unnamed ordinary watercourse is generated by surface water running off the steep sided fields into a network of open channel land drainage ditches, which combine and flow into the culvert beneath Main Street (as illustrated in Photograph 20-1 and Photograph 20-2). An abandoned railway line runs to the north of the village. It is likely that drainage associated with this abandoned line also conveys water towards the culvert beneath Main Street, although it is not known to what extent this may contribute during significant rainfall events. It is believed that the sheer volume of water that fell was unable to be conveyed effectively into the culvert and thus forced it to back up and get out of bank towards Main Street. No evidence has been submitted as part of the investigation to suggest that the inlet to the culvert beneath Main Street or the trash screen became fully obstructed by the event. It is possible that some debris was washed down and caught on the trash screen during the event, but it was not fully obstructed. This further suggests the main cause of the flooding was the sheer volume of water which fell and the culvert was unable to cope.

Photograph 20-1: Open watercourse in the field north of Main Street that flows into a culvert looking northwards

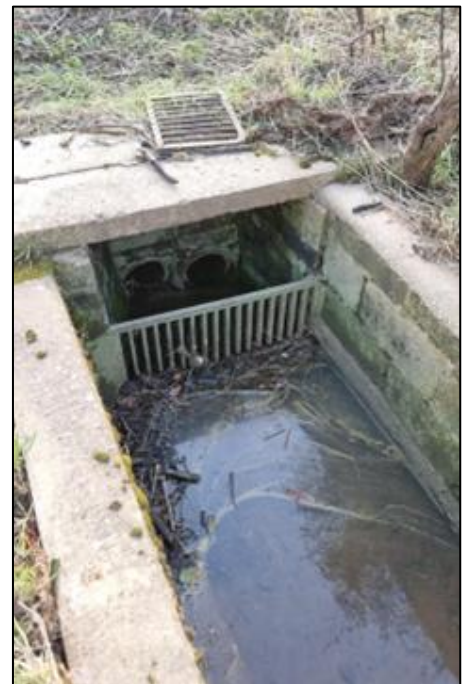
Photograph 20-2: Trash screen and culvert inlet at the field north of Main Street

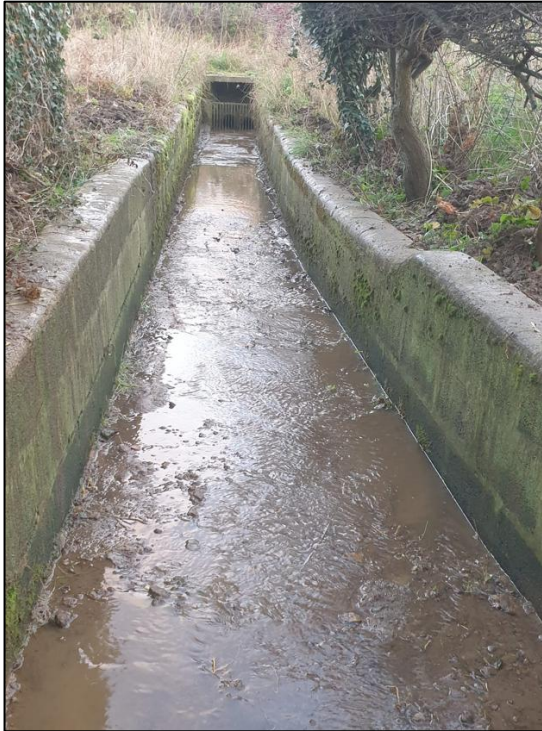
Photograph 20-3: Condition of open watercourse to the north of Main Street after maintenance

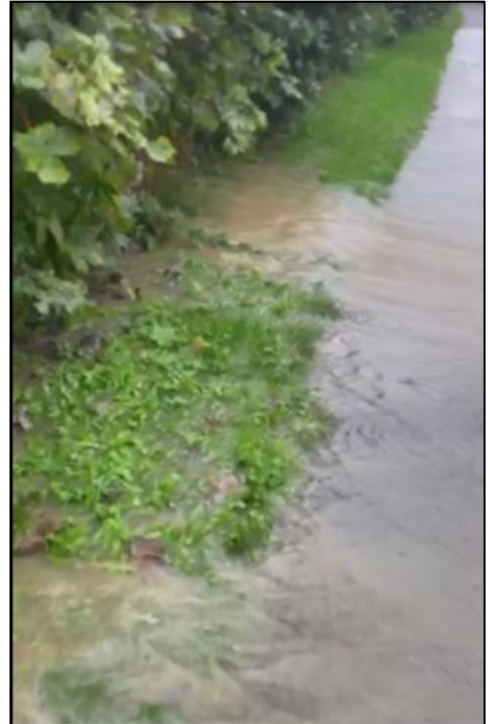
Photograph 20-4: Water running off field north of Main Street on the highway

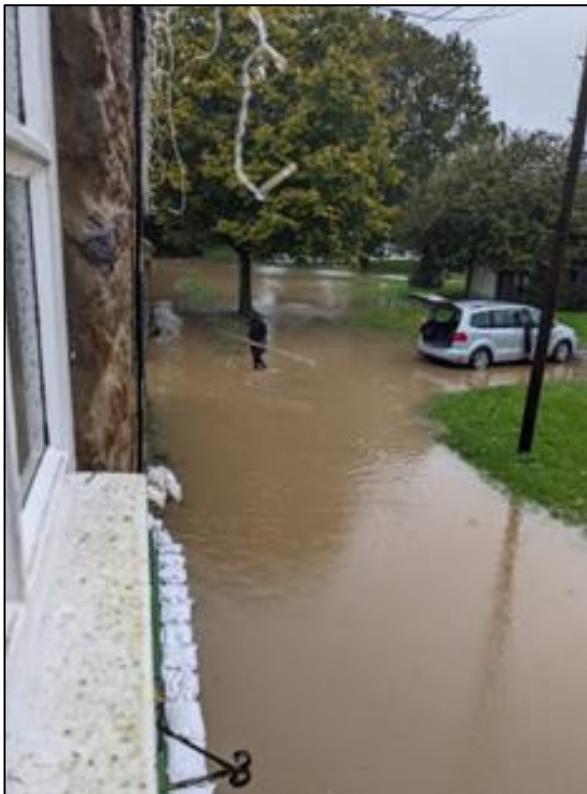
The mechanism of flooding in Wymondham was reported by local residents to be primarily a result of out of bank flows from the unnamed ordinary watercourses north of Main Street. This combined with significant surface water which was running off the fields to the north (see **Error! Reference source not found.**). The water flowed onto Main Street towards properties situated at a low point to the field and highway. Water also flowed onto Spring Lane and Sycamore Lane. Water inundated gardens, driveways and eventually properties once depths exceeded building thresholds (see Photograph 20-5 and Photograph 20-6).

Anecdotal reports were made of water backing up behind an access gate to 19, Main Street during the flood event. The water pooled here and struggled to get away (Photograph 20-5 and Photograph 20-6) breaching thresholds to the front of properties along Main Street. It is therefore likely that this access gate may have slowed the movement of the flood water away from properties.

Photograph 20-5: Water collecting in front of houses in Main Street between Sycamore Lane and Spring Lane

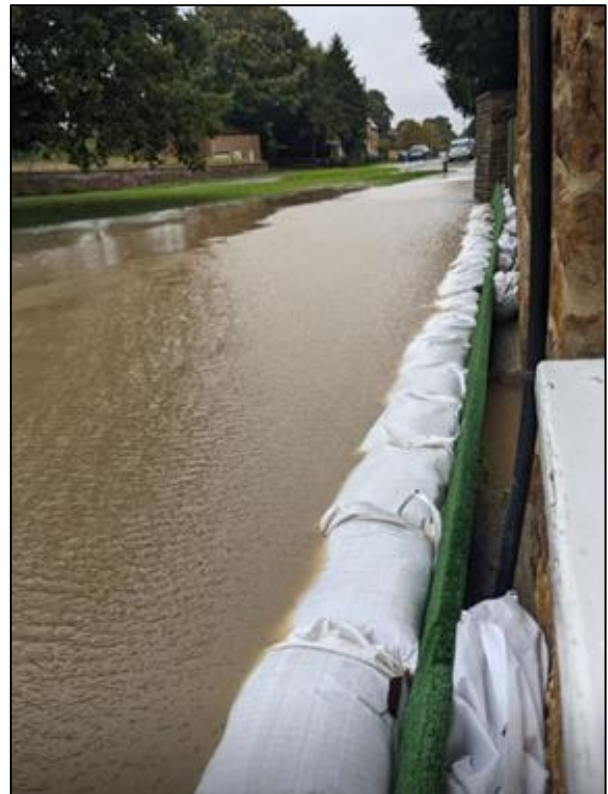
Photograph 20-6: Water collecting in front of houses in Main Street between Sycamore Lane and Spring Lane

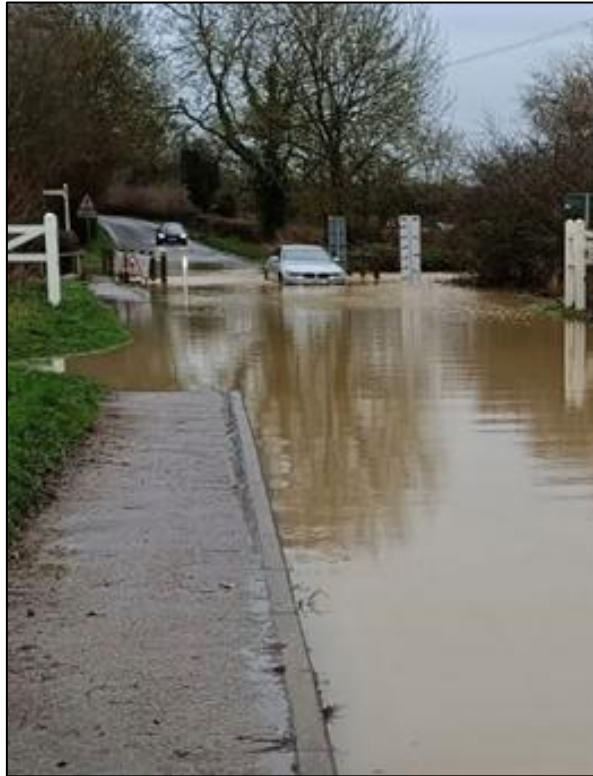
Additional properties experienced external flooding further eastwards along Main Street, and external flooding of the highway at Edmonthorpe Road and Wymondham Drift (as depicted in Photograph 20-7) where Wymondham Brook crosses these was reported. As these were external flooding incidents and the source of the floodwater is known, these areas have not been discussed further for the purposes of this report.

**Photograph 20-7: Flooding at Wymondham Drift –
depth shown on flood gauges**

ACTION	ACTION DETAIL	LEAD RMA or ORGANISATION	CURRENT STATUS
Flow Depth Gauges	Re-establishment of flood depth gauges at Wymondham Drift.	LCC LLFA	Complete
