Flood Investigation Report

Flooding at Watling Street, Hinckley –
27th December 2017

Final Report
October 2020

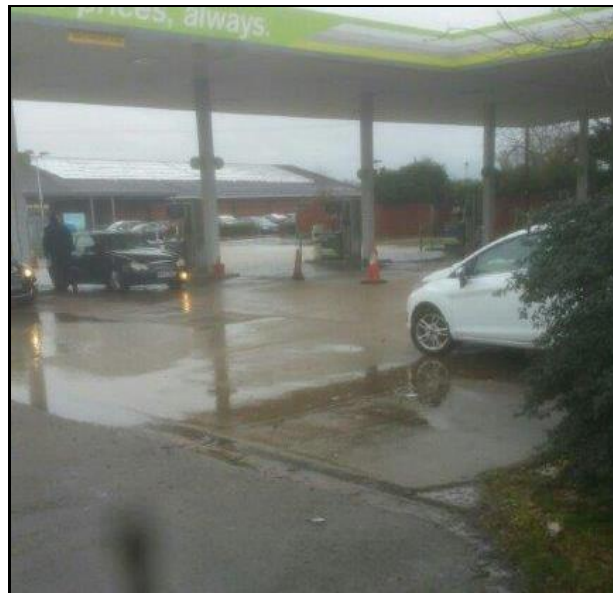
Residents and witnesses reported seeing the water flowing from the highway, bypass the gullies on the carriageway and overtopping the footway, flooding the frontages of the properties and businesses on Watling Street. The standing water on the garage forecourt was sufficient to lift the lids on the petrol storage units beneath the forecourt, further polluting the flood water which then made its way to the front of the properties on Watling Street (Figure 3).

Figure 3: Watling Street Petrol Station following forecourt flooding which lifted several fuel tank caps

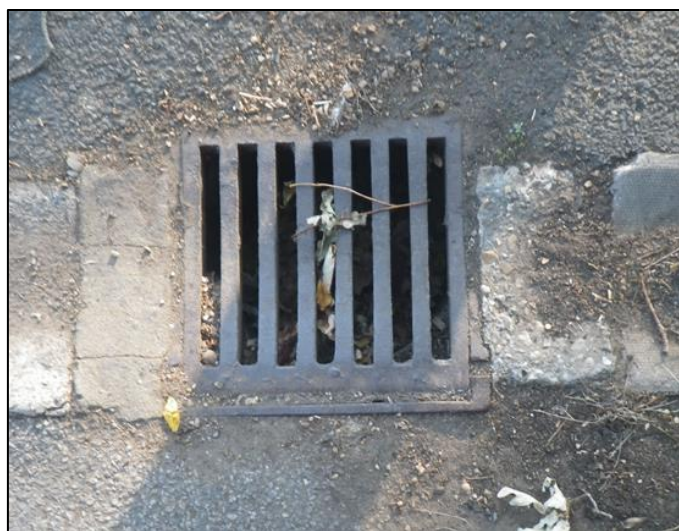
After the event, HE investigated the anecdotal reports of the silted gullies by inspecting their adopted infrastructure within the carriageway. It was identified that the gullies were silted (Figure 5) and that the integrity of the 225mm diameter surface water culvert had been compromised by tree root ingress and a third-party intrusion (metal pile/fence post).

Figure 5: The pavement gully outside the affected properties (taken after the event illustrating siltation)

- To undertake a detailed drainage inspection of their assets in order to identify any blockages or other intrusions that could have directly impacted on the ability of the system to drain at normal capacity and to review the system capacity, to identify any sections of the design which require upgrading or replacing.
- To take action to rectify any identified blockages within the pavement drainage system as identified in future surveys, as discussed in the RMA meeting on 15th August 2018.
- To create a work plan to identify what upgrades (if any) are to be planned in as remedial action in the coming months.
- To create a further action plan for works that can be incorporated into the planned A5 Watling Street widening project.

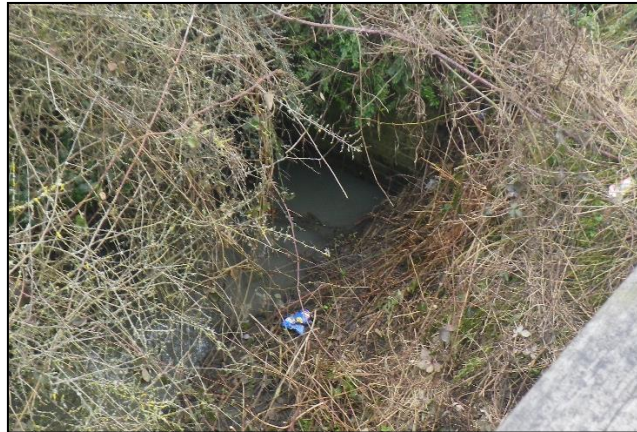
During the wider investigations into the functioning of their infrastructure, HE also identified that the outfall from the 225mm diameter surface water culvert was depressed by approximately 50% into the watercourse bed. This prevents the culvert from discharging at full capacity and causes the outfall to become easily submerged when the water level of the watercourse is increased (see Figure 6). This issue is further compounded by the angle at which the outfall is placed. As shown on Figure 2,

the outfall is arranged at a 'T' junction which creates a confluence where any flows from the 225mm diameter surface water culvert will be competing with the flow already in ordinary watercourse 1. These two issues result in the culvert being unable to discharge at its designed maximum rate.

Figure 6: The highway system outfall the day following the flood event. The outfall is still submerged and poorly positioned to discharge effectively

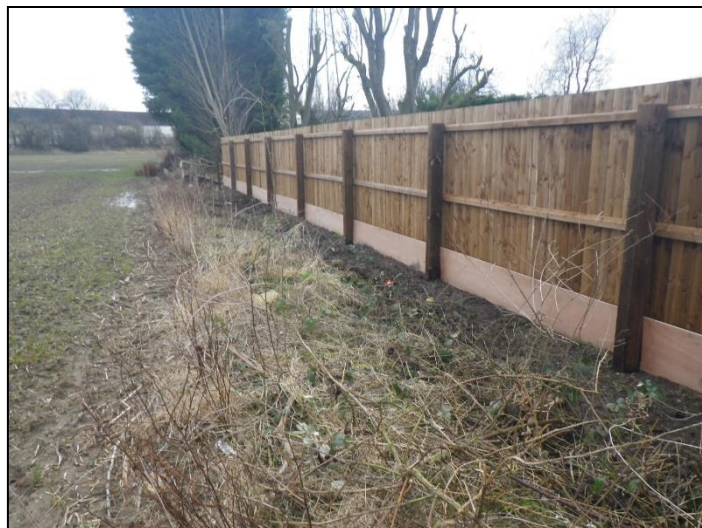
During a site walk over, conducted by the Council on 9th March 2018 it was identified that a section of the drainage ditch (highlighted red on Figure 2) located behind the affected residential properties, had not been maintained and had consequentially become silted and been filled with garden debris such as grass cuttings and soil (Figure 7).

Figure 7: The ditch to the rear of properties on Watling Street. A small depression was still present however capacity has been severely reduced.

- The landowner of the agricultural field has completed required maintenance to the ditch, which has restored connectivity of sub-catchment b.
- Local residents have agreed to refrain from depositing garden waste into the field ditch and have expressed interest in joining the Flood Warden Scheme.
- Aldi superstores have agreed to inspect their site drainage and undertake any required maintenance.

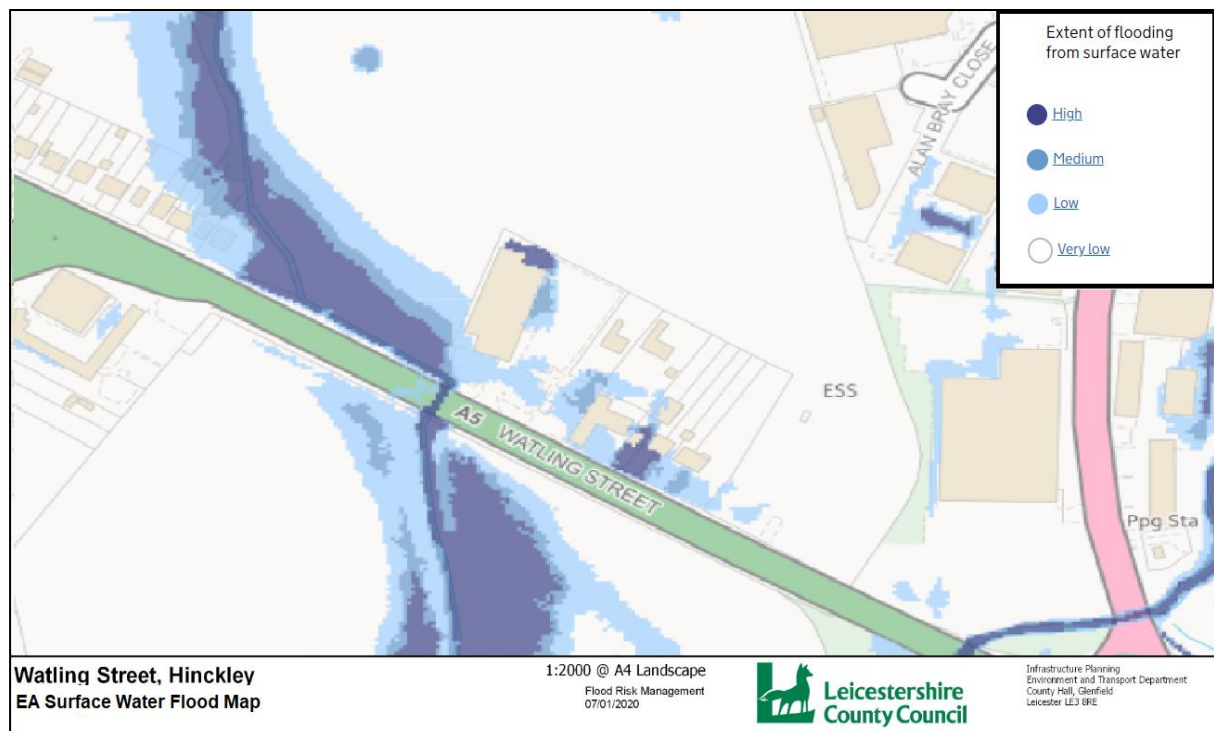
Figure 8: Environment Agency surface water flood risk map.

The site walkover conducted by the Council after the event also identified that the location of the affected properties appeared to be at a localised low point between the confluence of two watercourses and the adjacent Highway. Water therefore found the natural low point and entered commercial and residential properties when the drainage system failed to intercept the flows. This is illustrated by the EA 'Long Term Flood Risk' map. The map shows modelled surface water flow paths which broadly followed those that were anecdotally reported on the 27th December 2017. In particular, they show surface water accumulating at the natural low point.
