A47 East Norton

Flood Report

DETAILED FLOOD INVESTIGATION

Investigation Ref.:	2016-INV-201
Investigation:	A47, East Norton
Date of Flooding:	21st November 2016
Revision	FINAL

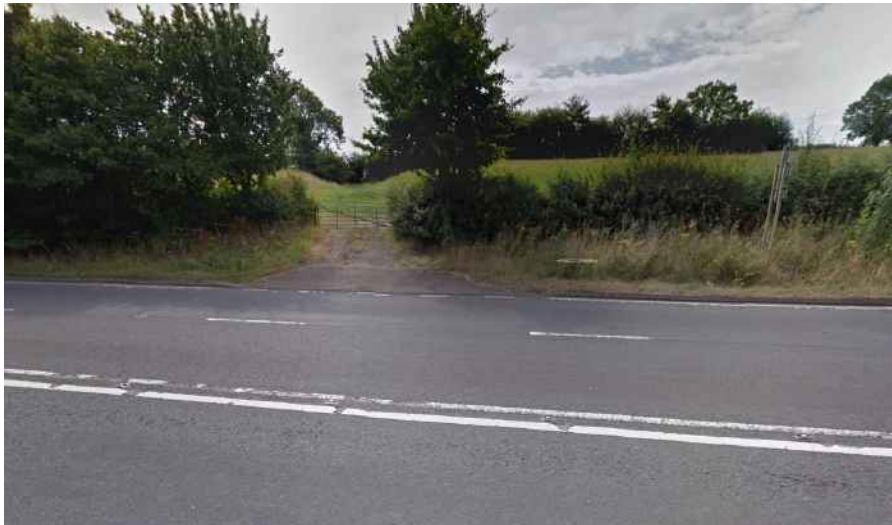
Photo A

At the time of the flooding incident, water is believed to have flowed from the agricultural land, following the natural contours, channelled through the agricultural field entrance (Photo A) to the

Field Entrance on the south side of the A47

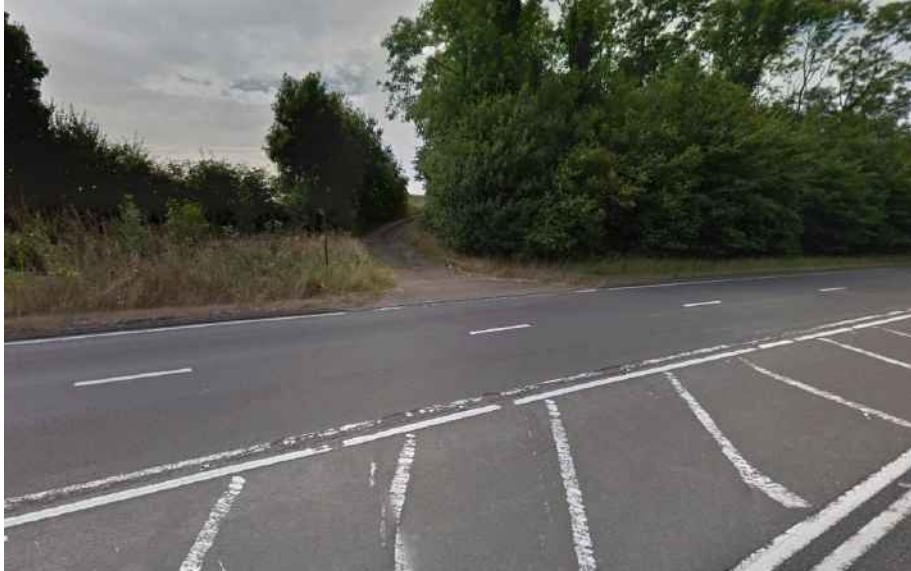
Photo B

There are two field entrances located along the southern side of the A47 in the proximity of the flooding incident (refer to Appendix A). The western most access is for an unclassified road (Photo B) and rises steeply following a route of a public byway west towards Moor Lane. From this access at the A47 the route is partially surfaced for approximately 30m. On investigation there is very little surface water catchment to this area and as such, it is not believed that significant quantities of surface water could be routed to the A47 from this access.

west of the incident and on to the highway. To a lesser extent it is believed to have flowed onto the highway via the un-classified road (Photo B).

Unclassified County Road on the south side of the A47

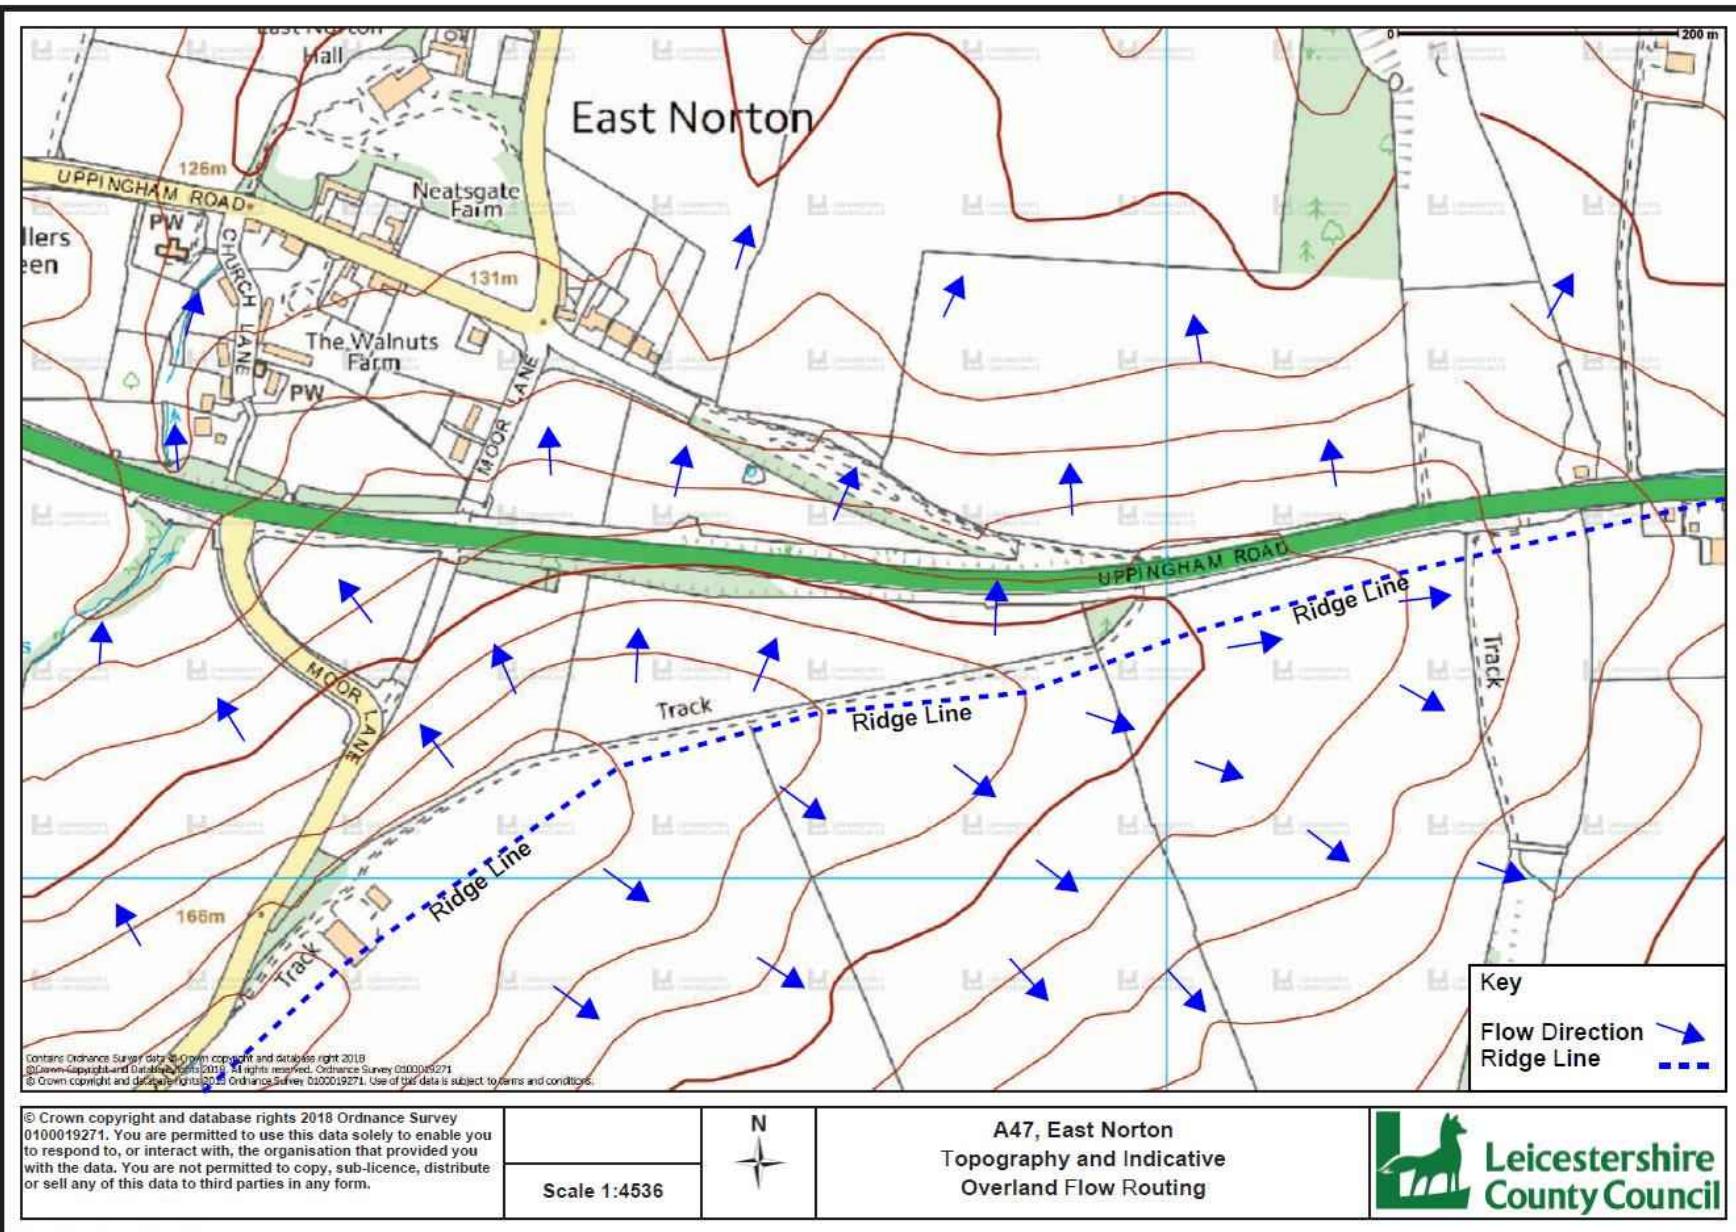
APPENDIX B

Appendix B illustrates the topography of the area around the incident and potential flow paths.

CONTOURS AND LOCATION OF ACCESS AND FLOW PATHS

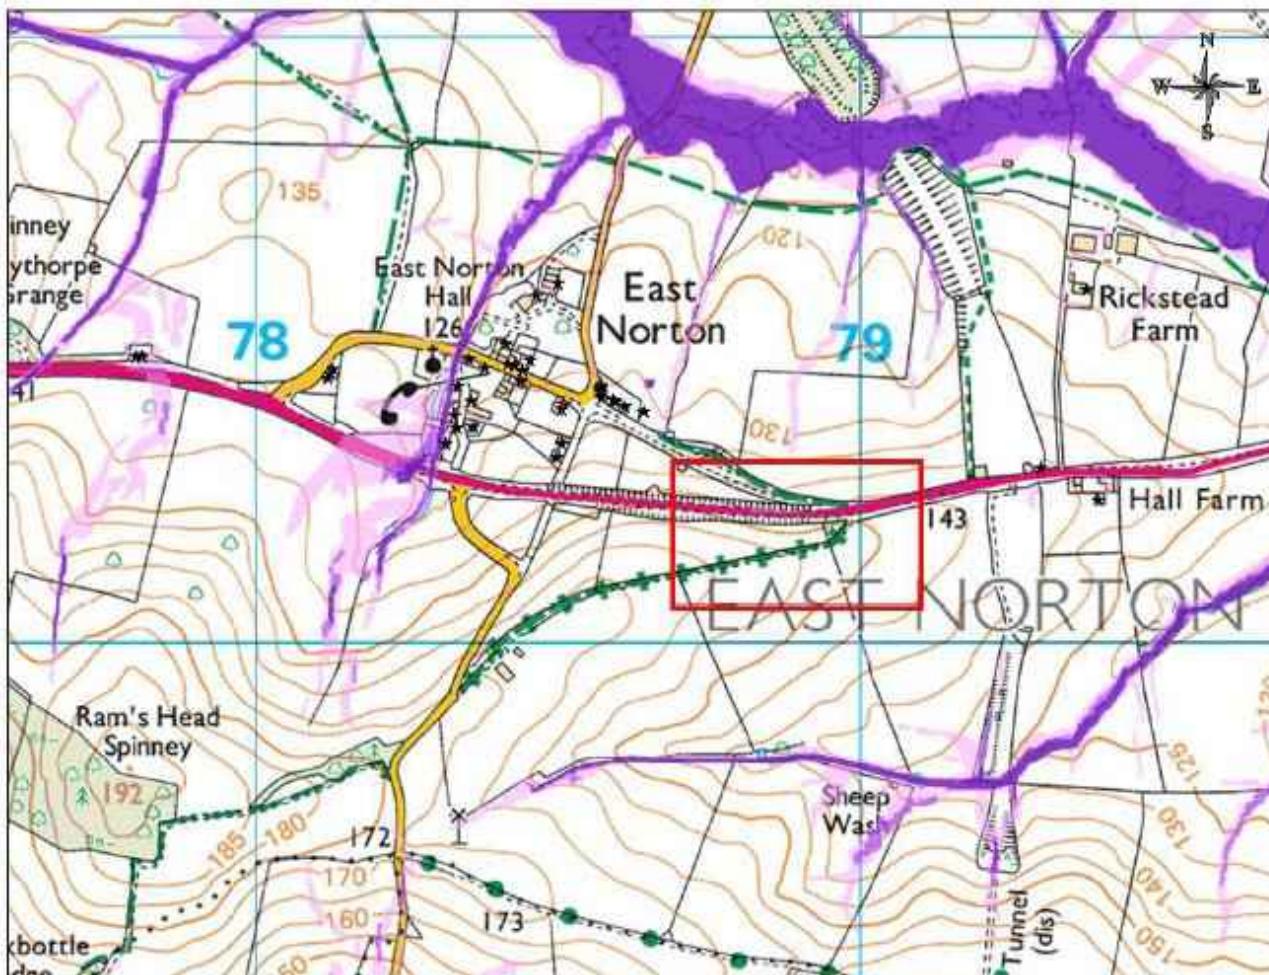
APPENDIX C

The updated Flood Map for Surface Water (uFMfSW) contained within Appendix C identifies this section of the highway as not being at risk of surface water flooding.

Red line: Approximate location of flooding
