Windsor Road, Loughborough

Flood Report

DETAILED FLOOD INVESTIGATION

County Council Investigation Ref.:	2016-INV-143
Investigation:	Windsor Road, Loughborough
Date of Flooding:	15th June 2016
Revision	Final

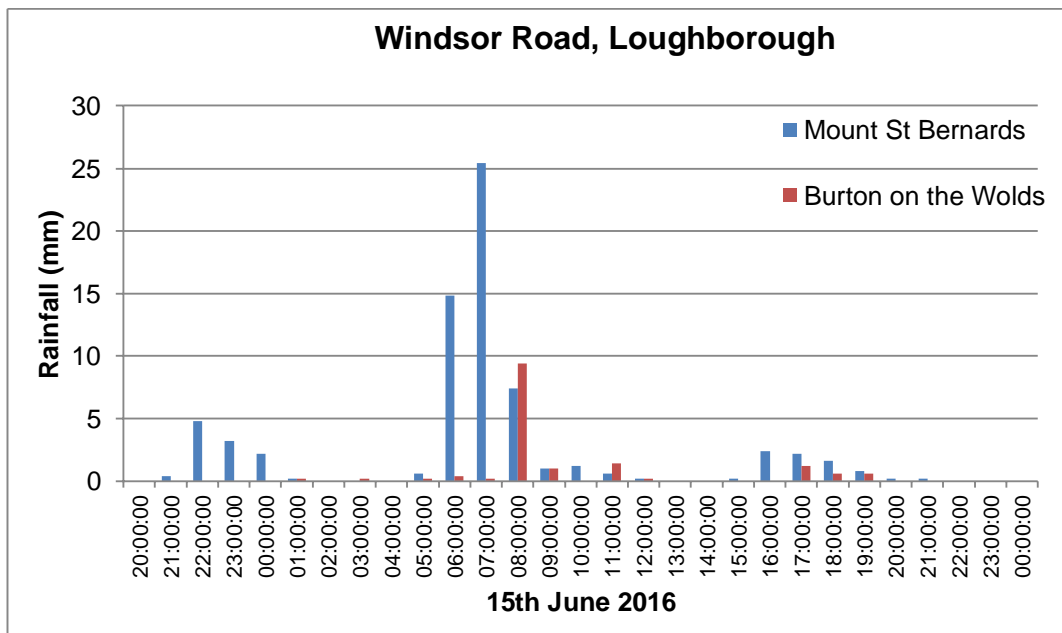
Figure 1 Rainfall data showing rainfall event which resulted in flooding on Windsor Road, Loughborough

On Wednesday 15th June 2016, intense rainfall fell over the area over a two hour period. Rainfall data from nearby rainfall gauges (Mount St Bernards and Burton on the Wolds) is shown in Figure 1. This is thought to have exceeded the design capacity of the drainage system in Windsor Road, causing flash flooding to occur. The grounds (car park and garden) of the two developments were inundated, although no internal flooding was experienced. The floodwaters remained for a number of hours after the rain had stopped.

The Depth-Duration-Frequency (DDF) model demonstrates that the rainfall events that occurred over the Windsor Road catchment had return periods of between 5 and 10 years, or more than a 10% Annual Exceedance Probability (AEP). However, as two rain gauges were used, neither directly at the location of interest, a certain amount of error is to be expected in the interpolation. Therefore it is worth noting from Appendix F-1 that the 2 hour duration rain event at the Mount Saint Bernards rain gauge has a 1 in 40 year return period and hence, dependent on the extent and track of the rain storm, the Windsor Road event could have been as much as a 1 in 40 year return period. In general, highway drainage is not designed to accommodate events of this magnitude.

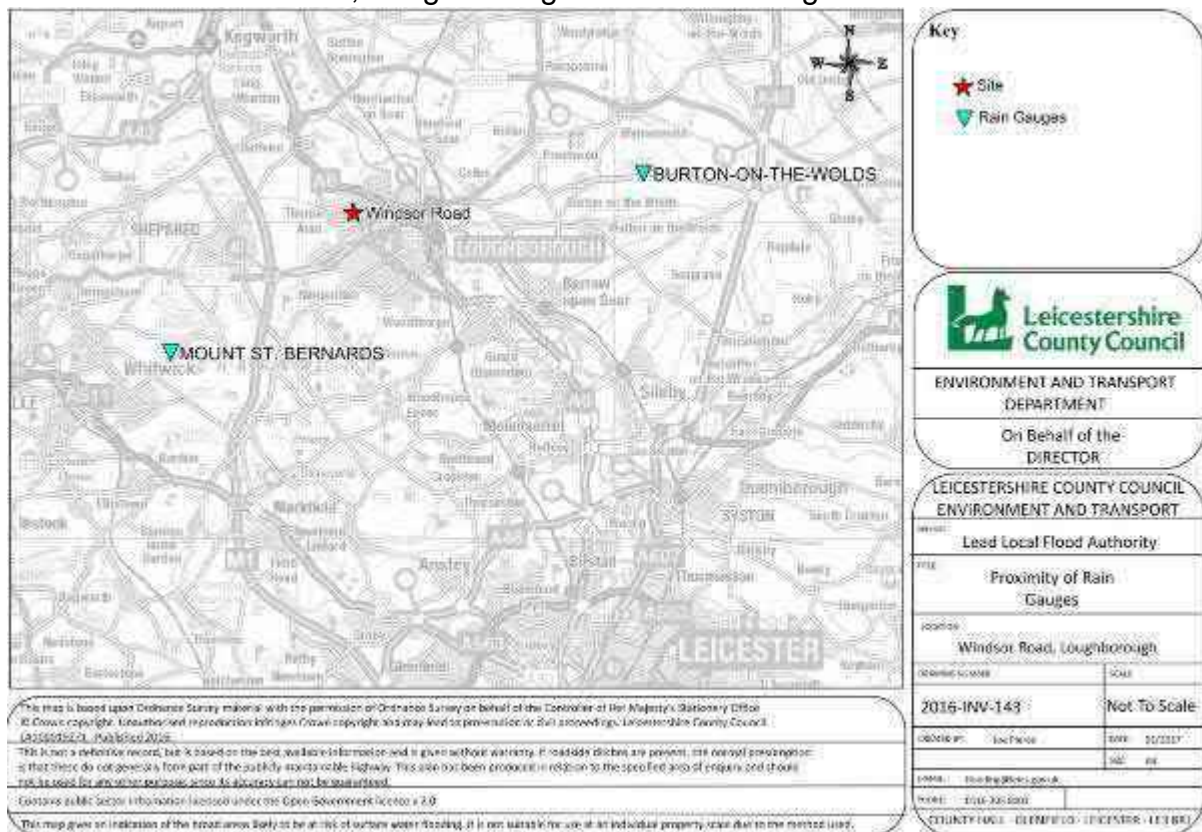
Figure 2 Location of rainfall gauges and flooding incident location

The flooding incident was located between two rainfall gauges (Mount St Bernards and Burton on the Wolds). Therefore an average of the maximum rainfall from the two nearest rainfall gauges has been used to estimate the event rarity for the rainfall event, using the Depth-Duration-Frequency (DDF) rainfall model⁴. The two rainfall gauges closest to Windsor Road, Loughborough are shown in Figure 2.

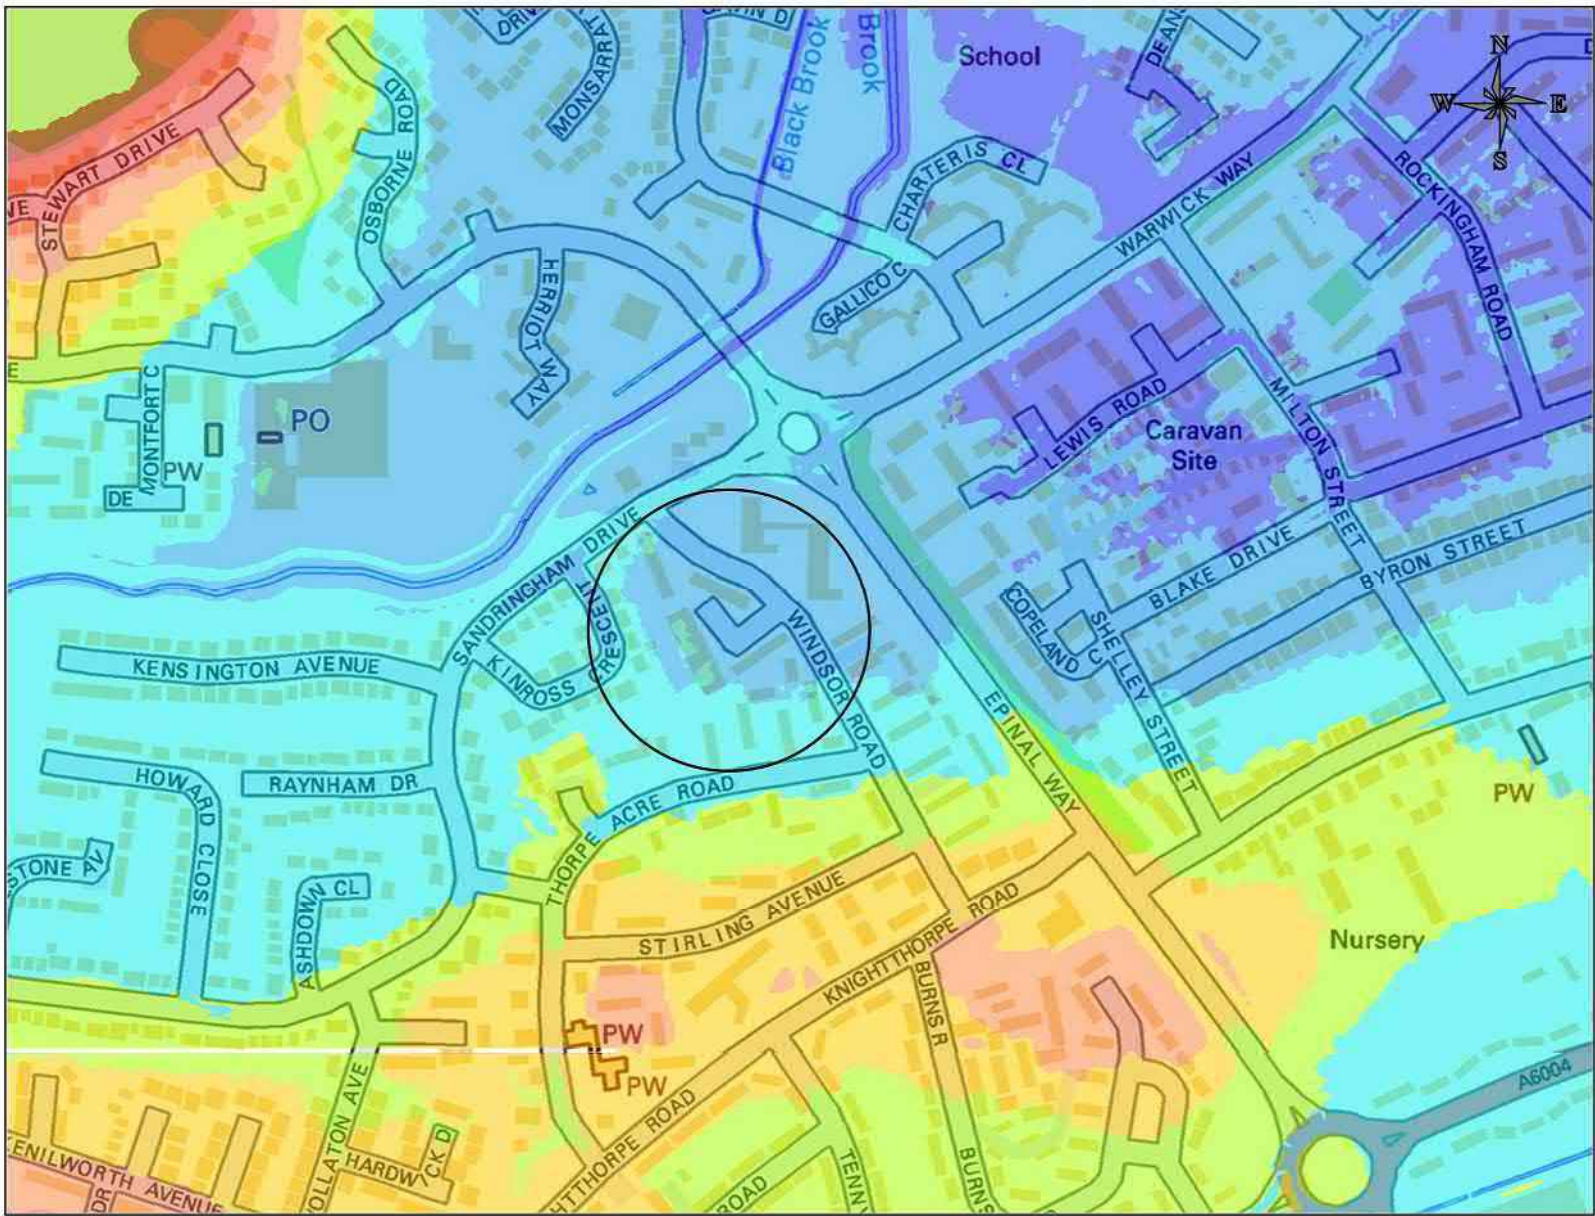
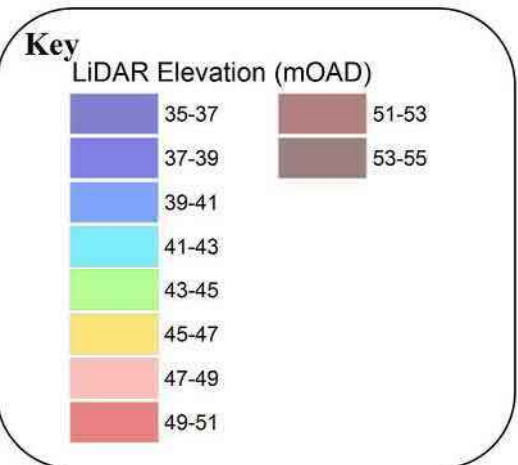
LIDAR MAPPING

A review of the Lidar data (Appendix D) suggests that the area to the south of Hanover Court and Sir Robert Martin Court is higher and run off from Knightthorpe Road and Stirling Avenue is likely to flow down Windsor Road during large storm events, exacerbating the flooding situation at the low point at the junction of the side road from Hanover Court with the main arm of Windsor Road.

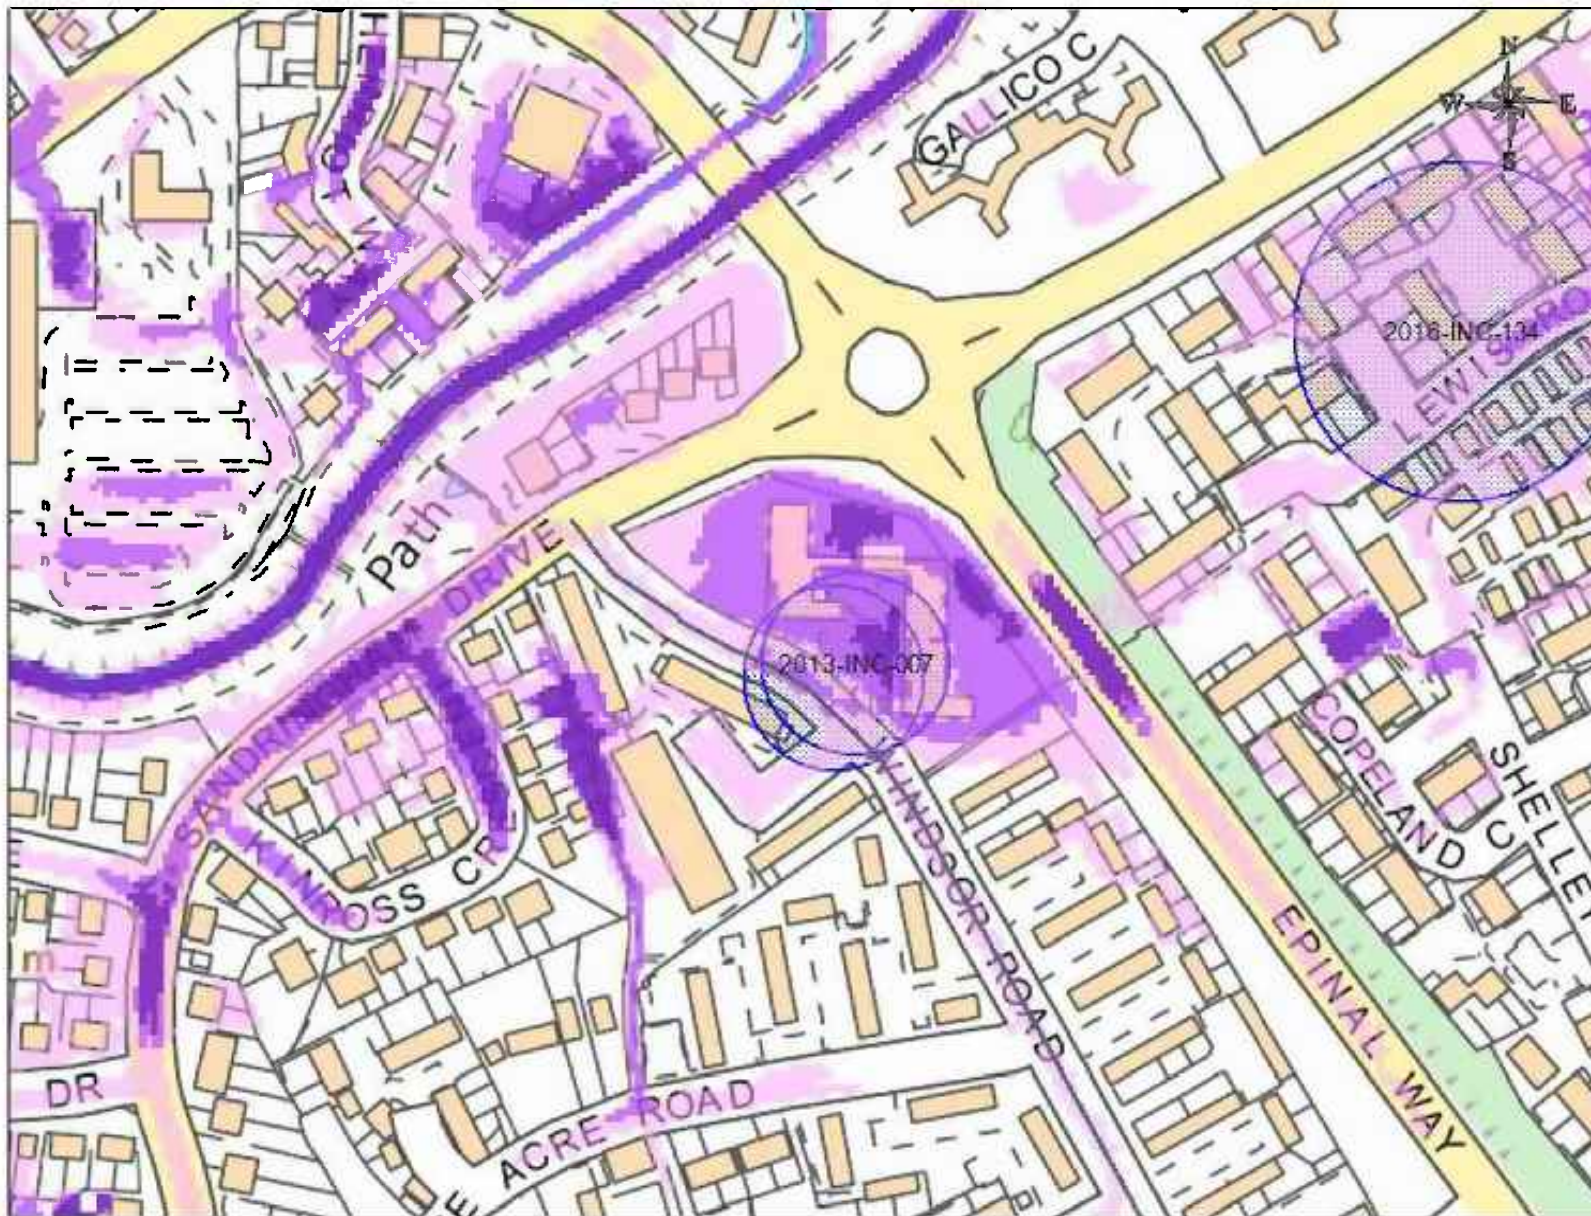
RISK OF FLOODING FROM SURFACE WATER (RoFSW) MAP

Environment Agency Long Term Flood Risk - Surface Water Flood mapping (Appendix G) suggests that Sir Robert Martin Court and a few places in the Hanover Court car park have a high risk of flooding from surface water. High risk means that each year this area has a chance of flooding of greater than 3.3%. The same mapping shows that Windsor Road and portions of the Hanover Court car park are at a low risk of flooding. Low risk means that each year this area has a chance of flooding of between 0.1% and 1%.

The extent of the reported flooding is larger than that suggested by the Environment Agency Long Term Flood Risk - Surface Water Flood mapping⁵. The maps suggest that flooding occurs throughout most of the Hanover Court car park during extreme rainfall events which is not supported by anecdotal evidence where the flooding is described to occur frequently during smaller less intense events. At Sir Robert Martin Court the map show flooding during less intense storm events, but the extent of flooding that occurred on June 15th 2016 is larger than that suggested by the Environment Agency Long Term Flood Risk - Surface Water Flood mapping.
