Flood Investigation Report

West End, Long Whatton – 14th November 2019

Final Report

September 2020

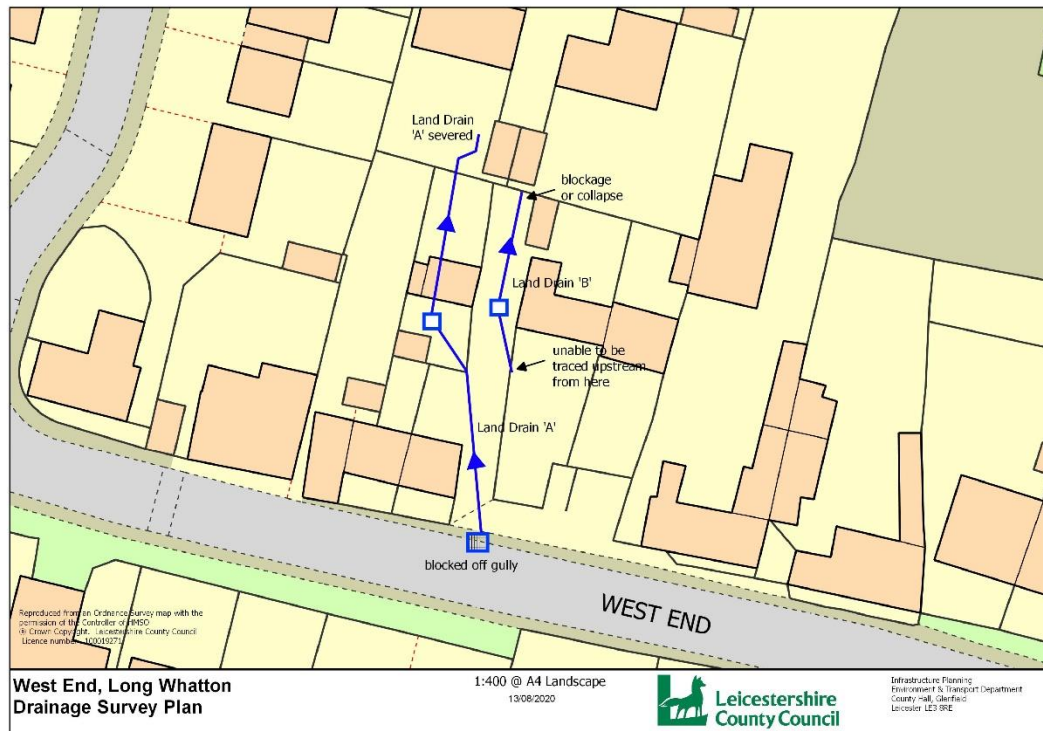
Figure 2: Location of land drains

There are believed to be two land drains running from No.16 & 20 West End and under land to the rear of these properties on which stands Sherwood Court (Figure 2).

- 'Land drain A' – located to originate from a highway chamber at top of the shared driveway of No.16/20 and runs down the driveway before diverting under No.20. This drain is severed in the land of No.10 Sherwood Court. The route of this land drain is not logged on any mapping or identified on any historical maps.

- 'Land drain B' - located between No.16/20 – believed to originate through front garden of No.16 and is currently severed in land of No. 12 Sherwood Court. The route of this drain is also not logged on any mapping or identified on any historical maps.

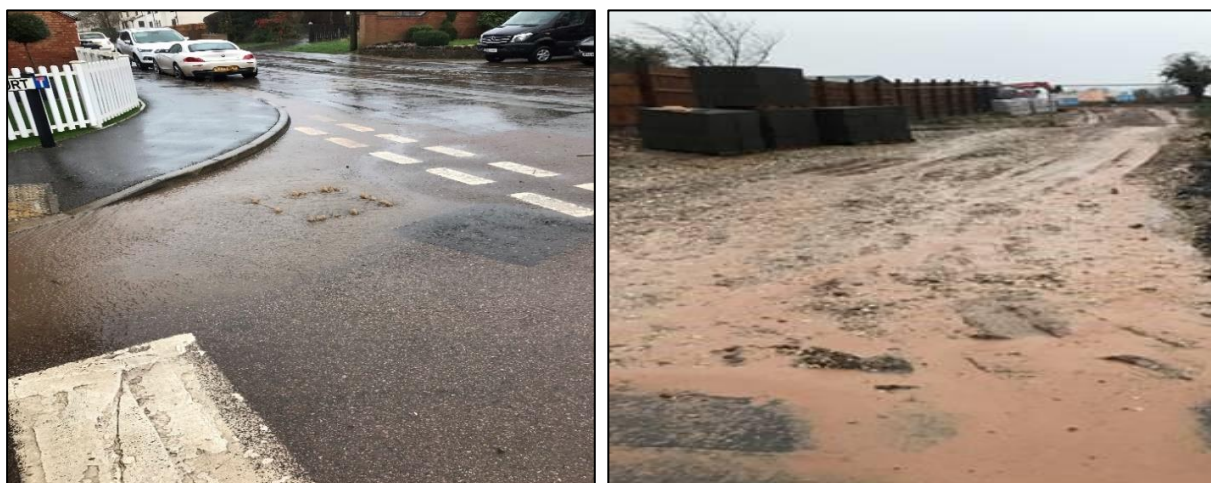
Resident and witness accounts on the day of the incident indicate that water was flowing down the driveway from West End and also from an inspection chamber on land drain 'A', located within the grounds of the property that flooded internally (Picture 3). During this event it was reported that an inspection chamber lid for the foul sewer was lifted and water was able to get away using this means.

Water was also identified to be running off a live construction site located opposite the shared driveway of the affected property. The muddy, silty nature of the water suggests that the water had run off the exposed groundworks relating to the construction works taking place (Picture 2). It has been reported that this water did not flow down the shared driveway towards the affected properties. Instead it caused extensive highway flooding at the junction of Sherwood Court and West End. There were also reports of water flowing from inspection chambers located within Sherwood Court (Picture 1). Figure 6 illustrates the surface water flow routes during the flood event of November 14th, 2019.

Pictures 1 & 2: Showing water surcharging from the inspection chamber in Sherwood Court (from a later flood event) and surface water flowing onto West End from the live construction site on 14th November 2019

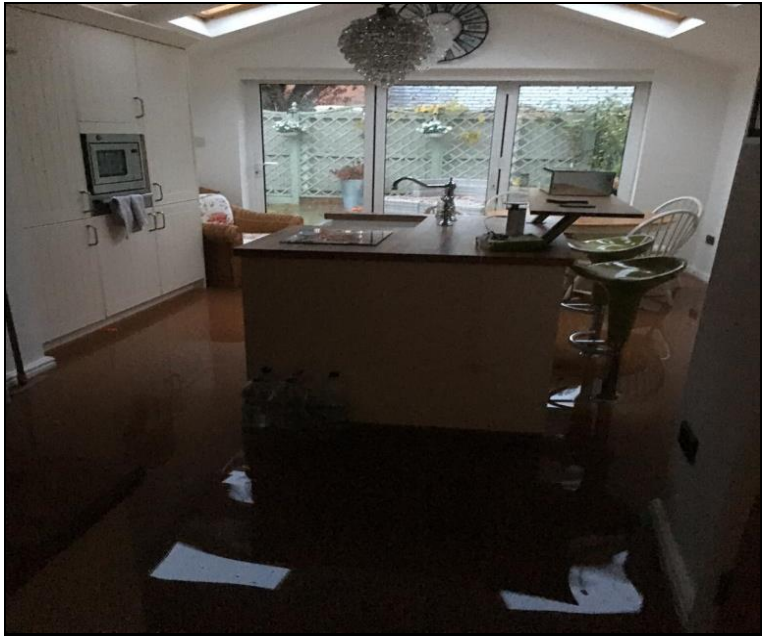
Picture 3: Resident photo showing extent of internal flooding

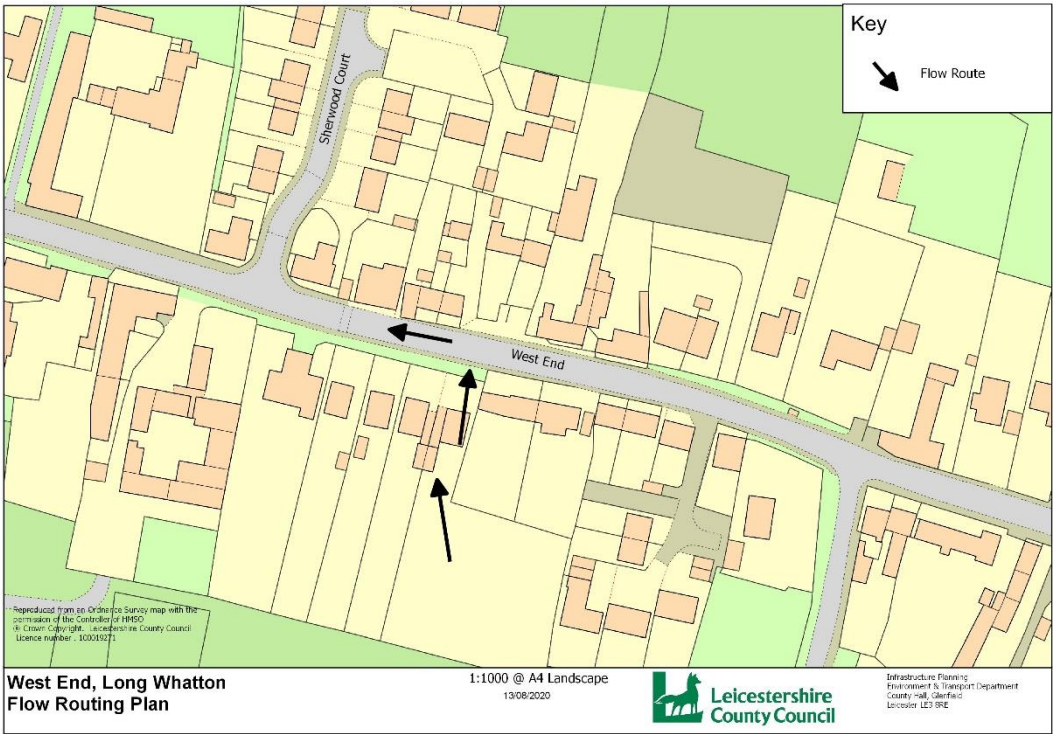
Figure 6: Surface water flow route off the minor development site

The live construction site opposite the affected properties had altered land levels which in turn has altered local surface water flow routes. During the intense rainfall event, silt and water flowed off the steep access drive onto West End where it ran along the road in the direction of Sherwood Court. This water caused extensive highway flooding on West End/Sherwood Court but did not exacerbate the issues experienced by the homeowners.

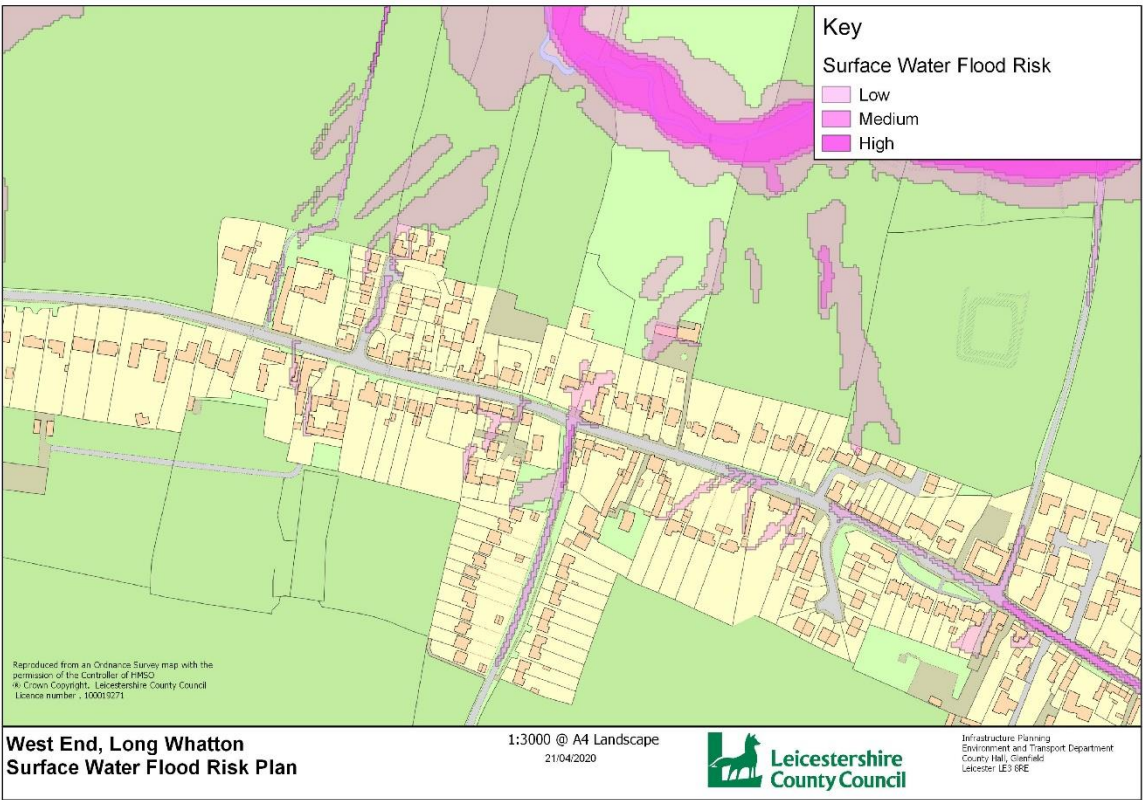
Figure 7: Surface water flood risk for West End and Sherwood Court

A review of surface water flood risk mapping (Figure 7) shows a risk of surface water flooding along Sherwood Court, however there is no risk predicted along West End in that location. This mapping does not highlight the reported flow path of water flowing off an active development site opposite the shared driveway of the affected properties. This mapping is unable to pick up local flow paths in some instances and is only

intended for use at a wider scale. It also suggests that the live construction works may have altered local surface water flow paths.

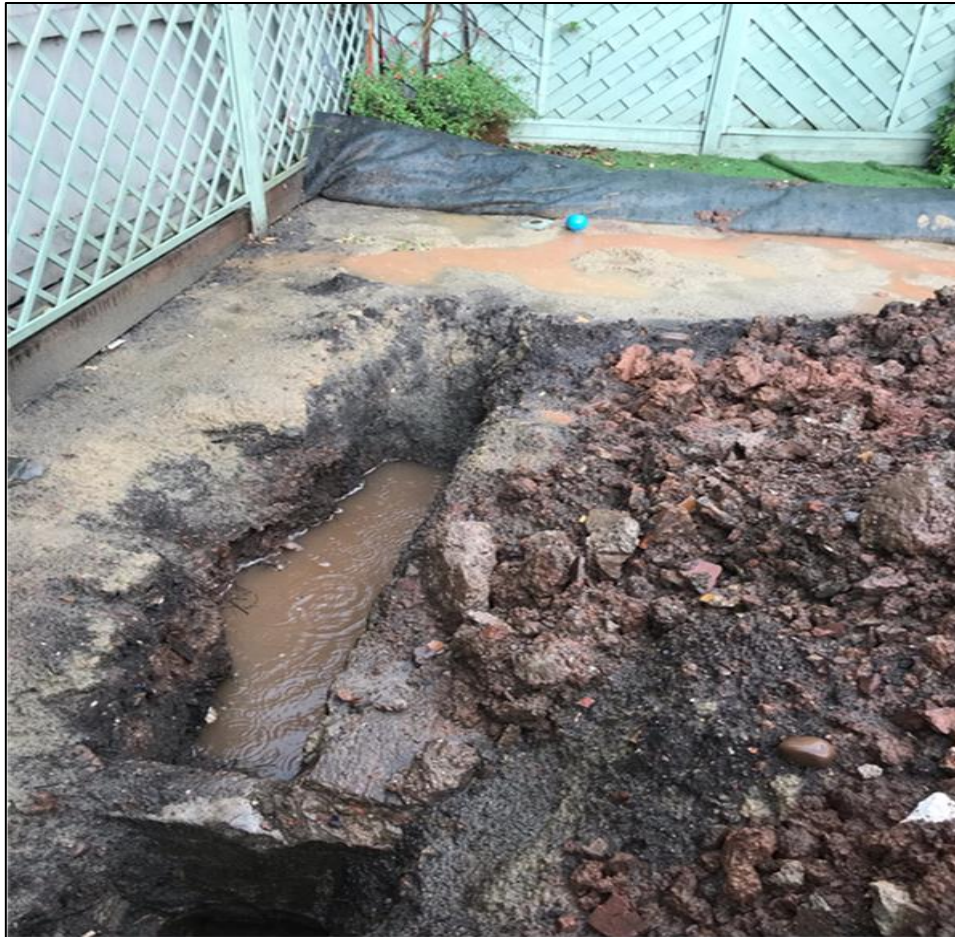
It has also been identified that *Campylobacter* now exists in the locality. Land drains A&B (Pictures 5-7) are currently severed and so any water that enters them will remain stagnant as there is nowhere for it to go except the ground (at a slow rate).

Picture 5: Water collecting in Land Drain A (No. 20) due to the drain being severed to rear of the property in Sherwood Court

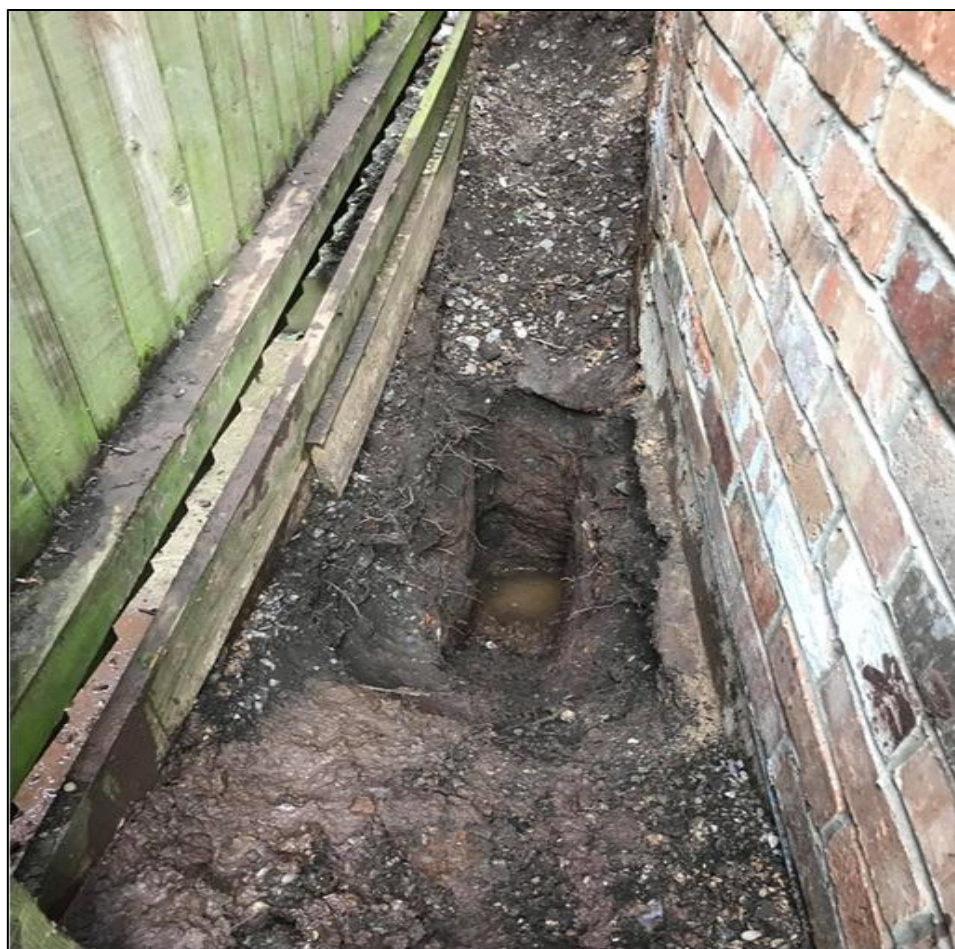
Picture 6: Water collecting in Land Drain B due to drain being severed where it leaves the property (No.16) and meets the property to the rear on Sherwood Court

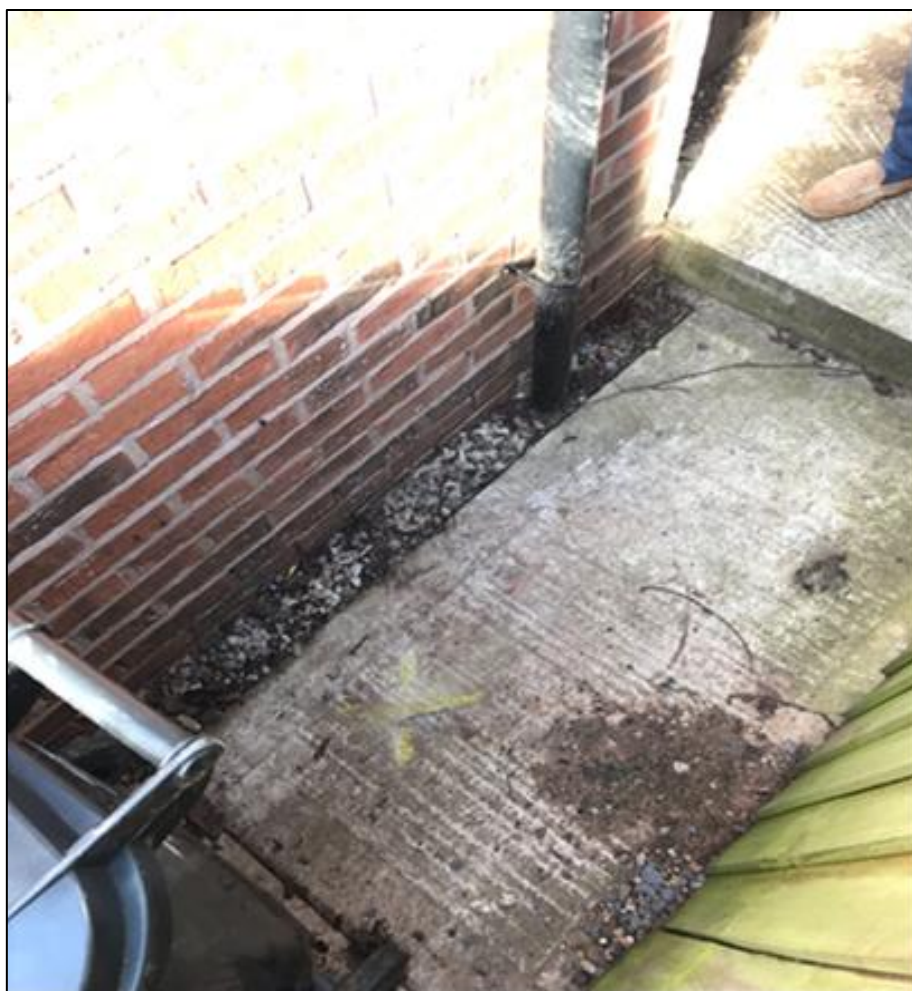
Picture 7: Yellow 'X' denotes location where Land Drain B running from No. 16 West End is severed at property to the rear in Sherwood Court
