Flood Investigation Report

REDMILE

16TH FEBRUARY 2020

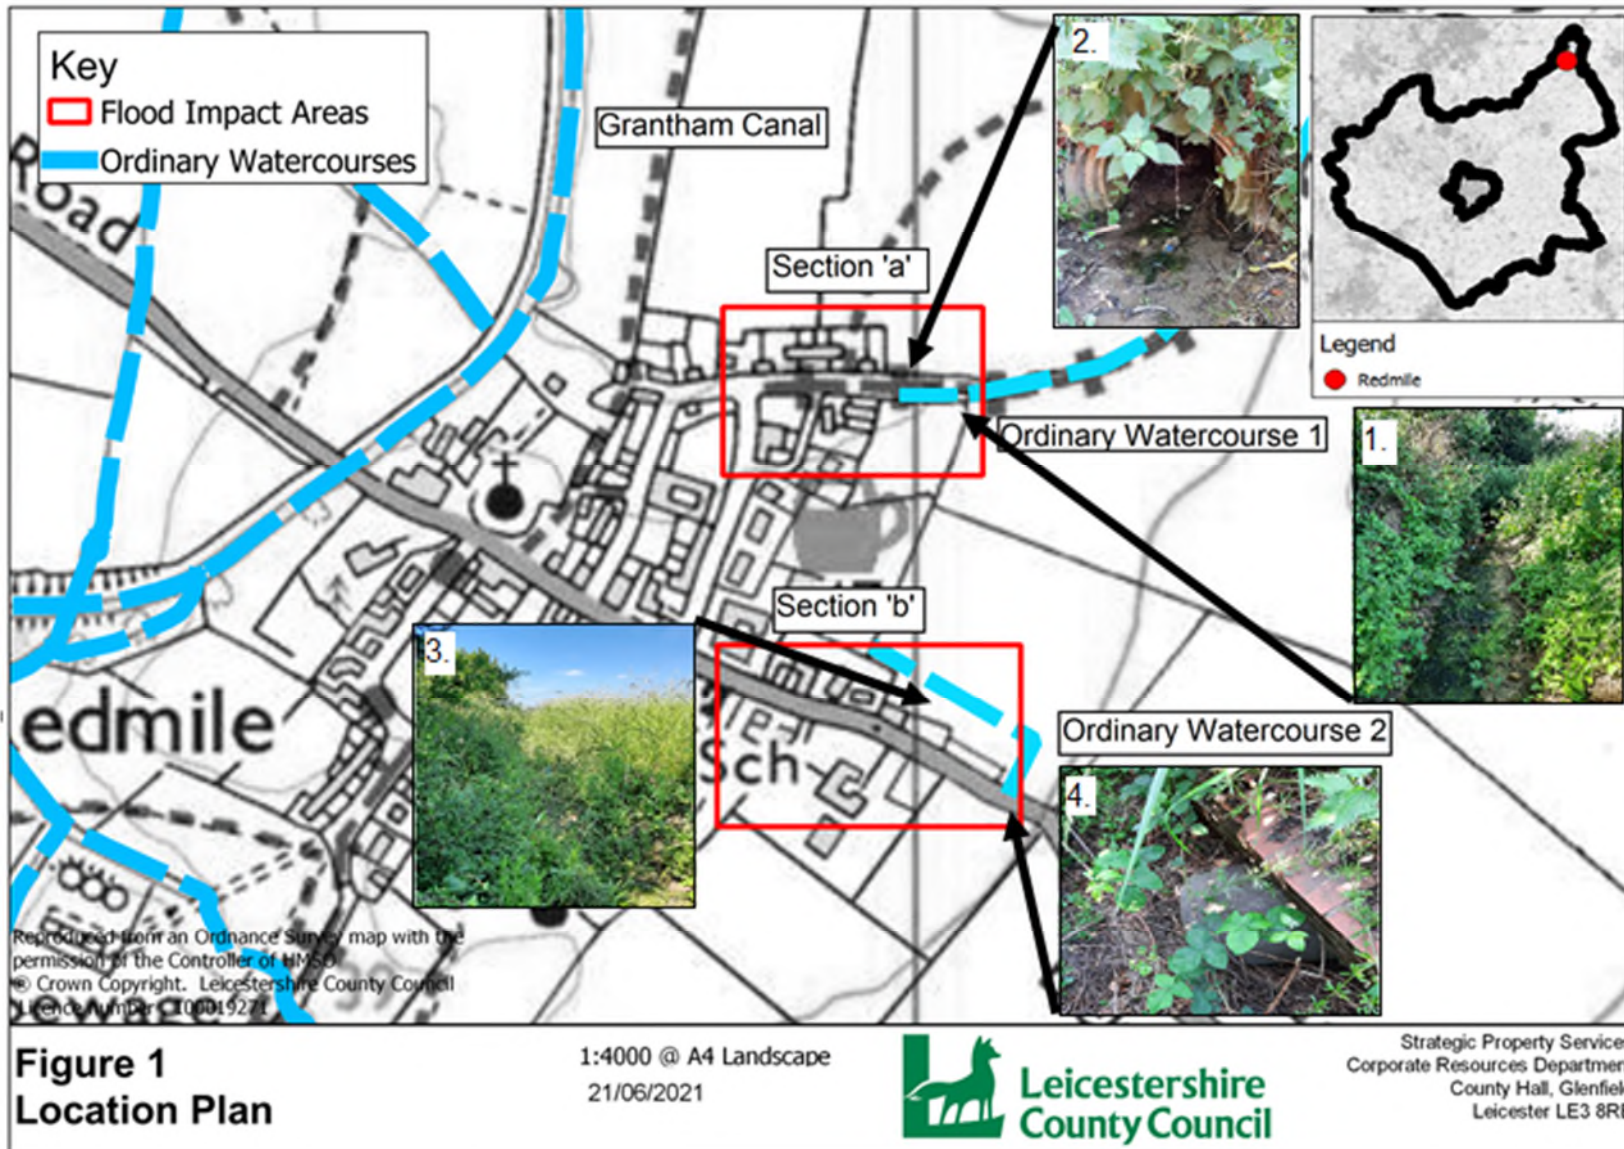
Figure 1 illustrates the two areas (sections 'a' and 'b') that were affected on the 16th February 2020.

The two focus areas of the report are Post Office Lane and Belvoir Road (Figure 1, sections 'a' and 'b' respectively) as these were the two locations which reported internal flooding during the flood event. Figure 1 presents the network of ordinary watercourses around Redmile including the Grantham Canal which flows along the western edge of the village and is the responsibility of the Canal and River Trust. The village is categorised as Flood Zone 1 and is served by foul and surface water sewer networks which are owned and maintained by STW.

Ordinary Watercourse 1 (Figure 1) flows in a south westerly direction towards the village centre through agricultural fields (Photo 1 in Figure 1) before it is culverted into a 600mm diameter pipe at approximately ordnance survey National Grid Reference (OSNGR) Easting: 480061; Northing: 335612 (Photo 2 in Figure 1). Highway gullies along Easthorpe Lane connect into this 600mm diameter highway drainage system, which then connects into a 450mm diameter STW surface water at approximately OSNGR Easting: 479887; Northing: 335598. The STW system flows in a westerly direction and then downsizes into a 300mm diameter pipe which passes under the Grantham Canal before outfalling into an ordinary watercourse at approximately OSNGR Easting: 479699; Northing: 335656. Pipe sizes mentioned above are based on asset records, to confirm pipe sizes a survey would be required.

Ordinary Watercourse 2 (Figure 1) is an unmarked ordinary watercourse (not available on the mapping available to the Council and anecdotally reported by residents) located to the north of the impacted residential properties (Photo 3 in Figure 1). Ordinary Watercourse 2 flows in an easterly direction before being culverted into a 300mm diameter pipe under Belvoir Road (Photo 4 in Figure 1). Ordinary Watercourse 2 then becomes open channel on the south side of Belvoir Road and flows west before being culverted again under private land. The condition of the culverted sections of Ordinary Watercourse 2 and where it eventually outfalls are unknown to the Council. Notably, in this section, there are depressions within the farmland to the north of section 'b' which fall towards Belvoir Road (Photo 5). There is also a 150mm combined STW system that flows in a westerly direction along Belvoir Road away from the village towards the local pumping station.

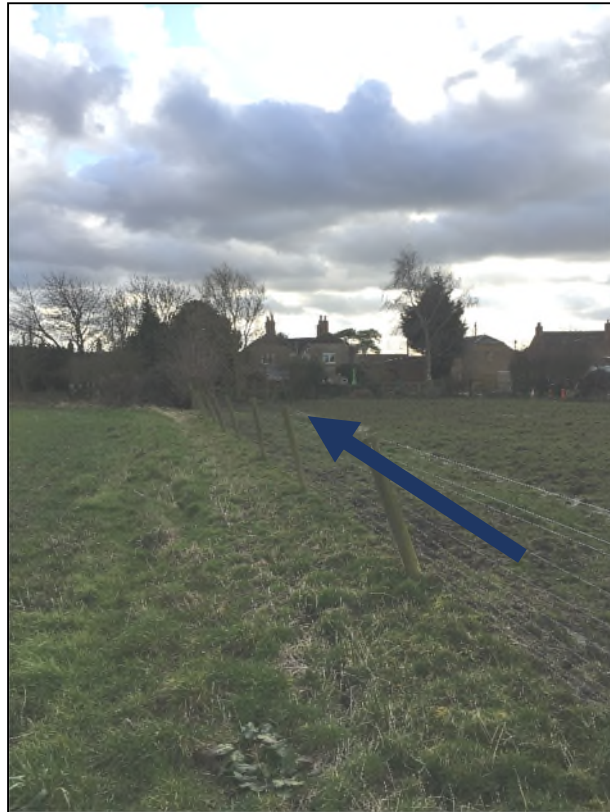
Photo 5: The farmed land between section 'a' and 'b' which has depressions along the land towards Belvoir Road. The blue arrow indicates the identified depression and direction of surface water flow.

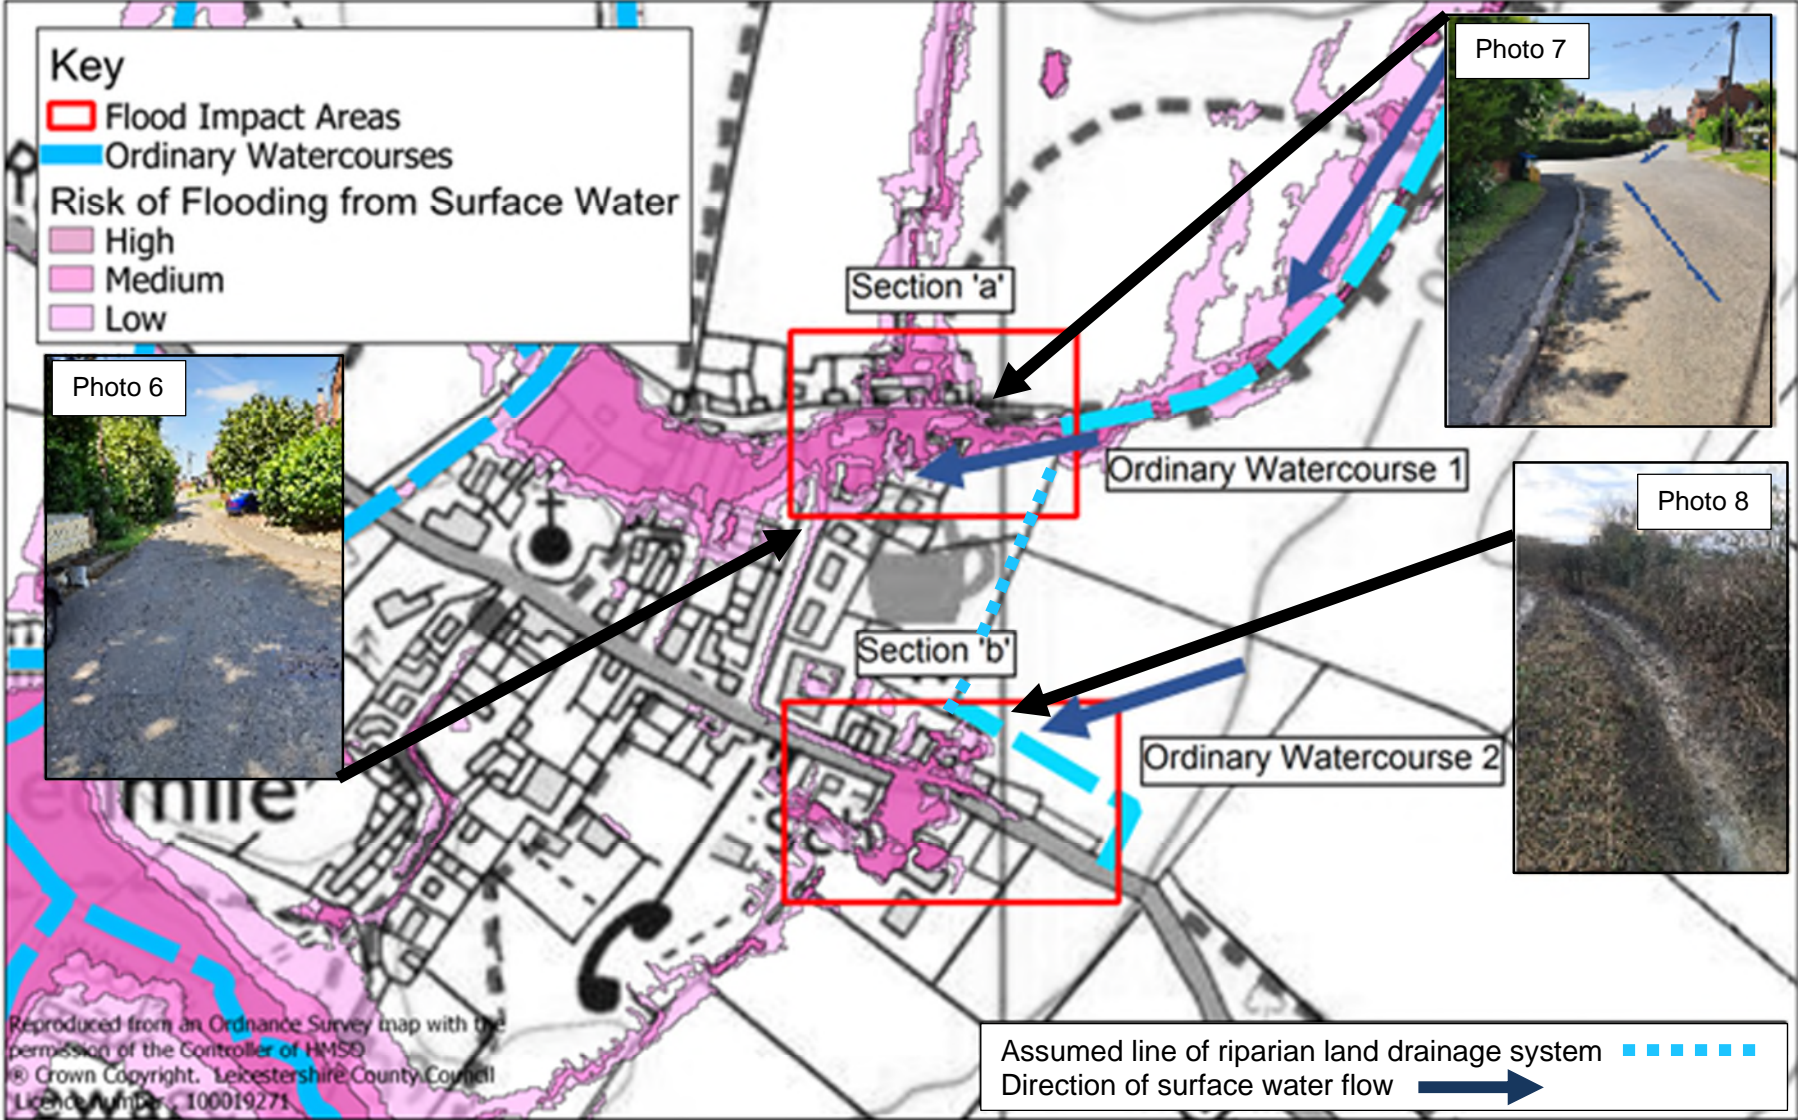
Figure 2
Risk of Flooding from Surface Water

Figure 2 indicates a high-risk surface water flow path along Ordinary Watercourse 1 and within section 'a'. The surface water flow path closely mimics what was anecdotally reported by the residents. This includes overland surface water flows following the topography of the adjacent agricultural land in a southerly direction towards Easthorpe Lane, as well as along Ordinary Watercourse 1 which breached its banks. Ariel photography available to the Council indicates potential depressions along the agricultural land which may be linked to historical ploughing of the land and could have exacerbated the overland surface water flows. Figure 2 also indicates that the impacted residential properties are located within a low point of the catchment; site visits and land height data available to the Council supports this analysis. Easthorpe Lane and Drift Hill (located opposite Easthorpe Lane) both fall towards section 'b' (Photo 6 in Figure 2), with Post Office Lane increasing in land height to the south of section 'b' (Photo 7 in Figure 2). This subsequently creates a 'bowl' effect around the impacted residential properties resulting in overland surface water flows from Ordinary Watercourse 1 and adjacent agricultural fields collecting in the natural low point.

Figure 2 also presents a high surface water risk flow path from the north of section 'a'. There is a known open ordinary watercourse which flows south before being culverted to the north of the residential properties and so this flow path may illustrate the culverted watercourse's path. It is believed that this culverted system connects into the highway drainage system along Easthorpe Lane. Although no water ingress through the rear of residential properties was reported, this extra volume of flood water in the highway drainage system may have overwhelmed the storm system and exacerbated the volume of flood water within Ordinary Watercourse 1. However, the extent that this may have influenced the flood event is unknown.

Figure 2 presents a high surface water flood risk within section 'b', indicating that the residential properties are located at a natural low point. The main source of flooding was anecdotally reported to be the overland surface water flows from the agricultural fields to the north of section 'b' flowing in a southerly direction and causing flood water ingress through the back of the residential properties. The sheer volume of overland surface water run-off would have quickly overwhelmed Ordinary Watercourse 2 and added to the volume of flood water flowing south towards the impacted residential properties (Photo 8 in Figure 2). Figure 2 does not illustrate this anecdotally reported surface water flow path. However, the surface water modelling data is not always accurate at a local level. Site visits and land height data available to the Council indicates that a large area of the catchment to the east of section 'b' falls in a westerly direction towards the flood impact area (Photo 9).

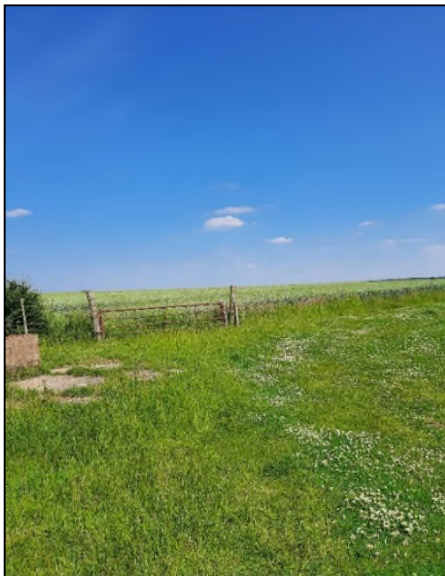
Photo 9: Facing east from the agricultural field between section 'a' and 'b' indicating how the falls in a westerly direction towards the field (photo taken in June 2021).

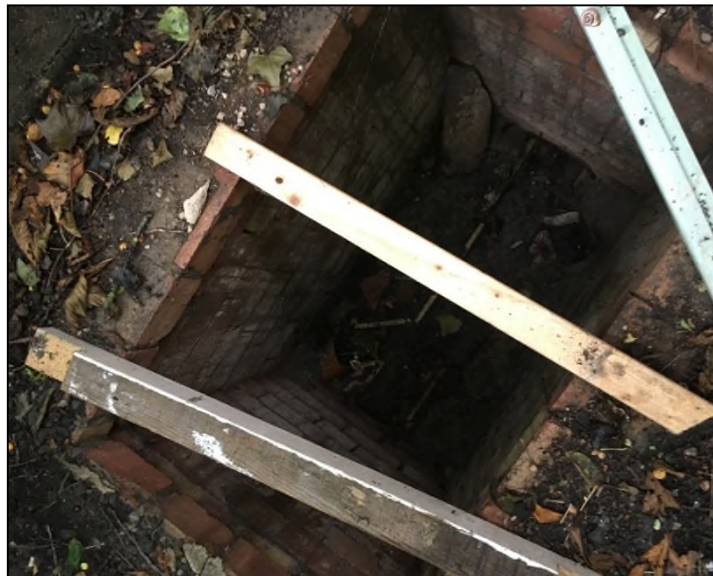
According to local reports, an inspection chamber to an old 100mm diameter land drainage system exists in private land to the north of the affected residential properties (Photo 10). It is unknown what connects into this system however local investigations have identified a discharge point into Ordinary Watercourse 1 (section 'a', Figure 3). During the flood event, the water level of Ordinary Watercourse 1 would have been high and therefore would have reduced the discharge rate of this land drain. Due to the unknown age and extents of the land drain, it is unclear to what degree the land drain would have influenced the volume of flood water impacting section 'a' and 'b'.

Photo 10: The inspection chamber which connects into the 100mm land drain and then Ordinary Watercourse 1.
