FLOOD INVESTIGATION REPORT

BRAMCOTE ROAD, LOUGHBOROUGH

1ST OCTOBER 2019

Final Report

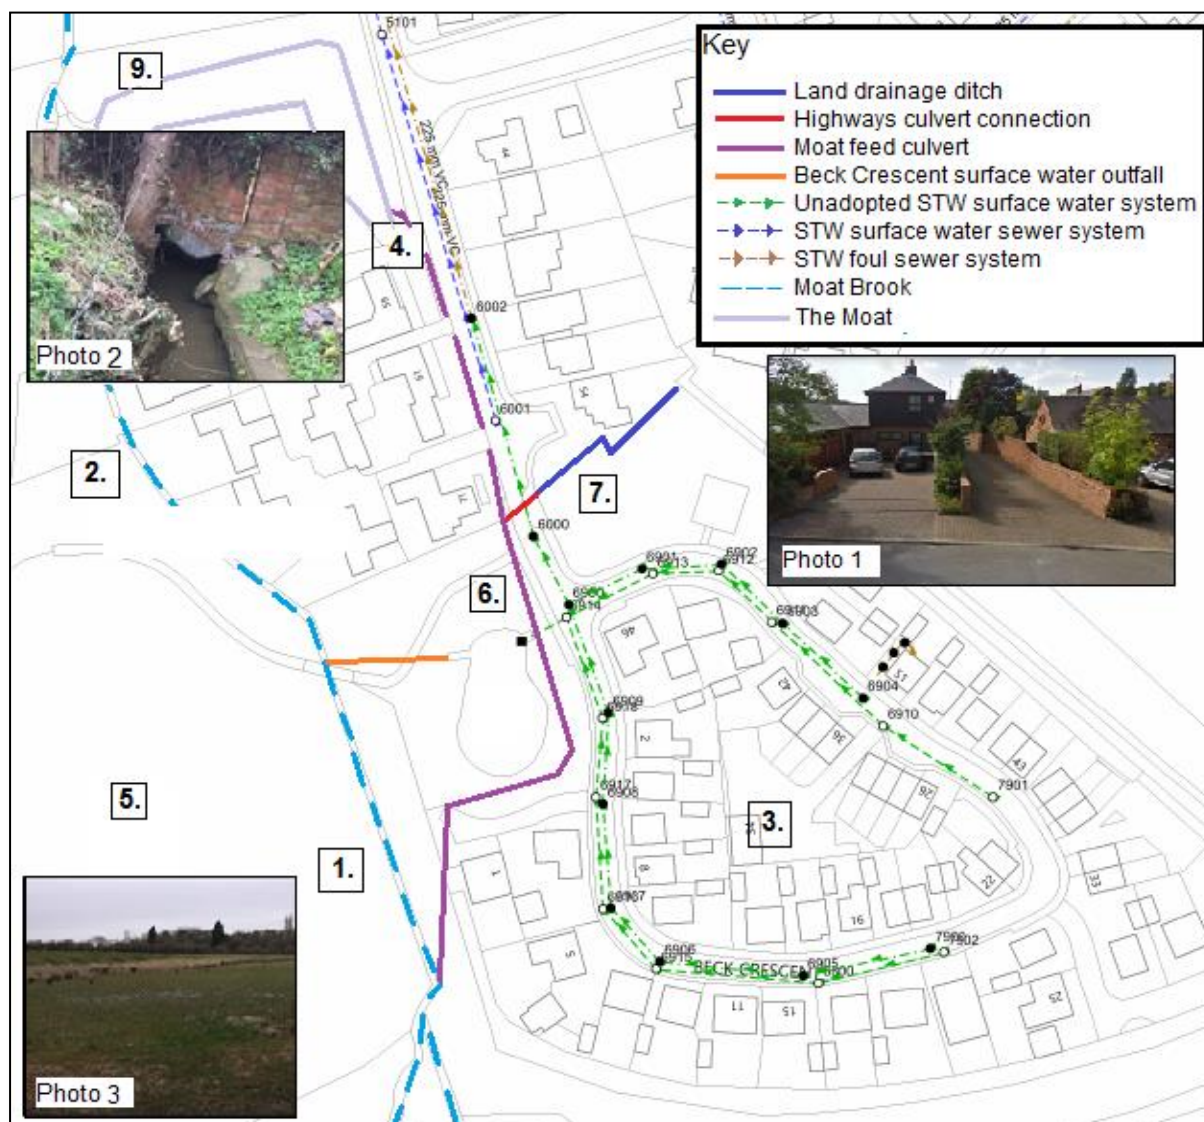
Figure 2: Major drainage features plan

Figure 2 below illustrates all major drainage features in the surrounding area.

2. Victorian Footbridge: A privately owned scheduled monument (Photo 2 in Figure 2). The footbridge culvert has an approximate diameter of 1250mm and is built into the Moat Brook House boundary wall. Water is unable to flow over or around the structure, creating a significant bottleneck.

5. Beck Crescent Flood Compensation Area: To offset the Flood Zone lost from the regrading of the land to facilitate the Beck Crescent development (Photo 3 in Figure 2), a compensation area was created to provide up to 442.9m³ of flood storage capacity. This is a betterment of 326.6m³ compared to pre-development volume.

7. Land Drainage Ditch & Highway Culvert (Dark Blue Line): This historic field ditch forms the boundary of the grassed area located to the north of the Beck Crescent Development. It now connects into the moat feed system via a 225mm diameter culvert.

- The moat feed system was completely inundated during the event with the land drainage ditch (Number 7, Figure 2) filling to the top and contributing to the amount of runoff entering the private parking areas and subsequently the residential properties.

consider if the highway drainage network in this area can be a more regular maintenance schedule.	frequency (20 months)
Review the status and condition of the Beck Crescent Highway Culvert (Figure 2).	3 months from publication date
To continue to work in partnership with other RMA's to establish potential multi-agency flood and pollution mitigation projects along the Moat Brook catchment. This should include continuing to explore future potential flood alleviation schemes	12 months from publication date

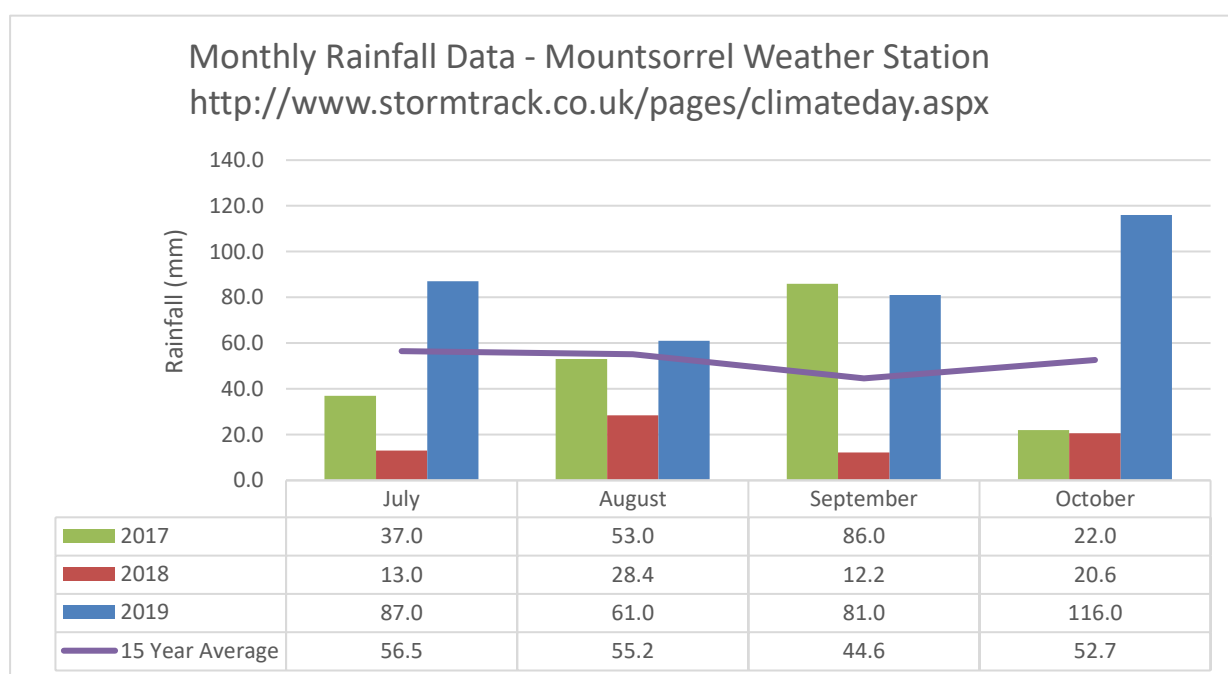
Figure 3: Recorded rainfall data from the Mountsorrel rain gauge.

The rainfall analysis in Figure 3 illustrates that the Moat Brook was subjected to a prolonged period of above average rainfall in the months prior to the flood event on the 1st October 2019, with the previous three months rainfall all significantly above the 15-year averages. A number of other communities in Leicestershire were similarly impacted at this time. The Hydrological Summary (Rainfall) produced by the Centre for Ecology and Hydrology for October 2019 states:

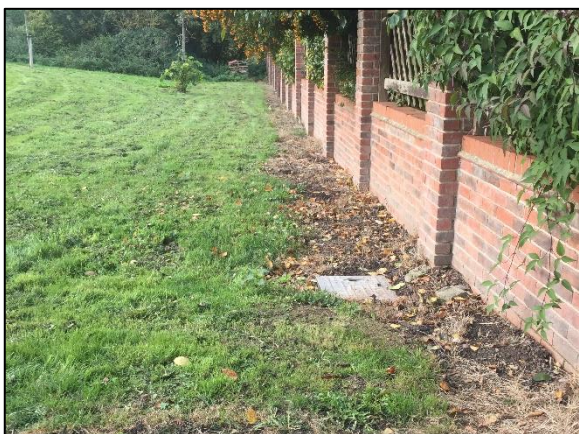
Photo 4: the route the flood water took during the flood event in dry conditions

This flood water then flowed around the Moat House development and onto Bramcote Road (Photo 4). The flood water overwhelmed the highway drainage system on Bramcote Road and breached the highway and property thresholds, resulting in extensive external property flooding and internal property flooding of five residential properties (reaching depths of two feet) and destroying several vehicles (Photo 5).

- The Victorian footbridge caused a significant bottleneck to the flow of the Moat Brook as flood water backed up to Bramcote Road and Beck Crescent. The ground profile along this boundary created a flow route onto Bramcote Road (Photos 4 and 5).

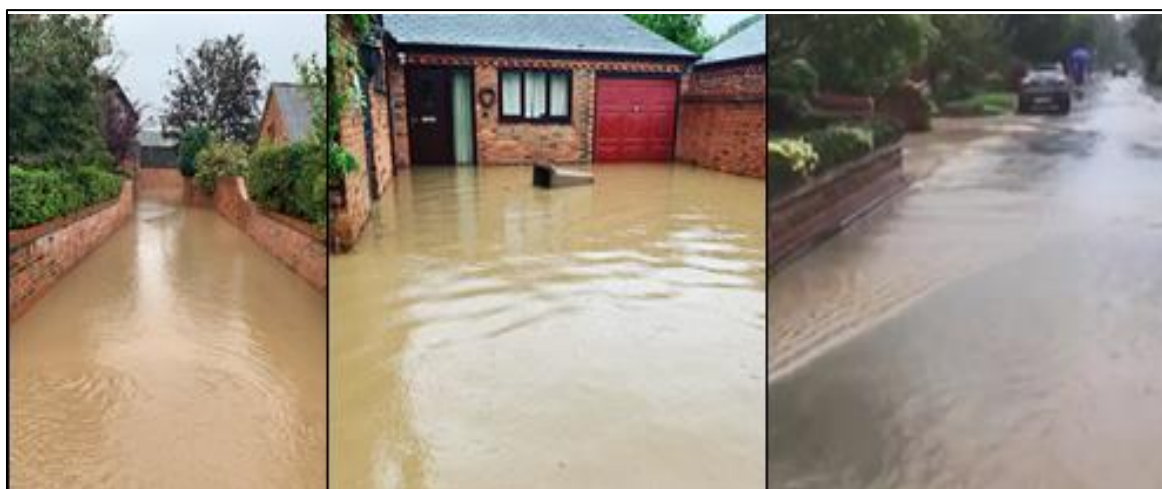
Photo 6: Photos of the impacts of the flooding

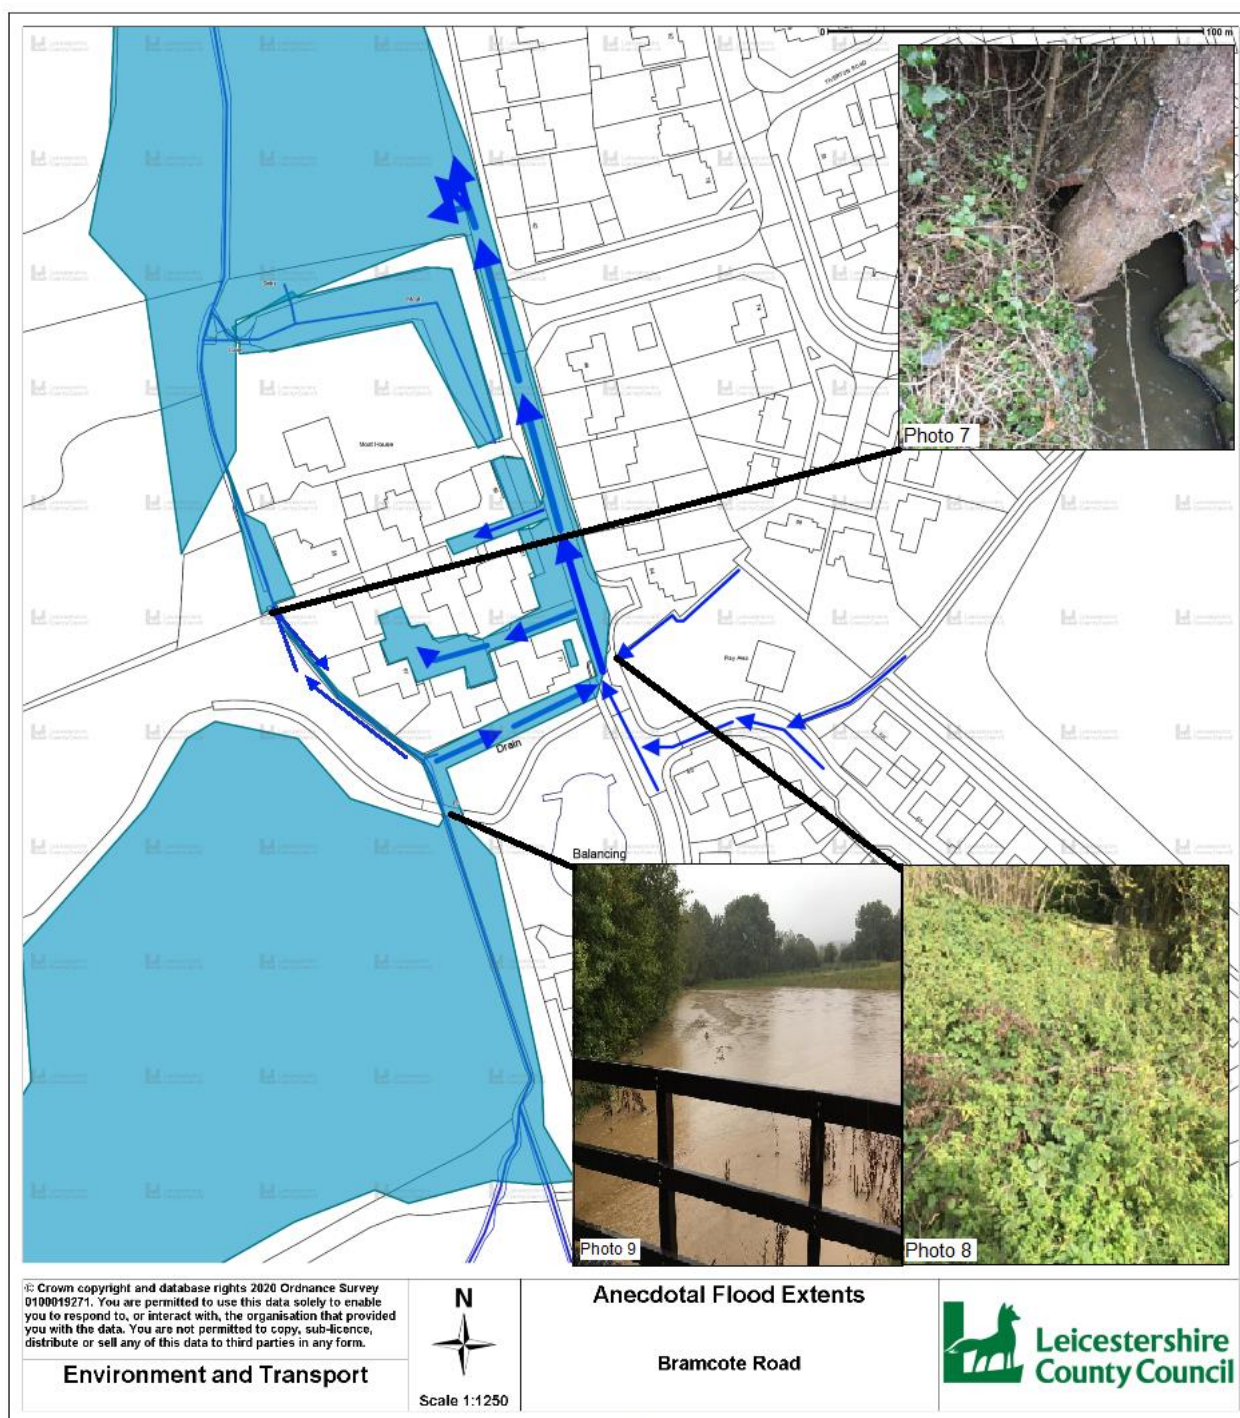
Figure 4: The flood extents and flow routes based off anecdotal reports.

The Victorian footbridge caused a significant bottleneck to the flow of the Moat Brook with flood water backing up to Bramcote Road and Beck Crescent. The ground profile along this boundary created a flow route onto Bramcote Road (see Figure 4).

- During the flood event, the flood compensation area filled quickly to capacity. Although the asset functioned as per its design, it did not act as a static storage area as expected by the residents (Figure 4). This water was observed flowing in the same direction as the Moat Brook (Photo 9), adding to the volume of flood water flowing towards the bottleneck and impacting residential properties.

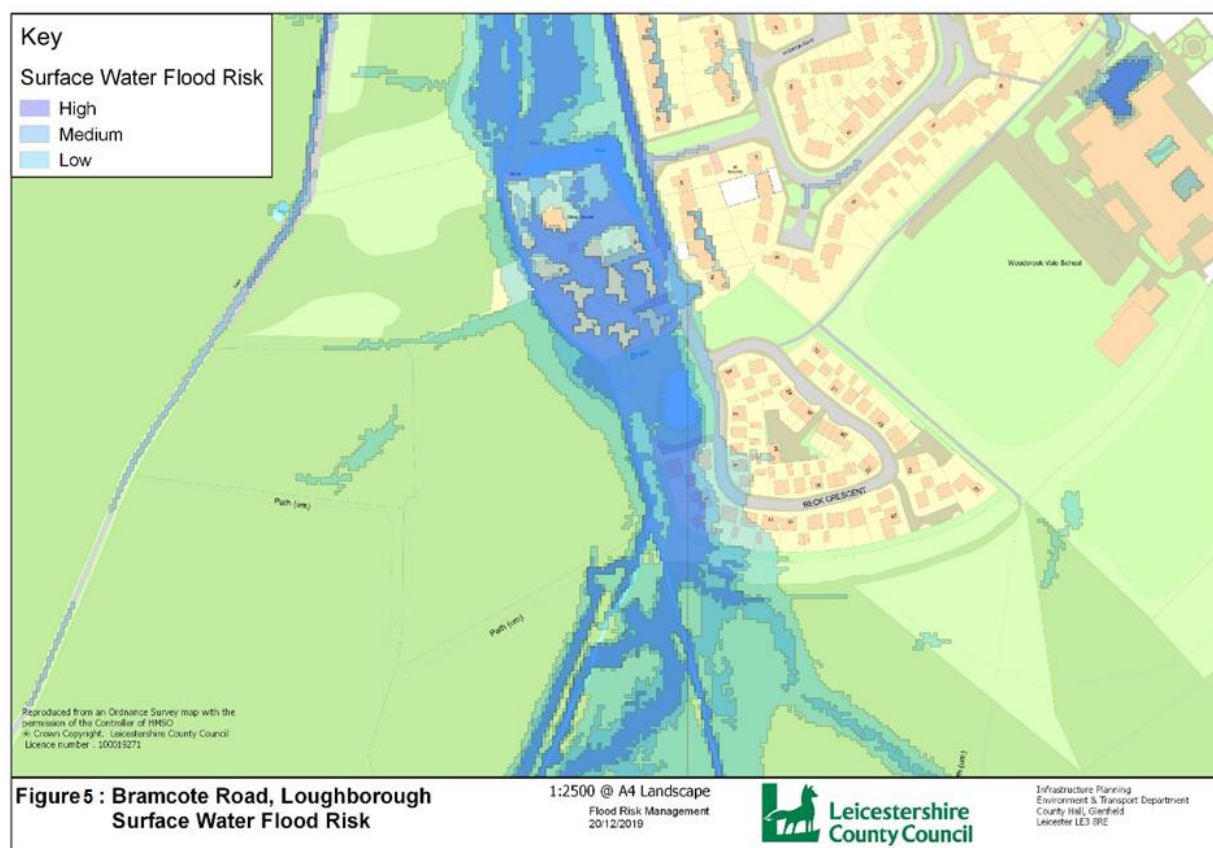
Figure 5: Environment Agency Surface Water Flood Map

The Surface Water Flood Map (Figure 5) for the flood incident location indicates that there is a medium risk of flooding from surface water to the location. This data was produced by the EA and is created using high-level modelling which replicates where water would fall during certain rainfall events¹. The data does not however consider the changed ground levels following the construction of the Beck Crescent development.

The output of Figure 5 does broadly depict what was witnessed on 1st October 2019 for the flood impact area, suggesting that the changes made to the local topography by the recent Beck Crescent development had a negligible impact on the flood extents and flow routes and that the properties on Bramcote Road are already considered to be at risk due to natural topography and pre-existing features.

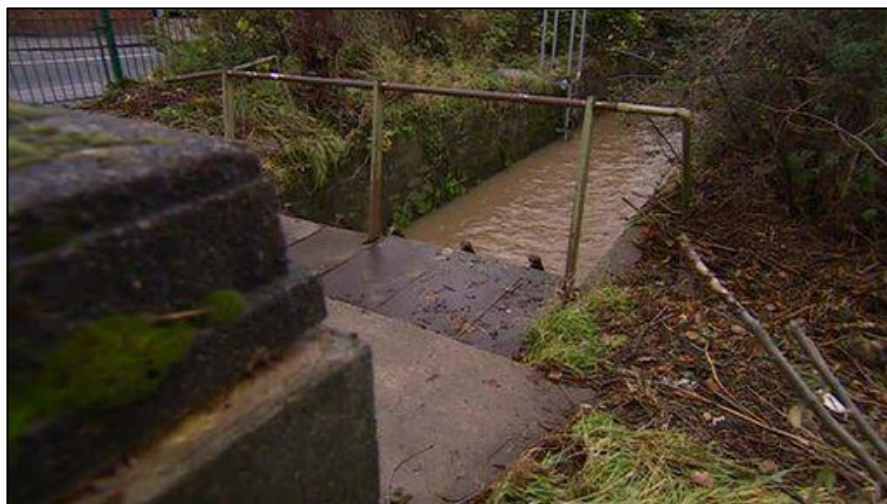
The Wood Brook and the lower reaches of the Moat Brook are identified in the Charnwood Surface Water Management Plan (SWMP) as a Critical Drainage Area (CDA). The Wood Brook is channelised and culverted along much of its length, which has an impact on the Moat Brook's ability to discharge in high flow conditions (Photo 10). This therefore causes flood water to quickly back up the Moat Brook during heavy rainfall. This was witnessed during the flood event, where flood water from the Wood Brook backed up the Moat Brook as far as the south end of Moat Road. This led to a significant slowdown in the flow of water in the Moat Brook, further reducing the volume of water that could pass through the Victorian Foot Bridge. This further exacerbated the bottleneck and contributed to the flood water rerouting onto Bramcote Road.

Photo 10: Typical example of the current condition of the Wood Brook and how it is a key throttle point

- The channelised and culverted nature of the Wood Brook would have reduced the discharge rate of the Moat Brook. However, this would have had a minimal effect compared to the restrictive nature of the Victorian Footbridge and fast run-off of the upstream Moat Brook catchment.

ACTION	PROPOSED TIMESCALE
To investigate the flooding that occurred on the Wood Brook to assess the impacts this had on the hydraulic performance of the Moat Brook.	12 months from publication date
