FLOOD INVESTIGATION REPORT

Investigation Ref:	37
Location:	Whitwick
Date of Flooding:	15th June 2016

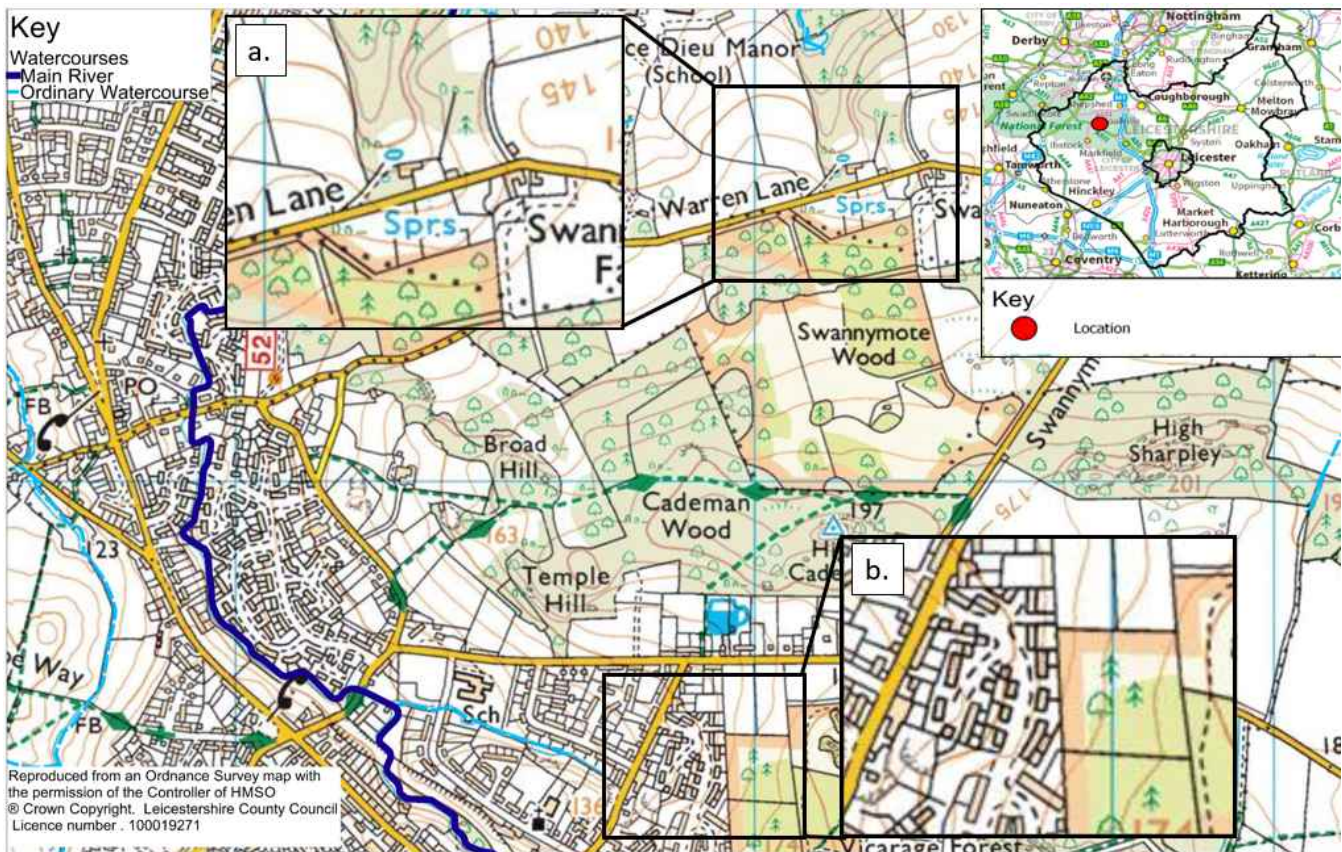
Figure 1:
Location Plan

The two focus areas for this report are Warren Lane and King Richards Hill, (Figure 1, sections 'a' and 'b' respectively) as these were the two locations which reported internal residential flooding during the flood event (excluding those affected by the Main River flooding). Figure 1 presents a network of watercourses which run through Whitwick, however these are not within close proximity to the affected areas. The village is predominantly served by extensive combined and surface water sewer networks, maintained by STW.

Approximately 250m north (downstream) of the focus area (section 'a' in Figure 1), an unnamed ordinary watercourse flows in a northerly direction. Figure 1 also illustrates springs upstream of the affected residential property, but it does not identify any other watercourses in the vicinity. Along Warren Lane, there are no recorded STW assets, however there are numerous highway gullies located outside of the affected residential property.

King Richard's Hill is located on a steep gradient with the land behind the residential properties, to the east, significantly increasing in altitude by approximately 50m in 250m. The focus area has a 225m diameter surface water sewer system that runs south down the highway to the front of the residential properties. The system joins with three other surface water systems before flowing north through a 1080mm surface water system which feeds into a combined sewer system. This combined sewer system flows north and eventually discharges into the Grace Dieu Brook.

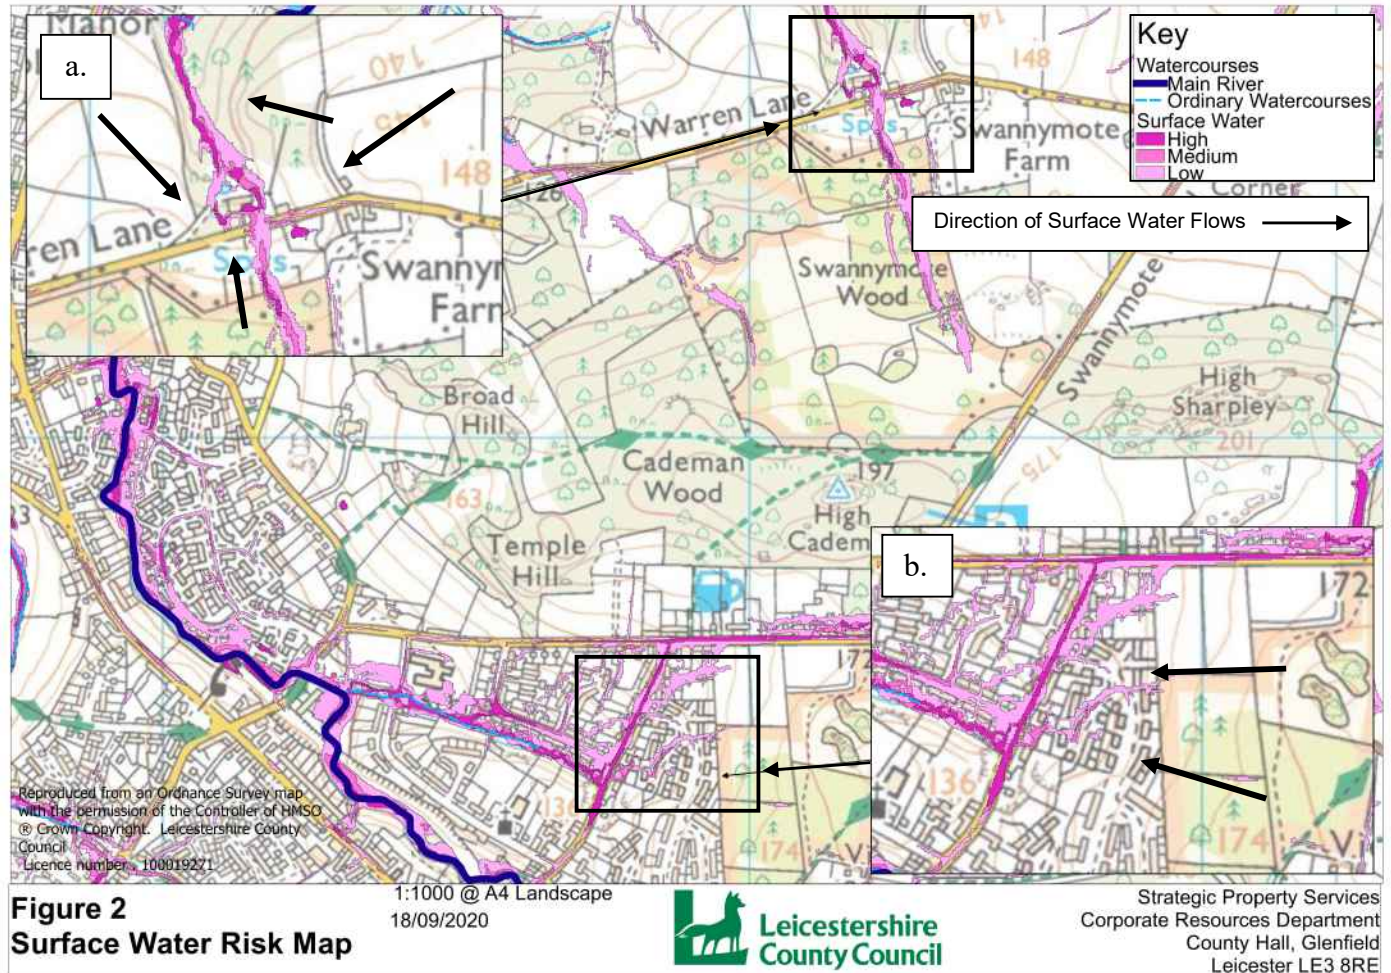
Figure 2 illustrates the Risk of Flooding from Surface Water for the study area. This data was produced by the Environment Agency and is created using high level modelling which replicates where water would fall during certain rainfall events. The risk levels for sections 'a' and 'b' are discussed in greater detail below. The closely packed contour lines on Figure 2 illustrate that Whitwick is surrounded by steep sided land and is therefore likely to be susceptible to fast flowing routes of surface water run off during a rainfall event.

Figure 2 illustrates that there is a surface water flow path passing through the impacted area. As part of the investigation following the flood event, an unmarked (not visible on any mapping available to the Council) unnamed ordinary watercourse was identified within the focus area. This watercourse passes through a culvert, for approximately 50m, underneath Warren Lane and a residential property (in close proximity to the affected residential property). This unnamed ordinary watercourse becomes open channel upstream of the highway (illustrated as springs on Figure 1), approximately 30m north of the residential properties. This ordinary watercourse closely follows the alignment of the surface water flow path displayed in Figure 2. It is understood that the highway gullies in this area are connected to this culverted watercourse.

As well as the data presenting the extents of surface water flood risk, the Council also have access to depth risk data associated with the surface water flood risk of an area. The map indicates that to the north of the impacted residential property, there is a risk of surface water reaching over 900mm, which is categorised as high risk¹.

This would indicate a significant low point adjacent to the impacted residential property, thus being the likely explanation of the surface water ingress to the front of the residential property. Although this analysis is indicative of what may have occurred during the flood event, it is important to consider that the output may not be 100% accurate due to the high-level modelling².

Although there is no direct surface water flow path identified in Figure 2 which impacts the residential properties on King Richard's Hill, the steep topography to the east of the residential properties would have likely caused significant overland flows following the intense rainfalls. The geology of the land adjacent to King Richard's Hill is mudstone which although is porous, has low permeability. Therefore, infiltration rates would likely be low, subsequently increasing overland surface water flows. This is supported by site visits conducted and anecdotal reports received. The sheer volume and speed of surface water was anecdotally reported to ingress to the back of the residential properties. The surface water then followed the topography of the land and flowed through the residential properties towards the highway to the front of the residential properties.
