FLOOD INVESTIGATION REPORT

Investigation Ref:	50
Location:	Cossington, Main Street
Date of Flooding:	1 st October 2019

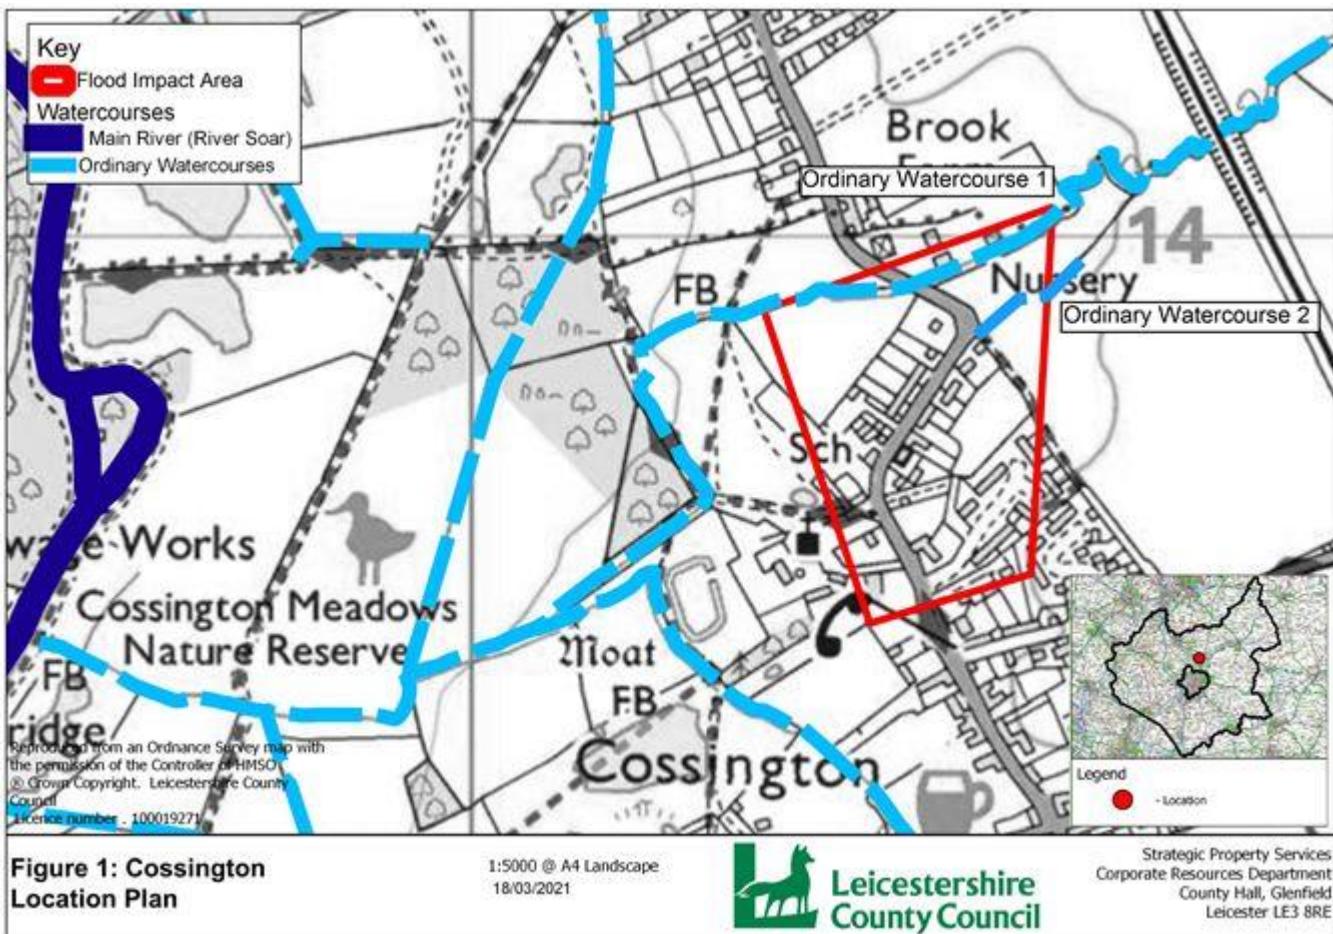
Cossington village is in Charnwood Borough (Figure 1) in the River Soar sub-catchment of the Humber River Basin District. The residential properties impacted during the 1st October 2019 flooding event are located to the north of Main Street, which is the main highway that runs through the centre of Cossington, south of where Ordinary Watercourse 1 is culverted beneath Main Street (Figure 1).

3.2 Flood Event

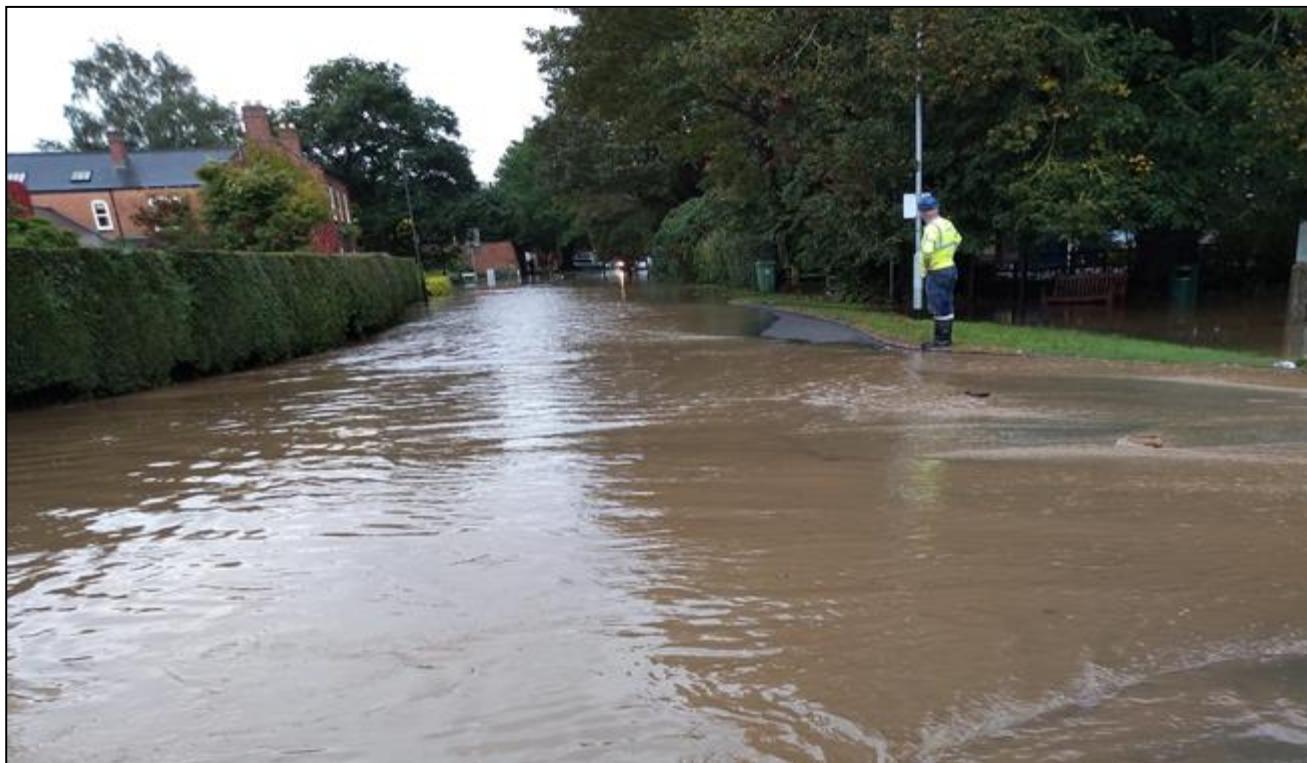
Photo 2: A section of Main Street which experienced flooding on 1st October 2019

It was reported that external flooding impacted driveways, gardens, footpaths, and the local highway network, with some reports indicating that flood water reached knee deep levels. Flood water eventually started to enter nine residential properties via overtopping the highway kerb thresholds and because residential property thresholds were lower than the highway in some instances. Internal water levels were described as varying from 2-30cm depending on the location and gradient of the residential property.

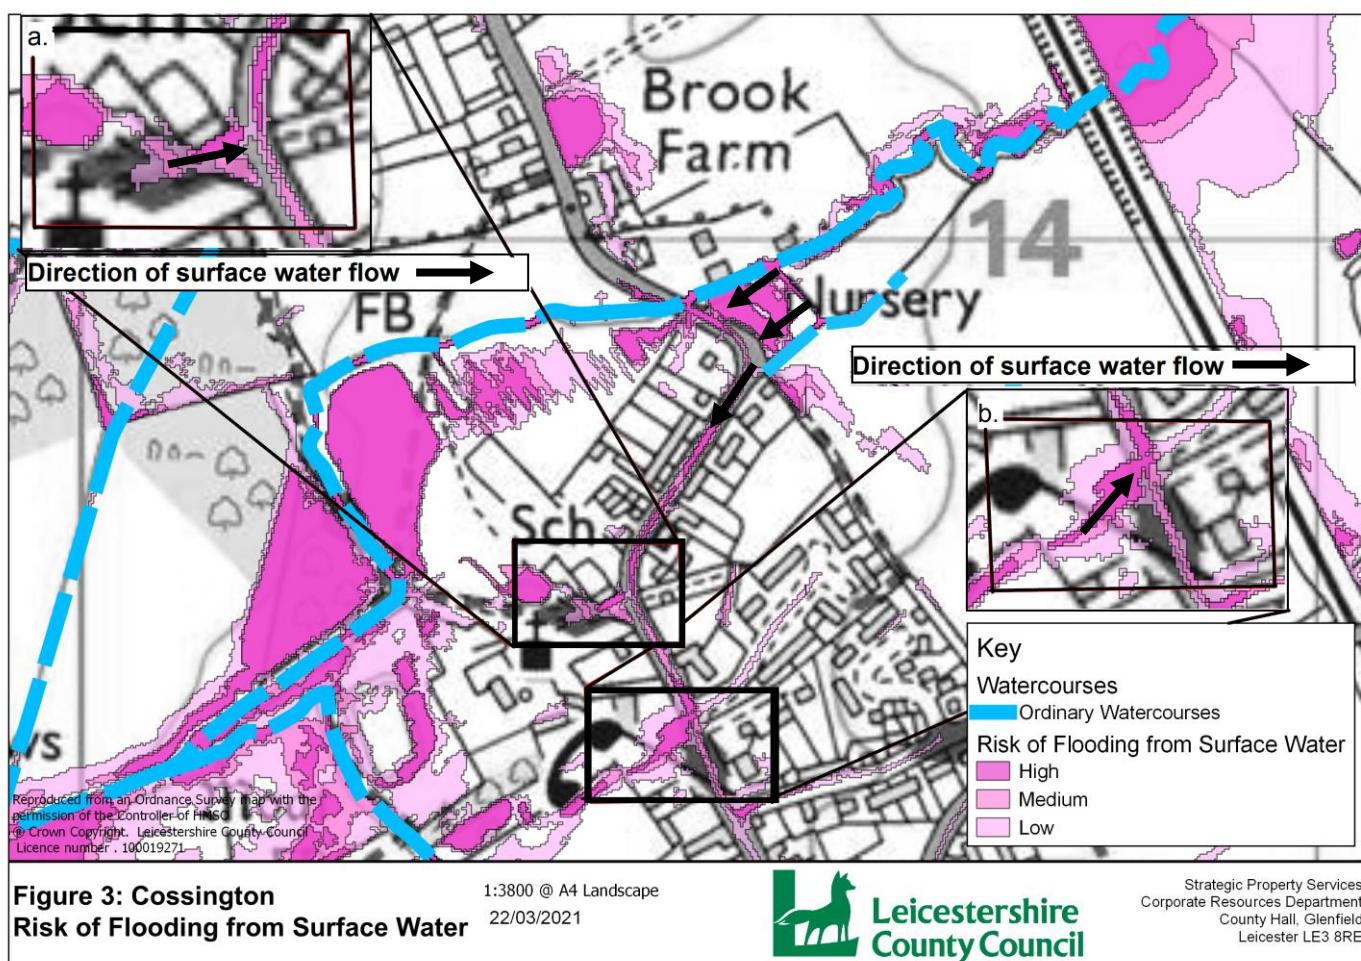
Figure 3 illustrates the Risk of Flooding from Surface Water for the study area. This data was produced by the EA and is created using high-level modelling which replicates where water would fall during certain rainfall events³. Land height data available to the Council indicates that the gradient of the agricultural land to the east of Cossington is relatively steep and falls towards Cossington Village, indicating that the village is situated in a relatively low point. Main Street has a slight gradient heading south, supporting anecdotal reports of flood water flowing south down Main Street towards the impacted residential properties; the output of this modelling supports this. Figure 3 identifies specific areas within Cossington (areas 'a' and 'b') which experienced internal residential property due to location specific factors and additional overland surface water run off routes.

During site visits conducted by the Council it was identified that the highway thresholds adjacent to three of the impacted residential properties were relatively low (identified as area 'a' on Figure 3). The thresholds would therefore have been easily compromised by the high volume and velocity of the flood water on Main Street. Overland surface water flows from agricultural fields to the west of the impacted residential properties in area 'a' were also anecdotally reported, which is supported by a surface water flow route in Figure 3. This would have subsequently increased the volume of flood water heading towards these residential properties.

It has also been identified that an impacted residential property in area 'b' on Figure 3 has a significantly low property threshold, with steps down to the front door. This would have been quickly compromised by the flood water along Main Street.

- The threshold levels of the highway in area 'a' were relatively low and so would have been quickly compromised during the flood event.
- The residential property threshold discussed in area 'b' would have been quickly compromised due to the front of the residential property being at a lower level than the highway.

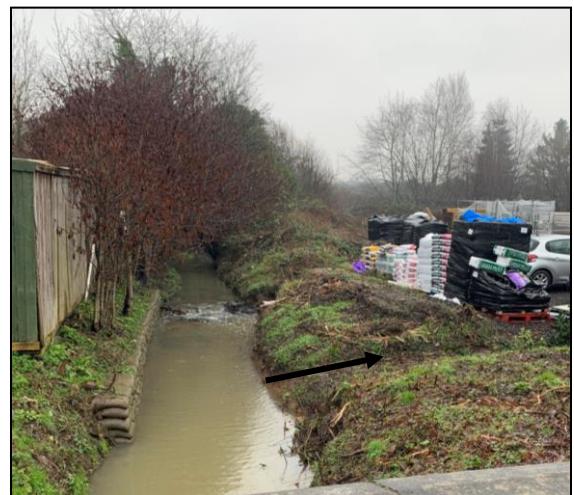
Photo 4: Ordinary Watercourse 1 facing east from the access bridge indicating the channels dug on the banks of the watercourse (photo taken in January 2021)

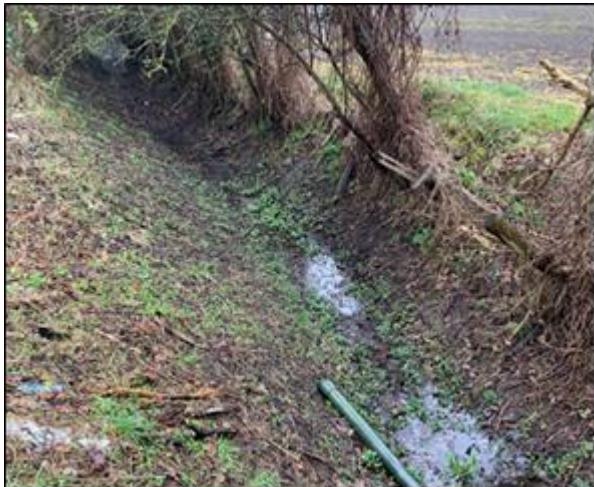
Prior to the flood event, Ordinary Watercourse 2 was not visible on any mapping available to the Council and was found following a site visit after the flood event (Figure 1 and Photo 5). Figure 3 presents a surface water flow path across agricultural land to the east of Main Street towards Ordinary Watercourse 2. This predicted flow path closely matches the anecdotally reported route of flood water during the flood event. The site visit indicated that a possible source of Ordinary Watercourse 2 is from a small pond in the adjacent agricultural field (Photo 6).

Photo 5: A section of the Ordinary Watercourse 2 facing east (photo taken during site visit in January 2021)

A submerged rock faced headwall was identified for Ordinary Watercourse 2, but it has not been identified where this watercourse connects too. Given the sheer volume of water that fell on the already saturated catchment, it is likely that the amount of flood water exceeded the capacity of Ordinary Watercourse 2. The flood water would therefore have flowed onto Main Street, due to the topography of the land, and subsequently increased the volume of flood water on the highway. Further investigations into the source and connections of Ordinary Watercourse 2 are required to better understand its possible influence on the 1st October 2019 flood event.

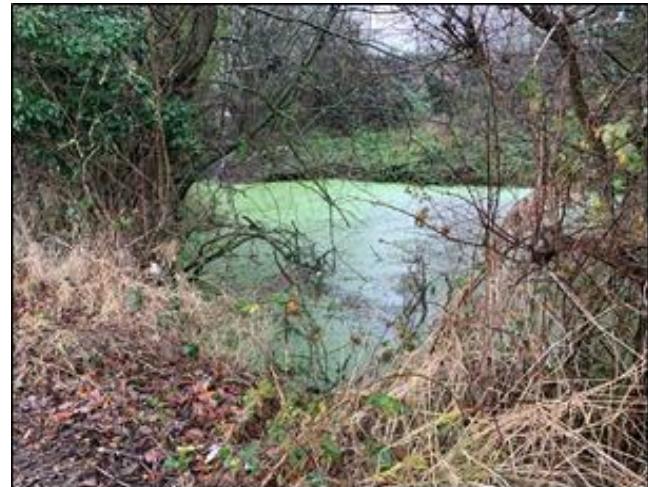
Photo 6: Pond located to the north east of Ordinary Watercourse 2 which is the likely source of the watercourse (photo taken during site visit in January 2021)
