FLOOD INVESTIGATION REPORT

| Investigation Ref: | 41 |
| Location: | Paterson Place, Shepshed |
| Date of Flooding: | 24th April 2018 |

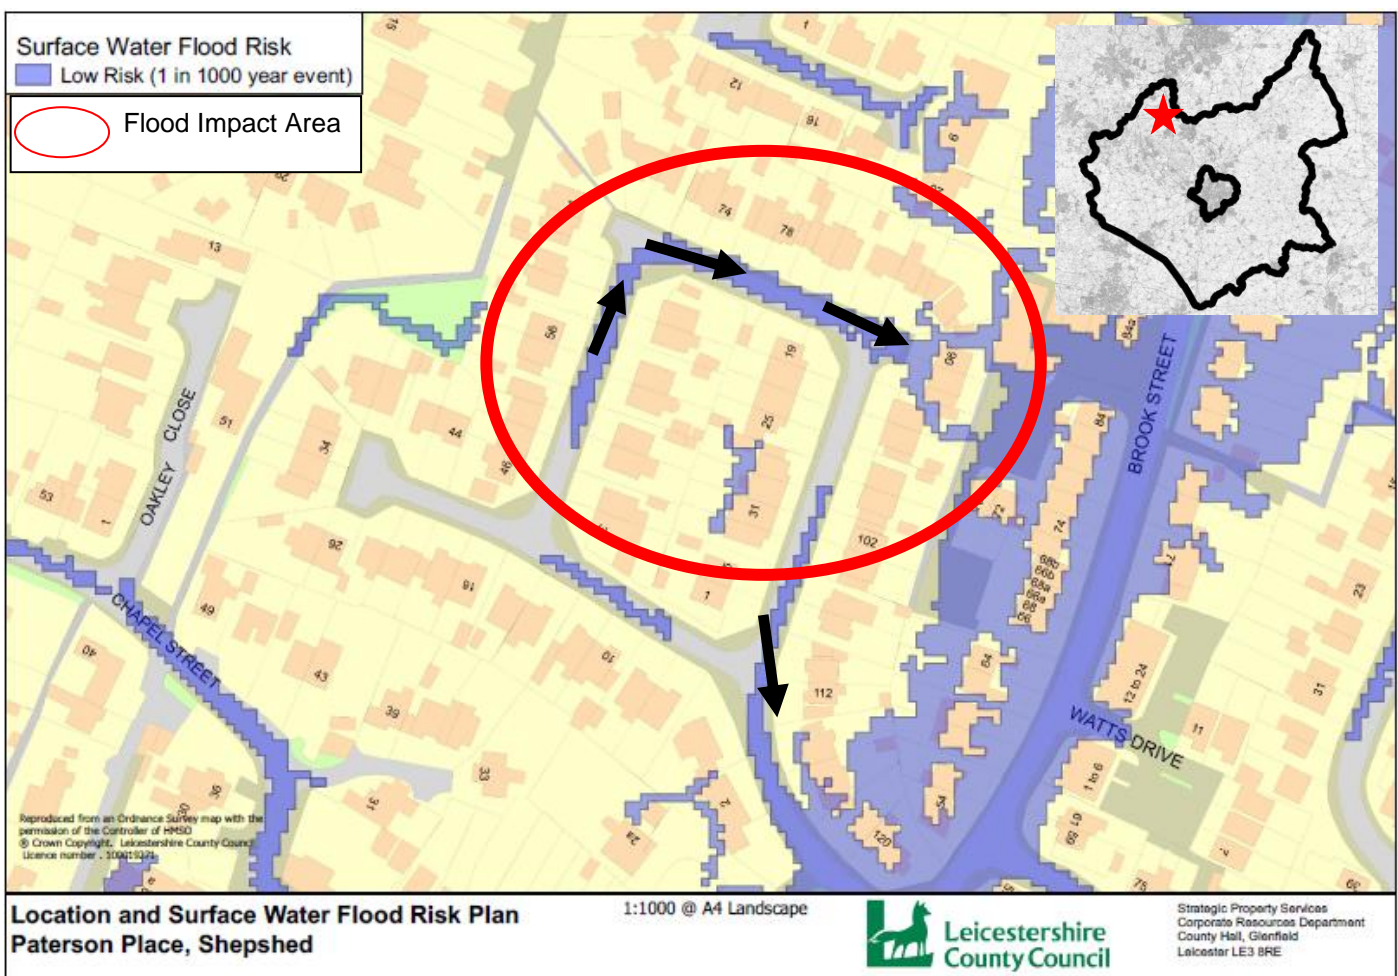
Figure 1: Location plan and low risk surface water flood risk map (black arrows indicate direction of water flow)

There are no watercourses in close proximity to the area of investigation. The Risk of Flooding from Surface Water Map (replicated in Figure 1) has been produced by the Environment Agency (EA) and produced using high-level modelling which represents where water would fall during certain rainfall events¹. The arrows on Figure 1 indicate the predicted flow directions of the flood water which closely replicates anecdotal reports following the flood event.

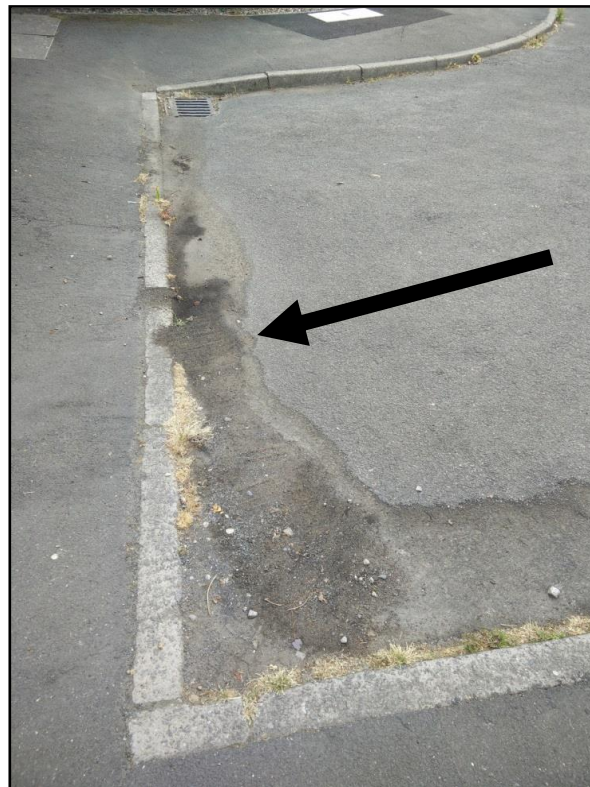
A site walk over confirmed that the affected properties were located at the lower end of the steep northern transect of Paterson Place. A manhole and single road gully were identified to be located within the highway adjacent to the affected properties; a dropped kerb was also identified (Photograph 1). Anecdotal reports and site visits confirmed that the reported flooding resulted from the speed of the runoff of water towards the property which quickly breached the dropped kerb (inundating the highway drainage within the road). Flood water accumulates within the highway and results in surface water flowing towards the lower ground at the properties. Evidence therefore suggests that the flood water comes from:

- a) direct runoff from the highway and impermeable areas upstream on Paterson Place,
- b) surcharge from highway gullies, and
- c) surcharge from surface water sewer manholes.

**Photograph 1: Dropped kerb with sediment build up and gully positioning (top left)
(arrow indicates direction of flow)**

- Undertaken cleansing of publicly owned highway assets (including highway gulleys).

- Provided the affected residents with sandbags as a temporary measure to aid personal resilience.
- To investigate the viability of minor realignment of highway kerbs to reduce flood risk associated with surface water runoff from the highway.
- To work with STW to investigate the viability of a scheme for delivery of Property Level Resilience for the affected properties.
- To work with the affected business owner to help them become more resilient to possible future flooding.

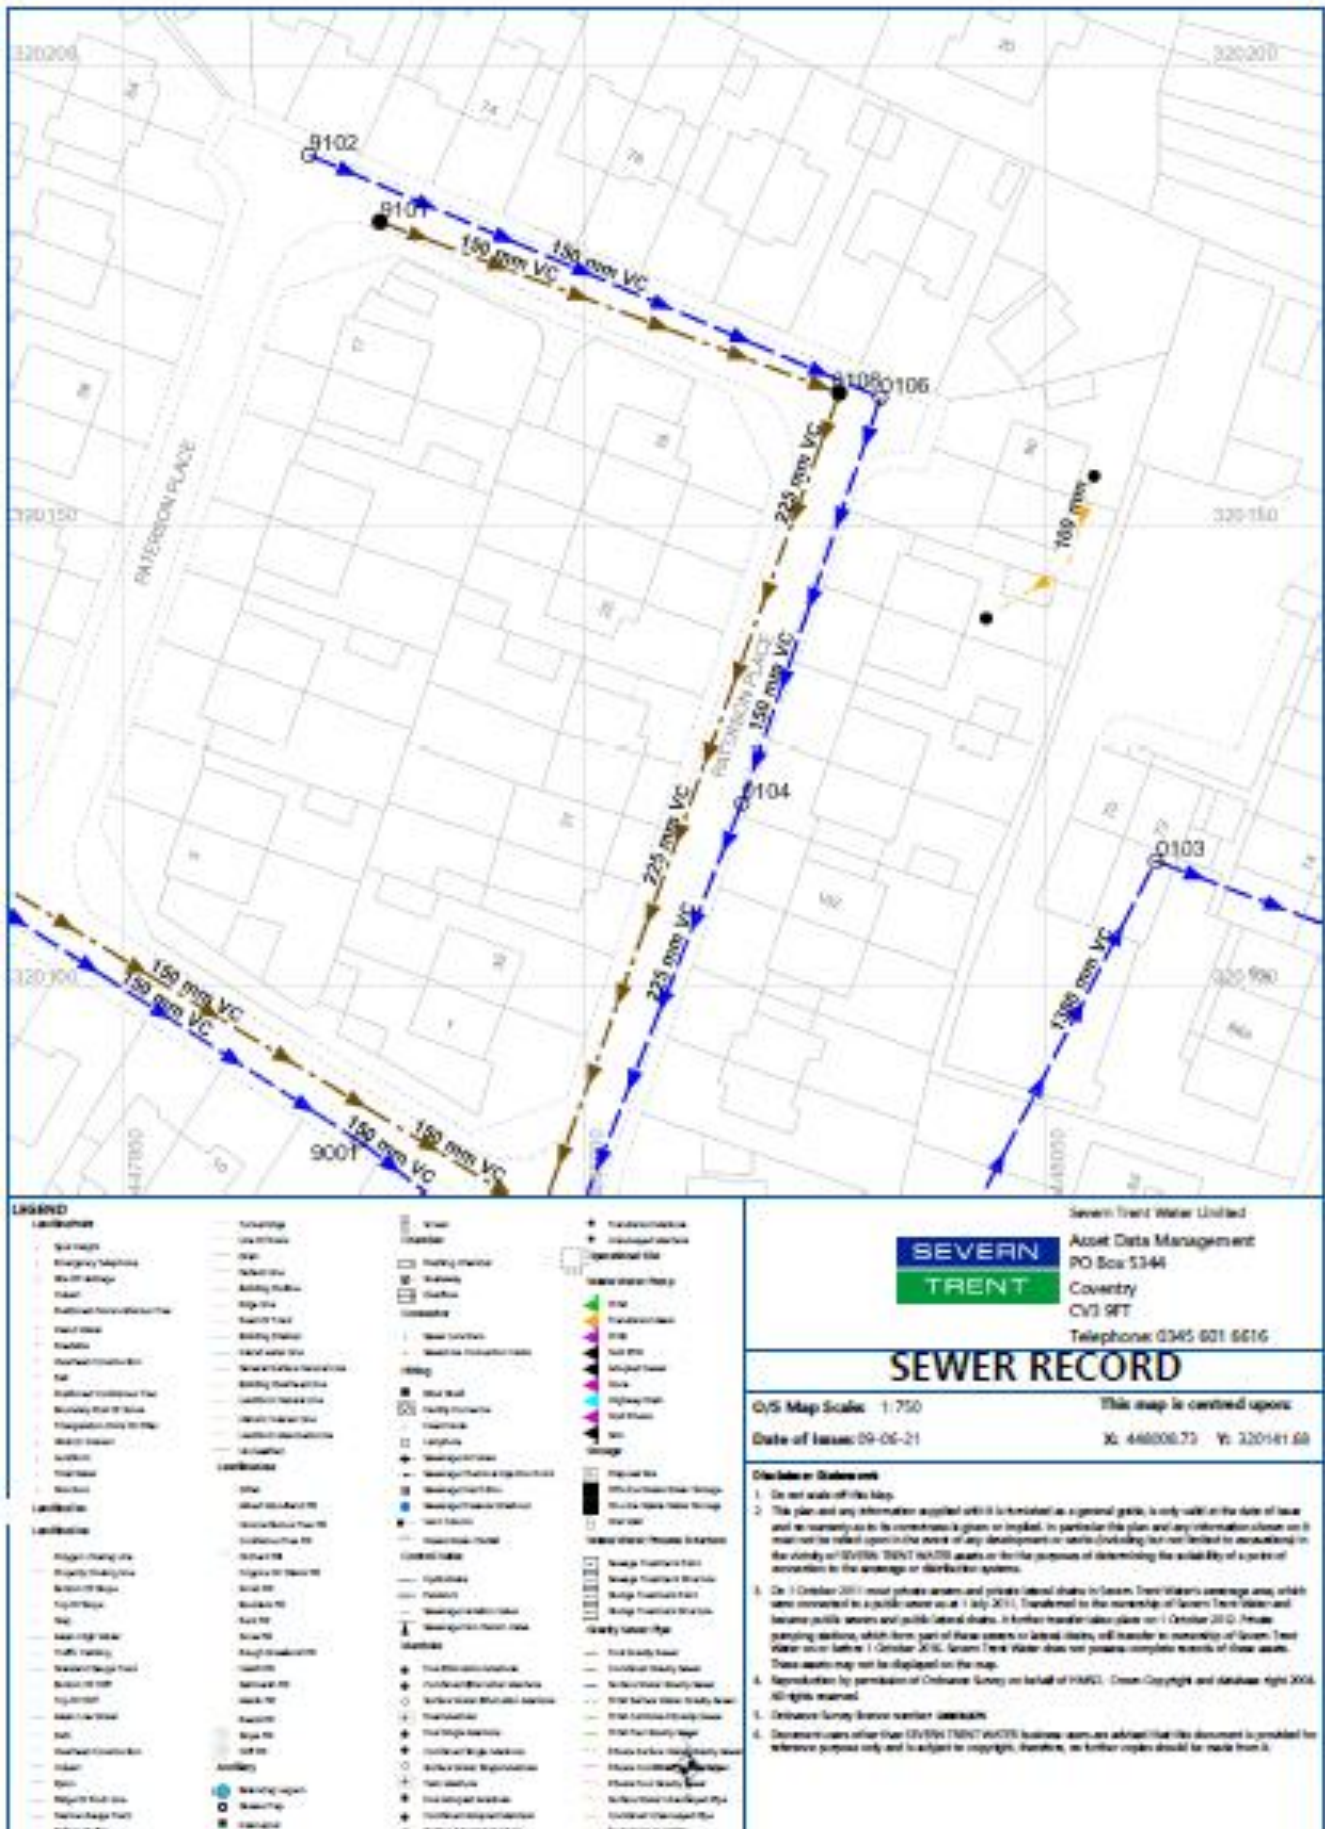
Appendix 1 – Sewer Record (provided by Severn Trent Water)

Paterson Place is served by a traditional highway drainage system which discharges to a surface water system operated and maintained by STW. This surface water system originates adjacent to No. 70 and flows south easterly in an 150mm diameter pipe towards the affected properties before turning 90 degrees in a westerly direction towards the centre of Shepshed and discharging into 225mm diameter system at the far western section of Paterson Place (see Appendix 1).

- The change in gradient and direction of the surface water sewer at the corner of No. 88 / 90 / 92 Paterson Place means that it is prone to surcharge in this location during short duration high intensity rainfall. Evidence suggests this is what happened in April 2018. Silt in the surface water sewer system downstream of this junction was also found during post incident CCTV inspections, which is also likely to have contributed to surcharge in the surface water sewer during this event.

- To complete routine maintenance to the surface water sewer on a biannual basis, with amendments to maintenance schedules to be evidence led following condition inspections prior to cleansing.
- Commissioned a sewer modelling study to determine the extent to which the surface water sewer contributes to flooding in Paterson Place.
- To work with the Council to investigate the viability of a scheme for delivery of Property Level Resilience for the affected properties.
