# **Flood Investigation Report**

Thornborough Road, Coalville – 27 December  
2017

Final Report

May 2020

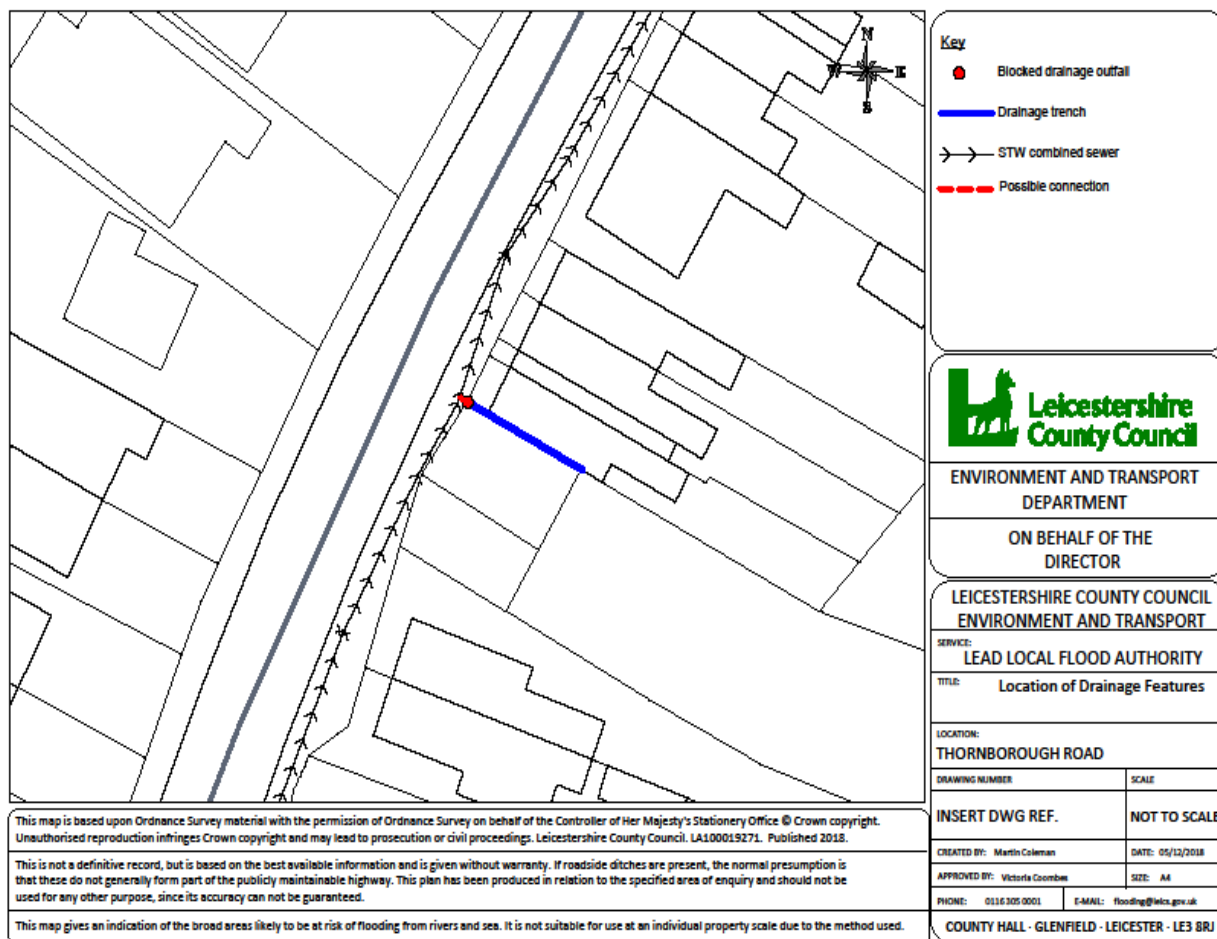
**Figure 2: Location of drainage features**

A site inspection carried out by the Council on 5 January 2018 identified a small concrete trench running alongside the property affected by the flood event. Figure 2 illustrates the location of this drainage feature which comprises a 200mm wide channel running in a north west-south east orientation. A drain is located at one end of this trench (photograph 2, see later in the document) and this was found to be blocked. It is likely that the trench outfalls into a Severn Trent Water (STW) combined sewer located under the footway outside the property; STW have not confirmed this.

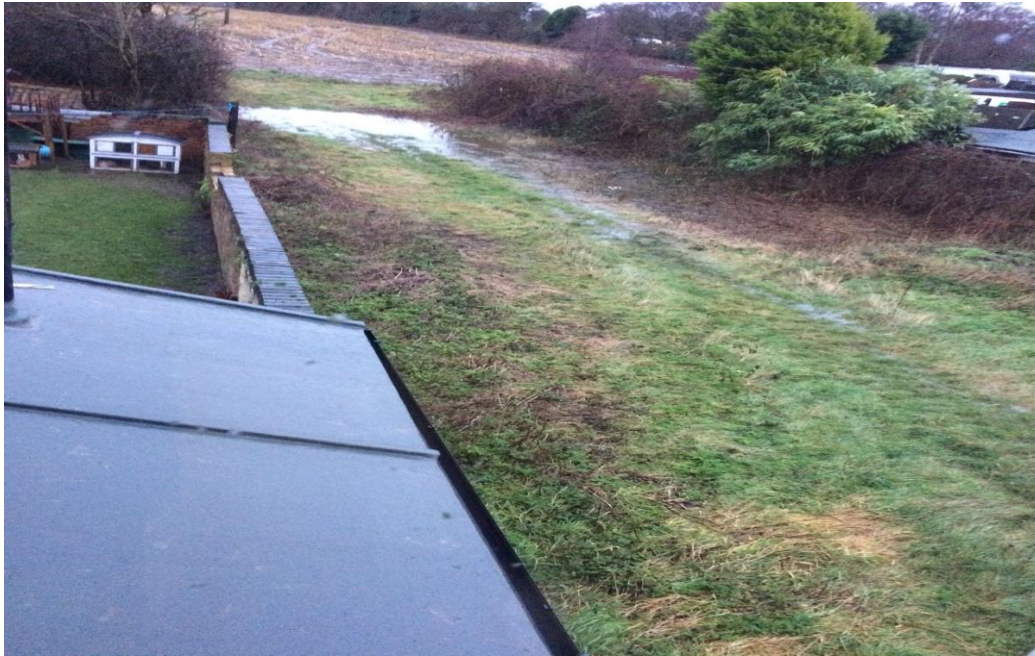
**Photograph 1: Water accumulated in the natural hollow**

Resident accounts on the day of the incident indicate that surface water was flowing from fields located to the east of the property and then accumulating in a natural grassy hollow beside the garden of the property (photograph 1). Having reached the property, the water entered the ground floor. The water then spread throughout the ground floor.

Residents reported that the water was dark brown and silty, which suggests that the source of water was surface run-off from neighbouring fields.

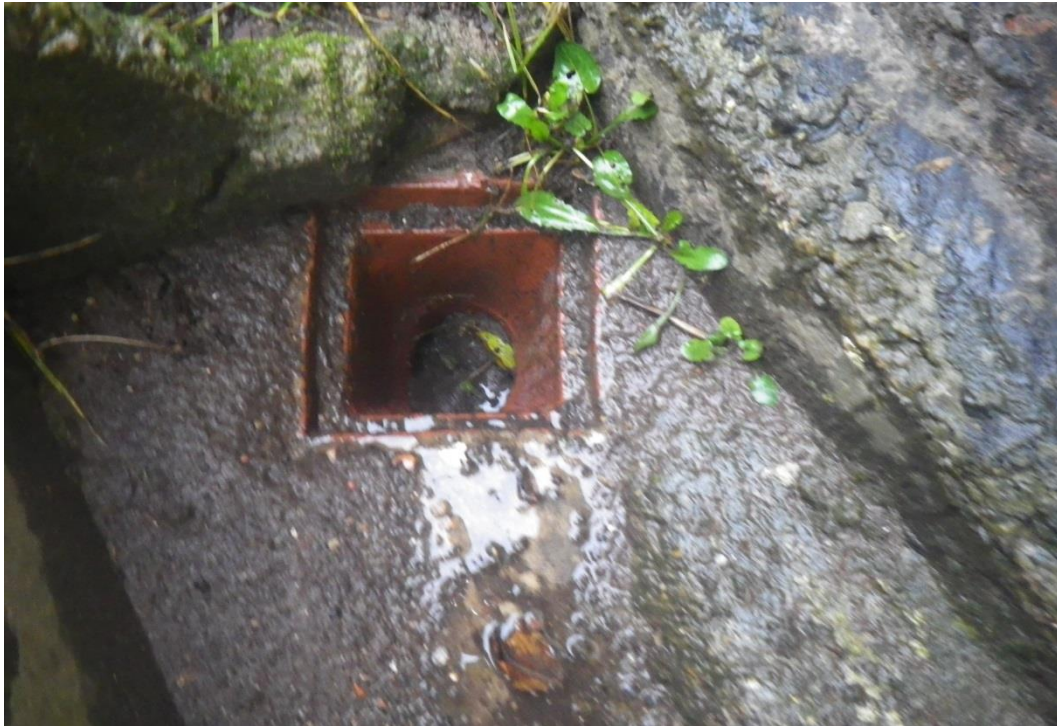
**Photograph 2: Blocked connecting pipe at the end of the trench**

It was observed during the site visit held on 5 January 2018 that the connecting pipe at the end of the trench appeared to be blocked (photograph 2) and was therefore unable to convey water flow.

- The location of the affected property in a natural low point on Thornborough Road.
- The inability of the ground to absorb more water following previous rainfall and snowfall.
- A blocked outfall in a trench running alongside the property prevented surface water from entering a private drain.
- A narrow gap between the trench and the side of the property would likely allow the ingress of water.

The owner of the property affected by the flooding incident was made aware of the points outlined in '5.1' and '5.2' in the 'Responsibilities' section of this report regarding the maintenance of the concrete trench and outfall alongside their property to ensure that the property at risk of flooding is protected.

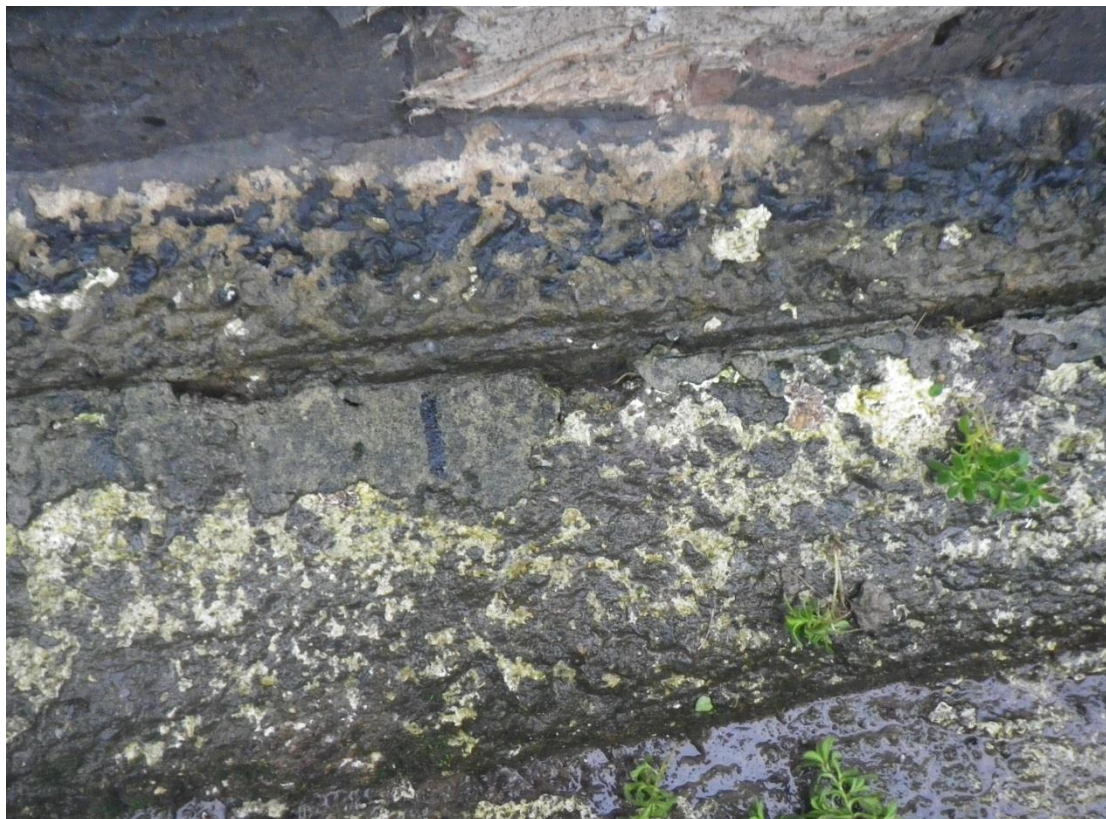
**Photograph 3: Gap between the trench and the property**

It was also observed that there was narrow gap between the side of the property and the trench (photograph 3). This may have allowed the water to enter the property.

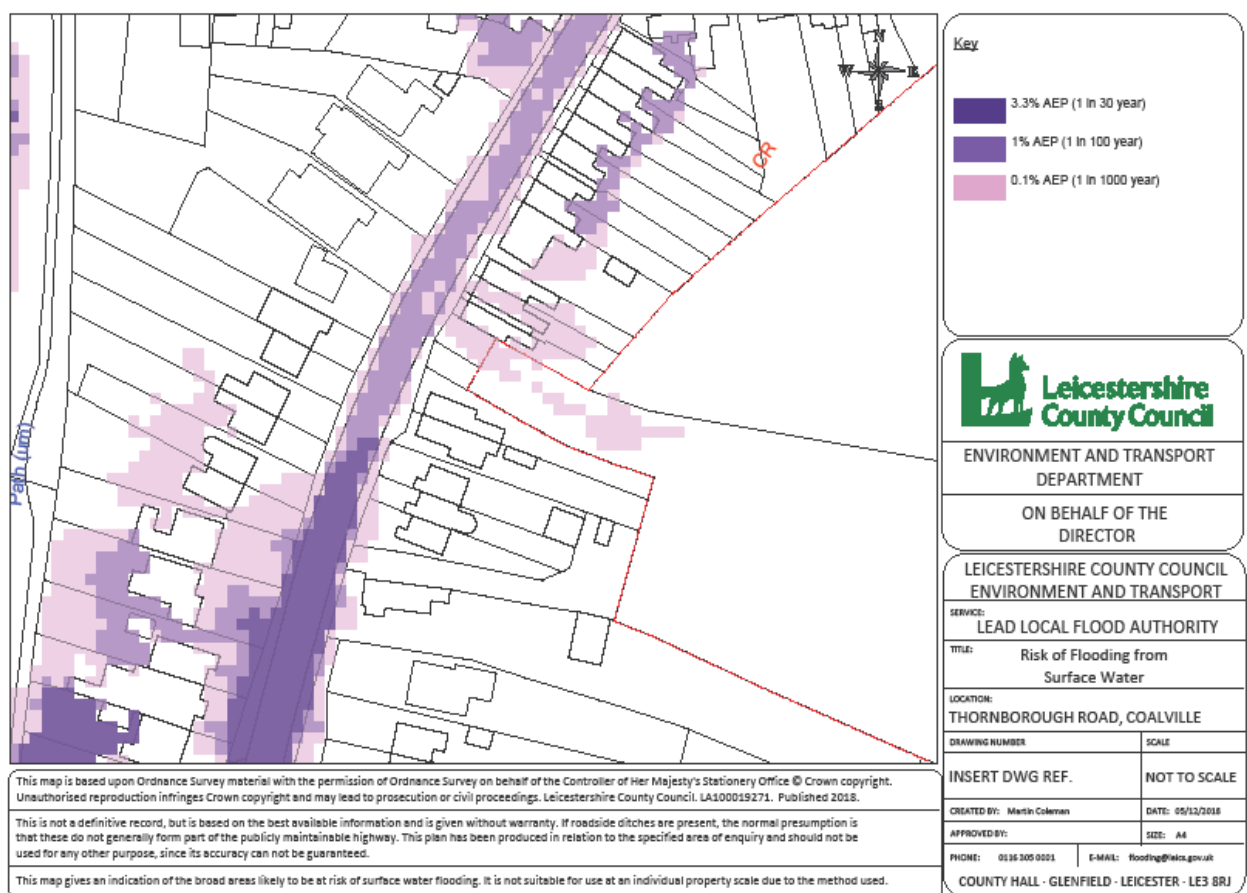
**Figure 3: Surface water flood mapping for Thornborough Road, Coalville**

Figure 3 shows the flood risk from surface water flood map. This country wide Environment Agency generated mapping recreates where water would fall during certain rainfall events based on land height.

This flood mapping closely replicates the surface water flooding that was observed on 27 December 2017. Accumulations are shown to occur immediately to the front of, behind and to either side of the property affected by the flooding event. These accumulations would naturally flow from the higher land to the east and south of the property and towards the property itself, which is at a lower elevation. There is then potential for the water to enter the property through any openings in the property.

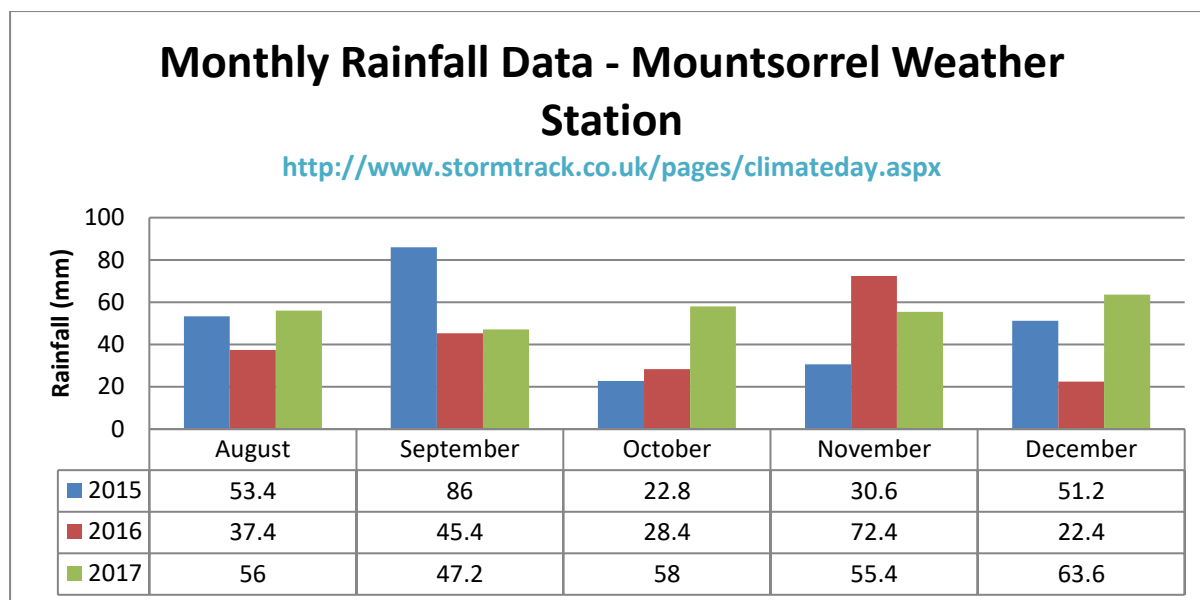
**Figure 4: Annual rainfall data August-December 2015-2017**

Slightly above average rainfall was experienced in the East Midlands during Autumn/Winter 2017 with approx. 64 mm rainfall being recorded at a nearby weather station at Mountsorrel in December 2017. According to MET Office data, the average rainfall for December was recorded as being 40mm-60mm between 1981-2010.

Figure 4 above shows that rainfall during December 2017 was higher than the rainfall recorded in the same month for the previous two years and significantly higher than 2016. This increase in rainfall throughout December could have contributed to the saturation of the ground, thus reducing the ground's ability to absorb water during the flood event of 27 December 2017.
