Flood Investigation Report

LOUGHBOROUGH ROAD, MOUNTSORREL

28TH JULY 2019

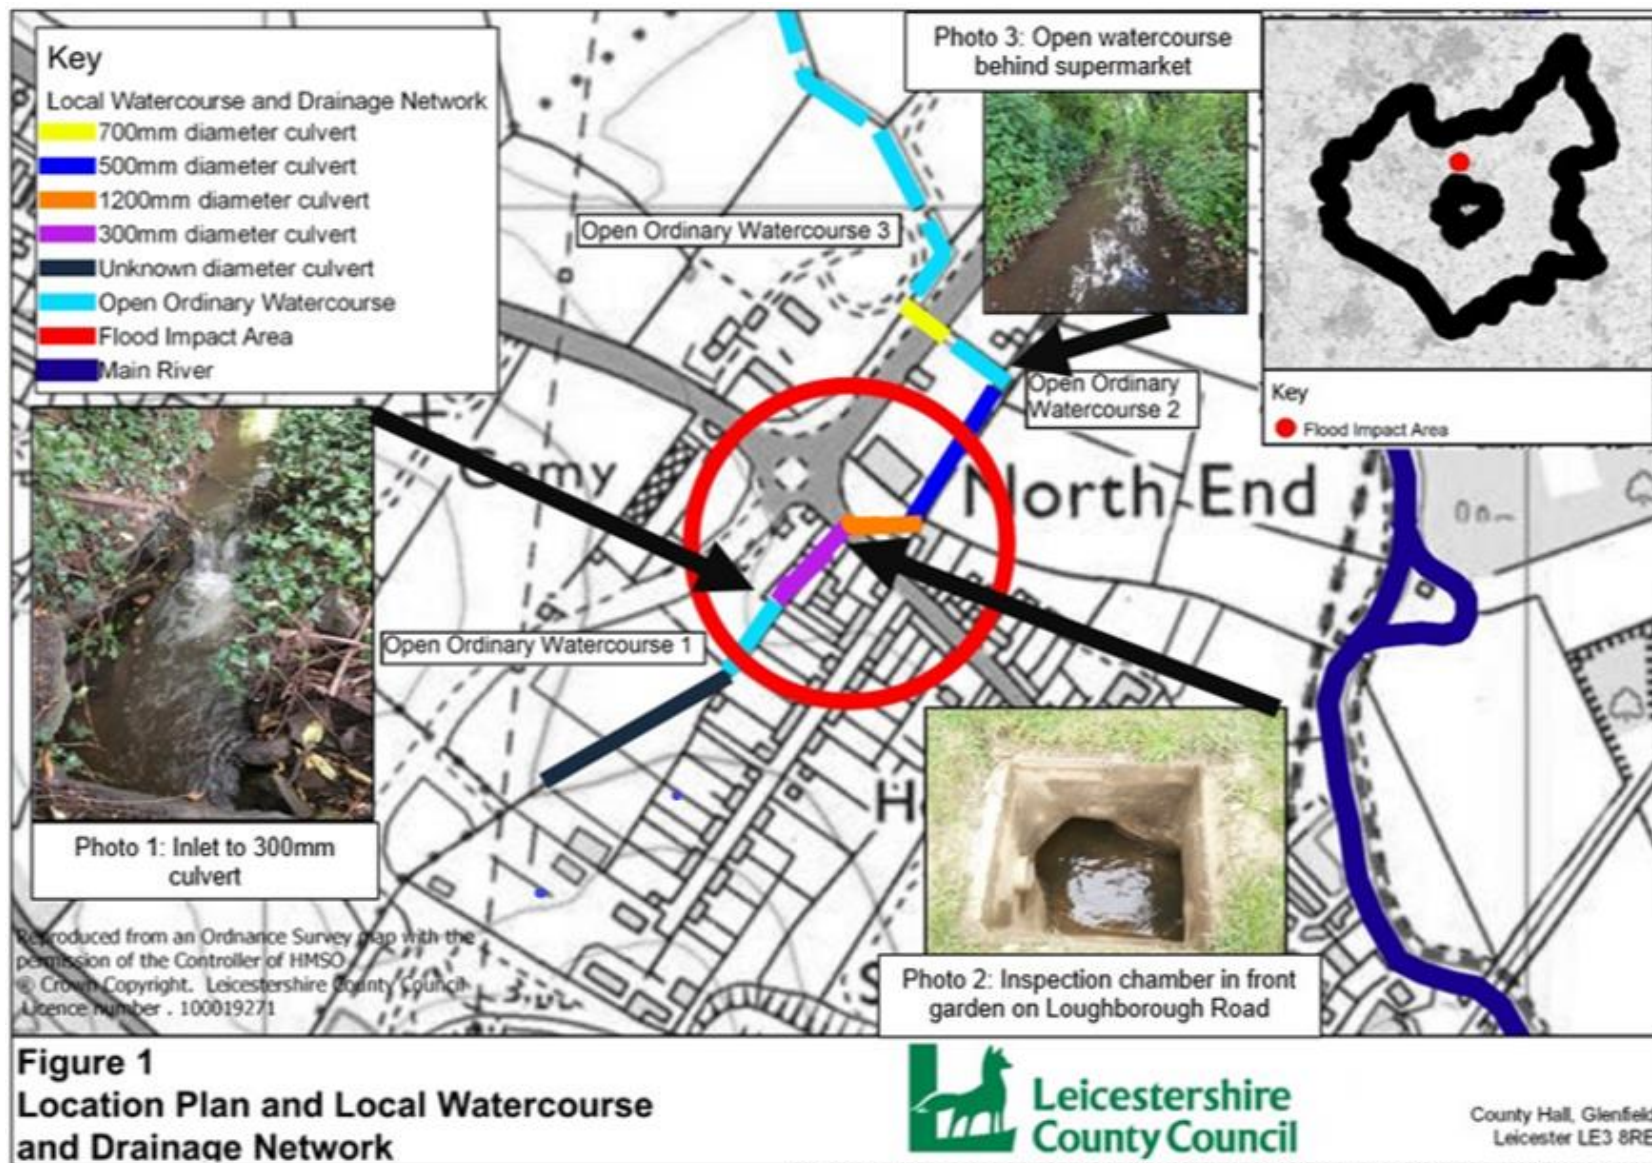
Figure 1 illustrates the locations of key ordinary watercourses within close proximity to the flood impact area. The ordinary watercourse system enters open ordinary watercourse 1 from an unknown diameter culvert behind the Mountsorrel Household Waste and Recycling Centre. Open ordinary watercourse 1 runs parallel to both Granite Way and Hawcliffe Road for around 85m (Photo 1 in Figure 1) before entering a 300mm diameter culvert. This culvert continues running in a north-easterly direction towards Loughborough Road where there is an inspection chamber (Photo 2 in Figure 1) located within a private landowner's property. The system then runs under Loughborough Road to enter a 1200mm diameter culvert which runs from Loughborough Road to Betty Hensers Lane. The culverted watercourse system then drops into a 500mm diameter culvert as it runs down Betty Hensers Lane before eventually outfalling behind the supermarket site into open ordinary watercourse 2 (Photo 3). Open ordinary watercourse 2 then outfalls into a 700mm diameter culvert passing under Granite Way before becoming open ordinary watercourse 3 which drains in a north-westerly direction towards the River Soar (Main River).

In December 2016, the Council received anecdotal reports of flooding within the flood impact area in relation to one of the impacted residential properties with an inspection chamber in the front garden (Figure 1). It was reported at the time that the inspection chamber had surcharged four times in 2016 causing external flooding. Further anecdotal reports of external flooding were received in both May 2017 and July 2018 by which time the Council had begun informal investigations into the flooding issues. In 2018 it was anecdotally reported that the flooding issues were caused by blockages such as silt, tree roots and rubbish in the 500mm diameter private culverted watercourse system down Betty Hensers Lane (Figure 1).

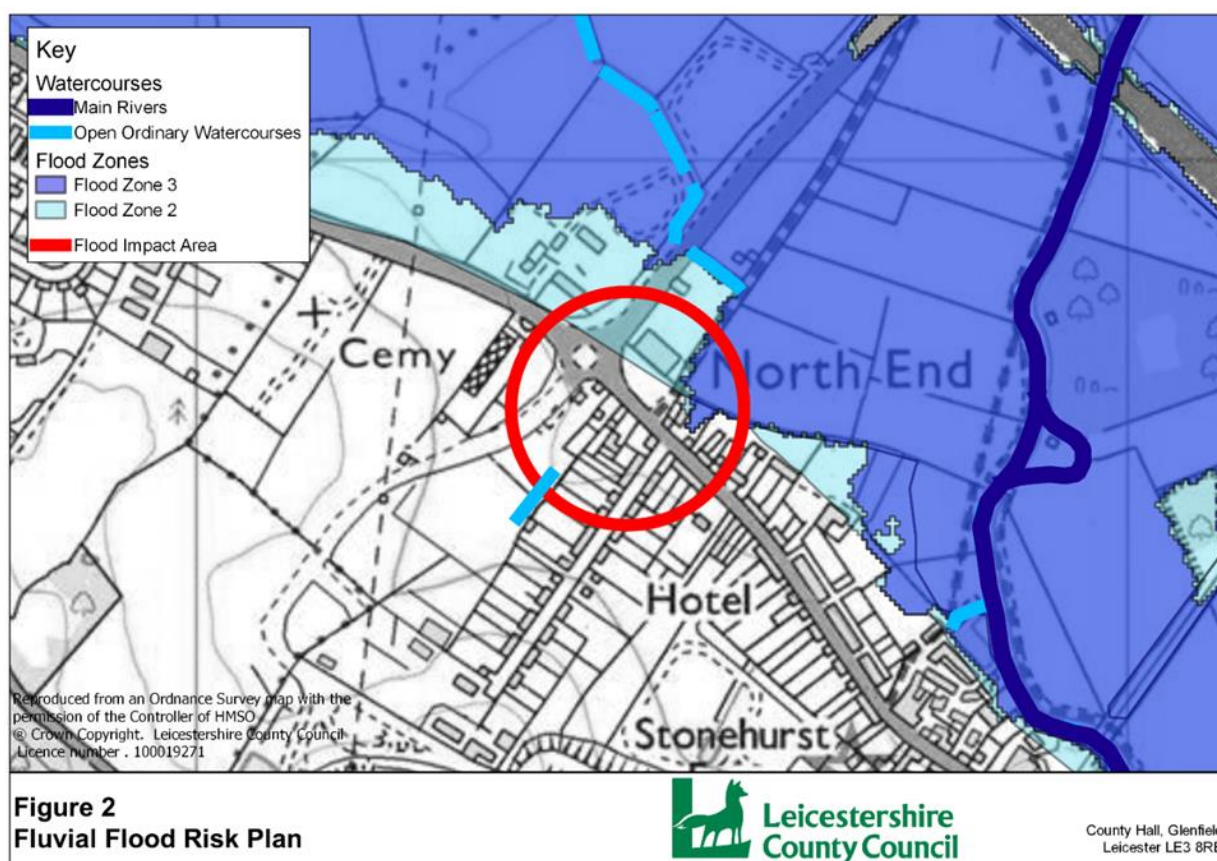
The flood impact area is approximately 0.5km away from the nearest Main River, the River Soar, and is categorised as Flood Zone 1 (low risk to fluvial flooding) although the area does lie in close proximity to both Flood Zones 2 and 3 (Figure 2).

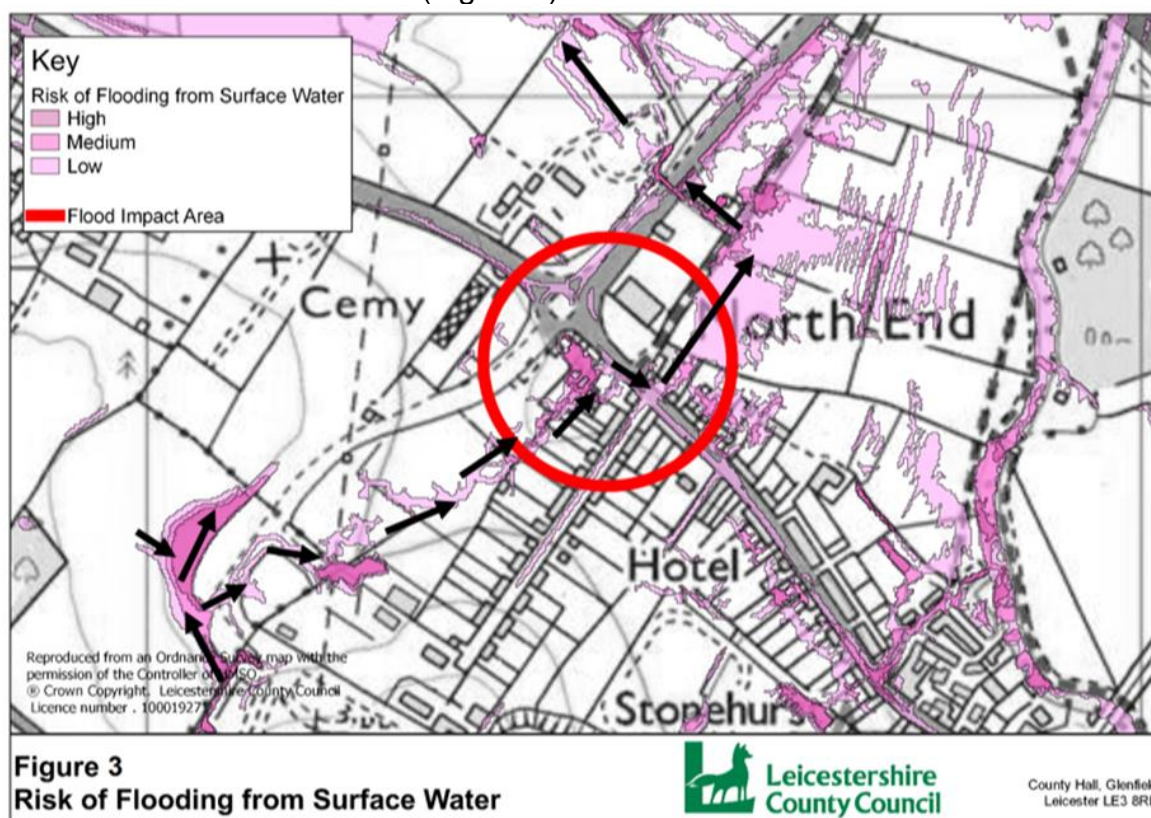
The Risk of Flooding from Surface Water map (Figure 3) has been produced by the Environment Agency (EA) and is created using high level modelling which represents where water could flow and accumulate during certain rainfall events⁵. Anecdotal evidence indicates that overland surface water flowed in a north-easterly direction from the Wood Lane area towards the rear of the impacted residential properties (indicated by arrows on Figure 3). Figure 3 illustrates a medium risk of surface water flooding (between 300mm – 900mm deep of flood water) to the affected residential properties. The Risk of Flooding from Surface Water map therefore supports the local reports of the event. The modelling is high level (not designed to be accurate at the local level) and was completed in December 2013. The modelling does not consider property threshold levels, and therefore cannot accurately predict internal flooding. However, in this case it indicates that the flooded residential properties were likely affected by the surface water flow routes (Figure 3).

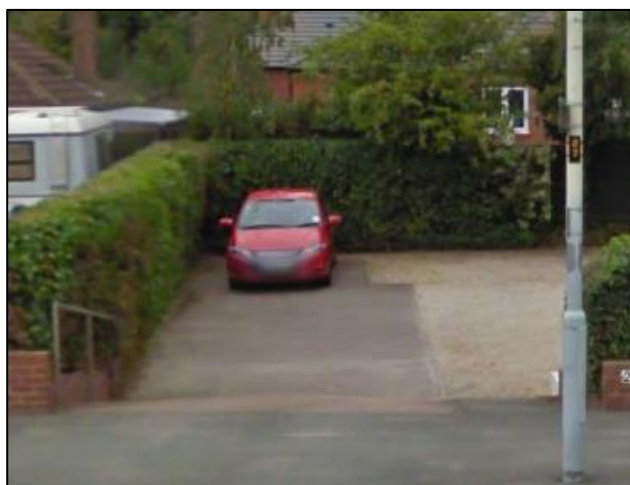
**Photo 7: Carpark height off
Loughborough Road in July 2011⁶**

Anecdotal reports from some impacted residents indicated how the change of building use, from an office into flats, to the west of the impacted bungalows may have changed the levels of the carpark and fitted kerb stones (Photos 7 and 8). It was reported that this may have further trapped the flood water from following its previous flow path in a westerly direction towards the bungalows and exacerbated the volume and depth of flood water impacting the residential properties. However, during the 2019 flood event the sheer volume of flood water overtopped the kerb stones and resulted in internal flooding to the ground floor flats as well as the bungalows.

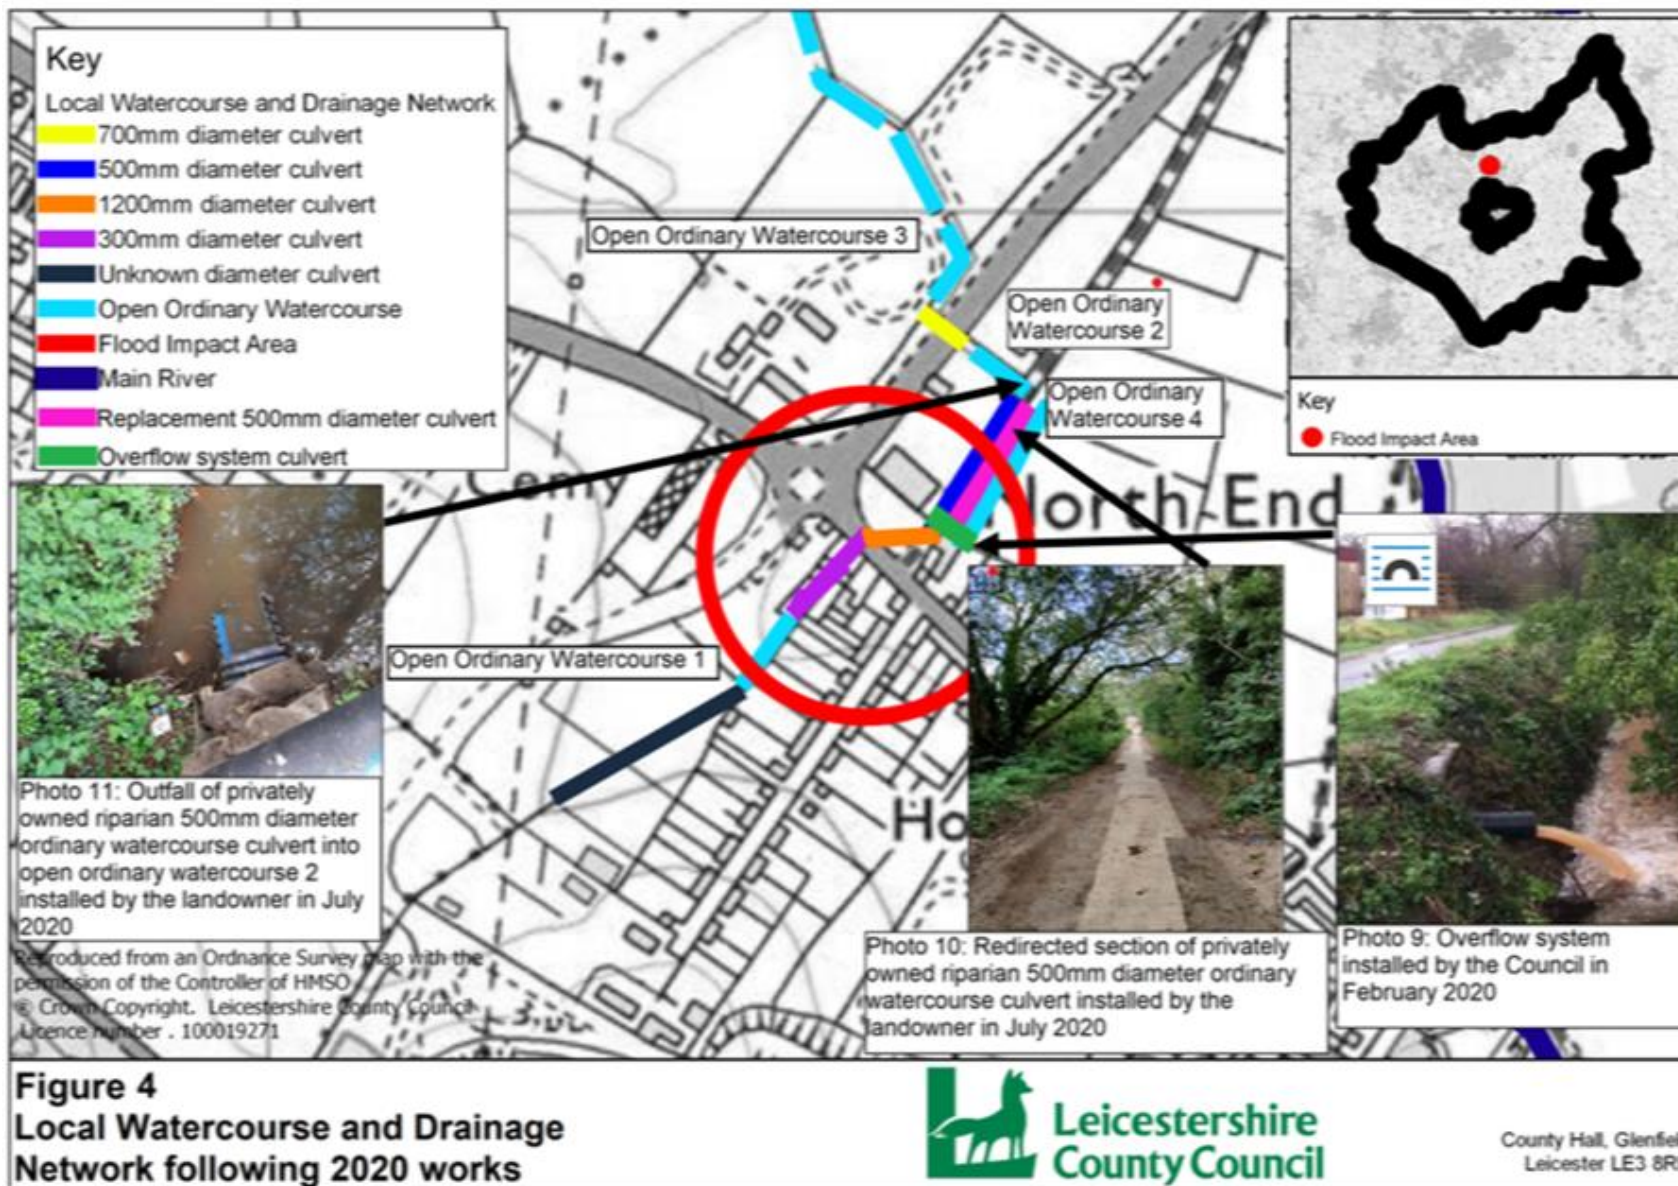
As part of the investigation it was reported that the volume of overland surface water was exacerbated due to a restriction in the 500mm diameter private culverted ordinary watercourse system downstream of the inspection chamber (Photo 2 in Figure 1). The Council conducted maintenance works following the flooding on the week commencing 12th September 2019 starting from the inspection chamber within private land, under Loughborough Road to the junction of Betty Hensers Lane. The Council also carried out three excavations on the 300mm diameter culverted system within the garden of one of the impacted residential properties. During these works the Council removed a build-up of siltation and debris from the culvert. The Council also carried

out clearance and exploratory works along Betty Hensers Lane. These restrictions combined with the reduced capacity (through root ingress and siltation) in the 500mm diameter private culverted watercourse would have likely contributed to the volume of flood water which surcharged from the inspection chamber (Photo 2) and pooled around the effected residential properties.

Following the flood event and recognising the capacity issues in the culverted ordinary watercourse system, the Council allocated funds, received a private sector donation and successfully applied for Local Levy funding towards works to install an overflow pipe (Photo 9 in Figure 4). This overflow pipe is designed to take excess flows during storm events from the 500mm diameter private culverted watercourse (Figure 4) to open ordinary watercourse 4. The Council also provided additional clearance works to the watercourse prior to the installation of the overflow system (Photo 9 in Figure 4).

system from an inspection chamber near the junction of Betty Hensers Lane and Loughborough Road, underneath the centre of Betty Hensers Lane (Photo 10 in Figure 4), and back into open ordinary watercourse 2 (Figure 1 and Photo 11). The riparian landowner was granted consent under Section 23 of the Land Drainage Act (1991) by the Council and eventually completed the rerouting of the system in July 2020.

| ACTION | PROPOSED TIMESCALE |
|---|---|
| Installed a new overflow system on Betty Hensers Lane into the open ordinary watercourse 4 to help with capacity in the culverted system in times of inclement weather. | Completed |
