# **Flood Investigation Report**

**MAIN STREET, LEIRE**

**31<sup>ST</sup> JULY 2019**

**Final Report**

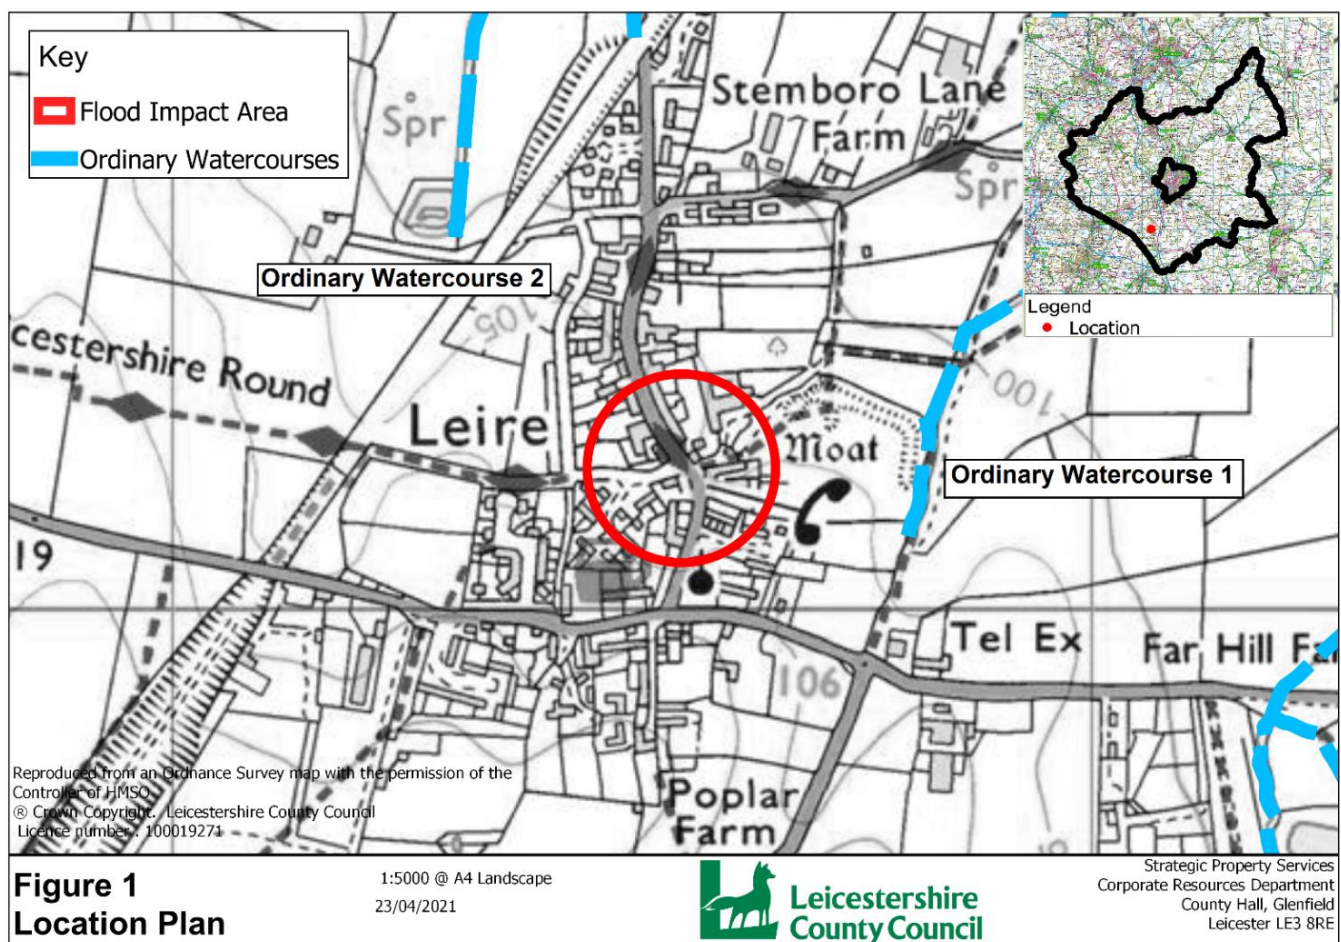
The flood impact area is approximately 2km south from the nearest Main River (River Soar) and is categorised as Flood Zone 1. Ordinary Watercourse 1 (illustrated on Figure 1) flows in a northerly direction parallel to Main Street approximately 250m to the east of the flood impact area before connecting with a tributary of the River Soar approximately 2km north of the village. Ordinary Watercourse 2 (illustrated on Figure 1) flows in a north westerly direction approximately 400m to the north west of the focus area.

maintained by STW. The surface water system consists of a 300mm diameter pipe which flows east along Back Lane, passing perpendicular through Main Street, before outfalling into Ordinary Watercourse 1 (Figure 1). A separate 150mm surface water system starts along Main Street within the flood impact area and flows in a northerly direction along Main Street before upsizing into a 225mm diameter system. There is also a 225mm diameter STW foul sewer system which flows in a northerly direction along Main Street.

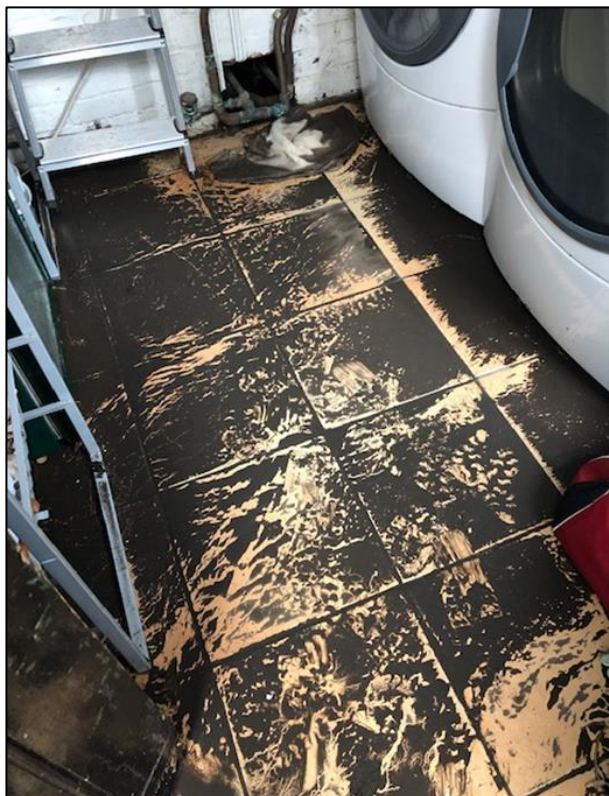
It was anecdotally reported that following the heavy rainfall event highway flood water was flowing east along Back Lane onto Main Street and towards the low point adjacent to the impacted residential properties. Flood water was also anecdotally reported flowing north along Frolesworth Road towards the flood impact area. The volume of highway flood water overwhelmed the local drainage network within the flood impact area (Figure 1), resulting in the flood water levels exceeding the highway kerb face. The flood water subsequently flowed onto the driveways of at least two residential properties on Main Street, where it then breached the thresholds of the residential properties and caused internal flooding (Photos 1 and 2).

**Photo 1: the debris left behind in one of the impacted residential properties following the flood event**

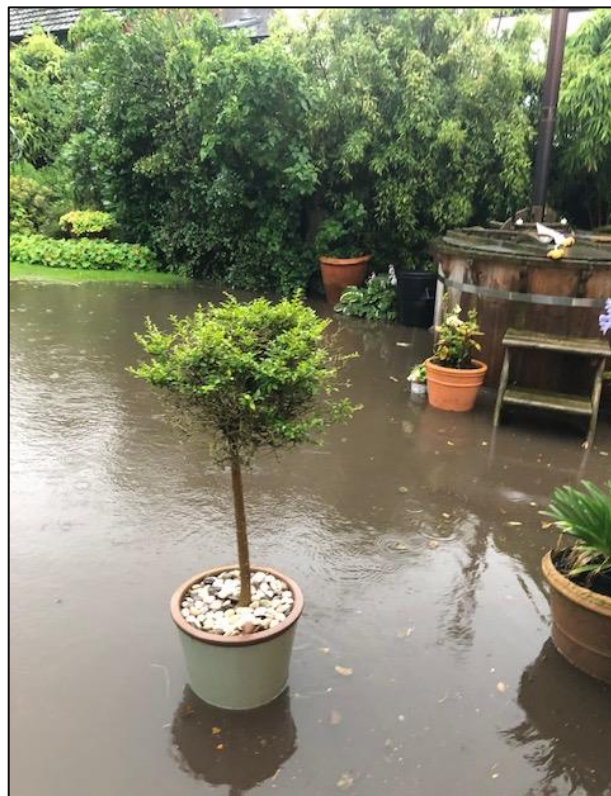
**Photo 2: external flood levels witnessed from one of the impacted residential properties**

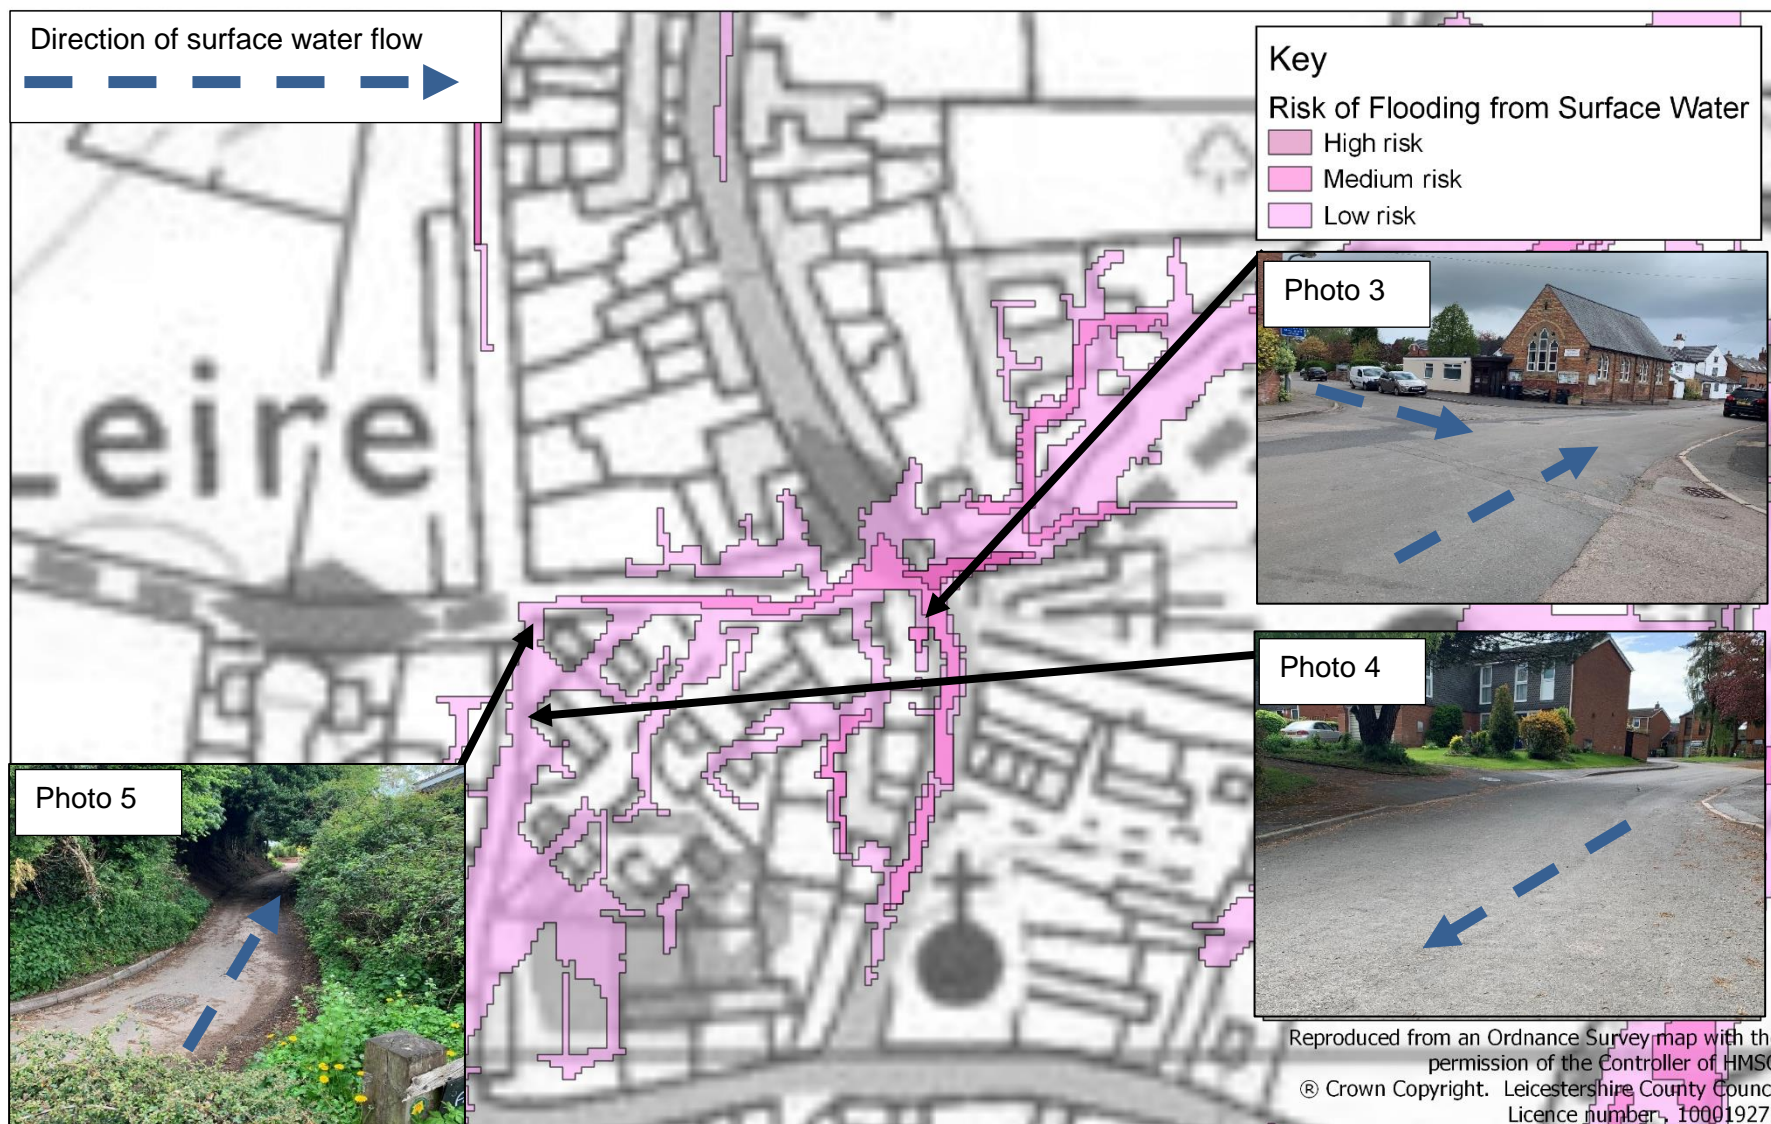
**Figure 2:**  
**Risk of Flooding from Surface Water**

The Risk of Flooding from Surface Water Map (Figure 2) has been produced by the Environment Agency (EA) and created using high-level modelling which represents where water would fall during certain rainfall events<sup>3</sup>. The arrows in Photos 3,4,5 in Figure 2 indicate the flow directions of the surface water which was anecdotally reported following the flood event and witnessed during a site visit conducted by the Council during a rainfall event in February 2020.

Figure 2 indicates a highway surface water flow route from Frolesworth Road along Main Street in a northerly direction towards the flood impact area (Photo 3 in Figure 2). During the site visit, it was noted that there was a limited number of highway gullies located along Frolesworth Road and the south of Main Street. As Leire is a historic village, there are relatively less highway gullies than newer highway developments. There is therefore little interception of water flowing on the surface of the highway.

Figure 2 also illustrates a medium risk surface water flow path from Oak Avenue in a northerly direction (Photo 4 in Figure 2), and onto Back Lane where it flows in an easterly direction towards the flood impact area (Photo 5 in Figure 2). It was also noted that there are few highway gullies along Oak Avenue and Back Lane which would have further contributed towards the volume of highway flood water accumulating near the residential properties that were impacted as there was little surface interception of the flow.

Figure 2 highlights that the flood impact area is categorised as high risk from surface water flooding, indicating it is situated in a relatively low topographic point. The site visit conducted by the Council also found a natural dip in the highway along the front of the impacted residential properties. This supports the data in Figure 2 and the anecdotal reports of highway flood water accumulating outside the front of the impacted residential properties during the flood event.

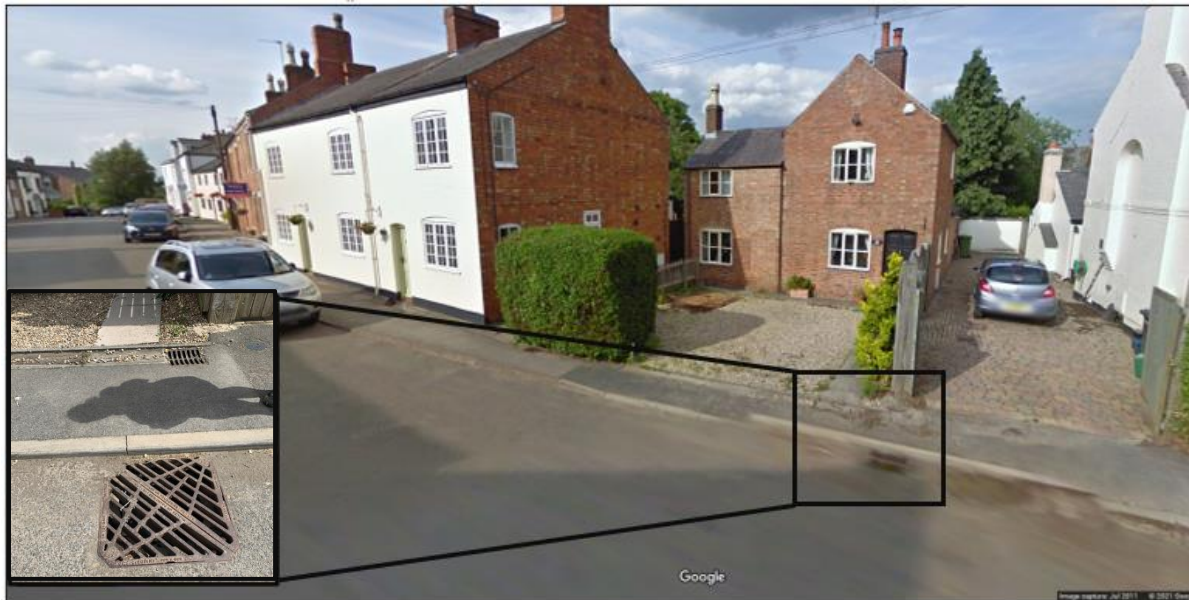
During the site visit, flood water from the roofs of adjacent residential properties (that were not impacted during the flood event) was witnessed to be flowing towards the impacted residential properties along a small concrete concave channel to the front of the residential properties (Photo 6). This would have added to the volume of flood water flowing onto the private driveways of the two impacted residential properties.

**Photo 6: Small concrete concave channel which runs along the front of the impacted residential properties (main photo taken from Google Maps in July 2011 and small photo taken in May 2021).**

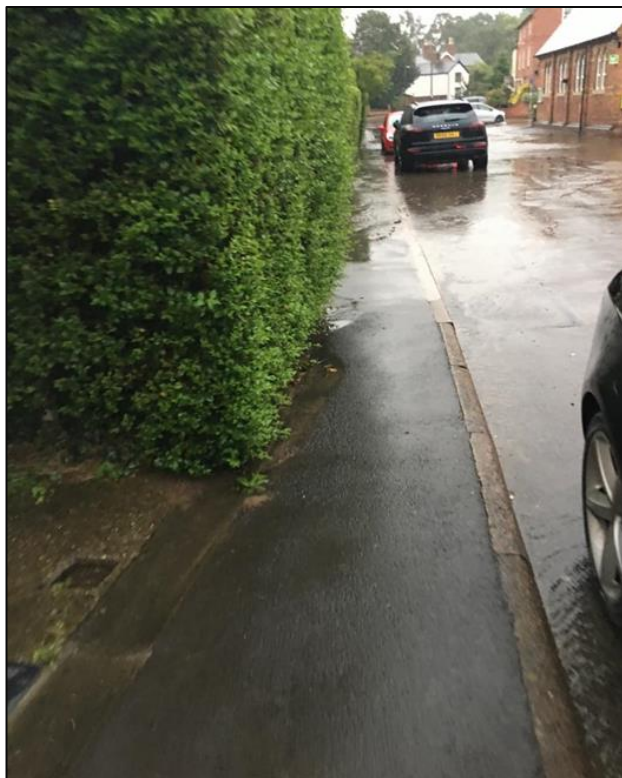
A second flood event was reported on 29<sup>th</sup> September 2019 resulting in the internal flooding of at least one residential property (Photos 7 and 8). This event was similar in nature to the 31<sup>st</sup> July 2019 flood event with highway flood water flowing towards the residential properties and pooling on the highway. The Council conducted further investigation works and completed maintenance works on the highway gullies along Main Street to remove siltation. Following this investigation, STW conducted further investigation works along their surface water assets on Main Street to the system's outfall at approximately OSNGR Easting: 452829, Northing: 290205. No restrictions or issues were found within the STW surface water system during this investigation. As the investigation works were completed several months following the initial flood event, it is not definitive that there was no obstruction within the system during the flood event which may have exacerbated the volume of highway flood water.

**Photo 7: highway surface water exceeding the thresholds of the highway onto private property on 29<sup>th</sup> September 2019.**

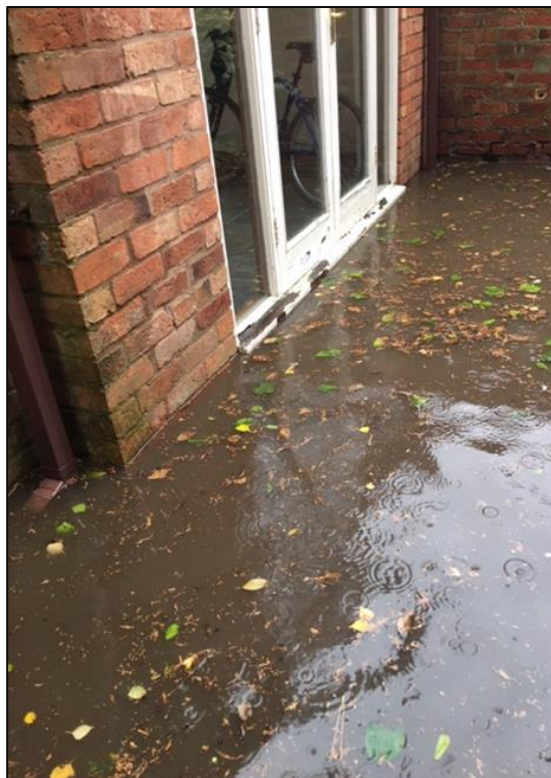
**Photo 8: surface water flooding to residential property threshold on 29<sup>th</sup> September 2019.**
