Flood Investigation Report

Newtown Linford

16th June 2020

Final Version

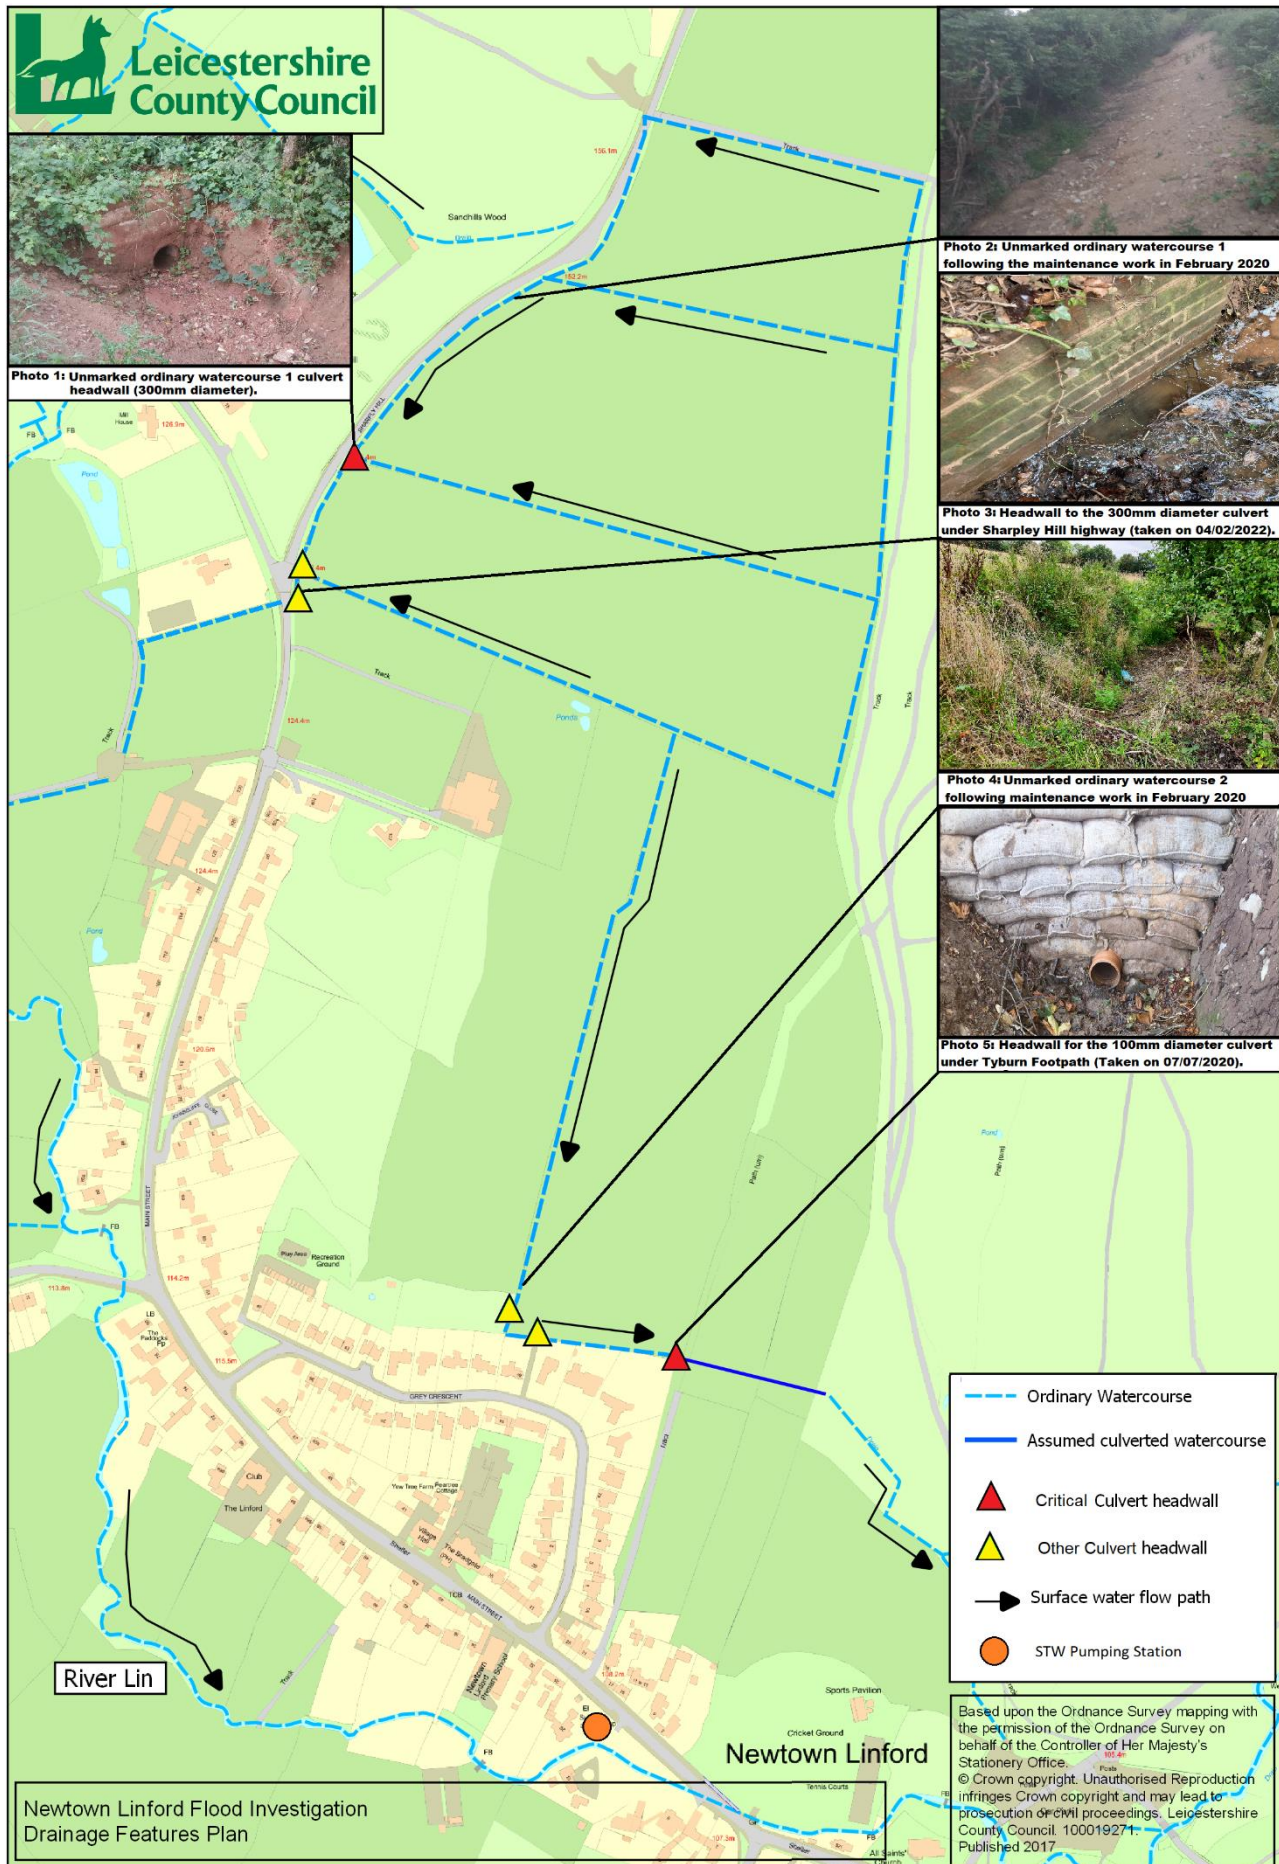
Figure 2: Local Drainage Features

Figure 2 shows a detailed plan of the marked and unmarked ordinary watercourses throughout Newtown Linford. Several unmarked ordinary watercourses are critical for draining the upland farmland to the north of Newtown Linford (labelled as unmarked ordinary watercourse 1 & 2 on Figure 2). Both of these watercourses comprise of historic and established field ditch systems which drain the water downhill towards the River Lin.

Unmarked ordinary watercourse 1 is partially culverted at a number of locations (adjacent to Sharpley Hill, see Figure 2) to facilitate various field accesses before reaching the highway where it bends east in an 300mm diameter culvert (illustrated on Figure 2 as a red square) and then eventually outfalls into the River Lin to the west of the village. Unmarked ordinary watercourse 2 is also culverted for access at two known locations (see Figure 2) both of these culverts are approximately 225mm in size.

As well as these natural and agricultural features, there are highway and surface water drainage systems along Sharpley Hill, Main Street and Grey Crescent. The highway drainage on Sharpley Hill is served by highway storm water gullies which connect directly into the adjacent ditch network shown on Figure 2 as unmarked ordinary watercourse 1. Main Street and Grey Crescent are served by a traditional highway drainage system, including highway storm water gullies which connect directly into the STW surface water system. The village is served by a combined foul and surface water sewer network, owned and maintained by STW. The combined sewer system consists of a 225mm diameter pipe and flows in a south-easterly direction down Main Street, connecting with the Grey Crescent branch (225mm) before connecting into the STW pumping station adjacent to Stamford Rise (as illustrated on Figure 2).

A number of old farm accesses have been identified along Sharpley Hill which are traversed by small culverts (circa 100mm, refer to Figure 2). The water was described to be entering the highway during the flood event at one of these old farm access points and this culvert was identified to be blocked following a site visit conducted by the Council on the 19th June 2020 (Photos 5 and 6 on Figure 4). It is not known if this culvert was blocked at the time of the flooding, however given the recent maintenance it is likely that this culvert was clear at the beginning of the event and likely blocked by debris and silt washed down by the flooding. During the site visit on 19th June 2020, it was also identified that the right-hand bank of unmarked ordinary watercourse 1 was lower than the left-hand bank and that the field tipped towards the highway. Therefore, it was concluded that this point was the lowest point for which water would leave the watercourse and enter the highway and that this would happen when the watercourse became overwhelmed (either through becoming overfull or unable to drain due to the culvert being blocked).

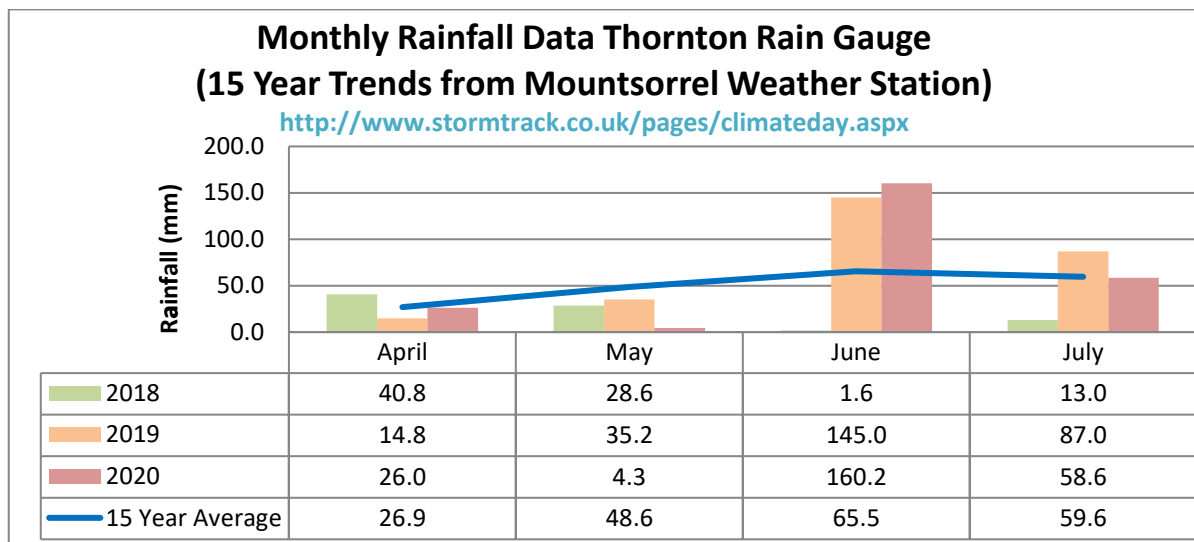
Figure 3: Long term rainfall trends – comparative rainfall data for the relevant period with previous 2 periods and the 15-year average

Figure 3 and Table 1 show that June 2020 was defined as a wetter than average month compared to the 15-year trends. However, the months overall were comparable over the same period in 2019, where throughout the summer no significant flooding events were recorded. June 2019 was characterised by consistent rainfall throughout the month, whereas conversely, Table 1 shows that more than half of the month's rainfall fell in five intense rainfall events. The ground conditions following the long period of dry weather from

late march were considered 'dry and hard' with agricultural pastoral land, grass footpaths and other high traffic areas at 'high risk of compaction'.

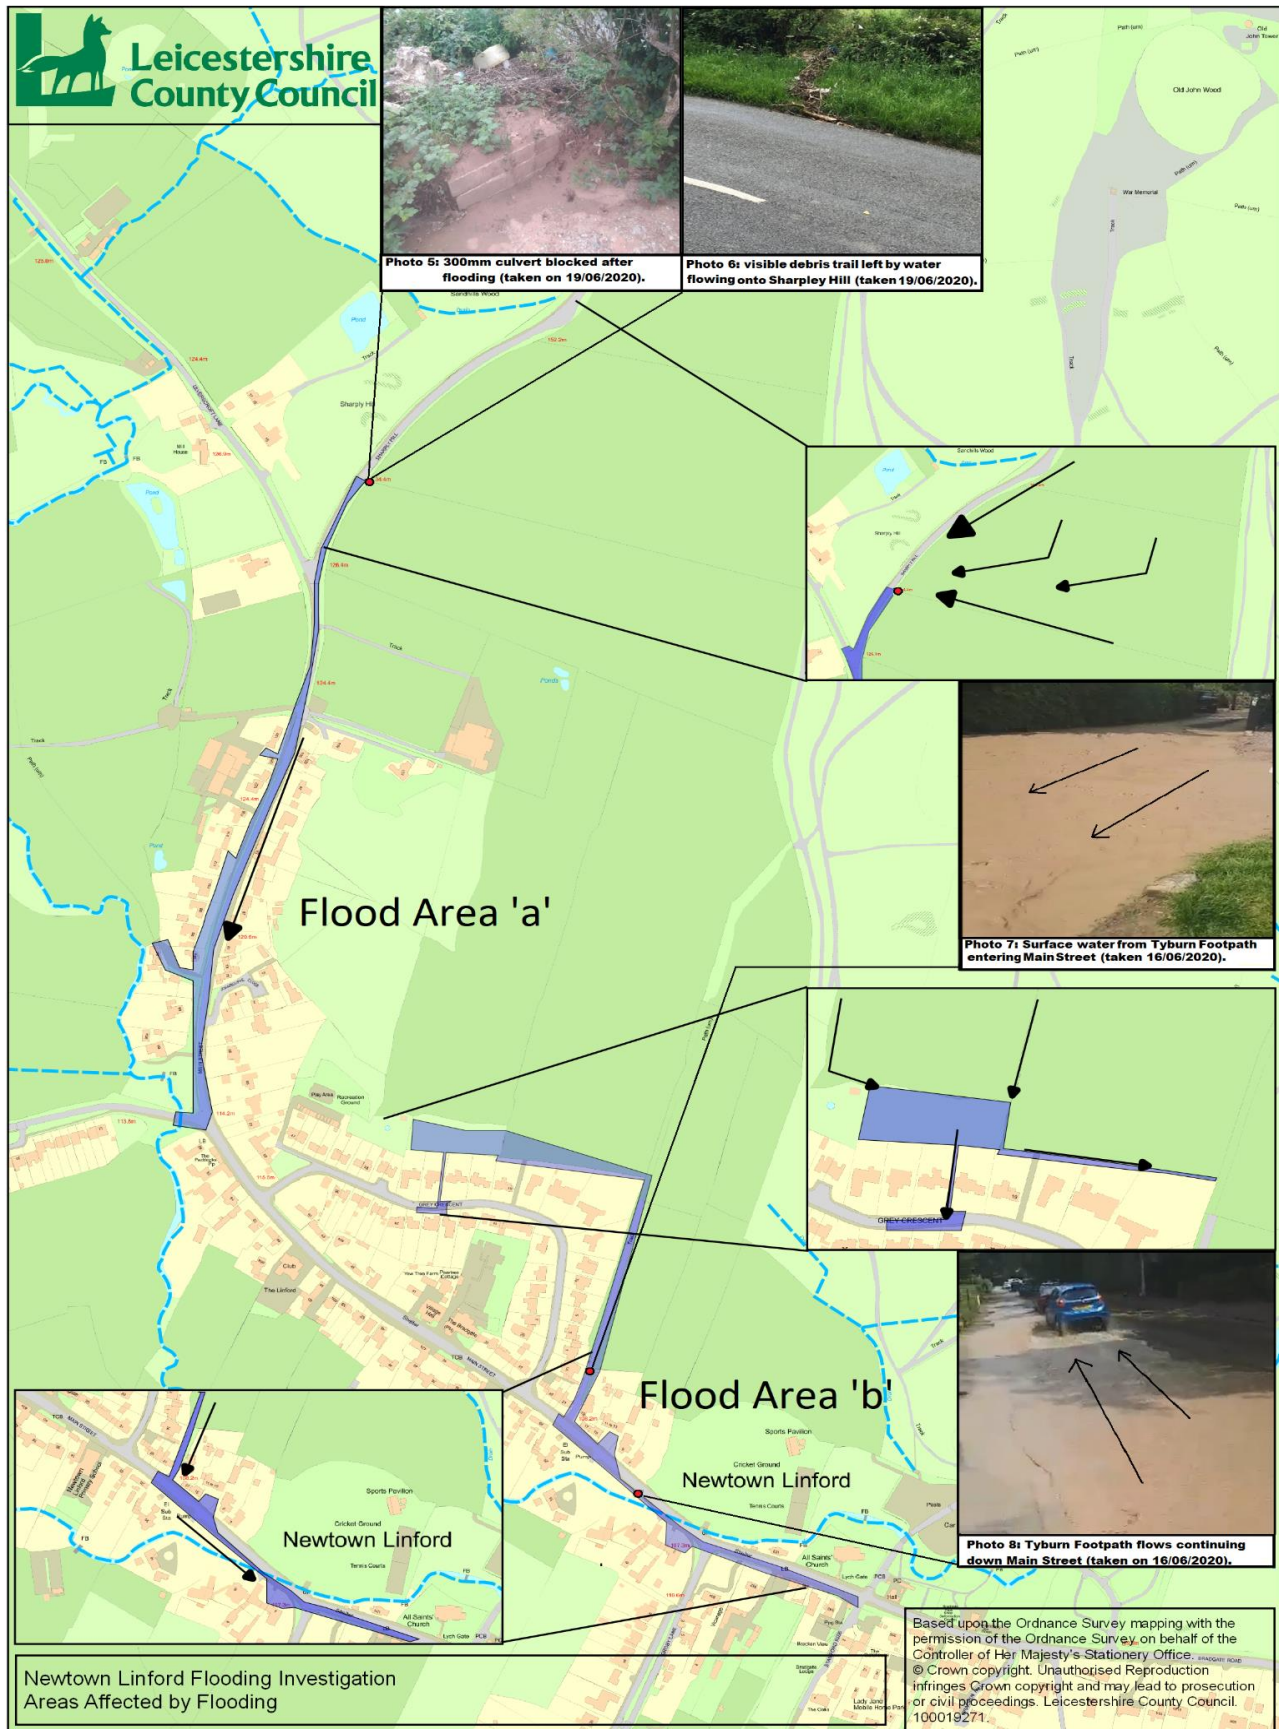
Figure 4: Areas affected by the flooding (arrows indicate the known and reported flood flow paths)

The nature of the event was described as a 'tidal wave' down Main Street, with anecdotal reports indicating it originated from unmarked ordinary watercourse 1 overtopping its banks along the field boundary of Sharpley Hill (refer to Figure 4, Photo 6). The water then used the highway as a conduit to flow southwards (Photos 5, 7 and 10) into the village via Main Street. The water overwhelmed highway drainage systems and gathered on the southern side of Main Street, and quickly overtopped kerbs and caused flooding to driveways, gardens, footpaths, and the local highway network. Flood water eventually started to enter residential properties via overtopping the highway kerb thresholds and where residential property thresholds were lower than the highway in some instances. Internal water levels were described as varying from 2-30cm depending on the location and gradient of the residential property.

Overland surface water run-off was described from the agricultural land to the north of Grey Crescent, where field drainage ditches were overwhelmed and overtopped, spilling across gardens and eventually entered the internal space of three properties and a business premises. Flood water also flowed down Tyburn Footpath (Figure 4 and Photos 5 & 6) and onto Main Street, where it flooded a further two properties internally along with a number of gardens, outbuildings and driveways.

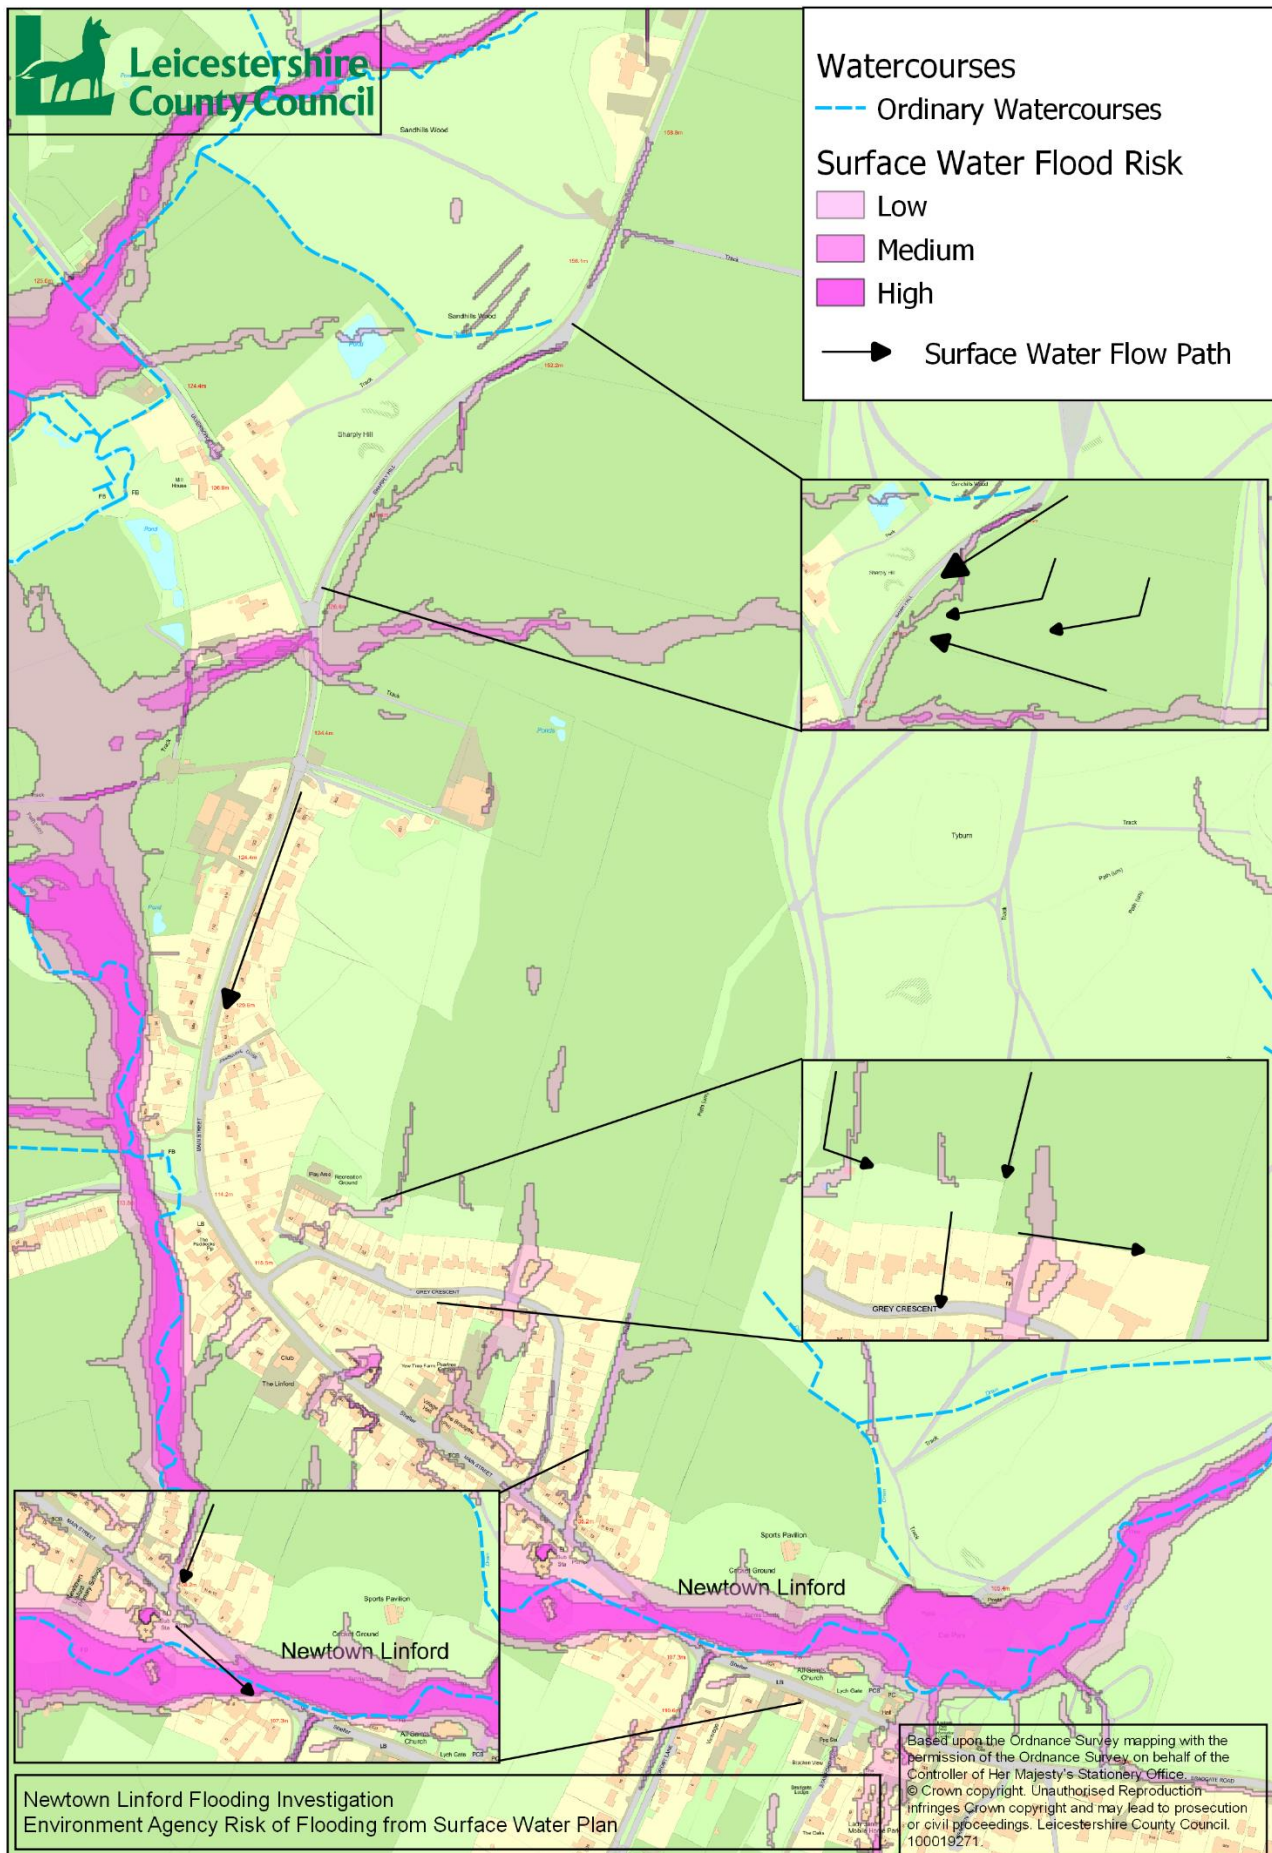
Figure 5: Surface water flood risk mapping

As part of the initial desktop study, the Council reviewed the Risk of Flooding from Surface Water Map (Figure 5) available online¹. This data has been produced by the Environment Agency (EA) and is created using high level modelling which represents where water could flow and accumulate during certain rainfall events. The surface water flood map illustrates flow routes which roughly compare to what was witnessed during the flooding. However, the severity, extent and risk of flooding are all underrepresented. The flood routing for Flood area 'a' roughly follows the course expected should the water remain within the unmarked ordinary watercourse 1. However, the flooding is considered 'low risk', only expected in a 1 in 100 year event. Flood area 'b' is better represented on the flood mapping, showing flows similar to those witnessed along Tyburn footpath and Grey Crescent. However, these again are considered 'low risk', only expected in a 1 in 100 year event. The surface water flood map does not accurately represent the upstream catchment and sources of flooding either although this could be explained by the modelling being very high level (not designed to be accurate at the local level).
