Leicester Road, Loughborough

Flood Report

DETAILED FLOOD INVESTIGATION

County Council Investigation Ref.:	2016-INV-115
Investigation:	Leicester Road, Loughborough
Date of Flooding:	7 th May 2016
Revision	Final

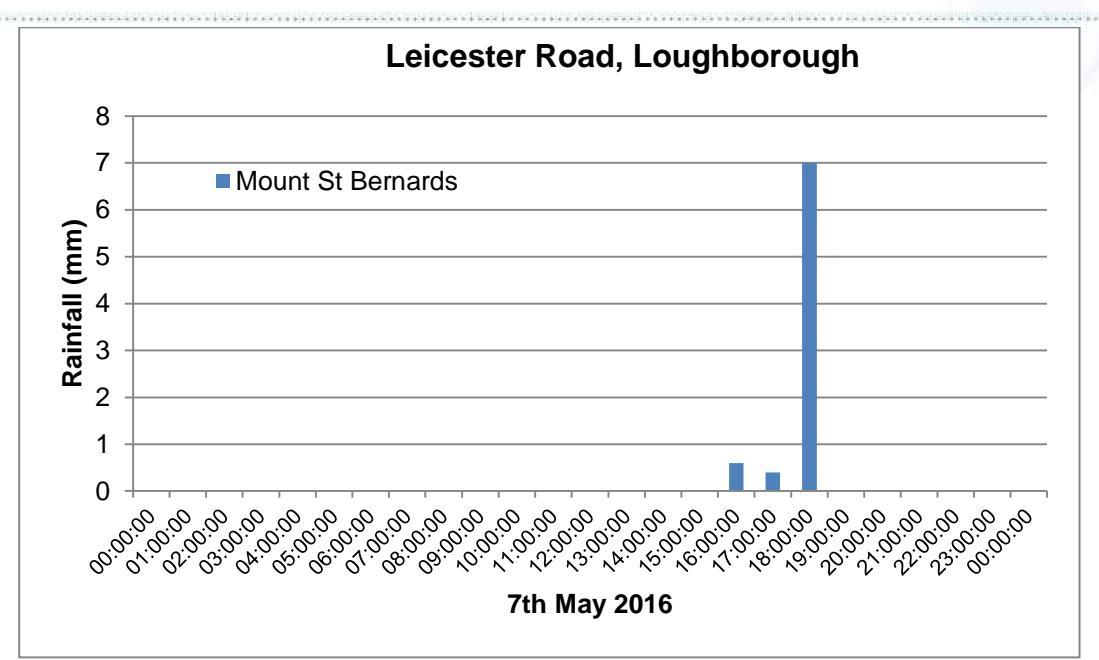
On Wednesday 7th May 2016, intense rainfall fell over the area for a short duration between 18:00hrs. to 19:00hrs. Rainfall data from the nearest rainfall gauge that recorded that rainfall event (Mount St. Bernards, 8.8 km away) is shown in Figure 1. This is thought to have caused localised flash flooding which may have exceeded the design capacity of the drainage system of Leicester Road. The flooding situation on Leicester Road was further exacerbated by the unmapped highway drainage that was discovered during the course of this investigation. Flood water ponded on the highway and rose to a level sufficient to overtop the footpath and flow onto a residential dwelling which is located at a lower level relative to Leicester Road, down the driveway of the residential dwelling and ponded until it entered the ground floor via the front door and garage.

Figure 1 Rainfall data showing rainfall event which resulted in flooding on Leicester Road, Loughborough

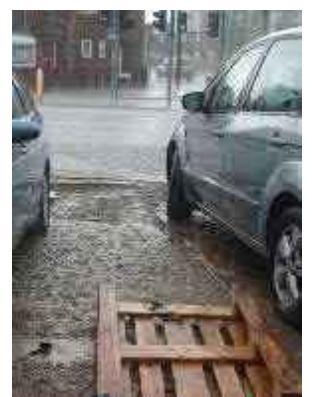
Figure 3 Flooding of driveway at Leicester Road

The locality of the ponded water during the flooding incident of May 7th 2016 (see Figure 3 and Figure 4) suggests that an issue existed in the highway drainage during the flooding incident. Once the water overtopped the pavement, it cascaded into the nearby driveway and flowed into the low-lying back garden (see Error! Reference source not found., Error! Reference source not found., and Error! Reference source not found.).

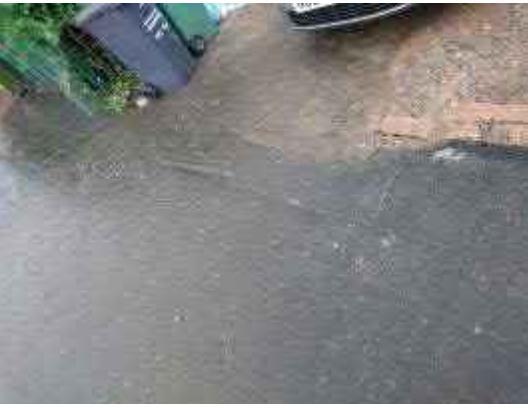
Figure 4 Ponding of surface water on Leicester Road

Since this portion of the previously unknown highway drainage network was blocked, during periods of heavy rain, surface water was reported to pond on the highway and footway. This rose to a sufficient level to overtop the footway and flow down driveways into the residential properties, which are lower than the road level.

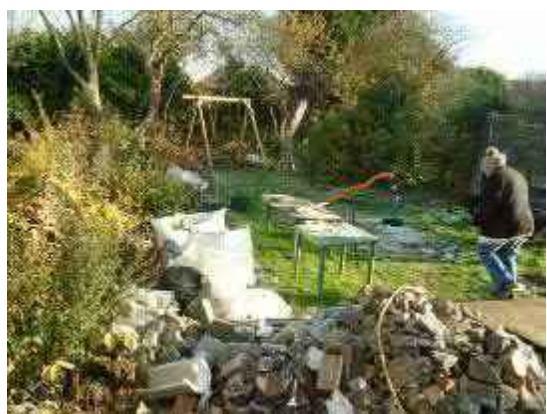
Figure 5 Flooded back garden

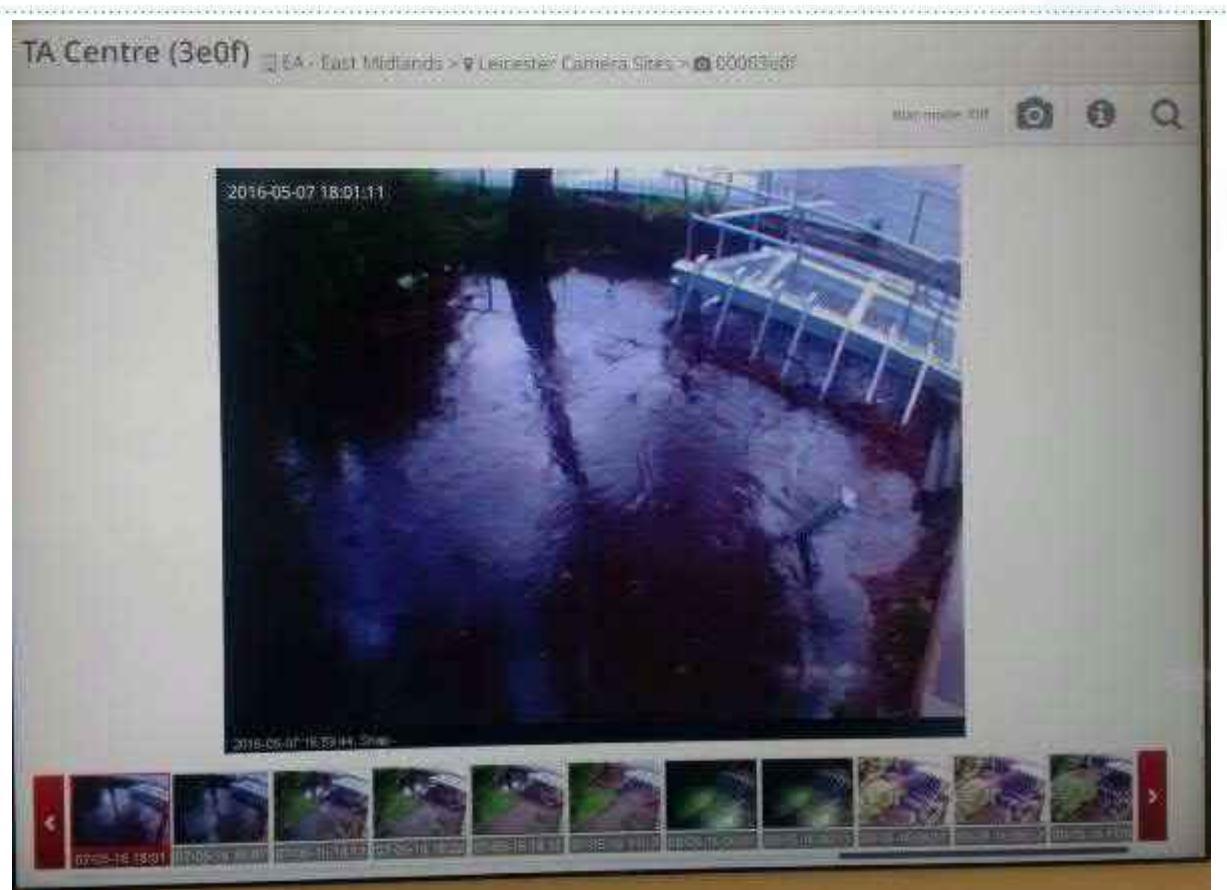
Anecdotal reports suggest that during recent flood events, the brook has been at a relatively low level and not near the top of bank. A series of photographs received from the Environment Agency shows Grammar School Brook beside the Army Reserve Centre on the date of the flooding. The images span from 18:00hrs on the 7th of May to 10:00hrs on the 8th of May and show that the brook did not overtop Leicester Road at any stage during this period of time. It is therefore not thought that the flooding issues were caused by capacity issues within Grammar School Brook.

Figure 6 Photographs from the EA showing the level of Grammar School Brook on between May 7th and May 8th

The Environment Agency has provided a series of photographs of water level in Grammar School Brook during the flood event. It was found that the Grammar School Brook was not the cause of flooding of the residential property on Leicester Road on May 7th 2016.
