Flood Investigation Report

Stoney Stanton – 1st October 2019

Final Report

April 2021

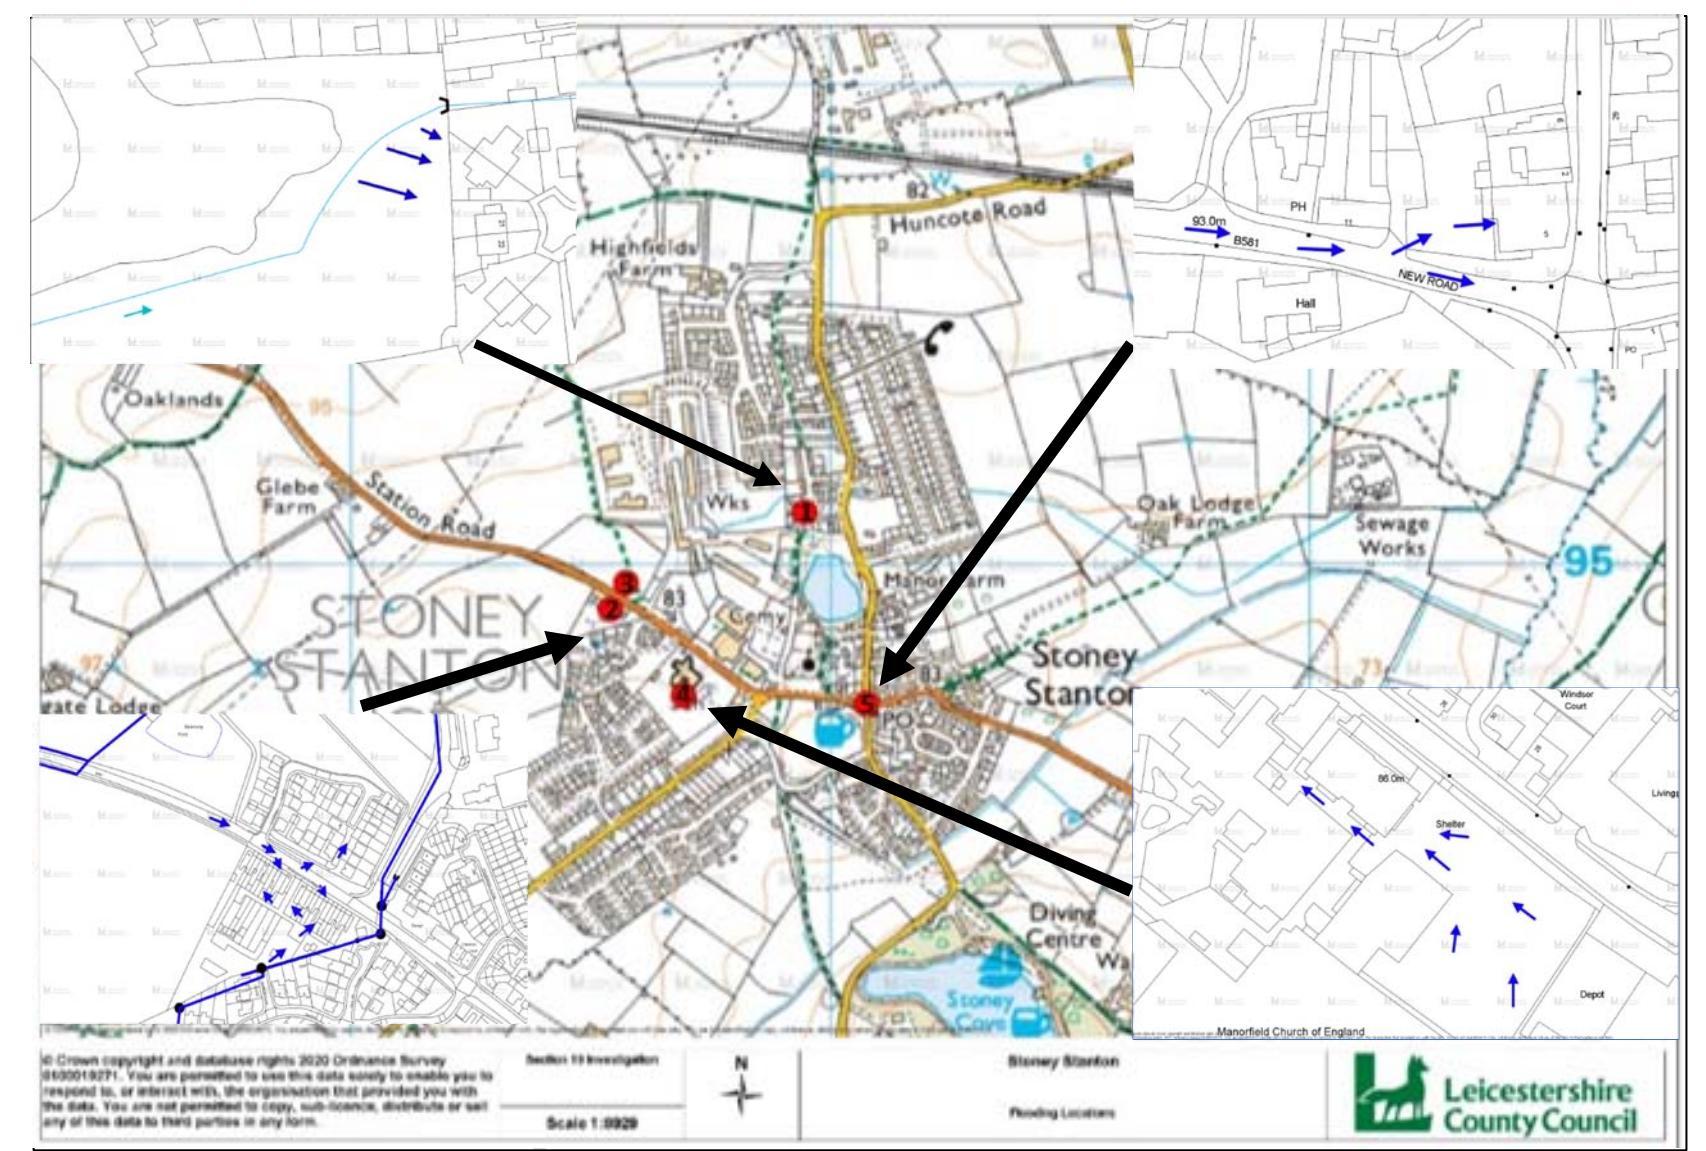
Figure 5: The key locations of flooding incidents in Stoney Stanton on 1st October 2019 (arrows indicate direction of flow)

Five key areas of the village were affected by flood water on 1st October 2019 (as illustrated on Figure 5, labelled with red circles) including:

Residential properties flooded from the adjacent watercourse as a result of a partial blockage to the trash screen covering the culvert inlet. It was noted that the trash screen was blocked by vegetation and brash, with the open section of watercourse leading up to the trash screen heavily silted with riparian vegetation within the channel. The obstruction caused water to flow out of bank, flowing eastwardly towards residential properties and gardens and the local highway network in Meadow Close and Highfield Street.

Water was described to have run off the agricultural field to the rear of the properties towards the local low-point (the properties). Water was also described to have bypassed watercourse B due to the sheer volume of water and due to the most upstream section being filled in. Water was described to have been flowing out of the chamber on watercourse B (where it joins with the 600mm diameter culvert from Robertson Close) with such force that it knocked a local resident over. This water also headed towards the rear of Mountsorrel Cottages.

Water was described to have breached the highway kerb off Station Road, through the hedge line and entered the property frontage. The threshold level of the affected property is the lowest on the development, in addition to being significantly lower than that of the level of the highway and the dropped kerb outside of the development adjacent to the property.

Surface water was described to have run off from the adjacent playing field and entered a single temporary school building internally. This building subsequently became unusable and the flooding caused significant disruption to the day-to-day running of the school.

Anecdotal reports suggest that exceedance flows from the highway entered the Cooperative car park via a dropped kerb which was exacerbated by a lack of drainage within the site. Surface water flows entered the shop via a rear store-room entrance resulting in flooding to storage areas and the shop-floor.

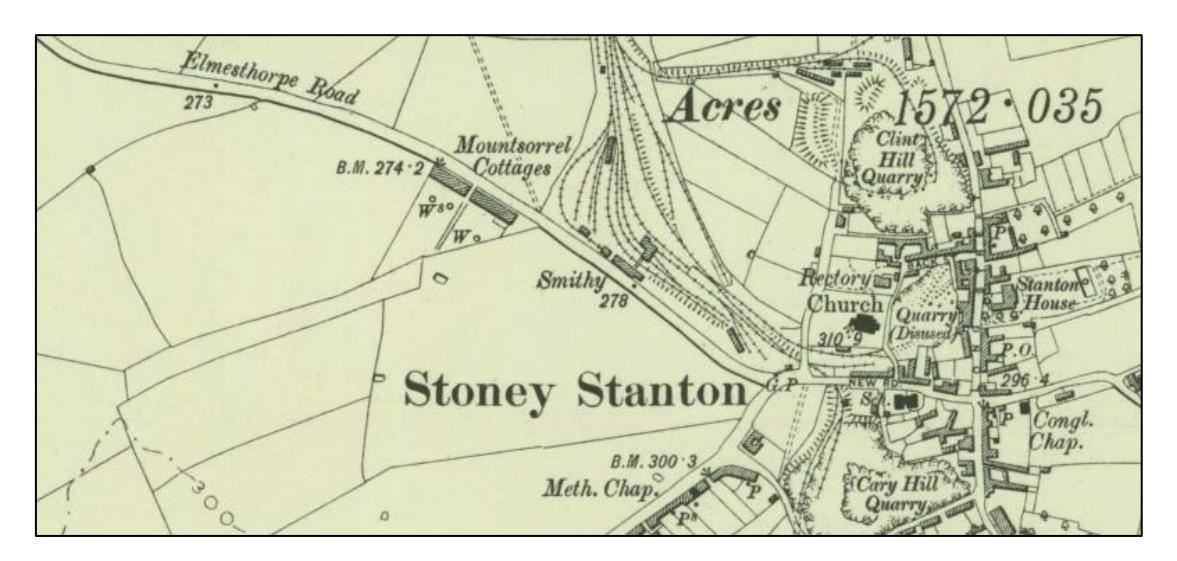
Figure 8: Historic map of Stoney Stanton indicating the likely watercourse to the rear of Mountsorrel Cottages and wells situated to the rear of the properties (Source: National Library of Scotland 1900's map).

Historic mapping from the 1900's indicates a watercourse existed to the rear of the Mountsorrel Cottages (watercourse B) in the form of the continuation of a boundary field drainage system (Figure 9). This mapping also indicates the existence of two wells situated in land to the rear of the Mountsorrel Cottages. Good groundwater resources close to ground level are indicative of a naturally occurring high groundwater level, attributable to naturally occurring geologies and local topography. The presence of the wells may indicate that the location is subject to high groundwater levels and that the flooding event on 1st October 2019 may have been exacerbated by the groundwater levels of the area, limiting the infiltration potential of the natural geology and exacerbating surface water flow routes within the sub-catchment.

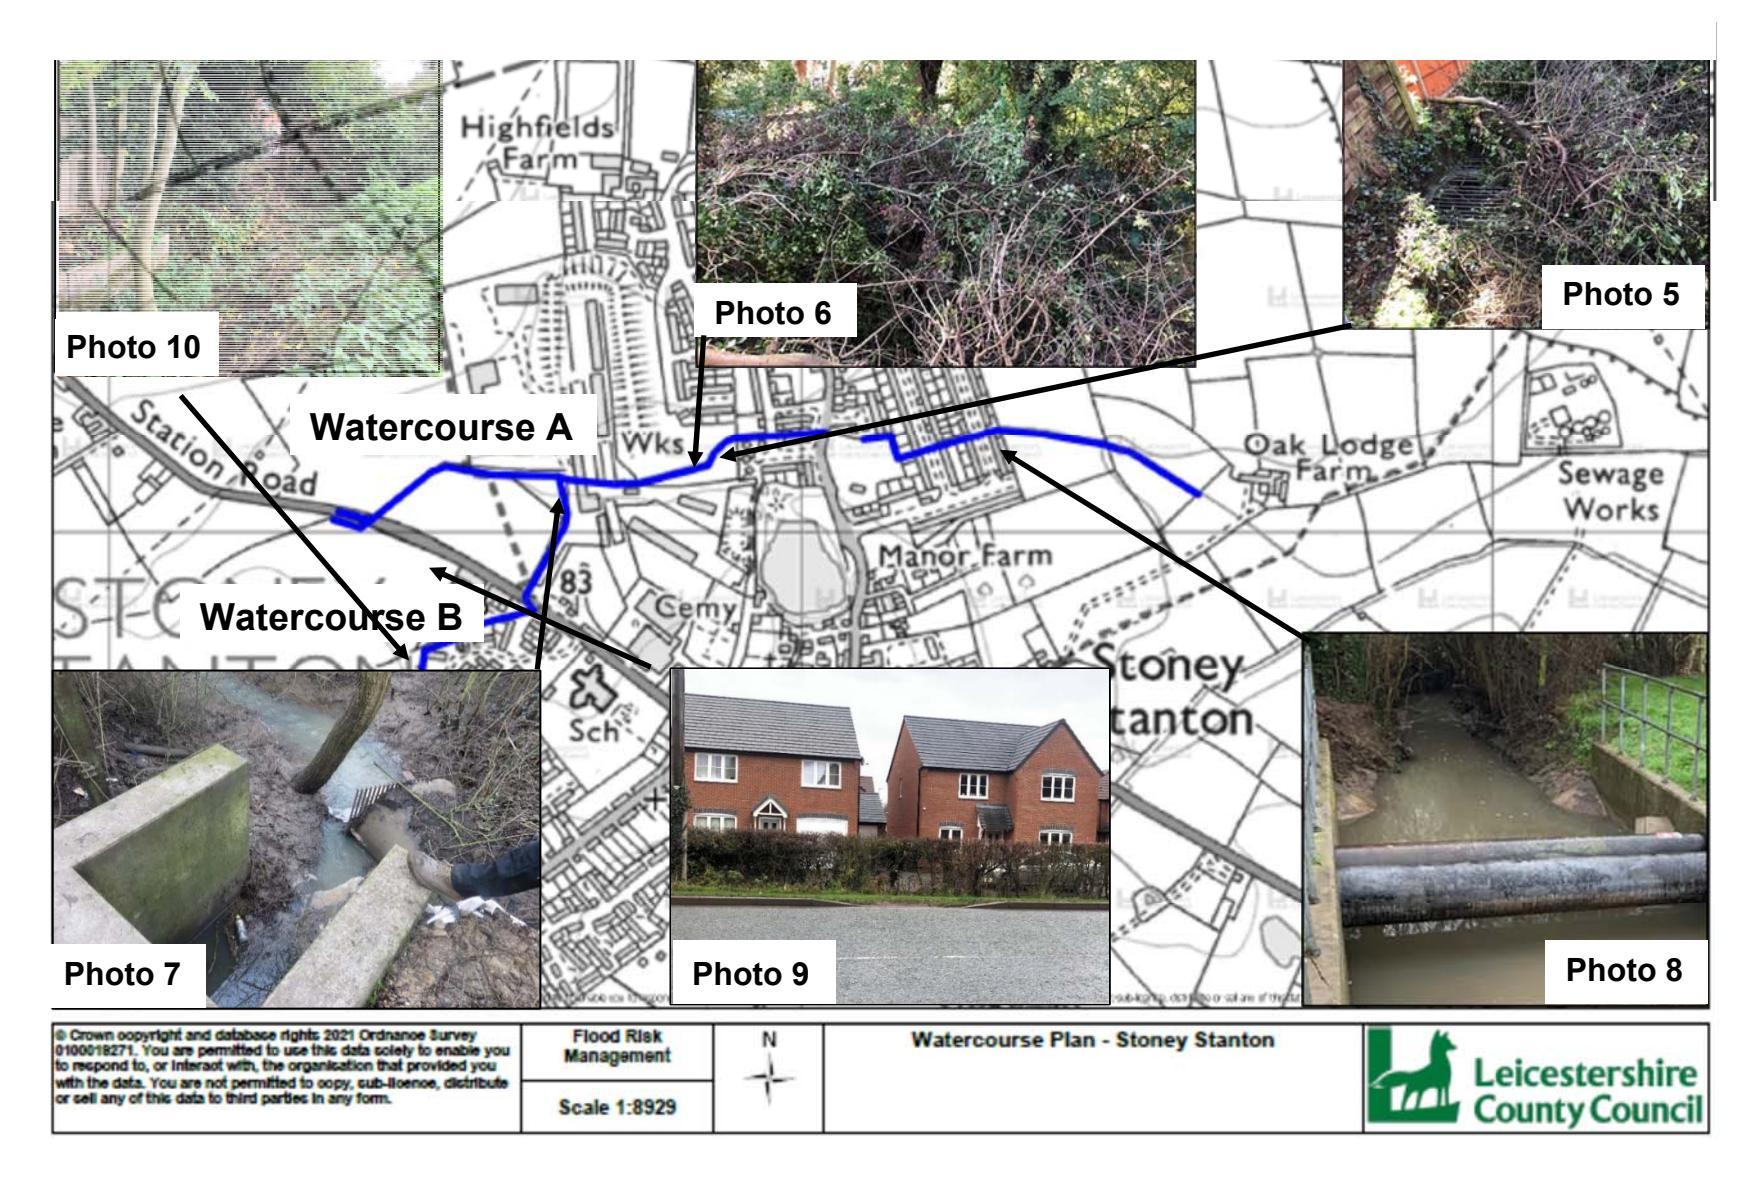
Figure 9: Summary of catchment features and obstructions within watercourse system during the flooding event.

- The trash screen at the culvert inlet adjacent to Meadow Close was found to be obstructed with debris after the flooding event (see Figure 9). This debris appears to have built up within the watercourse over an extensive period of time leading up to the flooding event. The open section of watercourse A in land upstream of the trash screen has also been identified to require maintenance as a result of vegetation growth and silt build-up (Figure 9). Despite the trash screen at the entrance culvert inlet being obstructed by debris at the time, water was described to have been able to make its way into the culvert via the top grating of the screen. Water was also described to have been exiting the culvert downstream at full capacity suggesting that the debris blockage of the screen was not the sole cause of the flooding at this location.

- Large sections of watercourse B have been found to be partially obstructed at various locations, with sections that had been completely filled in by riparian landowners. Various informal trash screens have also been identified along this section as previously mentioned in Section 2.2. The open chamber and 600mm upstream connection (opposite Mountsorrel Cottages) were also found to be partially buried due to silt deposition within the chamber and pipe.

There are many obstructions along the lengths of watercourse A and watercourse B which restrict/alter the flow of the watercourses including:

- Multiple informal trash screens that are not built to industry standards (as discussed in Section 2.2). This includes the junction of watercourse A and watercourse B where water is forced upstream before it can access watercourse A (refer to Photo 7).
- The restrictor plate located within watercourse A in the Foxbank Industrial Estate, downstream of the confluence of watercourse A and watercourse B (limited information is currently available on this structure).
- Fencing over sections of watercourse A (including upstream of Stressline).
- Piped sections of apparatus such as STW sewers, gas mains etc. Including at the most downstream sections of watercourse A (see Photo 8).
