# **FLOOD INVESTIGATION REPORT**

Investigation Ref:	54
Location:	Barrs Way, Mountsorrel
Date of Flooding:	1 <sup>st</sup> October 2019

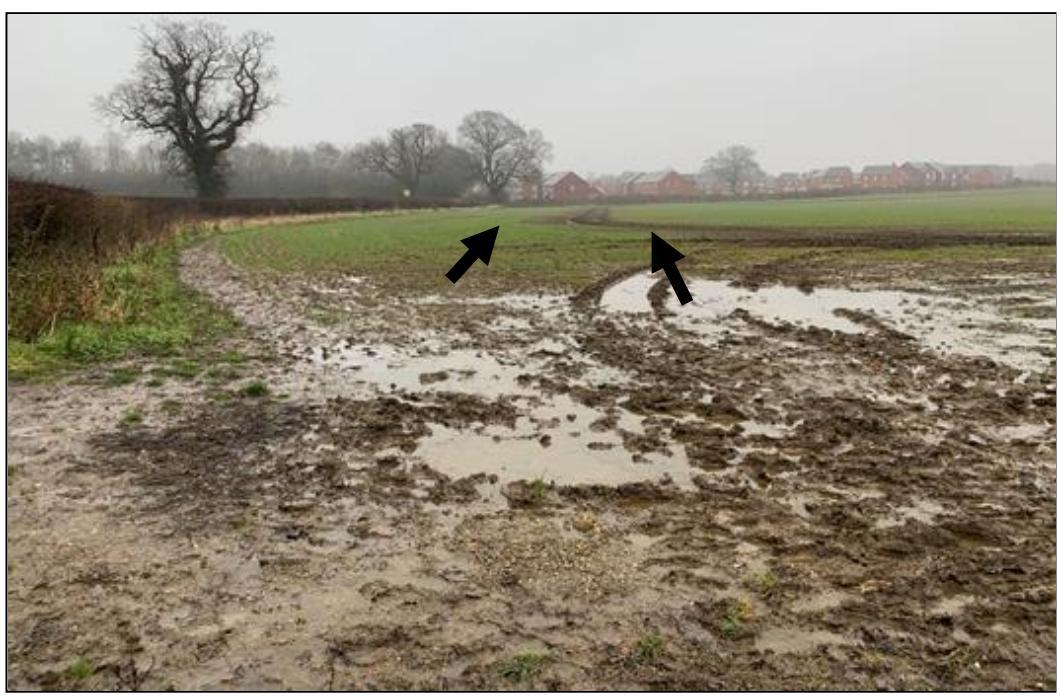
During the flood event, surface water was anecdotally reported as following the topography of the land and flowing in an easterly direction over agricultural fields towards the residential properties on Barrs Way (Photos 1, 2 and 3).

Photo 1: illustrating the low point of the affected residential properties in comparison to the agricultural field (photo taken during a site visit following the October 2019 flood event). Black arrows on the photograph indicate the direction of surface water flow

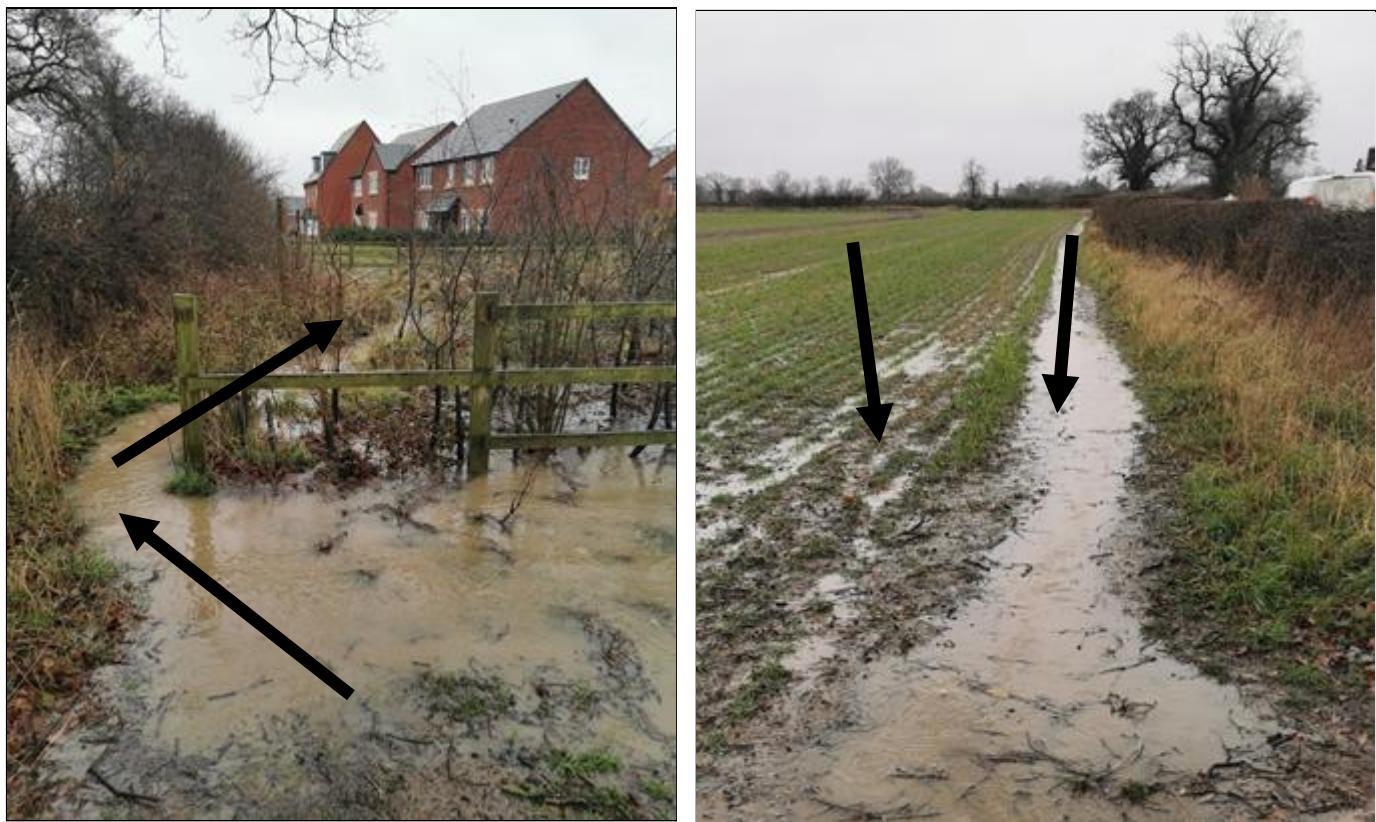
Photos 2 and 3 (left and right respectively): the surface water flow route, with the black arrows indicating the direction of flow, through the agricultural field adjacent to the impacted residential properties (these photos were taken during a site visit following the October 2019 flood event)

The volume of overland surface water flow towards the residential properties from the adjacent agricultural field was anecdotally reported as being exacerbated by obstructions within Ordinary Watercourse 4. The sheer volume of rainfall, along with the restrictions in Ordinary Watercourse 4, resulted in flood water exceeding the capacity of the ordinary watercourse and adding to the surface water flows heading east across the agricultural land (Figure 1). This volume of surface water was exacerbated by the volume of flood water exceeding the design capacity of the 100mm diameter UPVC and 225m diameter culvert system, creating additional overland surface water flows (Photo 2).

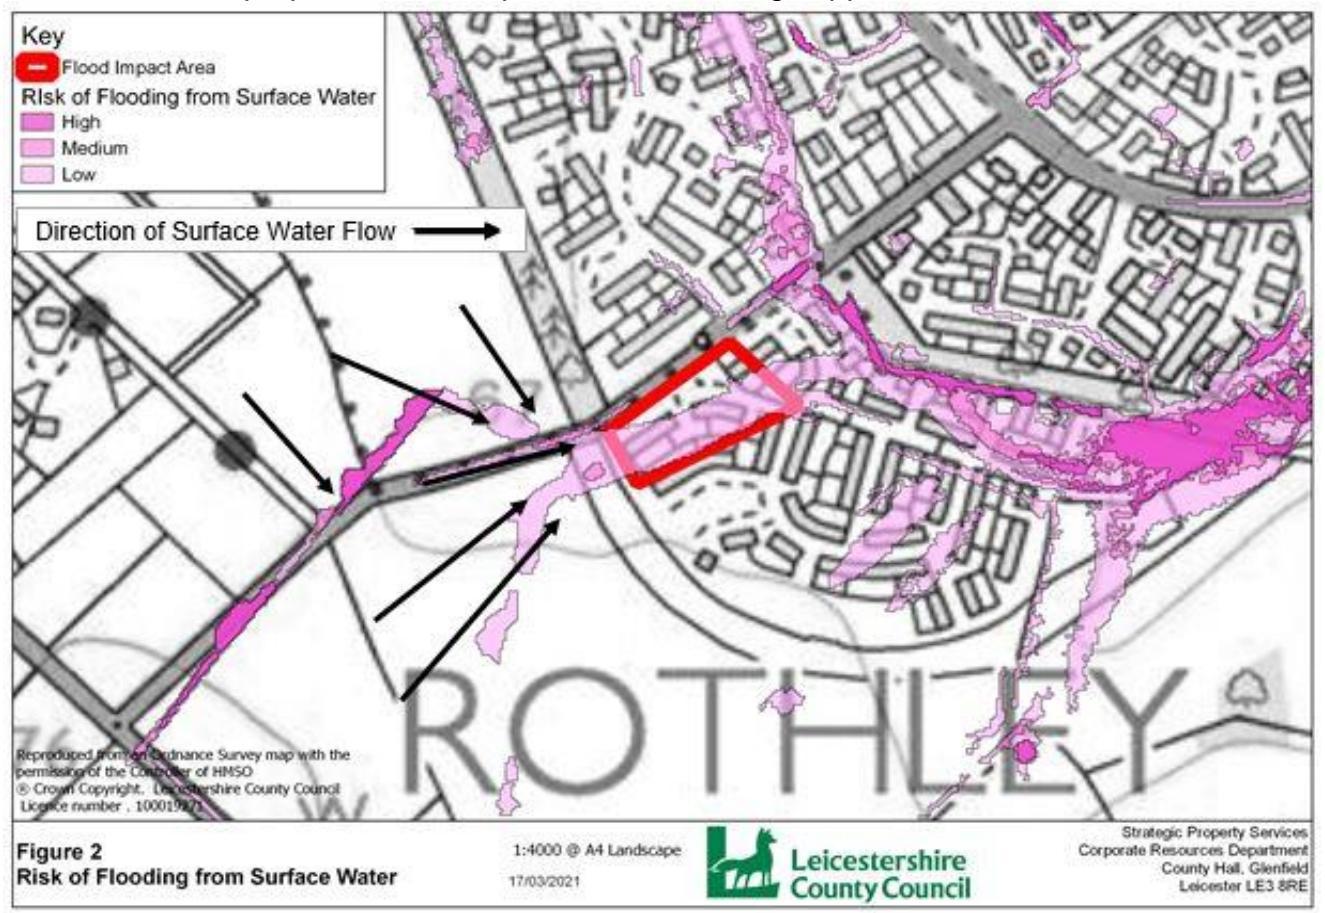
The Risk of Flooding from Surface Water Map (Figure 2) has been produced by the Environment Agency (EA) and is created using high level modelling which represents where water could flow and accumulate during certain rainfall events<sup>4</sup>. Anecdotal evidence indicates that overland surface water flowed in an easterly direction across the agricultural field adjacent to Barrs Way towards the affected residential properties; the output of this modelling supports this.

Figure 2 illustrates a low risk of surface water flooding (less than 300mm deep of flood water) to the affected residential properties. The flooding depths that affected the residential properties are anecdotally reported to have been higher than this. The modelling is high level (not designed to be accurate at the local level) and was completed in December 2013. Since the release of the model output, land heights have also changed around the housing development, and so the flow routes and depths predicted are also not entirely accurate. The modelling also does not consider property threshold levels, and therefore cannot accurately predict internal flooding.

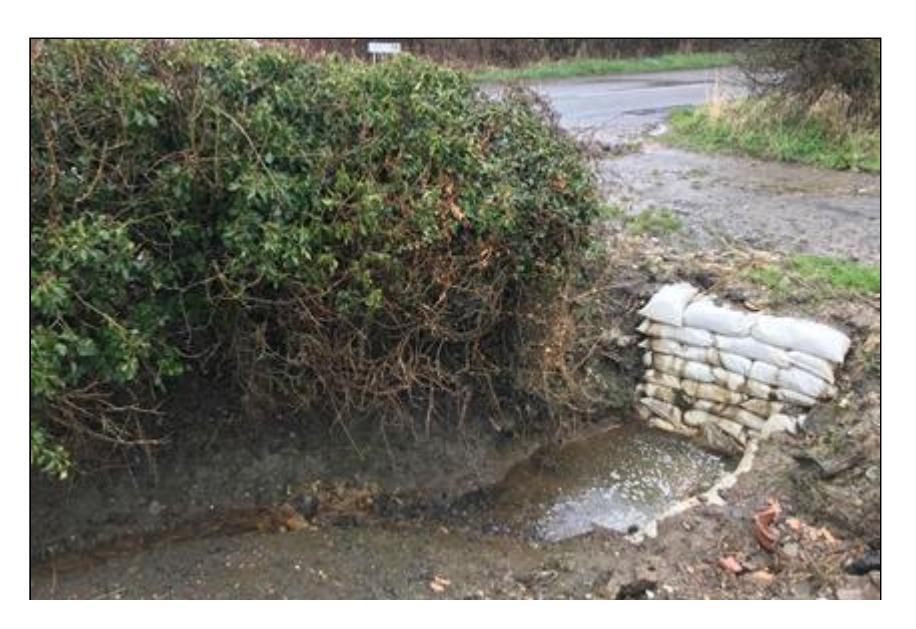
# Photo 4: 100mm diameter UPVC culvert inlet at the junction of West Cross Lane and Gipsy Lane (not visible as submerged beneath the sandbag headwall)

This 100mm diameter UPVC culvert connects with the 225mm diameter drainage system shortly downstream (Figure 1). At the time of the flooding incident, it is understood both these systems were heavily silted, with root ingress also found during investigations following the October 2019 flood event within the 225mm diameter drainage system. These restrictions would have likely contributed to the volume of flood water pooling on, and travelling down, West Cross Lane.

- The 100mm UPVC culvert was described to be partially impeded and requiring some maintenance. This culvert acted as a throttle and the sheer volume of water overwhelmed the upstream catch pit, subsequently adding to the volume of surface water on the agricultural field adjacent to Ordinary Watercourse 4. Given the amount of water which fell during the flood event, and the wider drainage issues, the maintenance impact is considered negligible.

The 100mm diameter UPVC pipe has been installed without consent from the Council and acts as a throttle. A review of this drainage system has concluded that upsizing this section for the access would bring negligible benefit to the downstream community. Since the flooding of 1<sup>st</sup> October 2019, the area has been affected by another very wet winter and this location has not contributed towards any flooding. If there were to be any benefit for upsizing this pipe, the whole network extent up to its discharge point into Ordinary Watercourse 1 would need to be upsized. This is considered to be cost-disproportionate to the negligible benefits brought.

- To log and progress a contravention of Section 23 of the Land Drainage Act (1991) for the infilling of Ordinary Watercourse 2 and the installation of the 100mm diameter UPVC pipe.

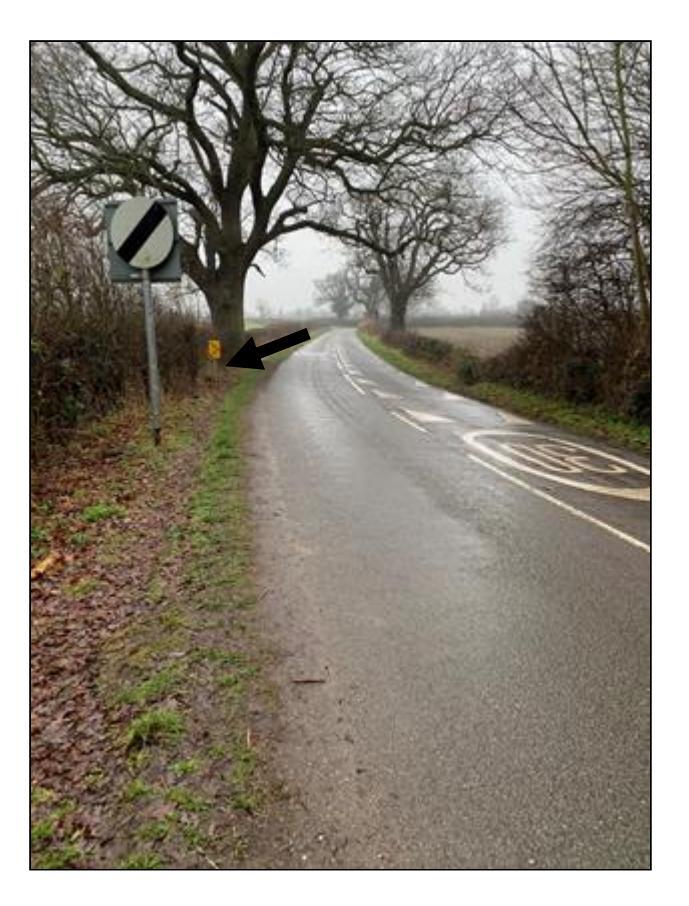
The impacted residential properties are located on land with a lower topography than West Cross Lane. Therefore, water on the highway flowed towards the impacted residential properties through a gap in the hedgerow (and dip in topography adjacent to the tree identified in Photo 5).

# Photo 5: West Cross Lane (facing west) with the arrow indicating a slope from the highway towards the hedge. There is a gap in the hedge around the tree and bare eroded soil.

- The Council has also raised the height level of land adjacent to West Cross Lane along the lowest points in the hedgerow to prevent flood water flowing into the agricultural field towards the residential properties.

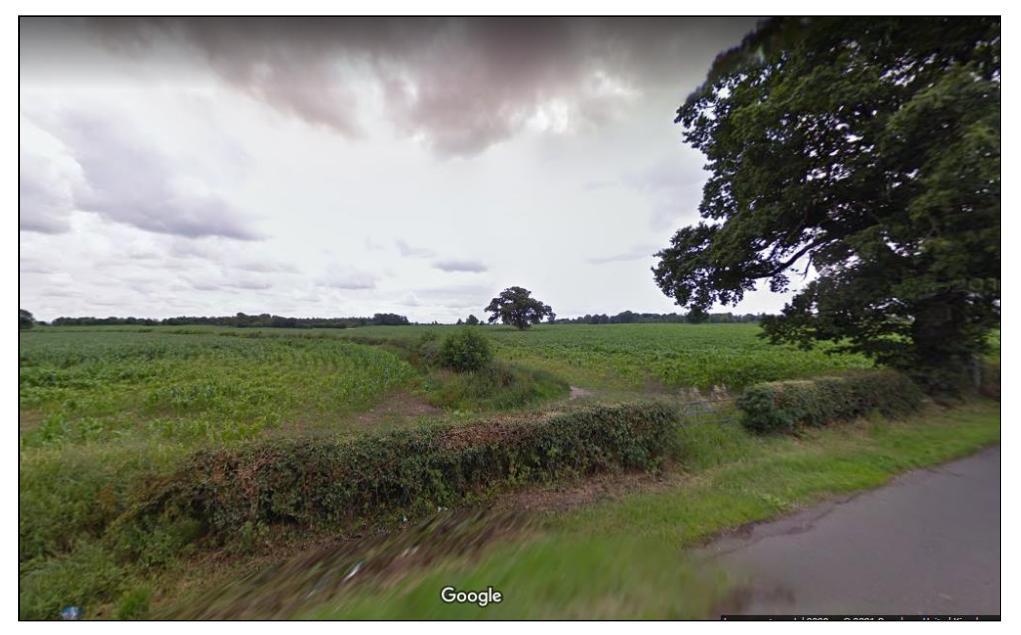
During this investigation it was identified that Ordinary Watercourse 2 existed prior to the Primrose Hill Estate (Photos 6 and 7). Ordinary Watercourse 2 was acknowledged in the site-specific Flood Risk Assessment produced by the developer, which stated that the Ordinary Watercourse 2 was dry during the time of a site inspection for the assessment. Following site visits after the flood event, it has been established that Ordinary Watercourse 2 has been infilled, however some parts of the existing hedge line remains as part of the new development. Under Section 23 of the Land Drainage Act (1991), these works would have required consent from the Lead Consent Body (the Council). The Council has not consented these works, and so they have been recorded as unconsented. The Council is working with the developer (Persimmon Homes) to resolve this matter.

Prior to the development of the site, Ordinary Watercourse 2 would have likely provided a key route for flood water to get away during a flood event. There is currently no route for this flood water, other than through the residential properties on Barrs Way. The infilling of Ordinary Watercourse 2 and the development of Primrose Hill Estate therefore interferes with the initial flow path of surface water (Figure 1) explaining why the flood water was described to pool to depths greater than the predicted depths of less than 300mm (Figure 2).

Photo 6: West Cross Lane (facing south) prior to the Primrose Hill Estate development. The change in vegetation within the field indicates the ditch line of Ordinary Watercourse 2 (Photo from 2009, taken from Google Maps)

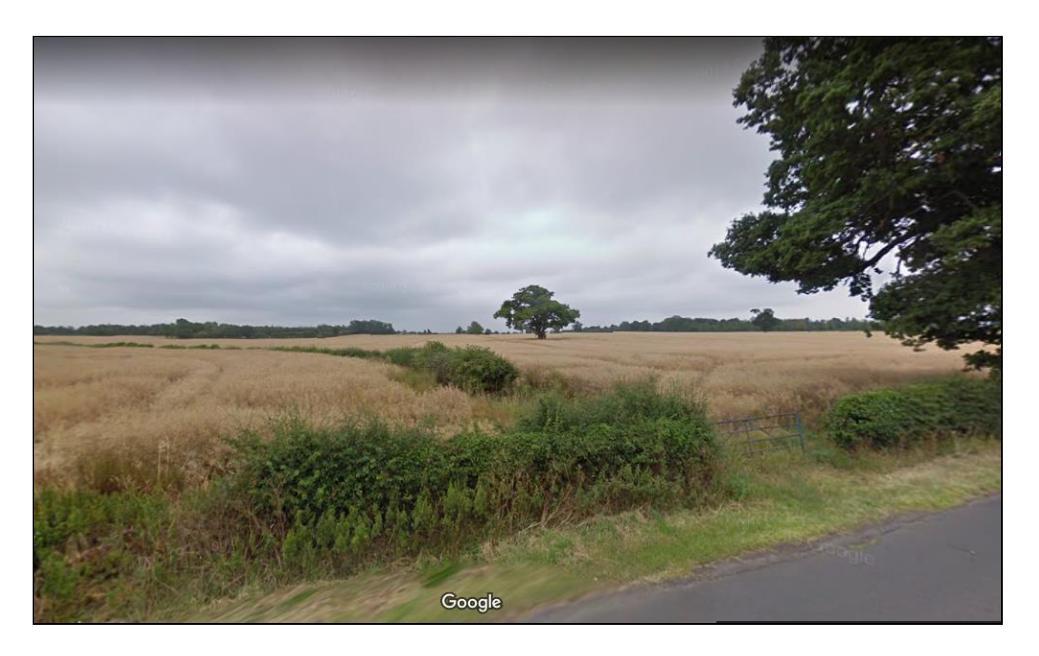
Photo 7: West Cross Lane (facing south) prior to the Primrose Hill Estate development. The change in vegetation within the field indicates the ditch line of Ordinary Watercourse 2 (Photo from 2009, taken from Google Maps)

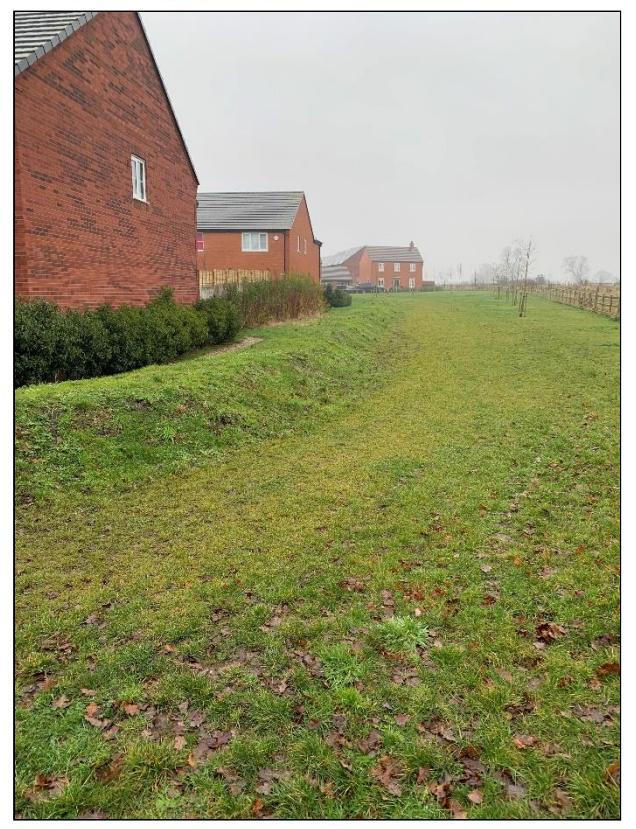
- The filter drain installed around the extent of the worst affected residential property is believed to be connected to the development sites unadopted surface water drainage. STW would not adopt the development sites drainage with this connection due to the existing systems not being designed to take unquantified volumes of land drainage.

Photo 7: the bund from a south westerly direction and the filter drain is visible in the centre of the photo.

- To liaise with STW and Persimmon Homes regarding the filter drain and its connection to the development's unadopted surface water drainage system.
- To investigate ways to help prevent overland surface water flows from the adjacent agricultural field to the north of West Cross Lane, along Ordinary Watercourse 3, flowing onto West Cross Lane.

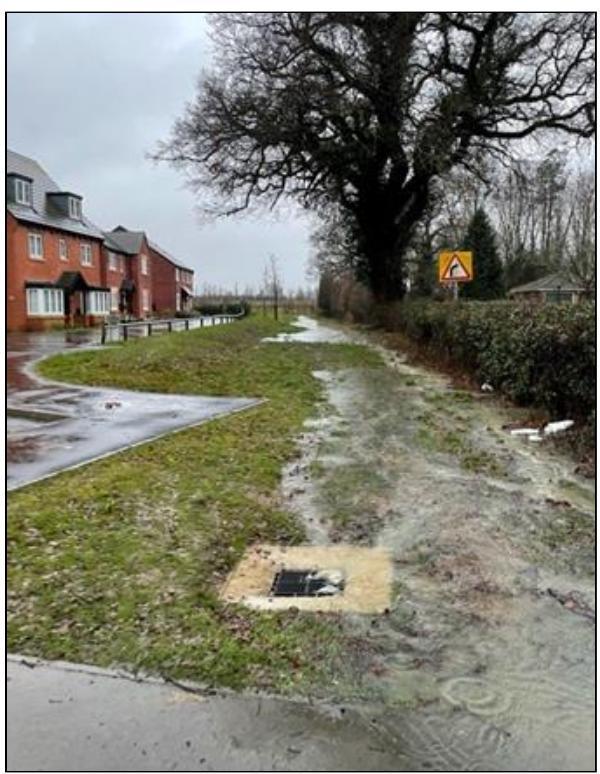
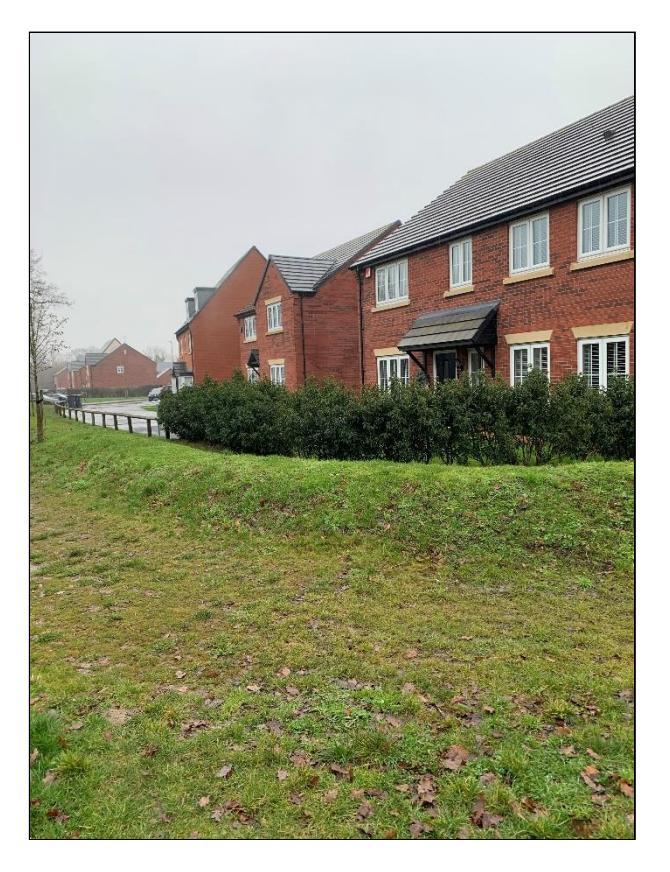
- The informal bund constructed by Persimmon Homes which extends around the affected residential properties does not have planning permission. There is no plan in place for who would adopt and maintain the structure and it has not been constructed to an engineered specification. The bund is eroding and shrinking and is an eye sore. It is agreed by all RMAs that the bund should stay in place until a long-term solution is identified as it does provide some benefit. The bund has been witnessed to prevent residential properties from internally flooding during Winter 2020/21, however the flood water is being directed onto the highway (Photos 7, 8, 9 and 10).

Photo 8: the bund from a westerly direction in front of the impacted residential properties.

- To work with all RMAs to understand the flooding mechanisms and identify ways to help mitigate future flooding.
- To work with all RMAs to alleviate the concerns relating to the informal bund.

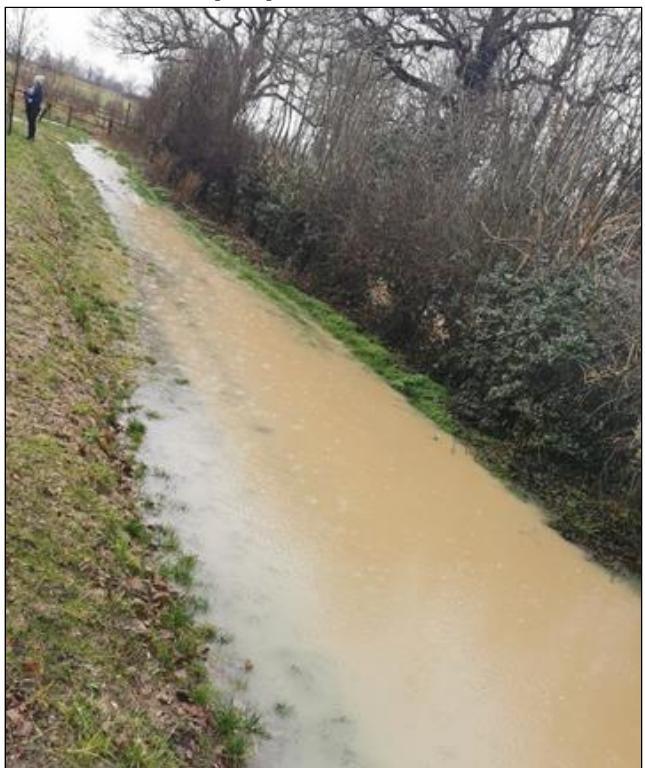
Photos 9 and 10 (left to right respectively); the earth bund constructed between Barrs Way and West Cross Lane with the aim of diverting overland surface water flows from the adjacent agricultural field. These photos were taken of the bund following the event in January 2021.
