Flood Investigation Report

Storm Henk

2nd January 2024

Broughton Astley

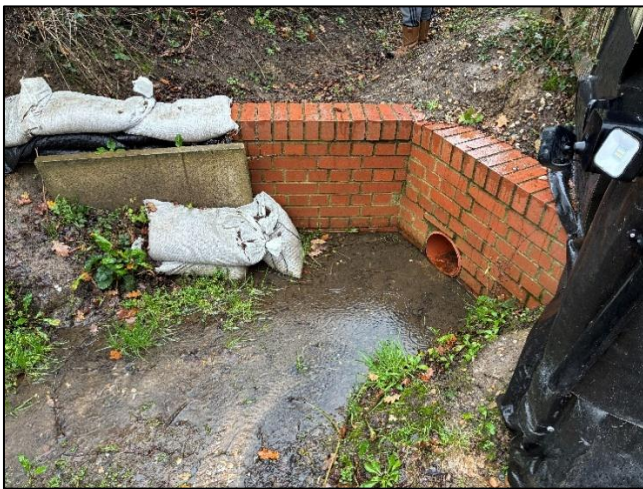
Here, surface water enters a 225mm diameter culvert pipe (Photograph 4-1), which flows under the rear garden of 20 Fretter Close and then under neighbouring rear gardens. During high flows, the pipe capacity is exceeded (Photograph 4-2) and surface water overtops into a higher-level ditch between 29 Dunton Road and 20 Fretter Close. The higher-level ditch enters a 225mm culvert pipe (Photograph 4-3), which eventually enters a manhole and turns right (Photograph 4-4) under the Fretter Close development and passes across the front of several properties along Fretter Close.

Photograph 4-1: 225mm dia culvert inlet during low flow conditions – December 2025

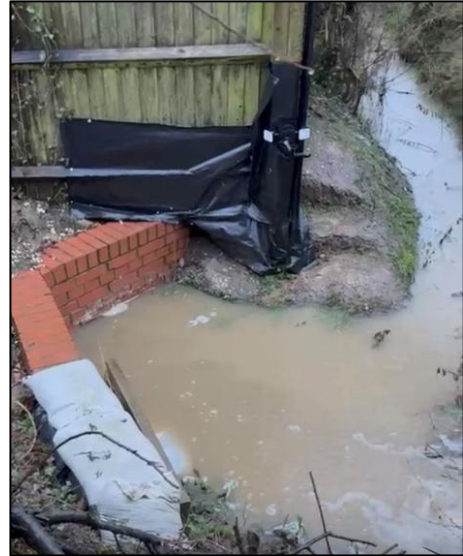
(Note not during the Storm Henk event but during wet weather February 2026)

Photograph 4-2: 225mm dia culvert inlet submerged during wet weather – February 2026

The capacity of the private 225mm pipe to the rear of 20 Fretter Close and 29 Dunton Road was quickly exceeded. The arrangements described above (Section 0 ‘Drainage Ditches to the West of Fretter Close’) cause water to enter a higher-level overflow ditch and then into a second 225mm pipe between the two properties (as illustrated in **Error! Reference source not found.**). Photographic and video evidence submitted as part of the investigation, shows clearly that the second 225mm pipe became overwhelmed.

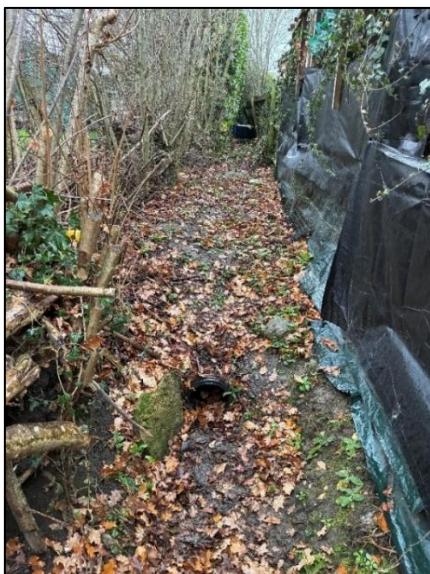
Photograph 4-3: High-level ditch / culvert – December 2025

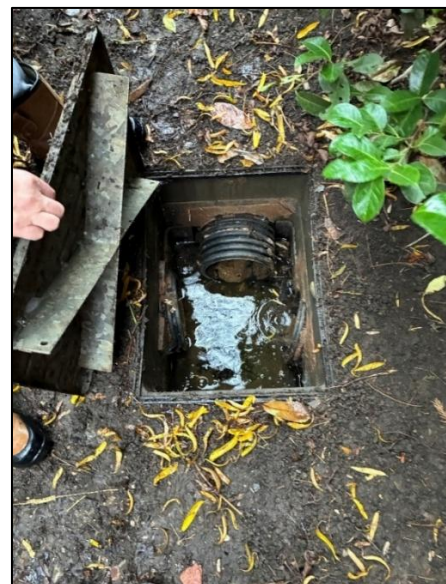
Photograph 4-4: Inspection chamber where high-level piped ditch ends before turning right into Fretter Close

Due to a lack of available evidence, it has not been possible to conclusively establish whether this was due to hydraulic overload or blockage within the second pipe, however, anecdotal reports advise that water levels quickly subsided when a member of the public lifted a private access cover, where the 225mm pipe changes direction. This may suggest a restriction or blockage was present in the culvert upstream of the access cover, although LCC, as Lead Local Flood Authority (LLFA), has not identified any further evidence to date to verify this.
