Flood Investigation Report

Storm Henk

2nd January 2024

Cosby

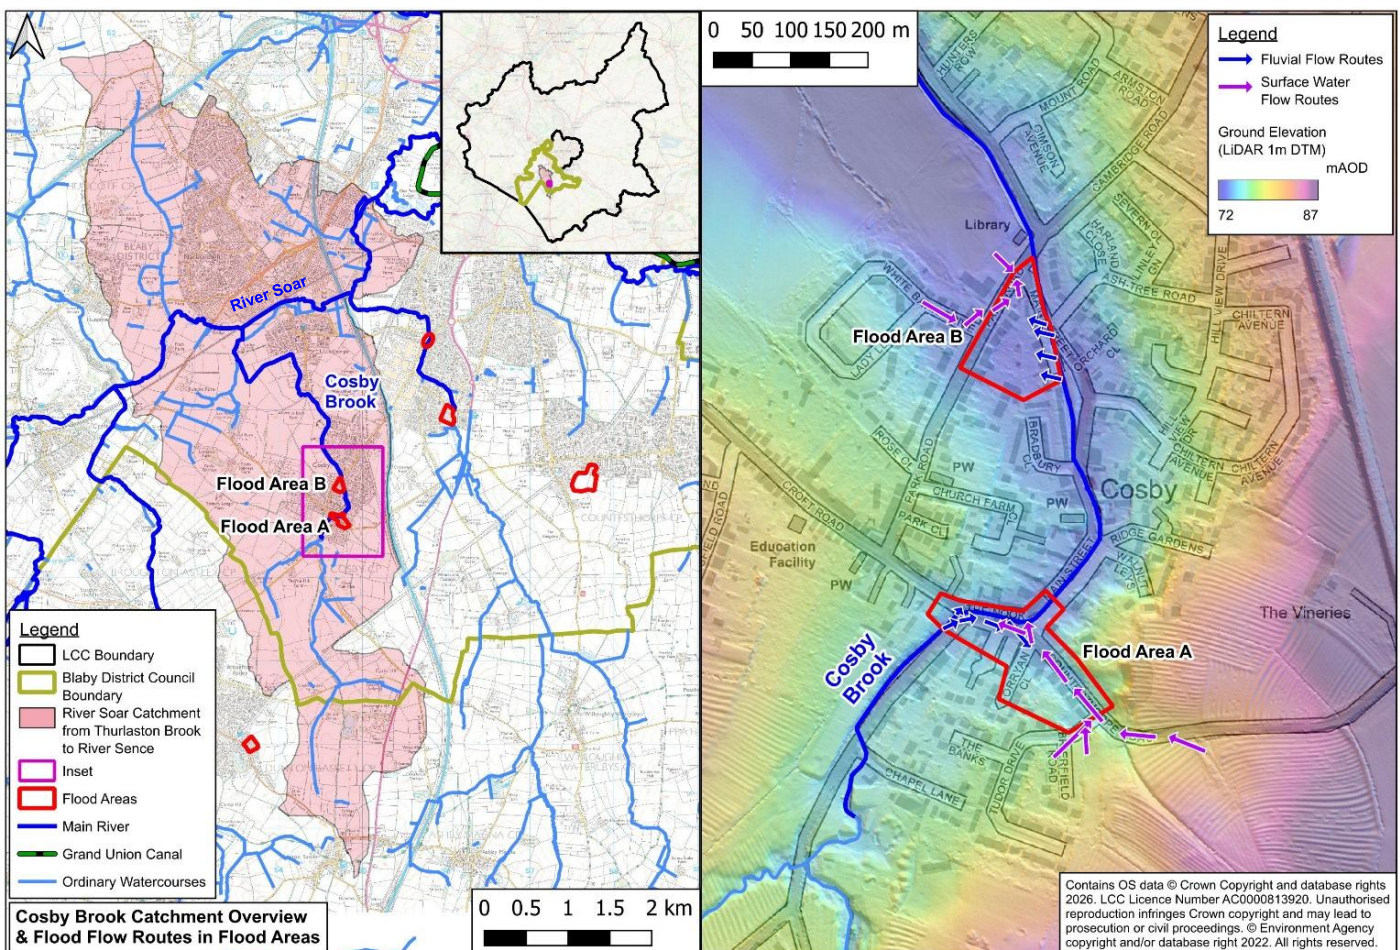
Figure 14-1: Cosby Location Plan, relevant Watercourse Catchment and Flow Routes through Flood Areas (INSET 1)

The Cosby Brook, a statutory Main River designated by the Environment Agency (EA) flows northwards through the centre of the village. Cosby Brook is a tributary of the River Soar (also designated as a Main River) and their confluence is located downstream of Station Road at Narborough (as illustrated in Figure 14-1) at Ordnance Survey national grid reference SP 54123 97296. The responsible agency for managing the risk from Main Rivers is the EA. Details relating to RMA responsibilities can be found in Section 21 of the main Storm Henk report. The properties that experienced internal flooding within Cosby during Storm Henk are located within Flood Areas A and B illustrated in Figure 14-1.

Flood Area A is located to the east of Cosby Brook at the upstream extent of the village, where the channel runs in close proximity to residential properties and a number of small businesses. During Storm Henk, river water in Cosby Brook rose, exceeded the bank capacity and spread laterally along The Nook and Countesthorpe Road as illustrated by the flow route arrows in Figure 14-1, leading to internal flooding of two business properties as their property thresholds were exceeded.

Overland flow of surface water runoff, generated by intense rainfall accumulating on the highway and adjacent land, also progressed downslope northwards along Tudor Drive toward the low point at its junction with Countesthorpe Road and intersected with the out-of-bank flows from Cosby Brook. This is consistent with the predicted flow routes mapped within the EA's RoFSW map (Figure 14-1).

Flood Area B is located further downstream and falls to the west of Cosby Brook between Main Street and Park Road as illustrated in Figure 14-1. In this area, the brook passes northwards within the village through a narrower corridor, with numerous residential properties and gardens within close proximity. Flooding in this area is understood to have occurred as river levels rose and flows exceeded the bank capacity, causing floodwater to flow along low-lying routes of Main Street and Burley Close located immediately adjacent to the brook, as illustrated by the flow route arrows in Figure 14-1. The depth of flooding resulted in external property flooding to at least one property.

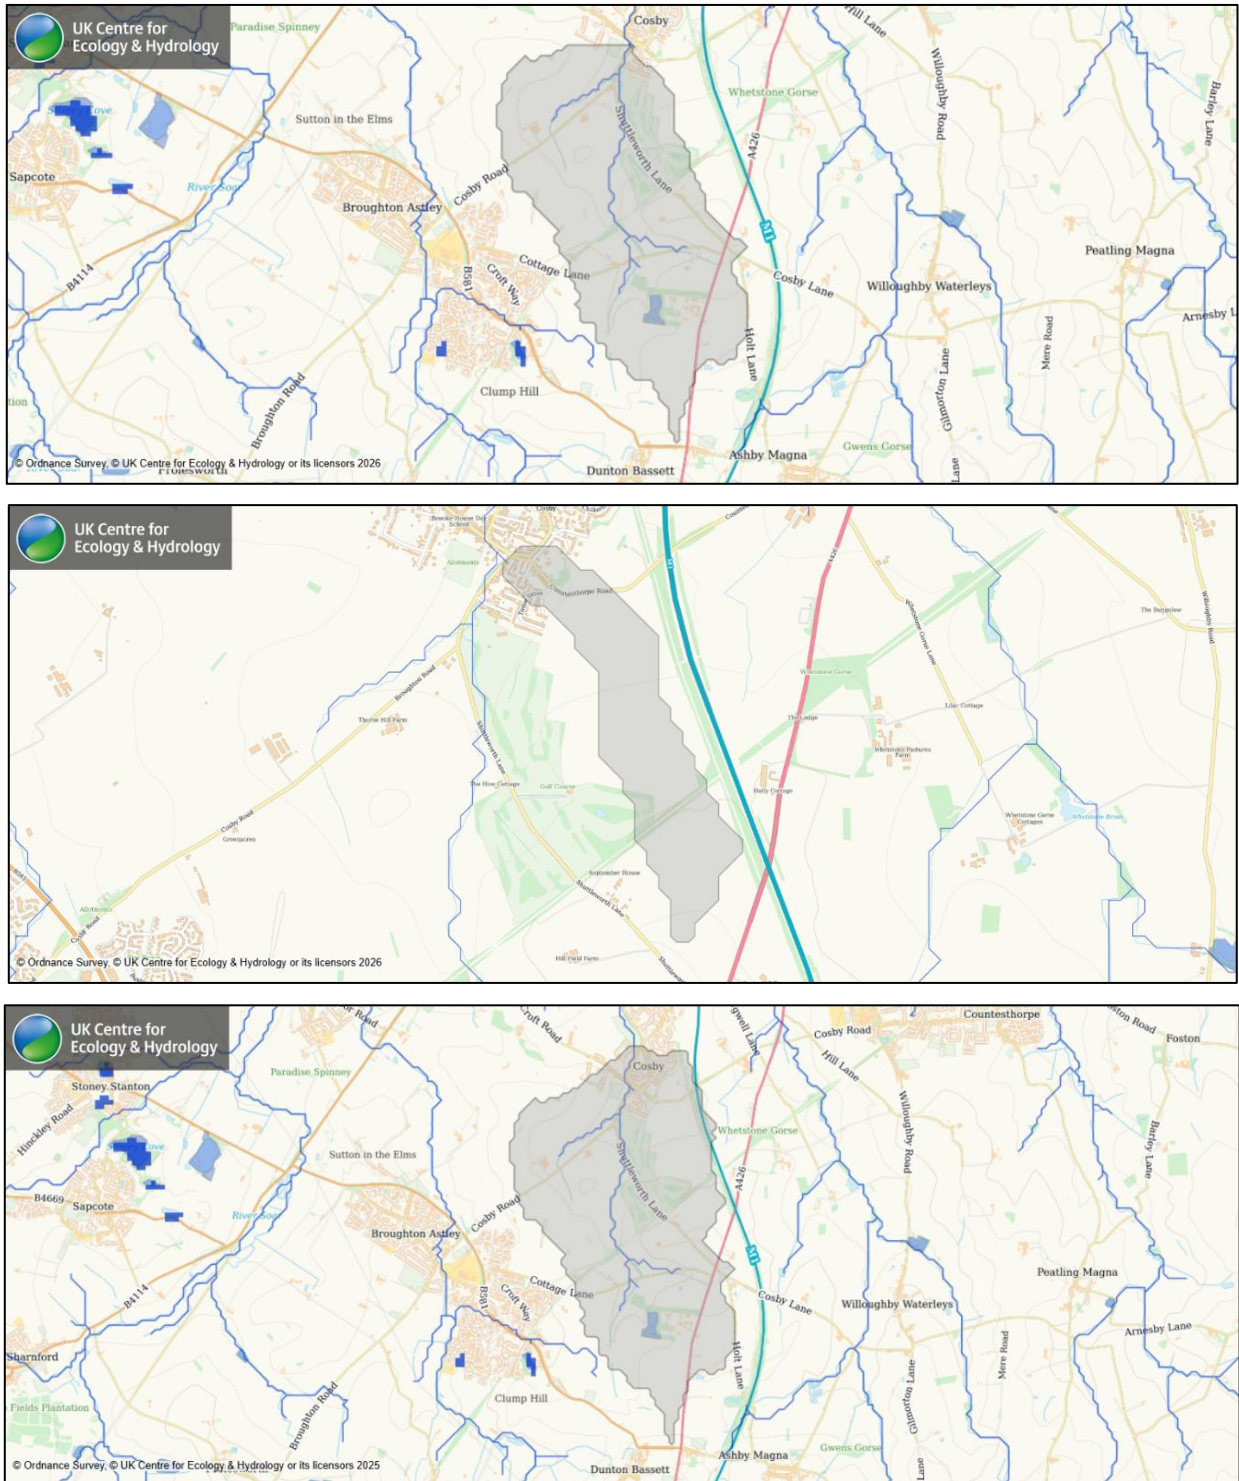
Figure 14-2: Cosby Brook FEH Web Service Catchment Extents upstream of The Nook (top), eastern un-named tributary (middle) and at Main Road (bottom)

The UK Centre for Ecology & Hydrology’s Flood Estimate Handbook (FEH) Web Service¹ provides strategic level catchment mapping. This identifies that the brook drains a catchment of approximately 10.6km² to its confluence with the River Soar.

At The Nook in Cosby (upstream extent of Flood Area A) the catchment area is 4.97km² and the catchment area of a joining un-named tributary ordinary watercourse from the east is 0.51km², as illustrated in Figure 14-2. The catchment area increases to 6.05km² at Main Road at the downstream extent of Flood Area B as illustrated in Figure 14-2.

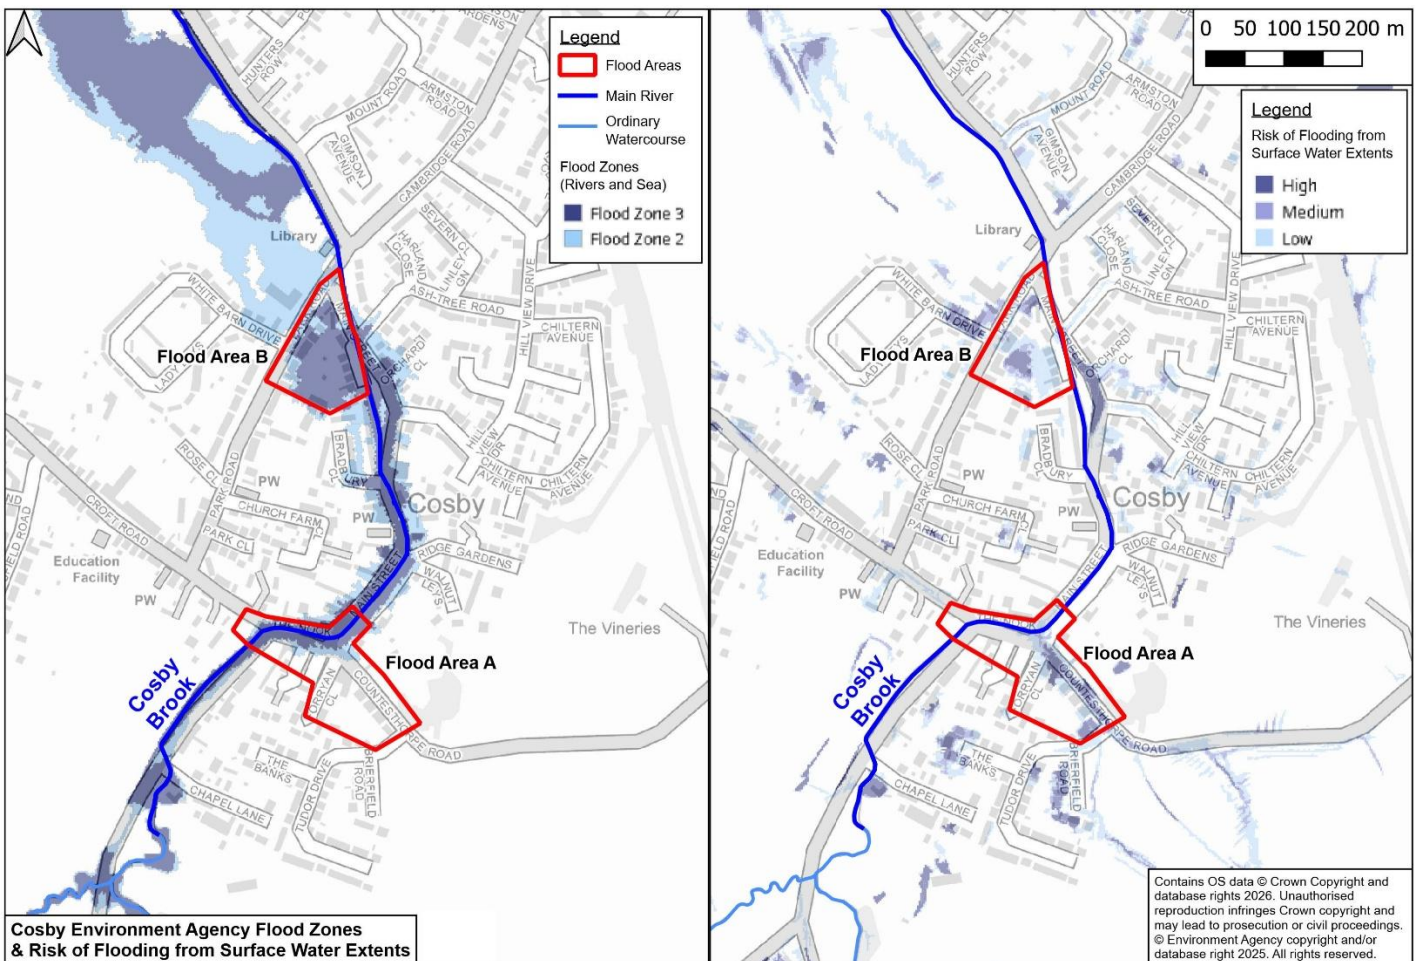
Figure 14-3: Cosby EA Flood Map for Planning Flood Zones³ and Risk of Flooding from Surface Water Extents⁴ in Flood Areas (INSET 11)

The EA’s Flood Map for Planning Flood Zone map (NaFRA2) (Figure 14-3) identifies Flood Zones 2 and 3 associated with Cosby Brook extending into parts of the village adjacent to the brook along The Nook, Main Street and Burley Close. Properties and land within these areas are therefore recognised as being at an existing high and medium risk of flooding from Cosby Brook during periods of high flow.

The EA’s Risk of Flooding from Surface Water (RoFSW) map (NaFRA2) (Figure 14-3) identifies areas at high, medium and low risk particularly along Countesthorpe Road, and Main Street around its junction with Burley Close.

Due to the already elevated water levels within Cosby Brook, the additional intense and sustained rainfall associated with Storm Henk caused the levels in Cosby Brook to rise rapidly. The amount of water in the brook exceeded the channel’s capacity which led to overflowing and out-of-bank flows onto adjacent land through the village at locations consistent with the routing of the mapped EA Flood Zones (see Figure 14-3).

There is no evidence to suggest that the flooding was caused or materially exacerbated by river maintenance issues, asset failure, or third-party works. The flooding observed was consistent with the volume of water overwhelming the watercourse channel and bank thresholds overtopping during a high-magnitude event (matching predicted river flooding as per Figure 14-3), and drainage networks becoming overwhelmed, rather than a failure of existing infrastructure.

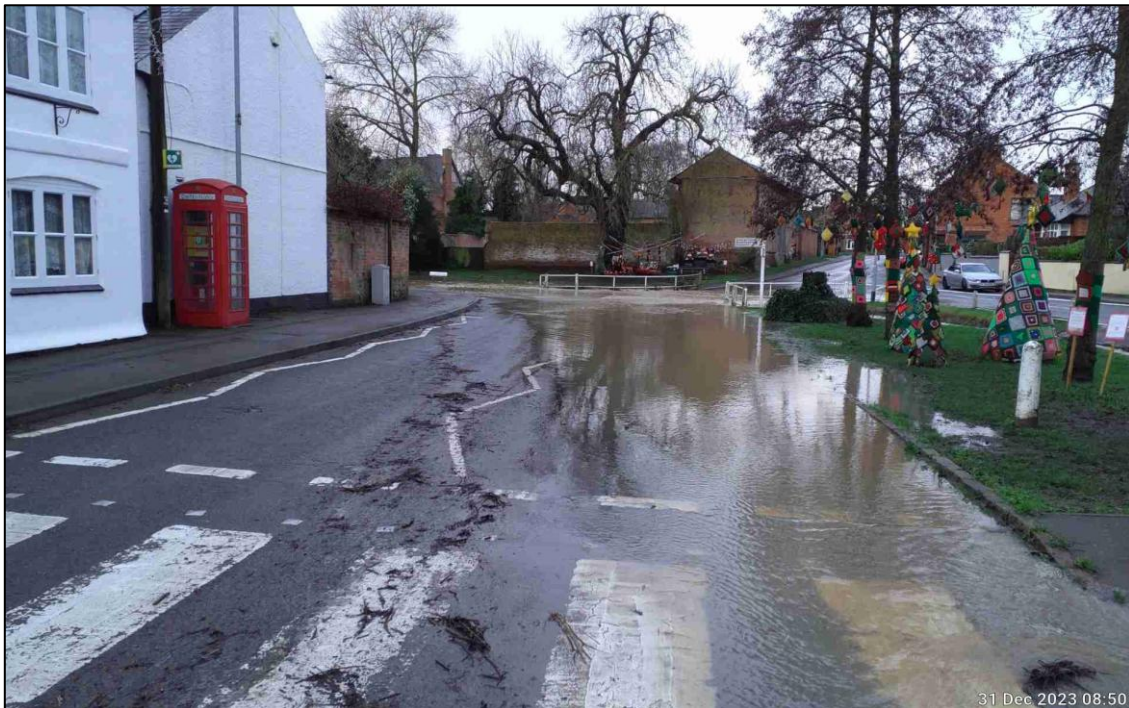
In the period leading up to Storm Henk, the area experienced prolonged rainfall, which resulted in elevated water levels within Cosby Brook. On 31st December 2023, prior to the onset of Storm Henk, Cosby Brook overtopped its banks, leading to localised highway flooding on The Nook as shown in Photograph 14-1 and Photograph 14-2. In response, Leicestershire County Council (LCC) as the Local Highways Authority (LHA) raised out-of-hours reactive jobs to inspect affected locations, deploy Flood Warning signage, and clear highway gullies where practicable.

Photograph 14-1: View from the Nook on 31st December 2023, looking towards the junction with Broughton Road and Croft Road.

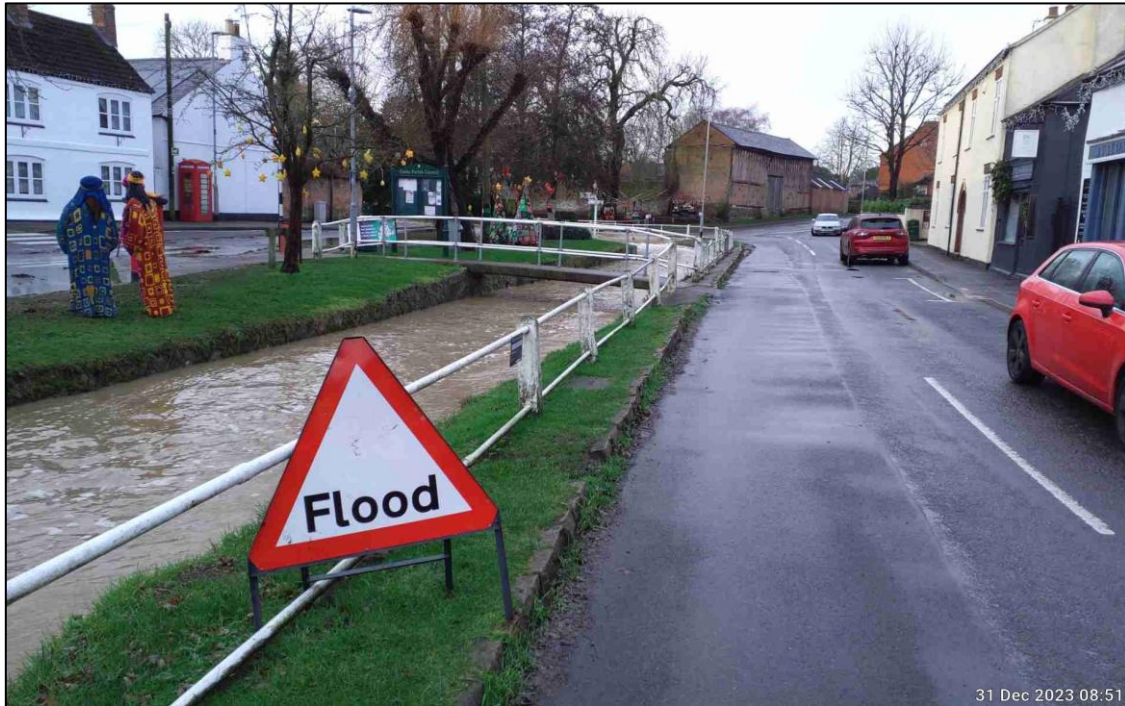
Photograph 14-2: View from the Nook on 31st December 2023, looking towards the junction with Croft Road
