Flood Investigation Report

Storm Henk

2nd January 2024

Countesthorpe

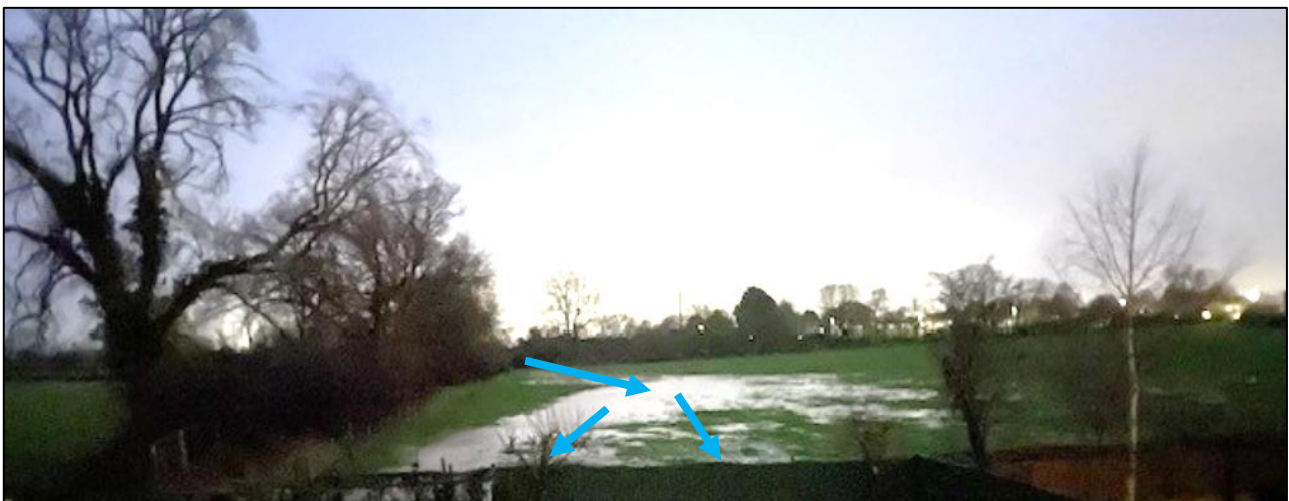
A culverted field access over the watercourse (Location A on Figure 5-1), between the two fields also reportedly became overwhelmed with the volume of water. This caused water to back up and overtop the culvert parapet/upstream face onto the bridge deck.

Photograph 5-1: View from Mennecy Close - Overland floodwater flowing north towards Mennecy Close after flowing out of bank at Location A

Due to the local ground elevations (topography), these exceedance flows were unable to re-enter the watercourse on the northern side, and instead, followed the lower-level contours of the field in a separate surface water flow route parallel to the land drainage channel. These flow routes, illustrated in Figure 5-1, proceeded northwards towards Mennecy Close and pooled and entered properties, causing internal flooding. The flow routes coincide with the modelled substantial surface water flow path identified in the EA's RoFSW (NaFRA2) map shown in Figure 5-3, but the observed extents were smaller than those identified as at high risk of surface water flooding.
