# **Flood Investigation Report**

Storm Henk

2<sup>nd</sup> January 2024

**Sileby**

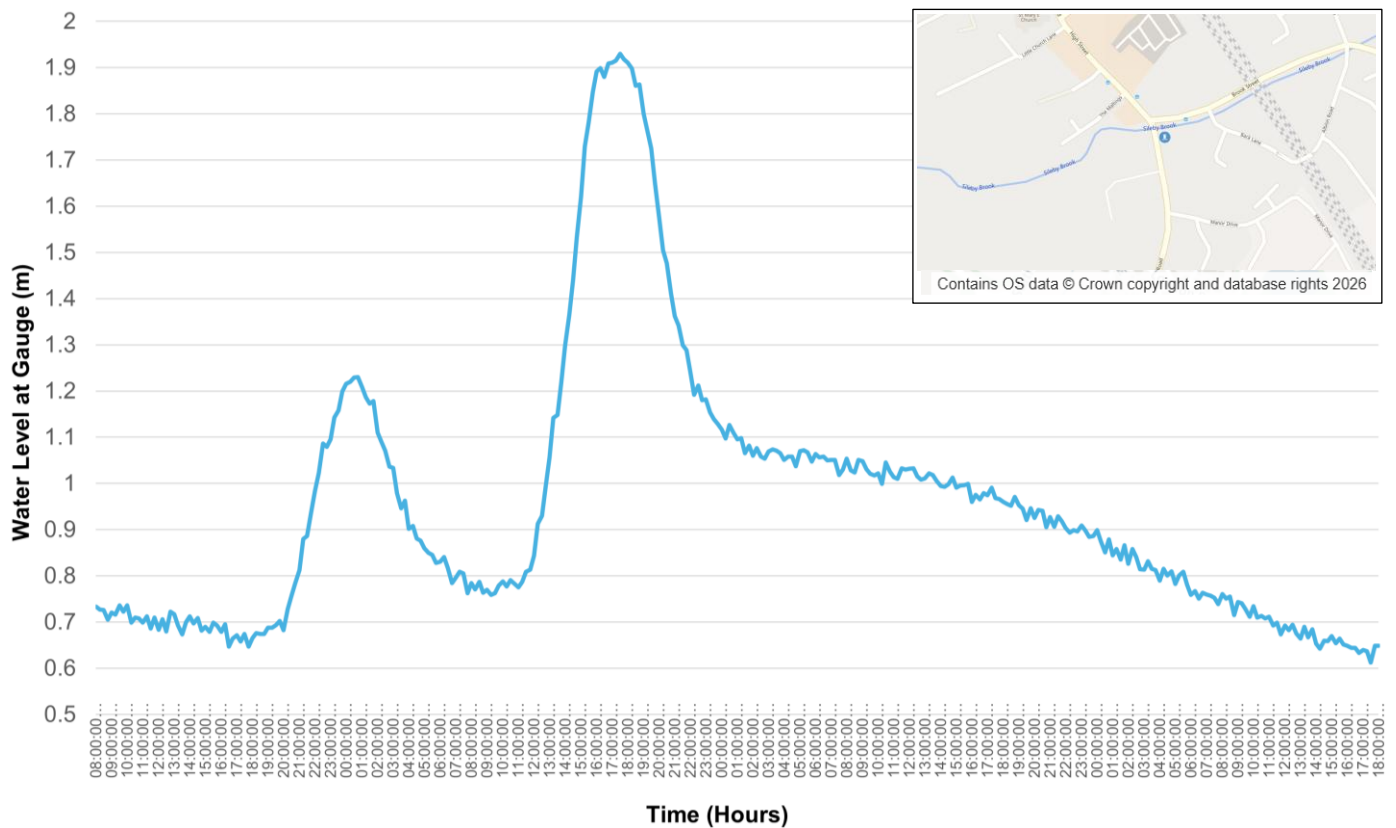
Figure 18-4: Sileby Brook at Silby Gauge (Station ID 4254<sup>8</sup>) Water Level from 08:00 hours on 01/01/2024 to 18:00 hours on 04/01/2024

Levels in Sileby Brook at Cossington Road were already higher than normal levels following rainfall in the preceding days to 2<sup>nd</sup> January 2024. Levels then responded quickly to rainfall, rising further from mid-morning as illustrated in Figure 18-4, peaking at 17:30hrs on Monday 2<sup>nd</sup> at 1.93 metres above the gauge station datum (mASD), only 0.04m lower than the record level recorded during Storm Dennis (16<sup>th</sup> February 2020).

The short duration of the peak on the hydrograph is reflective of the low permeability of the geological composition which produces flashy runoff as witnessed during the Storm Henk event.

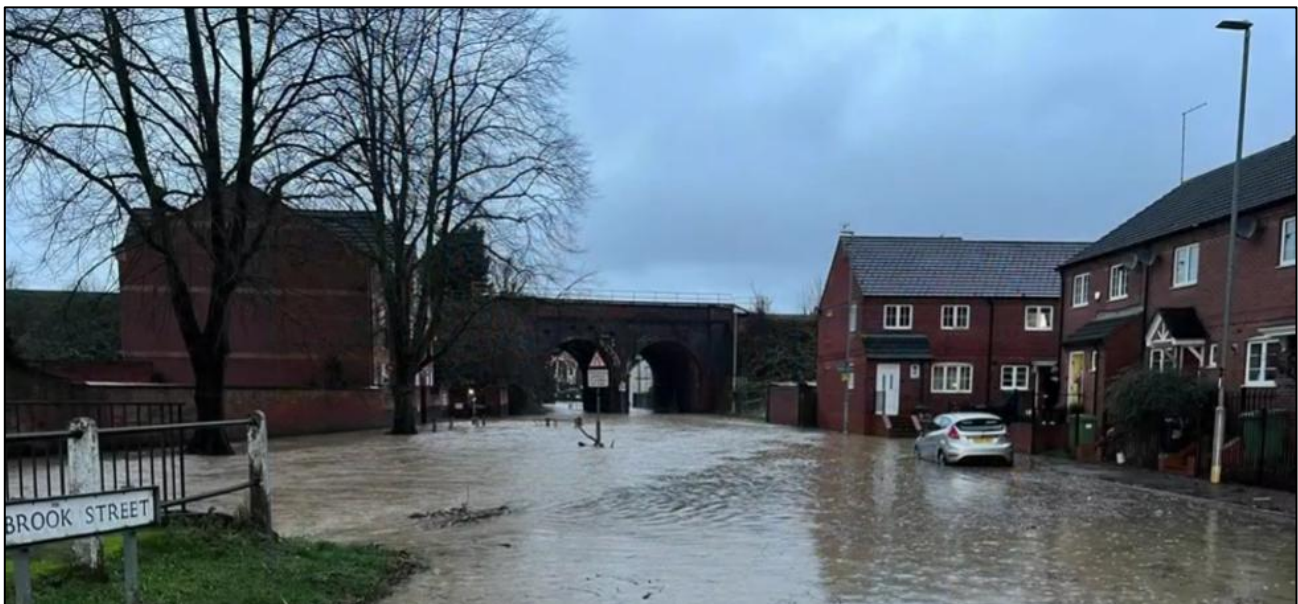
Flooding from Sileby Brook is reported to have started at around 15:00hrs at both Cygnet Close (Flood Area A) depicted in Photograph 188-1 and Brook Street (Flood Area B). Reported flood extents were similar to those predicted by national flood risk mapping (Figure 18-3).

**Photograph 188-1: Sileby Brook flooding along Brook Street, looking south towards railway arches<sup>9</sup>**

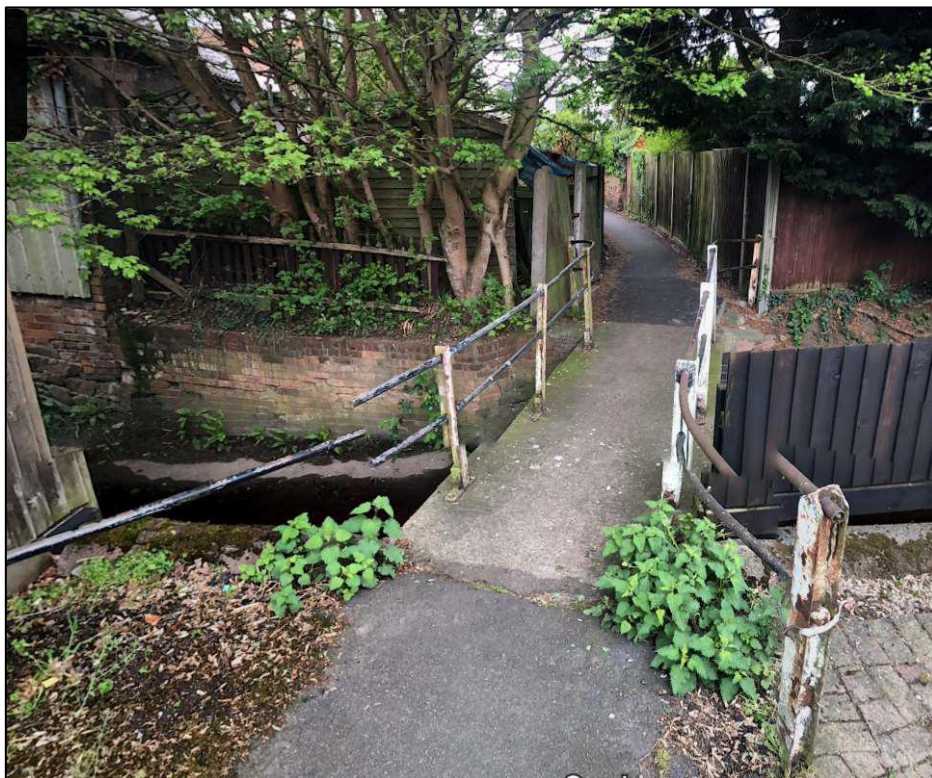
A public footbridge crossing the brook (location identified in Figure 18-1, see Photograph 188-2) was reported by local residents to have partially restricted flows in Sibley Brook, increasing the amount of overtopping into Cygnet Close. Photographs taken during the event show water flowing over the top of the footbridge, and onto Cygnet Close (see Photograph 188-3). This combined with the already pooled surface water, increasing it to a maximum depth of 2ft in places at around 6pm, leading to one property flooding internally through doors and airbricks. The flooding appears to be of a similar extent and nature to Easter 1998, although Cygnet Close was constructed in the early 2000's. A number of the properties impacted were also affected in October 2019 and February 2020.

**Photograph 188-2: Footbridge across Sibley Brook south east of Cygnet Close<sup>10</sup>**

In July 2024, the EA published a modelling report which indicated that the footbridge did have an impact on flood risk. However, due to the severity of the flood event, it is unlikely that removal of the bridge alone would have prevented properties flooding internally. The modelling also does not account for the accumulated depths of surface water from the blocked unadopted highway drains.

ACTION	ACTION DETAIL	LEAD RMA OR ORGANISATION	CURRENT STATUS
<b>Cygnets Close Footbridge Raising</b>	Raise footbridge with ramp and railing works for accessibility	LCC LLFA	Design phase complete. Funding secured. Works date TBC
<b>Henk Property Flood Resilience Repair Grants</b>	LCC LLFA administered the National Flood Grant for Property Flood Resilience on behalf of DEFRA following Storm Henk. One grant awarded and four being used as contribution to EA scheme (below)	LCC LLFA	Complete
<b>Property Flood Resilience</b>	Provision of Property Flood Resilience to five at risk properties	EA	Complete

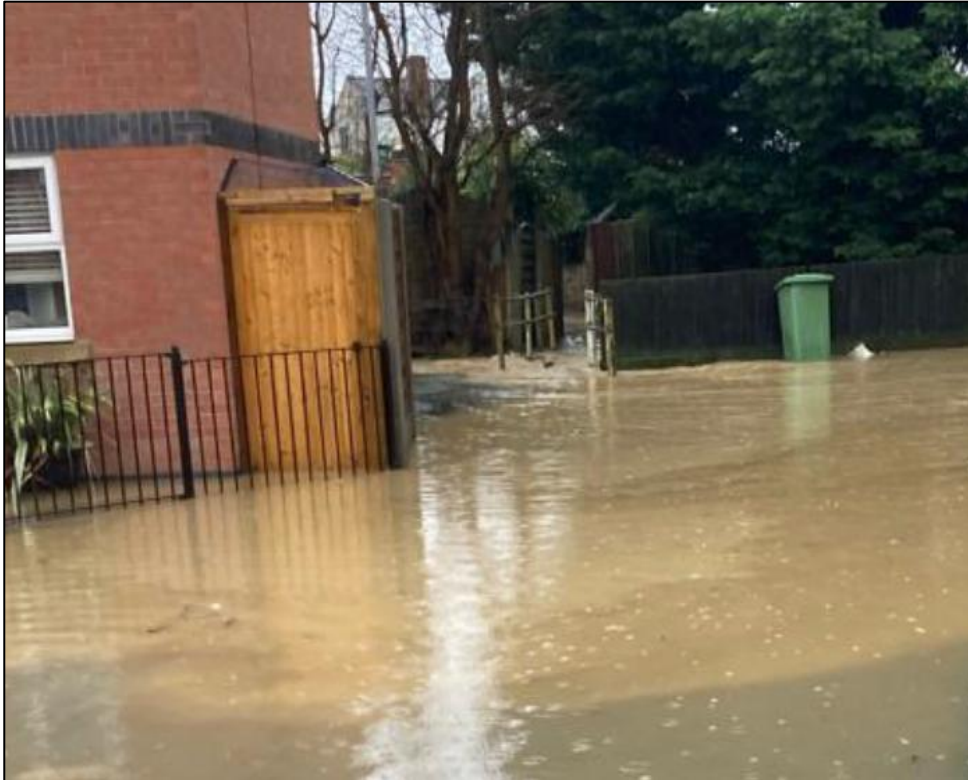
**Photograph 188-3: Footbridge during the Storm Henk event, showing water overtopping from the Sileby Brook onto Cygnet Close**
