Flood Investigation Report

Storm Henk

2nd January 2024

Whetstone

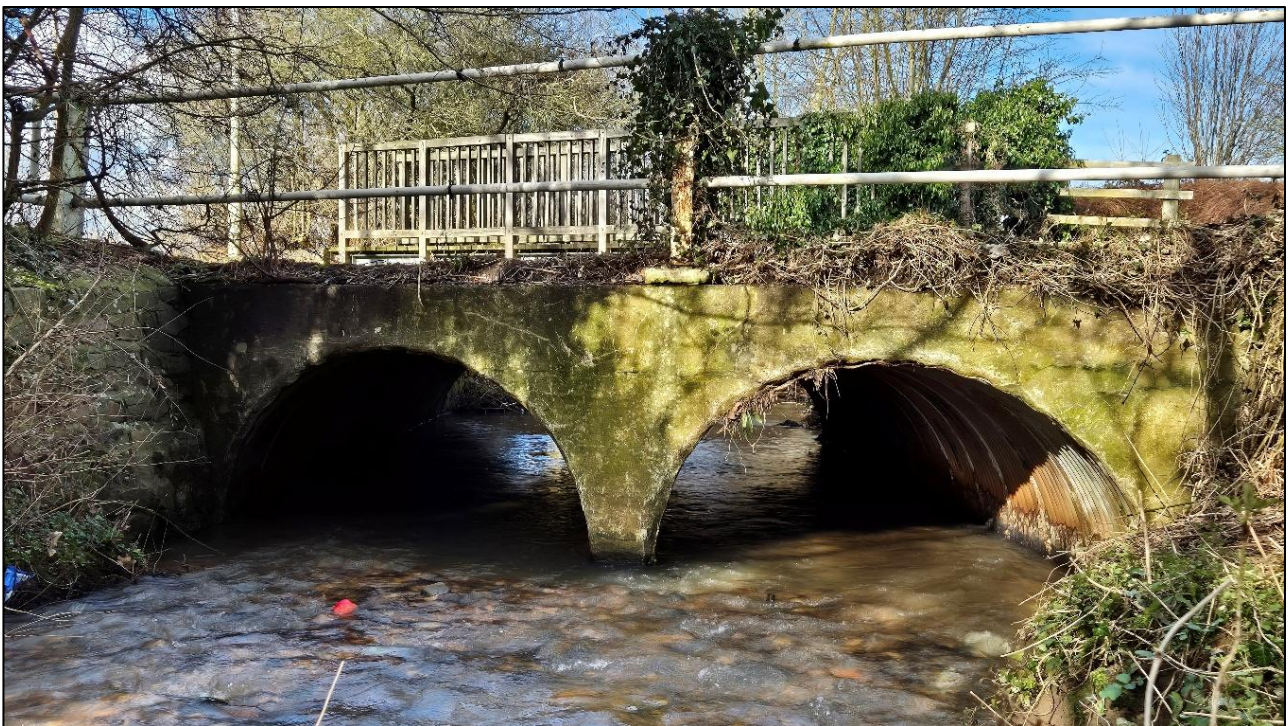
Photograph 11-1: The Dog and Gun Lane Twin Arch Bridge

The Dog and Gun Lane Road Bridge is a twin-arch structure (as depicted in Photograph 11-1), built on the site of a ford in the 1960’s, and is believed to have been part of the wider flood works undertaken by BRDC to reduce the occurrence and severity of flooding in Whetstone. The structure is designed to control Whetstone Brook in heavy flow but has a lowered road deck to allow severe flooding to pass over the bridge and into the brook on the downstream side.

Whilst Whetstone Brook reached record levels, it is reported to have stayed within the bank until the Dog and Gun Lane bridge, which overtopped, with water anecdotally reported to be flowing over the road deck and back into the Whetstone Brook. The water level was high enough to flow across the eastern edge of the bridge and onto the lower region of the car park at the Co-op.

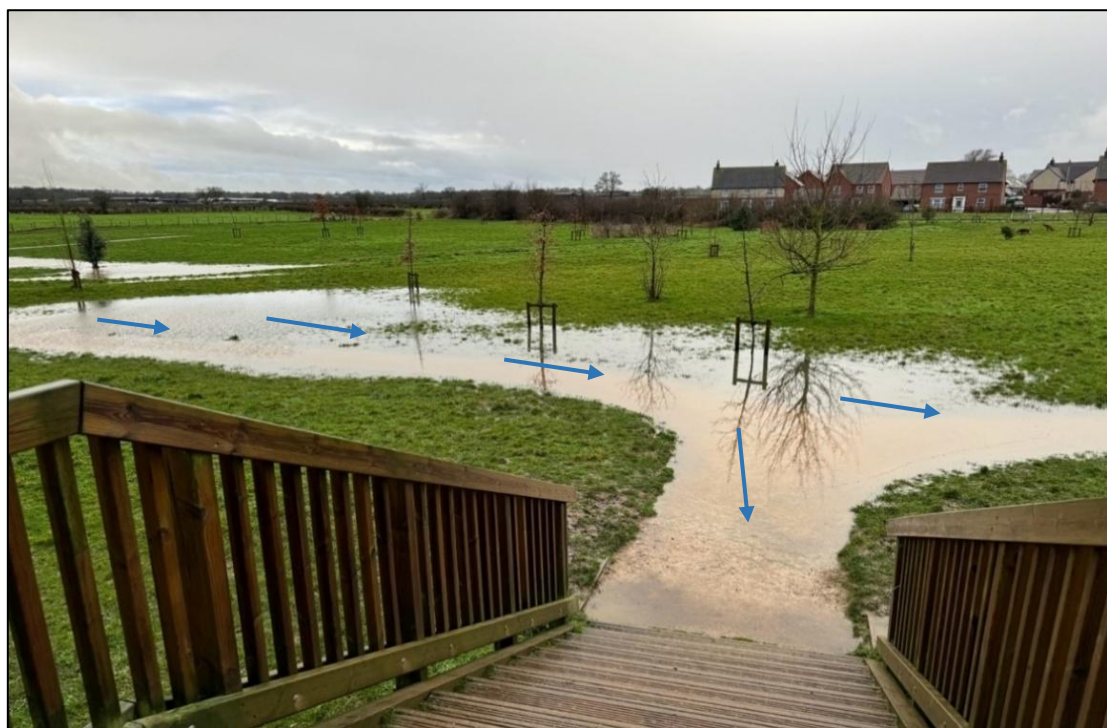
Photograph 11-3: Surface water flowing across public open space towards Elliott Close looking south towards Balancing Pond

Close and Wrights Close via private rear gardens flowing from the public open space (as depicted in Photograph 11-3). The houses in this area sit lower than the area of public open space to the south and have around a 150mm threshold above the surrounding ground levels.

Despite anecdotal claims, there are no known artificial flood features such as sluices or gates upstream of Whetstone that could have been opened or closed to affect the level of Whetstone Brook. An anecdotal report was made of potential issues with the Balancing Pond facilitating highway drainage from a recent development upstream of Elliot Close (Cooper Crescent, Hall Drive, Abbott Way and the southern area of Wright Close). This discharges eastwards into Whetstone Brook via a 375mm dia STW public surface water sewer, as illustrated in Figure 11-5. The Balancing Pond can be seen in the rear of Photograph 11-3.

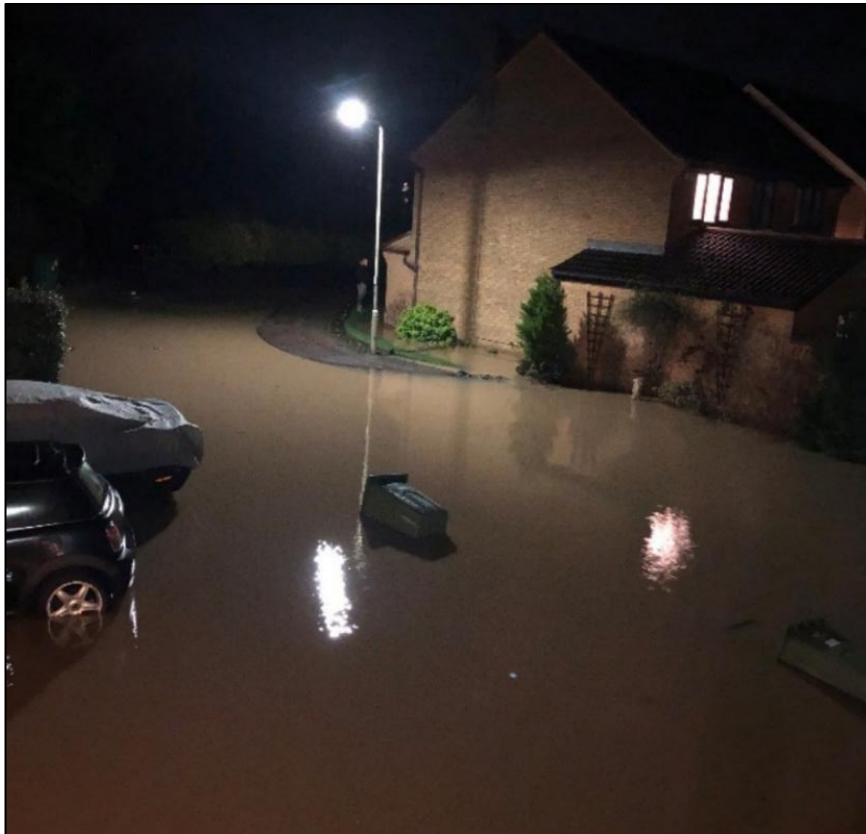
Photograph 11-4: Pondered surface water flow within residential street (Elliott Close)

Internal and external residential property flooding occurred, with water depths reaching between ankle and knee deep in places (Photograph 11-4). Due to the volume of overland surface water flows, the highway and residential surface water drainage systems were overwhelmed, unable provide effective drainage. The time of flooding of residential properties in this flood area was recorded as being between 16:30 and 18:45hrs, approximately 2 hours after the Flood Warning was issued, and coinciding with the peak water level at the Whetstone gauge (18:30hrs). It should be noted that the Flood Warning is triggered by water levels in the brook reaching a predetermined level based on historic depths and rainfall levels.
