# **Flood Investigation Report**

21<sup>st</sup> September 2024

Market Harborough Town Centre

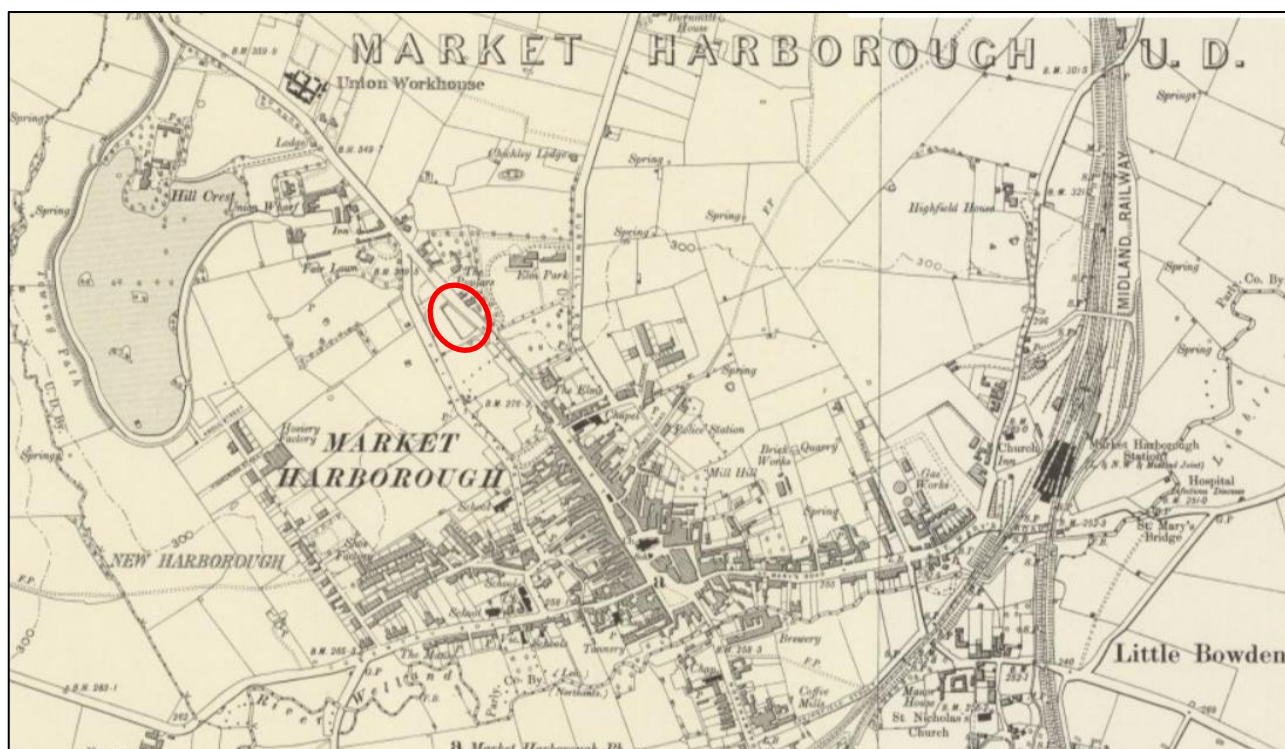
*(Folly Pond circled in red)*

**Figure 3-4: Historic Mapping of Market Harborough (year 1900) illustrating the Folly Pond and River Welland<sup>24</sup>**

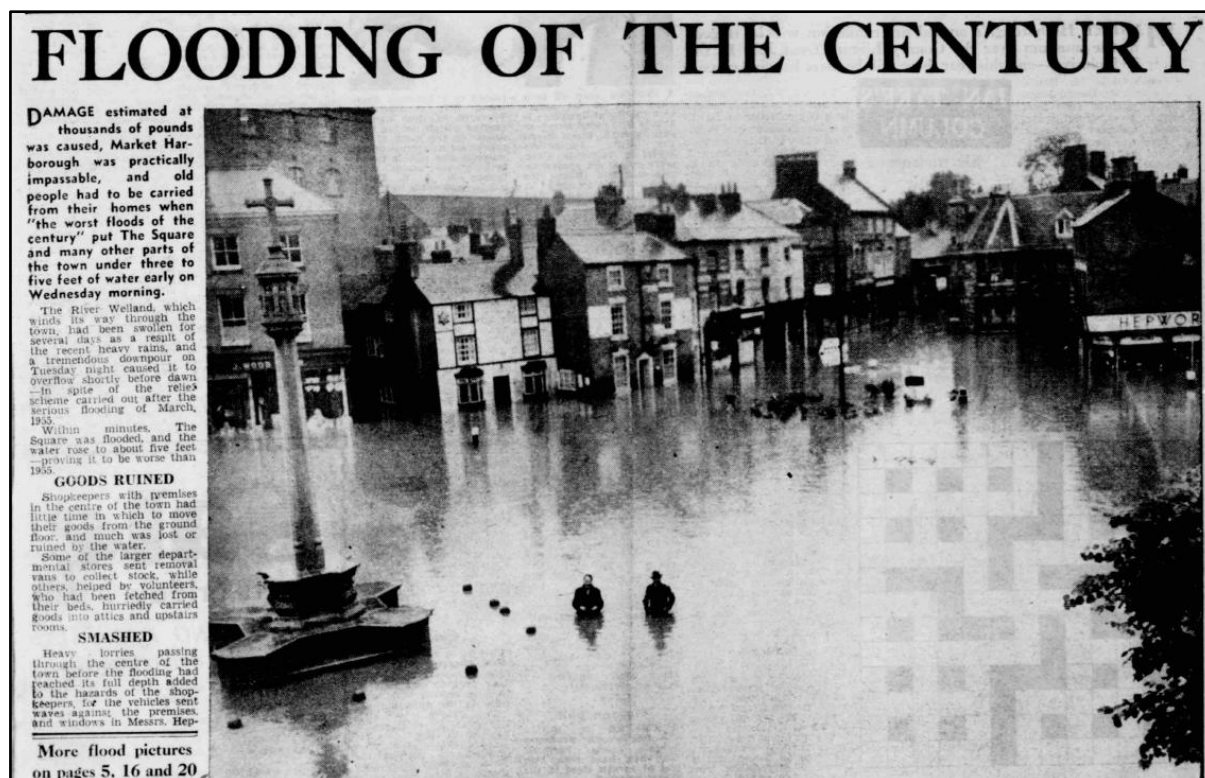
**Figure 3-5: Market Harborough Town Centre flooding of July 1958 as featured within the Market Harborough Advertiser & Midland Mail**

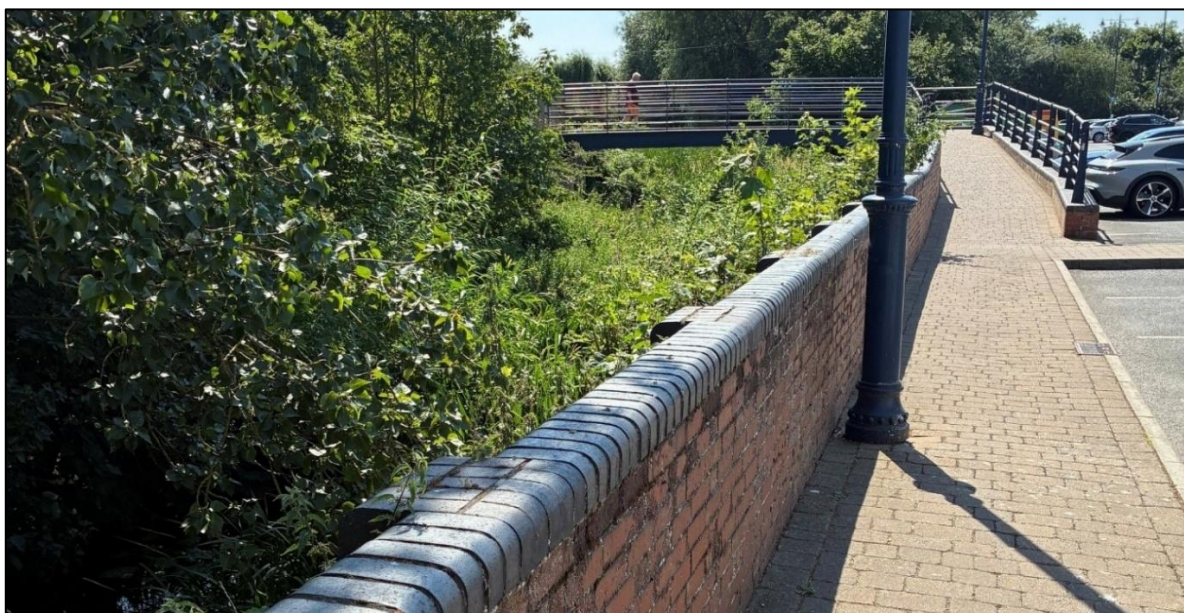
In 1967, a series of raised flood defences were constructed by the Welland and Nene River Authority between Welland Park and the Garden of Remembrance to protect the Town Centre from the risk of fluvial flooding from the River Welland. Photograph 3-1 depicts the section of flood wall in The Commons car park extending along the northern bank of the river (EA Asset Information Management System (AIMS) ref: 132744, crest level 77.77 mAOOD). These are currently owned and maintained by HDC.

**Photograph 3-1: Raised Flood Defence in The Commons car park, Market Harborough Town Centre (7<sup>th</sup> July 2026)**

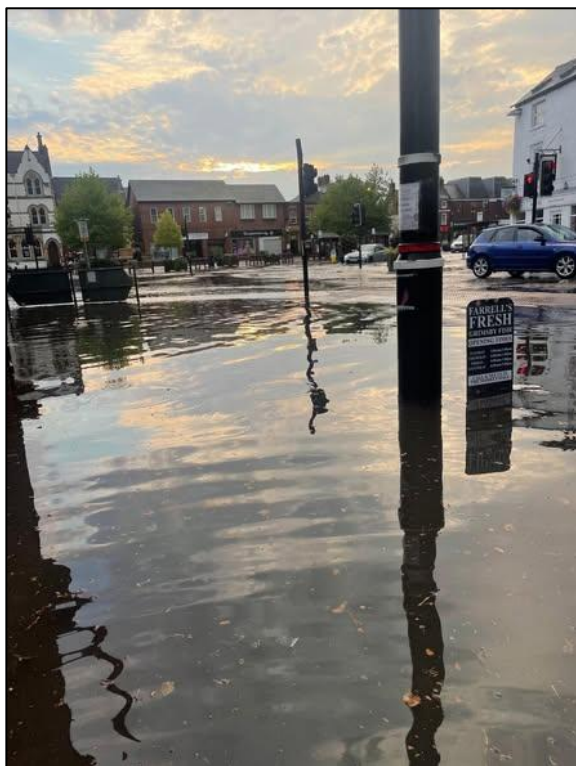
These coincided with the areas identified as being at high risk of surface water flooding within the EA RoFSW map (Figure 3-7). Significant surface water flows were reported flowing along on Burnmill Road and Bowden Lane, which converged on the lower region of Leicester Road and proceeded along High Street, Church Street, Church Square, Adam and Eve Street, The Square (Photograph 3-2), St. Mary's Road and Northampton Road (Photograph 3-3). These flows were observed to have overwhelmed the surface water drainage network serving the area and the additional runoff, unable to get into the network, accumulated at the surface.

**Photograph 3-2: Flooding across The Square viewed from High Street<sup>37</sup>**

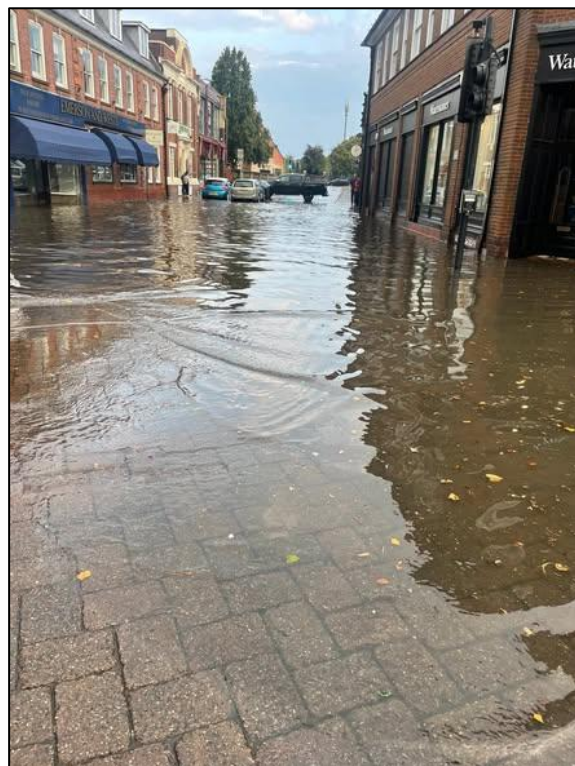
**Photograph 3-3: Flooding along Northampton Road<sup>38</sup>**

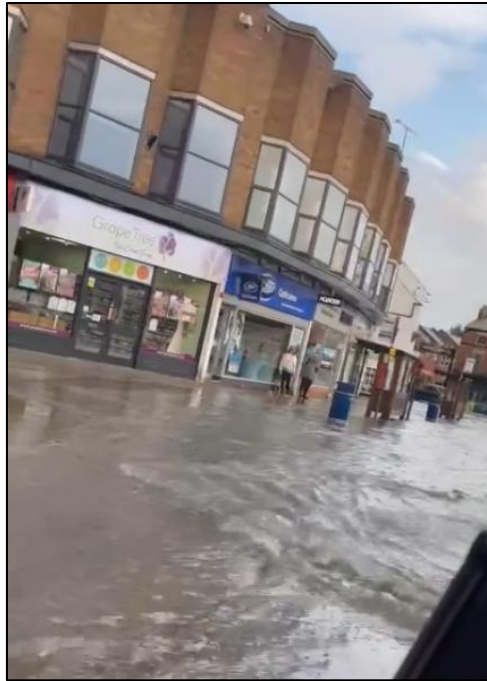
Due to the commercial nature of the Town Centre and the short and flashy nature of the event, the roads remained open and many vehicles continued to use them, as illustrated in video footage taken during the event<sup>39</sup> & <sup>40</sup>. This inadvertently resulted in the formation of bow waves as vehicles passed through flood water as depicted in Photograph 3-4. The internal flooding to some commercial properties with low thresholds compared to the external ground levels was described to have been exacerbated by these bow waves.

**Photograph 3-4: Bow Waves in floodwater from cars moving through The Square<sup>40</sup>**

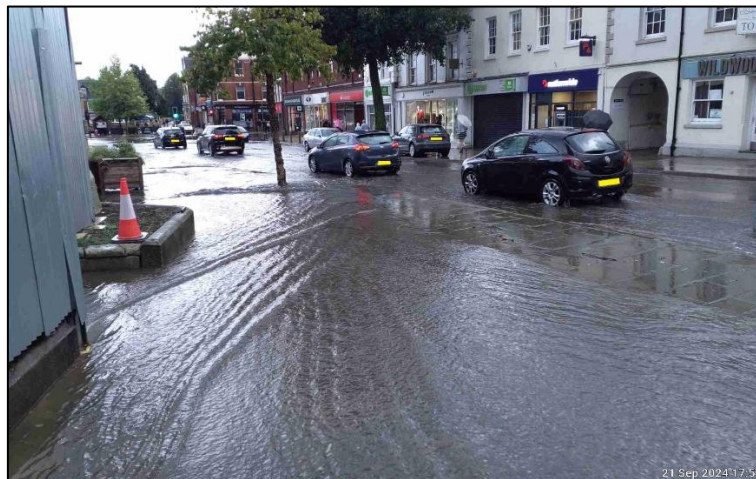
**Photograph 3-5: Flooding along High Street at 17:54 hours BST**

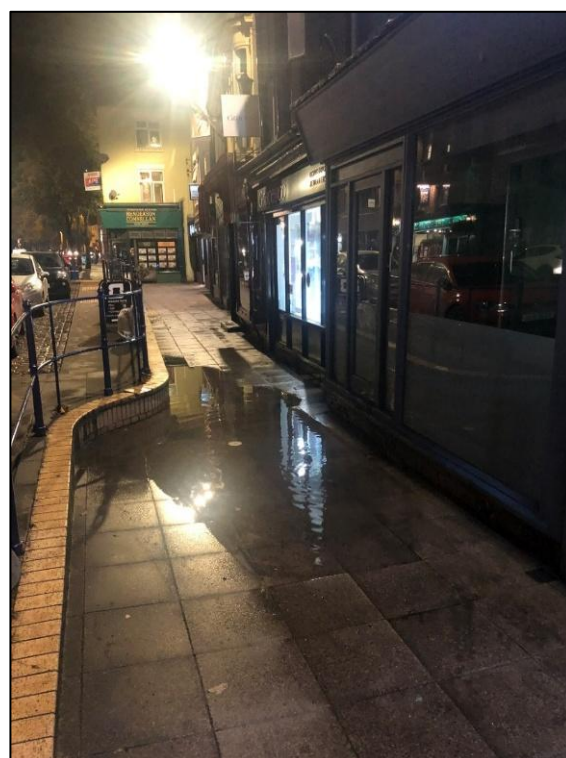
Once the intense rainfall has ceased, the surface water drainage infrastructure was described to gradually drain the flood water away. Several reports however were received by LCC of blocked drains and gullies, which were preventing residual puddles of flood water from draining away from the surface as depicted in Photograph 3-6 and Photograph 3-7.

**Photograph 3-7: Ponded floodwater along High Street looking northwards at junction with Church Square at 20:30 hours BST**

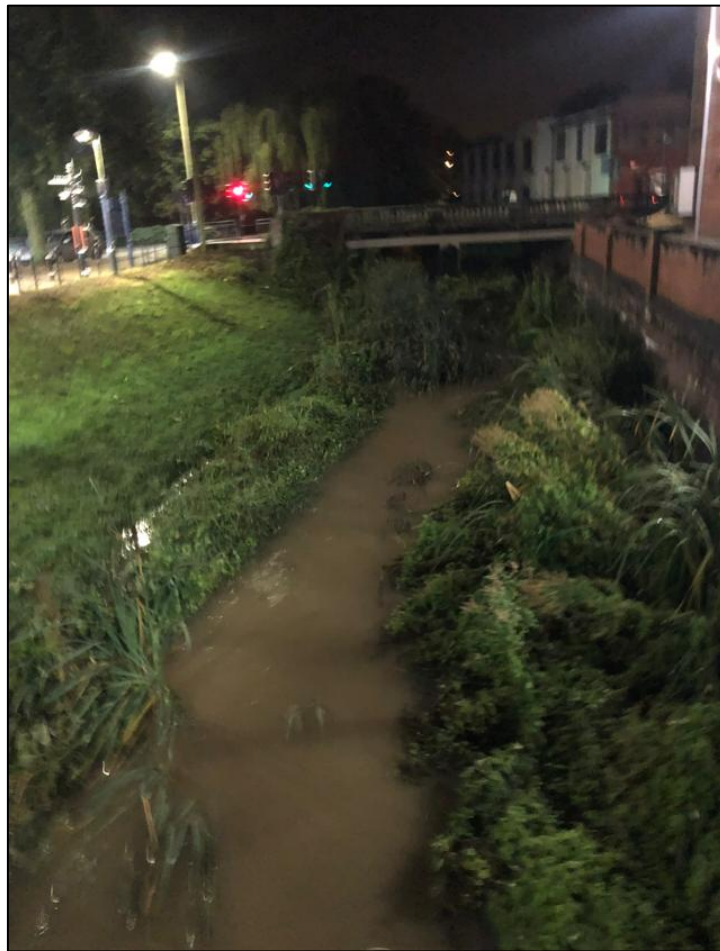
Photograph 3-8 below depicts the condition of the River Welland viewed upstream towards Northampton Road bridge at 20:30 hours on the 21<sup>st</sup> of September, evidencing that its raised water level had subsided in the vicinity of the key sewer outfalls by this time.

**Photograph 3-8: River Welland viewed upstream towards Northampton Road bridge at 20:30 hours BST**
