Diseworth and Long Whatton Catchment Study

FINAL REPORT

January 2014

Prepared for:
Leicestershire County Council

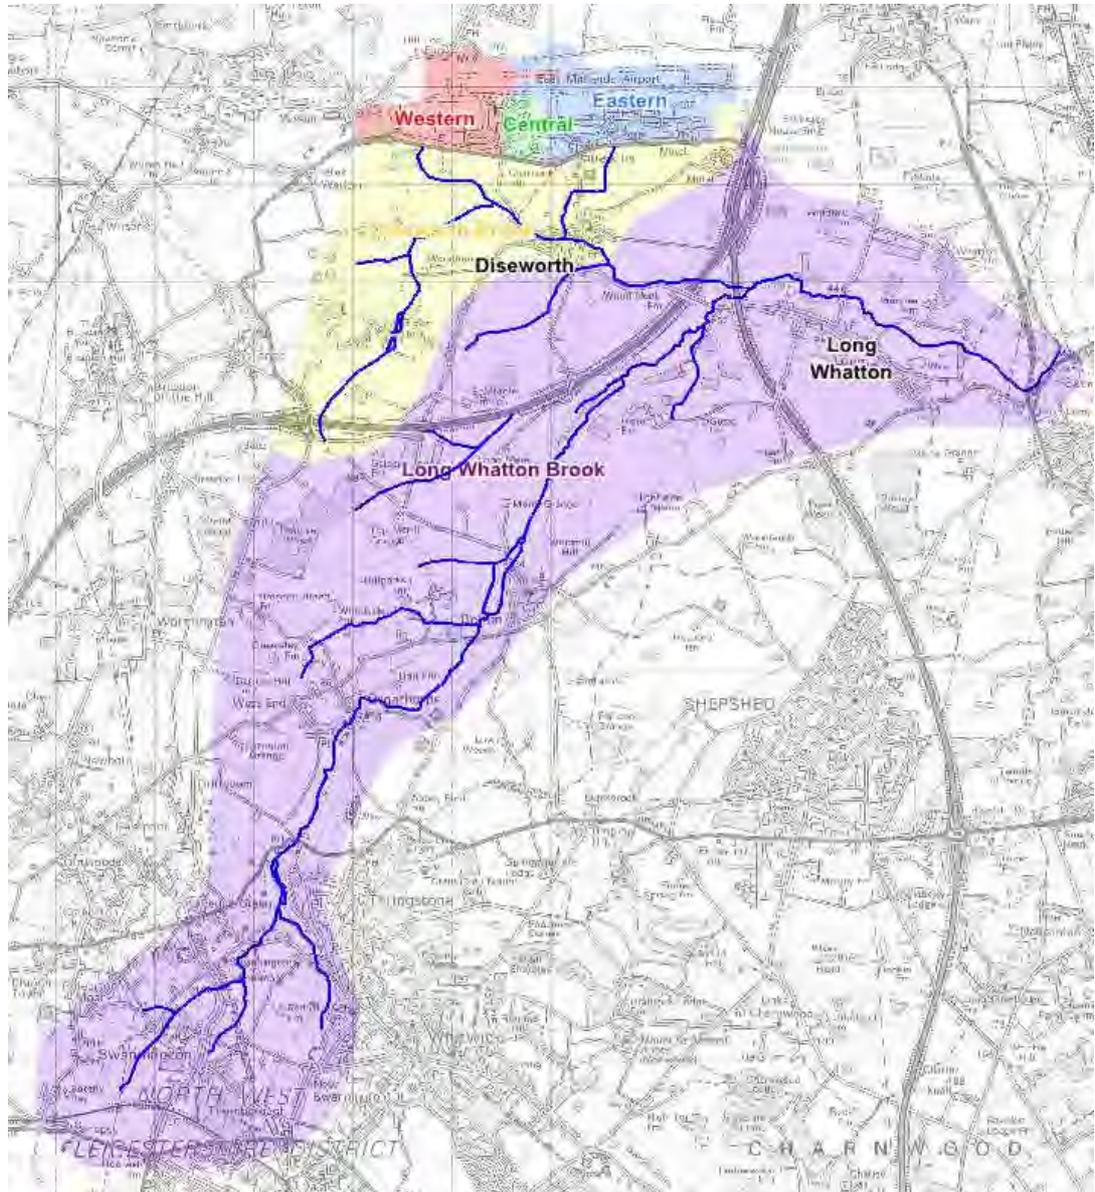
Figure 2-2: Catchments
 Reproduced from Ordnance Survey Digital Mapping Data © Crown Copyright and database right.
 All rights reserved. License Number 0100031673

Figure 2-2 shows the approximate extents of the Diseworth Brook and Long Whatton catchments, and indicates the three individual surface water catchments draining East Midlands Airport via a series of surface water attenuation basins. Details of the surface water attenuation basins are included in Section 3.

In total, the Diseworth Brook catchment as far downstream as Diseworth covers an approximate area of 10.0 km², of which 6.9 km² is considered to be a natural catchment. The remaining 3.1 km² is drained via the surface water attenuation basins at East Midlands Airport.

The Long Whatton catchment as far downstream as Long Whatton covers an approximate total area of 32.0 km². Excluding the Diseworth Brook catchment, the remaining Long Whatton catchment covers an area of approximately 22.0 km².

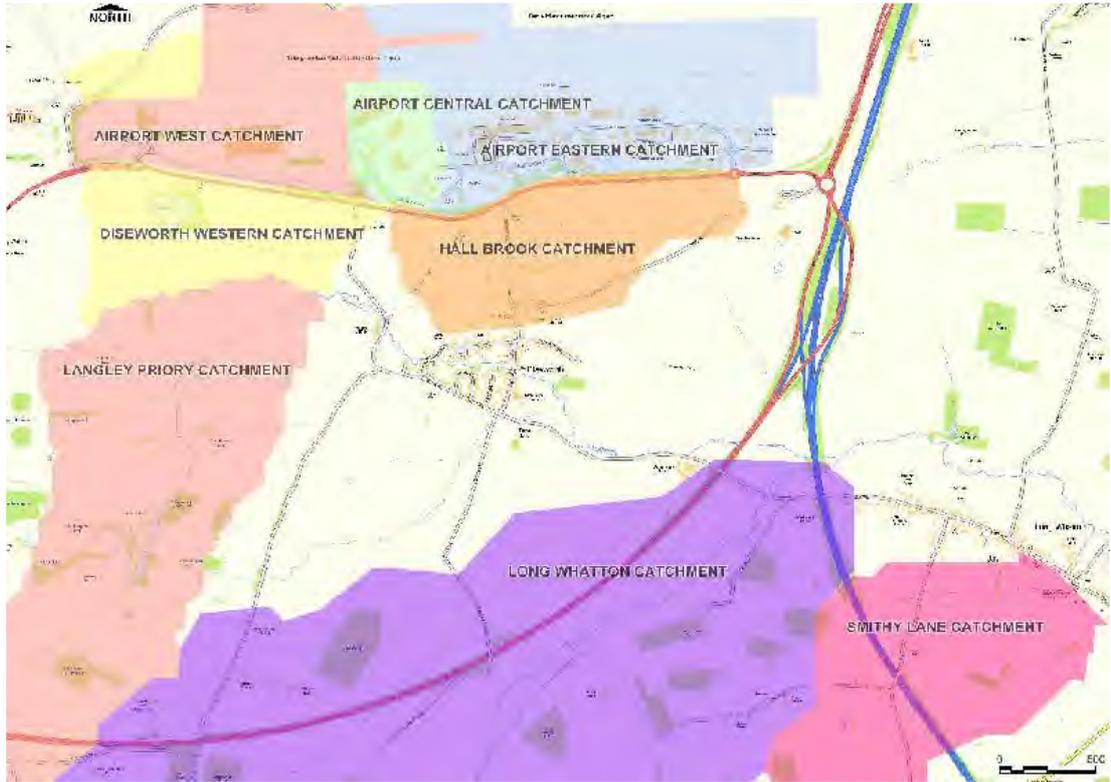
Figure 2-3: EMA Catchments

An assessment of potential flows generated by the Diseworth catchments (excluding East Midlands Airport) and the Long Whatton Brook catchment (upstream of the confluence with Diseworth Brook) has been undertaken using the Revitalised Flood Hydrograph (ReFH) method. Where appropriate, the catchments have been delineated into sub-catchments, which are indicated on Figure 2-3.

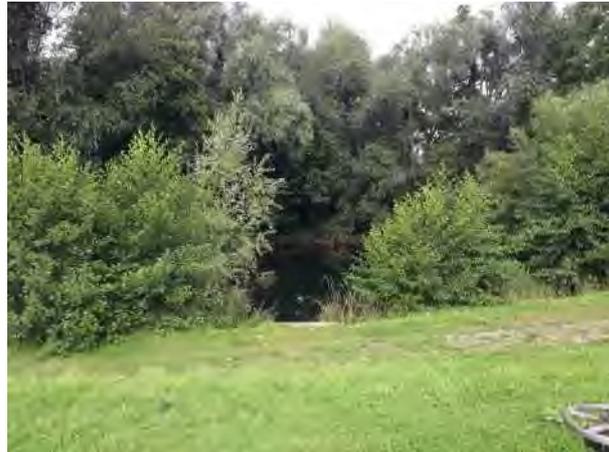
Photograph 3-1: Central Catchment 'Summer' Basin

The central summer basin discharges via a 450 mm pipe and discharges into a secondary basin, which also receives inflow from two land drains serving adjacent agricultural land. The discharge from the central summer basin to the secondary basin is reported by EMA to be 0.26 m³/s and is controlled by the diameter of the outfall pipe. No engineering drawings have been provided by EMA to enable the maximum discharge rate to be verified.

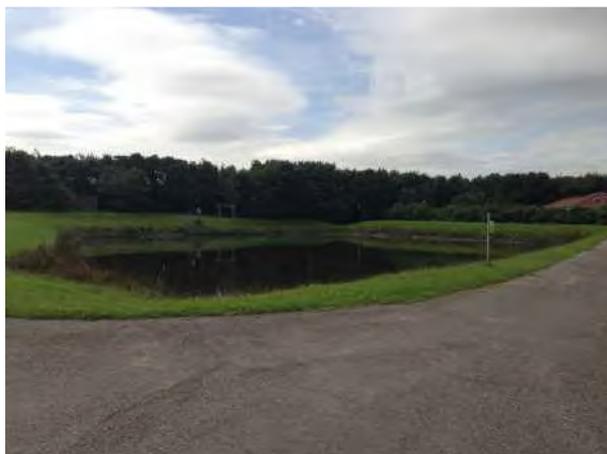
Photograph 3-3: Eastern Catchment 'Summer' Basin

The eastern summer basin discharges to Hall Brook via an 800 mm outlet and is reported by EMA to have a maximum discharge of 1.50 m³/s. No engineering drawings have been provided by EMA to enable the maximum discharge rate to be verified.

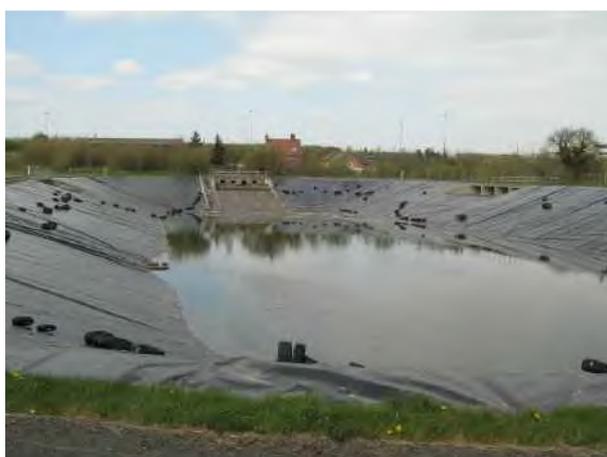
Photograph 3-5: Western Catchment 'Summer' Basin

The western summer basin discharges via a 450 mm diameter pipe at a maximum rate of 0.35 m³/s as noted above and there is telemetry installed at the outlet to monitor flows and water depths.

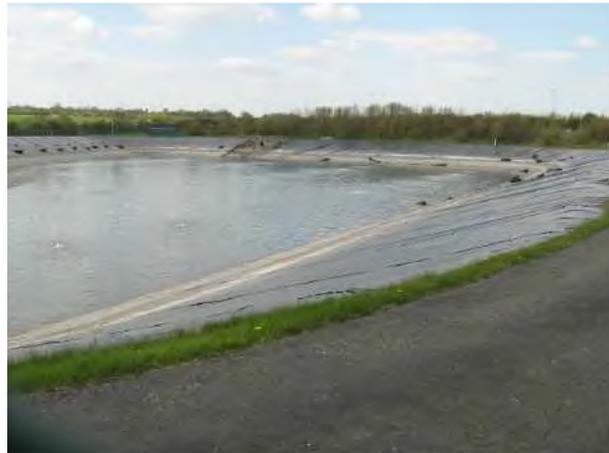
Photograph 3-6: Western Catchment 'Winter' Basin

The outlet from the western winter basin connects to the River Trent through a 225 mm diameter pumping main. Effluent is pumped (at a maximum rate of 0.025 m³/s) to the river when the BOD level exceeds limits set by the EA that prevent it from being discharged into Diseworth Brook.

During a significant event, should the capacity of the western winter basin be exceeded, then this would overflow into the adjoining western summer basin and discharge to the Diseworth Brook catchment at a maximum rate of 0.35 m³/s. Should the capacity of the western summer basin also be exceeded then this would discharge via the emergency overflow to prevent uncontrolled overtopping of the basin. From the EMA records of the November 2012 event, this emergency overflow was not in operation at any time during the event.

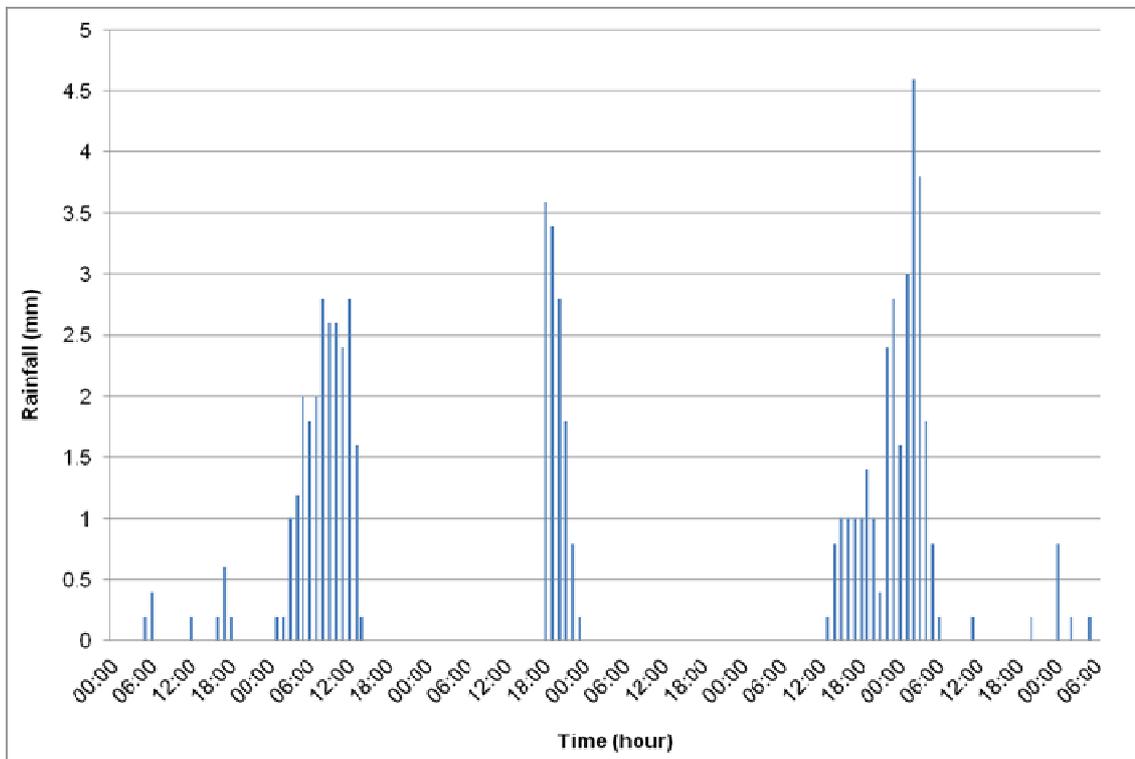
Figure 4.1: Rainfall Profile from 00:00 on 20/11/12 to 06:00 on 27/11/12

As part of the study URS acquired rainfall data for the period for November 2012. The rainfall data was provided from a gauging station located at The University of Nottingham, Sutton Bonington Campus, approximately 4 miles to the east of the study area. The hourly rainfall profile for late November 2012 is included in Figure 4-1.

The rainfall profile indicates that three separate rainfall events occurred during the period 20th November 2012 to 27th November 2012. As a result of the successive heavy rainfall the Diseworth and Long Whatton catchments became saturated. Rather than infiltrating into the ground, rain falling on the ground surfaces effectively ran off into watercourses. This would have caused water levels in the watercourses to respond very rapidly to the onset of rainfall.

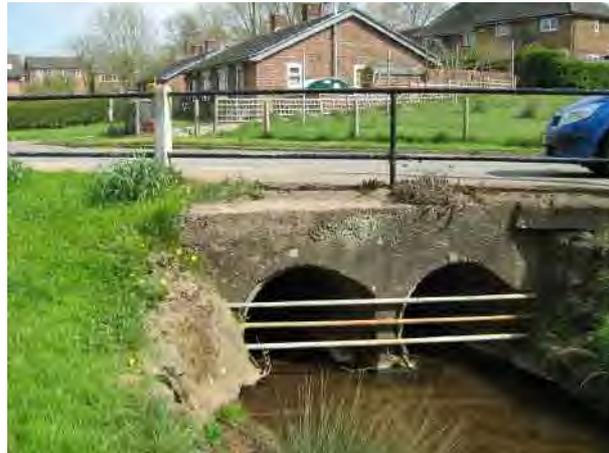
As it flows into Diseworth from the west, Diseworth Brook enters a 60 m long culverted section which conveys the brook beneath 'The Bowley'. The culvert consists of a 2 x 1000 mm pipes and is fitted with an informal trash screen on the upstream entrance (Photograph 4-1). At the site inspection both pipes were observed to be clear.

Photograph 4-1: Upstream view of the Bowley culverts

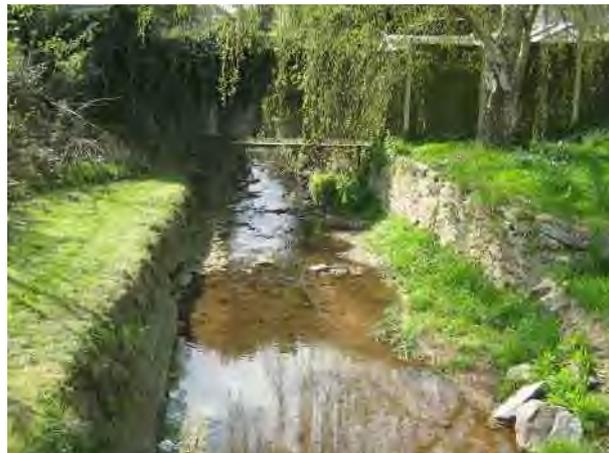
The area immediately upstream of the culverts is an area of relatively wide channel measuring approximately 3 m from bank top to bank top (Photograph 4-2). Upon exiting the culvert, the watercourse narrows down to a width of around 2m from bank top to bank top. As a result, through the reach adjacent to Shakespeare Close the profile of the channel changes from being wide and shallow to being very narrow and still quite shallow. Photograph 4-2 and Photograph 4-3 demonstrate the difference in channel profile between the upstream and downstream lengths.

Photograph 4-2: View looking upstream from culvert

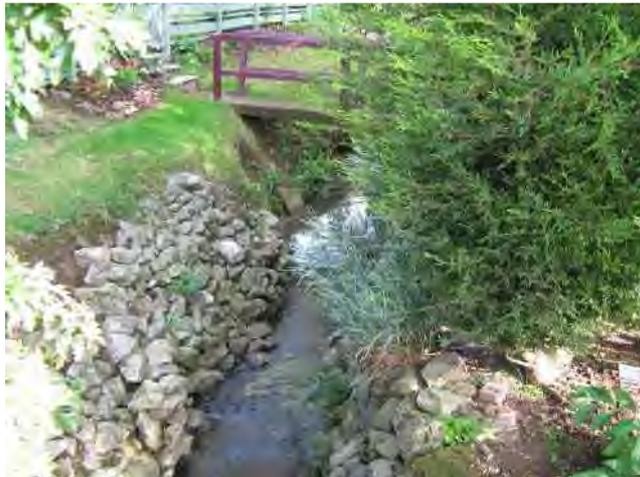
Photograph 4-3: View downstream towards constriction adjacent to flooding location at Shakespeare Close

During the flood event in late November 2012 the runoff flow rates would have been significantly increased due to the saturated conditions within the catchment. During the event, the flow being conveyed by the watercourse downstream of the Bowley culverts exceeded the capacity of the channel causing inundation to the area on the left bank. This in turn caused flooding to properties at Shakespeare Close.

Based on observations made during the site visit and in consideration of design flow rates, the principal cause of flooding at the location is considered to be the geometry of the channel, specifically the constriction as the brook negotiates the reach adjacent to Shakespeare Close.

- (B) **Channel works to improve capacity and conveyance** – Improving the capacity of watercourses through either undertaking channel widening schemes and/or undertaking routine channel maintenance could be further considered.

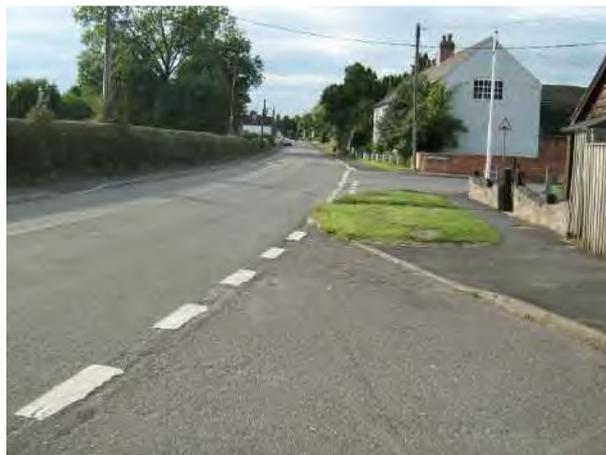
It is understood that the flooding of properties at Main Street and Mill Lane in November 2012 was caused by the unnamed watercourse which drains approximately 1.5 km² of farmland to the south-west of the village. In order to flow past Main Street the watercourse is culverted beneath the road. Having flowed beneath the road the watercourse continues to flow south

The site visit in September 2013 included discussions with a number of local residents who were able to describe the mechanism by which flooding of the road resulted in several properties becoming flooded. The flooding appears to have been caused by ‘backing up’ of the culvert beneath the road, which caused flooding to the adjacent farmland upstream. Flows coming off the fields caused flooding to occur along Main Street which overtopped the kerbs and flooded adjoining properties on the north side (shown in Photograph 4-4) which are set down below the road level. The floodwater also affected a low area at the corner of Main Street and Mill Lane. Having flooded the lower lying land at Mill Lane, the floodwater caused flooding of the properties on Mill Lane. The floodwater also extended into Crawshaw Close flooding several properties.

Photograph 4-4: View west along Main Street

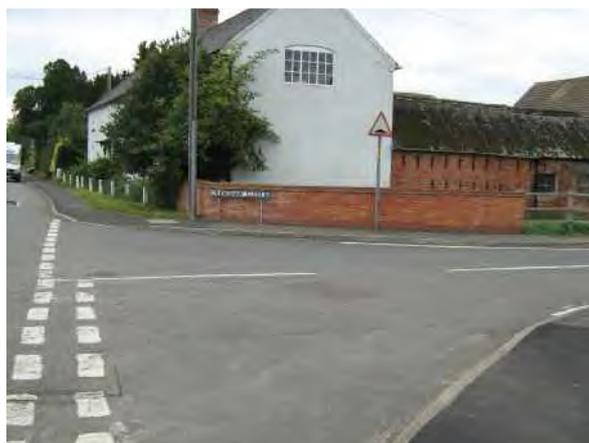
It is understood that a relatively new brick headwall (photograph 4-5) has been built at the downstream end of the culvert, adjacent to the footpath. It is reported that this brick wall prevented flows from returning to the watercourse channel, and exacerbated the flooding. It is also reported by local residents that the road levels on Main Street have been raised several times as a result of resurfacing (no scarifying first), which has reduced the kerb height over the years. This has increased the likelihood and frequency of floodwater overtopping the kerb and inundating adjacent properties.

Photograph 4-5: View across Crawshaw Close

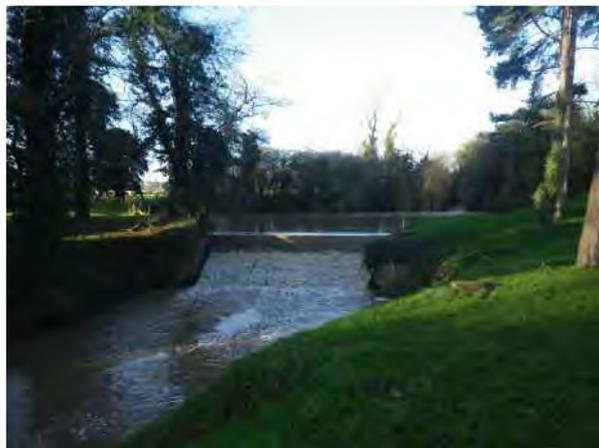
During the flood event in late November 2012 the runoff flow rates would have been significantly increased due to the saturated conditions within the catchment. During the event, the flow being conveyed by the watercourse downstream of the Mill Lane culvert exceeded the capacity of the channel causing inundation to the low lying areas. Based on observations made during the site visit and in consideration of design flow rates, the principal cause of flooding at this location is considered to be the geometry of the channel and volume of water. Photographs 4-6 and 4-7 below compare the water levels at the same point in the watercourse both during typical winter flow conditions and at the time of the 2012 flood event.

Photograph 4-6: Long Whatton Brook in Typical Winter Flow Conditions

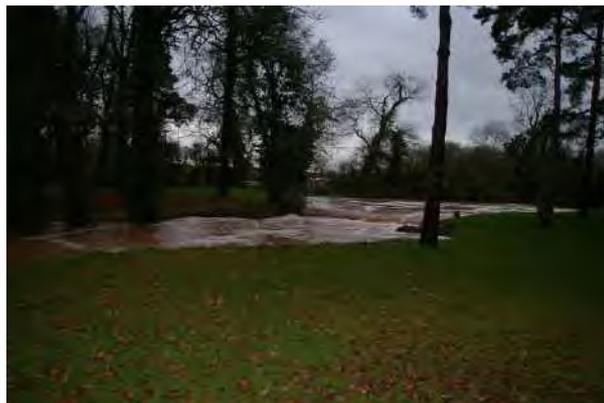
Photograph 4-7: Long Whatton Brook During Flooding in November 2012

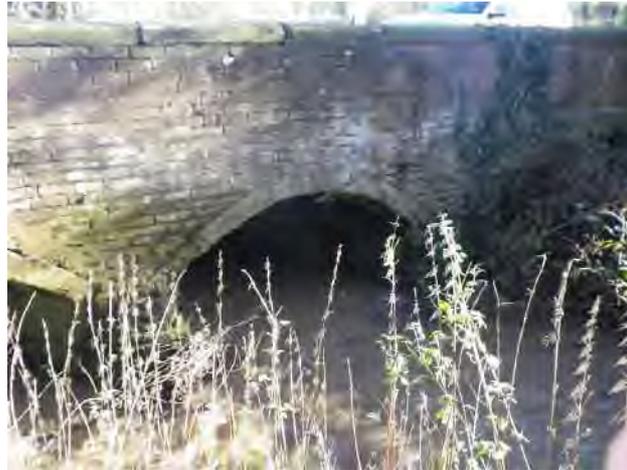
During the event, the flow being conveyed by the watercourse downstream of the Mill Lane is believed to have exceeded the capacity of the channel. The watercourse will also have been constricted by the brick arch culvert shown in Photograph 4-8 below.

Photograph 4-8: Brick Arch Culvert

This in turn caused localised flooding to the carriageway. It has been reported from residents that the ditch adjacent to Zouch Road was also partially blocked which wasn't able to accommodate the additional surface water. In consideration of the observations made during the site visit and the design flow rates, the principal cause of flooding at the location is likely to have been the geometry of the channel and volume of water.
