Flood Investigation Report

Breedon on the Hill – 15th June 2016

Final Report

NOVEMBER 2018

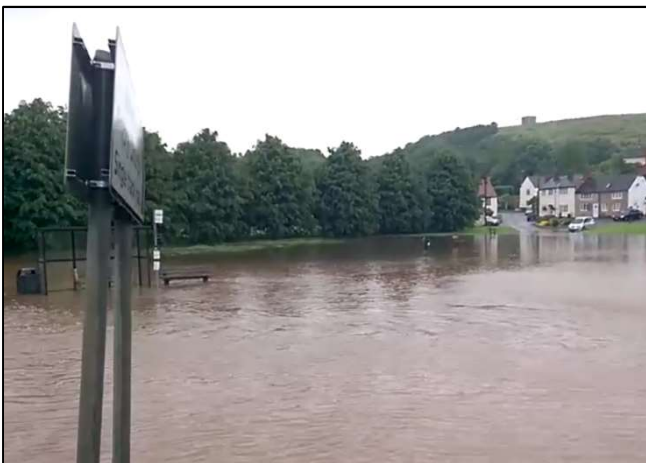
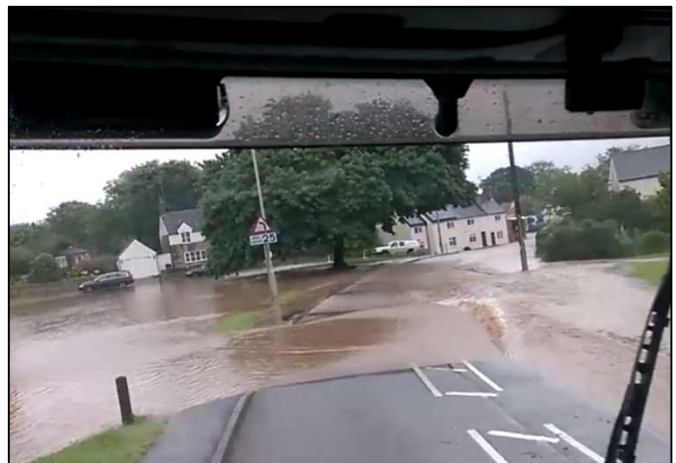
Pictures 1 & 2: Illustrating the extent of flooding on the village green and water being conveyed along Main Street during the events of 15th June 2016. Picture 2 is a video still taken by the fire and rescue service at it approached the village centre.

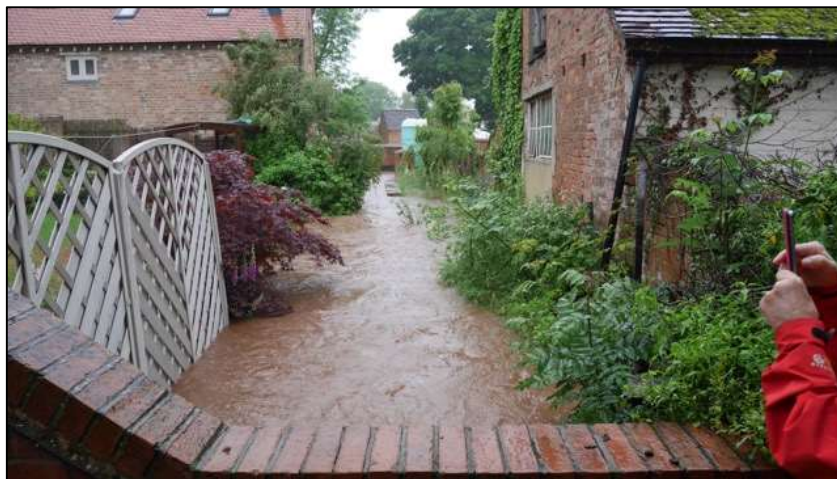
Picture 3: Local resident's photo showing watercourse levels within the channelled sections through the village during the rainfall event on the 15th June 2016 facing upstream of The Lime Kilns towards the pedestrian access bridge onto Pear Tree Mews.

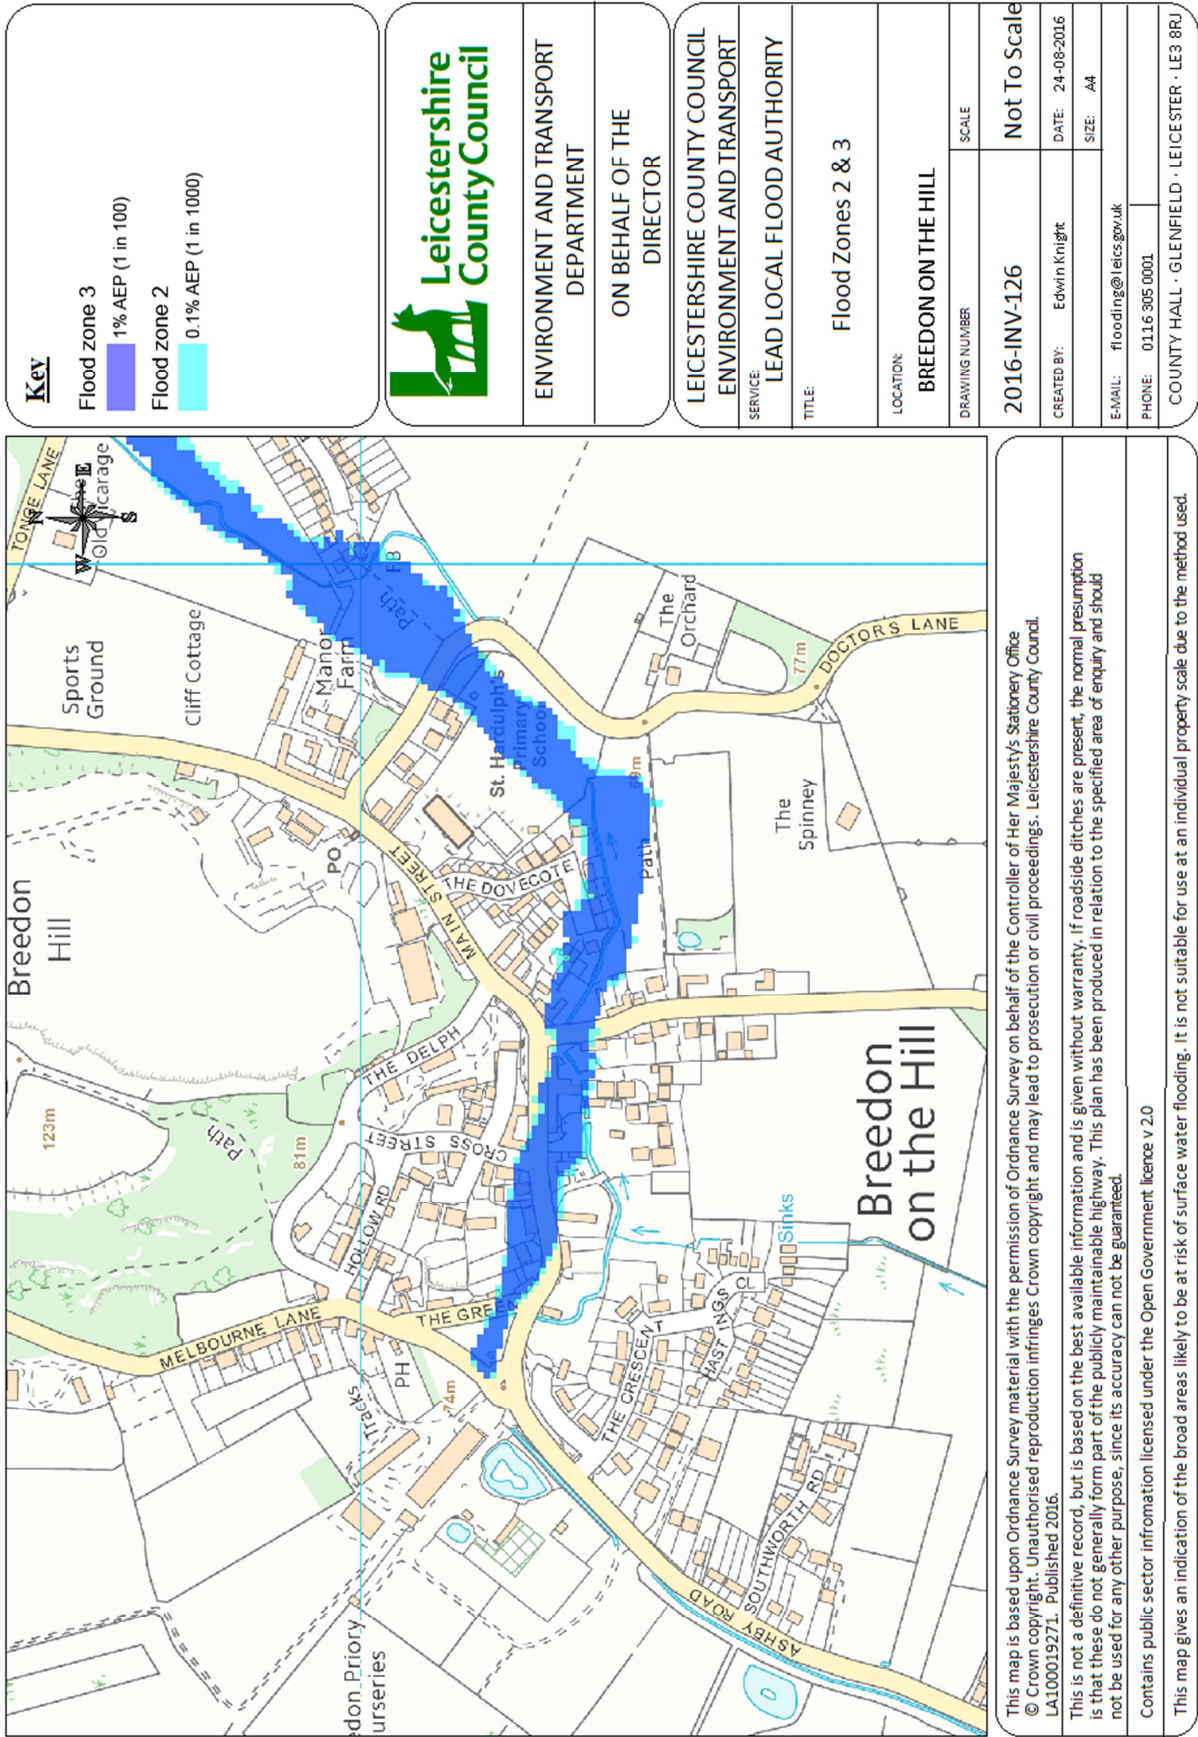
APPENDIX D – FLUVIAL FLOOD RISK MAP

Appendix D illustrates the fluvial flood risk map which again closely replicates the areas of flooding that were experienced as a result of watercourse flooding on 15th June 2016.
