# Highgate Road, Sileby

# DETAILED FLOOD INVESTIGATION

<b>County Council Investigation Ref.:</b>	<b>2016-INV-187</b>
<b>Investigation:</b>	<b>Highgate Road Sileby</b>
<b>Date of Flooding:</b>	<b>10<sup>th</sup> June 2016</b>
<b>Revision</b>	<b>Final</b>

**Report produced for Leicestershire County Council by AECOM,**

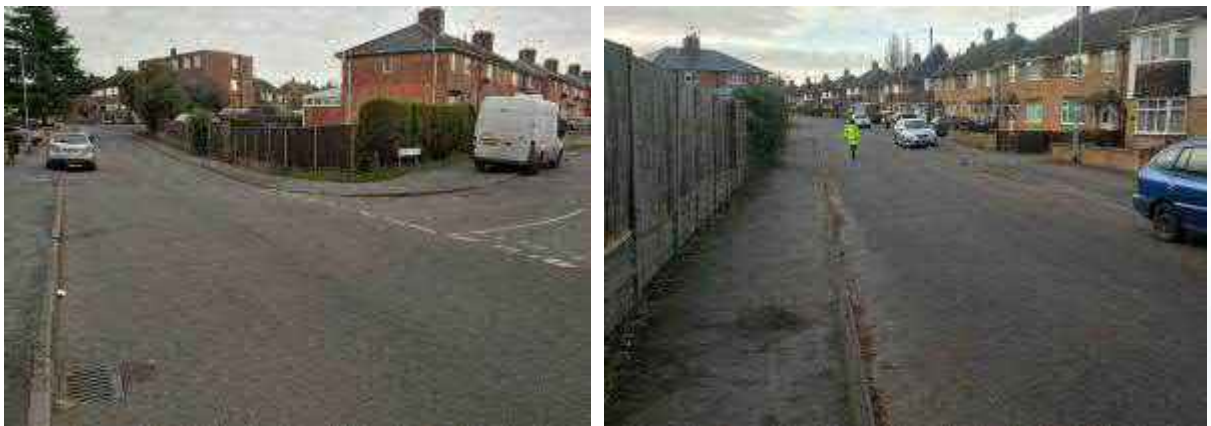
**Photo 1 & 2: The junction where flooding regularly occurs, Highgate Road on approach (from north east end) to the junction.**

LiDAR data (found in Appendix B) also identifies the junction of Highgate Road and Wellbrook Avenue to be at a low point. Once water reaches a depth greater than the height of the highway kerbs, it flows down through the driveways and garages of several residential dwellings; finding the easiest route to Sileby Brook.

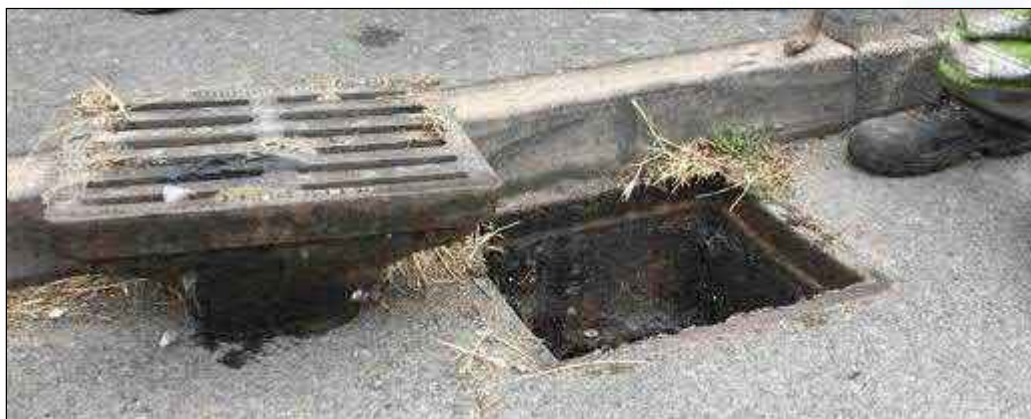
The highway drainage network consists of bucket gullies, which are pictured in Photo 3 below.

**Photo 3: A pictured 'bucket' gully located on Wellbrook Avenue, Sileby**

The bucket gullies along the highway have small openings, which could easily become overwhelmed during intense rainfall and are susceptible to blockages. Anecdotal reports suggested that at the time of the flooding in June 2016 the bucket gullies were potentially silted. During a site walkover in September 2018 it was identified that the gully connections were approximately 100mm in diameter and conveyance capacity was reduced due to siltation in the system. This could have possibly contributed to the cause of the flooding. Following the incident in June 2016, LCC reported that these gullies were jetted. It was identified during a site walkover in September 2018 that maintenance of the bucket gullies were required as they had begun to silt up.

LCC is to investigate the potential to replace the bucket drains with normal gully pots, and examine whether implementing a new gully at the corner between Wellbrook Avenue and Highgate Road would be beneficial. They will also continue to monitor and maintain their gullies as per the Council's current maintenance policy, keeping them clear from obstruction so they can function at full capacity.

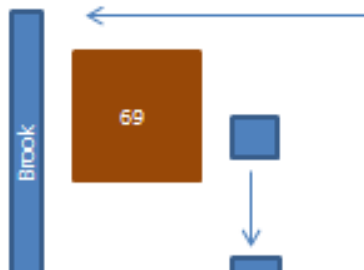
2. Details of Flooding							
Flood damage incurred? :	Internal flooding of one house. Driveways flooded of two houses		Through doors:		Water flooded the ground floor of one house		
			Through windows:				
			Through floors:				
			Through airbricks:				
			Through drainage:		Water flowing from the gullies by the Junction, flooding the junction and surrounding driveways.		
Source of flooding (if known):	Main River	Other Water Course	Road	Overland	Public Sewer	Private Drain	Other e.g. blocked culvert, gully etc,
			Y	Y			Y
Comments (include estimate of flow path and sketch where possible):	<p>The origin of the water is the storm; however it is thought that the drainage network might be the main cause of the flooding experienced. The pipes were recently jetted, where apparently it was determined that water is relayed up hill, which could lead to a build-up of water (if levels are not correctly designed) in the chambers and subsequent flooding.</p> <p>The resident also reported that the pipe diameters are only 4", which might also be adding to the problem by reducing the rate at which water is relayed. The system shown below was described.</p>

<p>It was also observed that there are only two outlets to the watercourse, which has the capacity to take this storm water. This might have also impacted the</p>

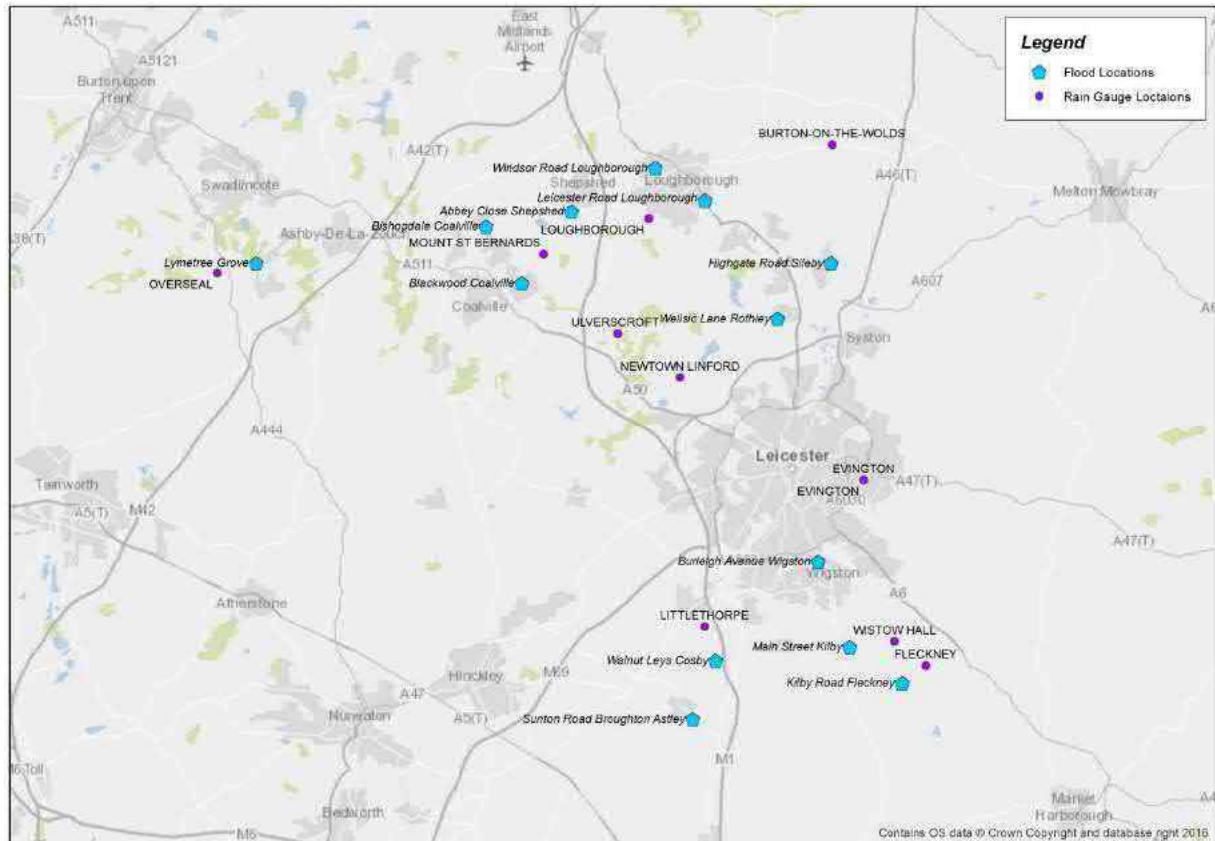
Figure 3-1: Location of flooding incidents and rainfall gauges

The Environment Agency provided hourly and daily total rainfall data for 10 rainfall gauges across the study area. However, only six of these rainfall gauges were appropriate to use for data analysis purposes due to the time period of the available data. Figure 3.1 shows the location of rainfall gauges and flooding incidents.

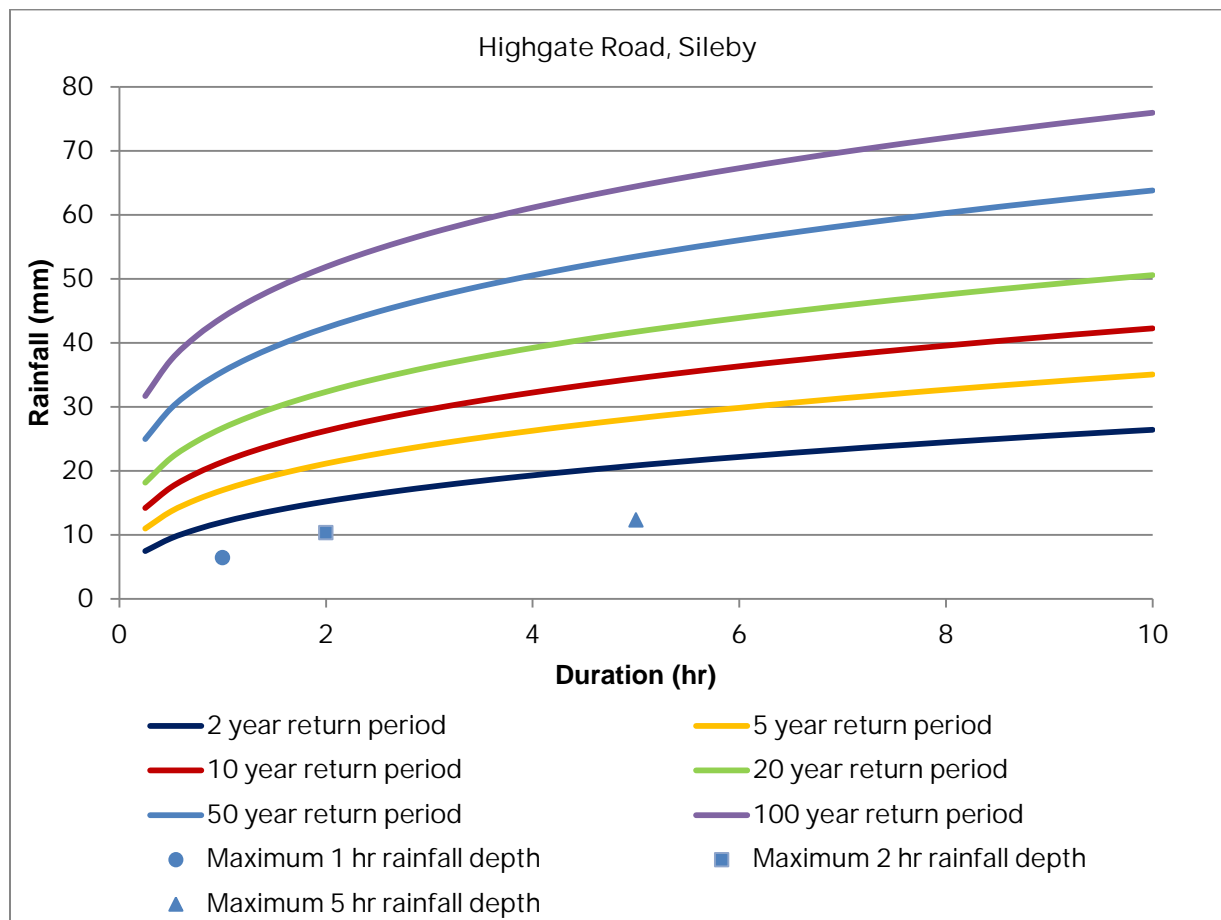
**Figure 1: DDF model for Highgate Road, Sileby**

The DDF model demonstrates that the 1 hour, 2 hour and 5 hour rainfall profiles over the Sileby catchment had an equivalent return period of less than 2 years, or a more than 50% Annual Exceedance Probability (AEP). However, it should be noted that the 2 hour rain event at Evington had a return period of between 2 and 5 years, so the rain event here may have been a little higher than the average value given above.
