Flood Investigation Report

BUCKTHORN WAY, GREAT GLEN

23rd DECEMBER 2019

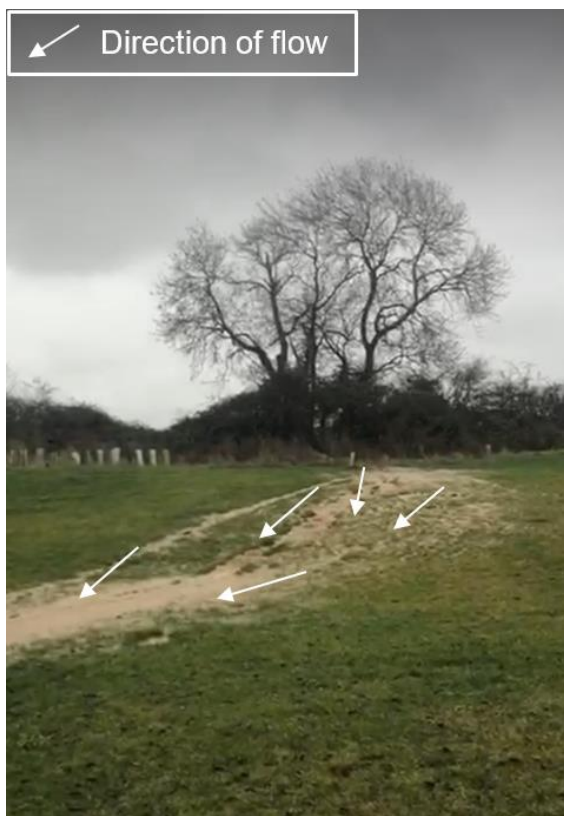
It was anecdotally reported that on 23rd December 2019, surface water flowed over the fields beyond the eastern boundary of the site towards a pond which sits on the eastern site boundary, this surface water ran through the public open space towards the impacted residential properties in a westerly direction. The water followed the Stretton Glen development sites topography and built up in the front driveways of the property before breaching the properties through the front doors. This surface water flow path is illustrated in Photos 1 and 2.

Photo 1: Surface water flow path from the development site easterly boundary towards homes on Buckthorn Way (uphill view)

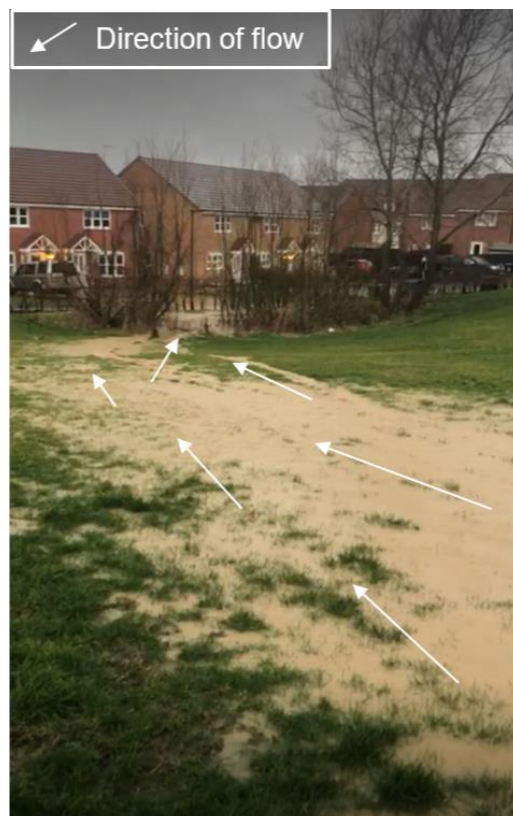
Photo 2: Surface water flow path from the development site easterly boundary towards homes on Buckthorn Way (downhill view)

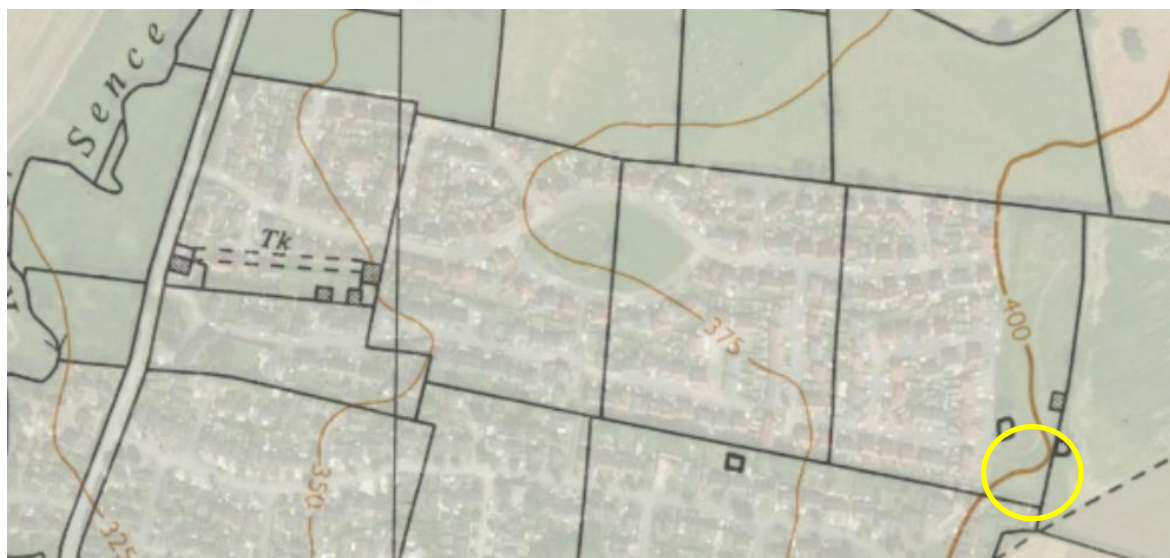
Historical mapping (Figure 4) supports that there were several ponds on the adjacent field dating back over 50 years prior to the flood event. A review of British Geological Survey maps² illustrates that there are superficial deposits of colluvium (Clay, silt, sand & gravel) placed within the glacial deposits of Diamicton. The deposit of colluvium follows an almost identical path to the surface water flow path as seen in Figure 2 and in Photos 1 and 2. Colluvium is typically known as hillwash and refers to slope-foot deposits formed as the result of runoff and creep. These deposits may indicate an area of weakness and fissure which encourages subsurface flow. Therefore, groundwater may be able to rise more easily to the surface, exacerbating overland flow as the ground is already saturated. These deposits may also be linked to the occurrence of the ponds seen on historical mapping, as these were effectively springs during wetter periods which retain the water from overland flow until this can infiltrate when ground conditions begin to dry out.

Figure 4: Current aerial photography overlain with 1955 Ordnance Survey Map (Published in 1967) highlighting ponds recorded (circled in yellow)³

The ponds on the site (Figure 4) are also referenced in the Flood Risk Assessment (FRA) written in November 2008 submitted as part of the outline planning application in 2009 (09/00536/OUT). The FRA notes that the pond to the south-east was reported to be dry at the time of inspection.

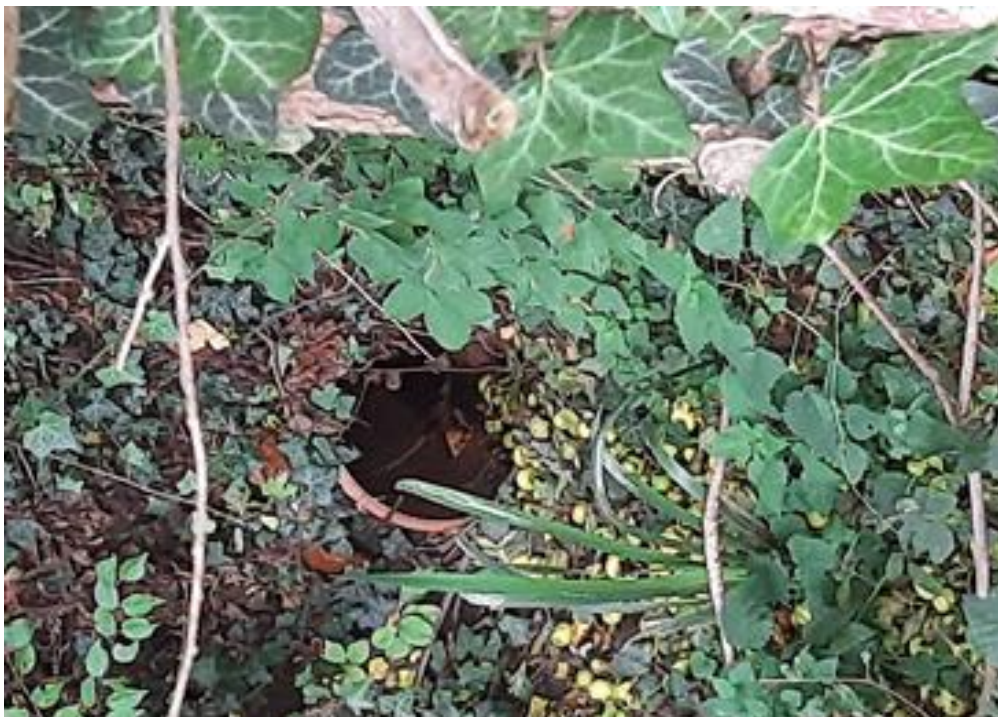
Although not hydraulically linked, during the site visit the Council also found the inlet of the section of culverted watercourse that enters the Stretton Glen development in the back garden of one of the properties on Coverside Road. It was identified that this inlet currently had no headwall (as shown in photo 3).

Photo 3: 300m culvert opening without a formal headwall which runs through the development site, as seen in purple on Figure 1

| ACTION | TIMESCALE |
|---|---|
| To install a formal headwall on the entrance to the culverted system through the Stretton Glen development following obtaining permission from the homeowner on Coverside Road. | 6 months from report publication |
