Flood Investigation Report

Storm Henk

2nd January 2024

Asfordby and Asfordby Valley

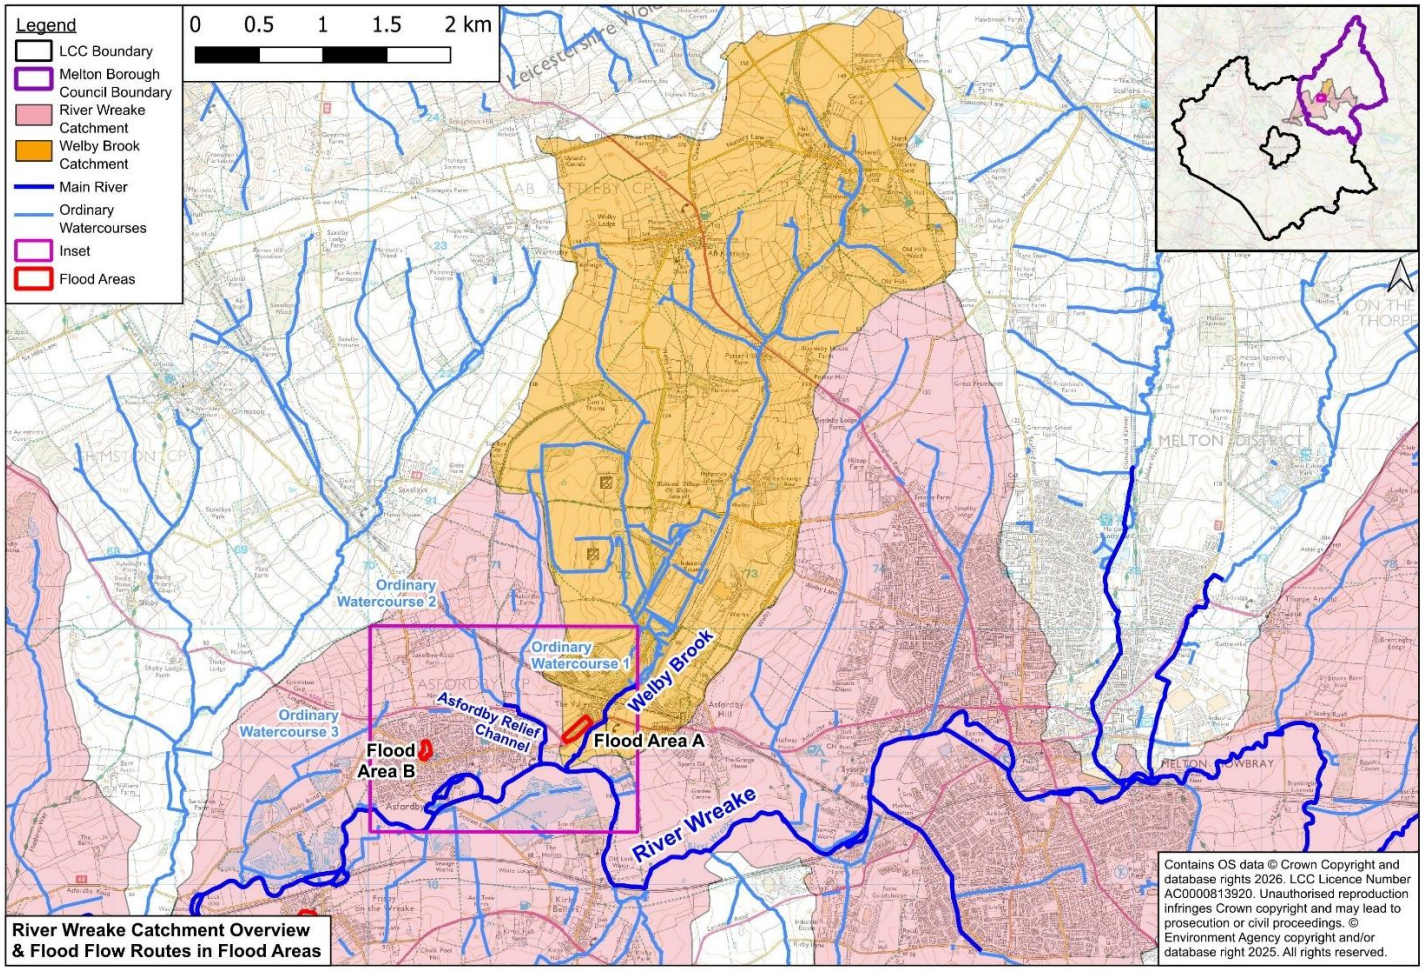
Figure 12-1: Asfordby and Asfordby Valley Location Plan, relevant Watercourse Catchment (INSET 5)

The River Wreake (an EA designated Main River) flows in a south-easterly direction to the south of Asfordby and Asfordby Valley as illustrated in Figure 12-1. Another Main River, Welby Brook, flows in a south-westerly direction alongside Welby Road and joins the River Wreake downstream of Asfordby Valley at Ordnance Survey national grid reference (OSNGR) SK 71565 18885. The responsible agency for managing the risk from Main Rivers is the EA. Details relating to RMA responsibilities can be found in Section 21 of the main Storm Henk report.

Flood Area A is located within the catchment area draining directly to Welby Brook (as illustrated in Figure 12-1), which is predominantly rural, but relatively steep**,** characteristic of flashy runoff. Its catchment area comprises 11.2km^2 at its confluence with the River Wreake.

It is therefore concluded that the intense rainfall event generated a large volume of overland flow of surface water on the highway that followed the local ground levels downhill southwards along the easiest route of the highway (as illustrated in Figure 12-1). It then ponded at the bottom of the hill where the limited highway drainage was overwhelmed, a gully became blocked, and was unable to drain the water away sufficiently. Ponded floodwater then accumulated and exceeded the threshold of one adjacent property, located at a low point, via their driveway flooding it internally. Two additional properties also flooded externally as a result of water flowing down Saxelby Road. The location of these coincides with the area at high risk along Saxelby Road identified in the RoFSW map (Figure 12-5).

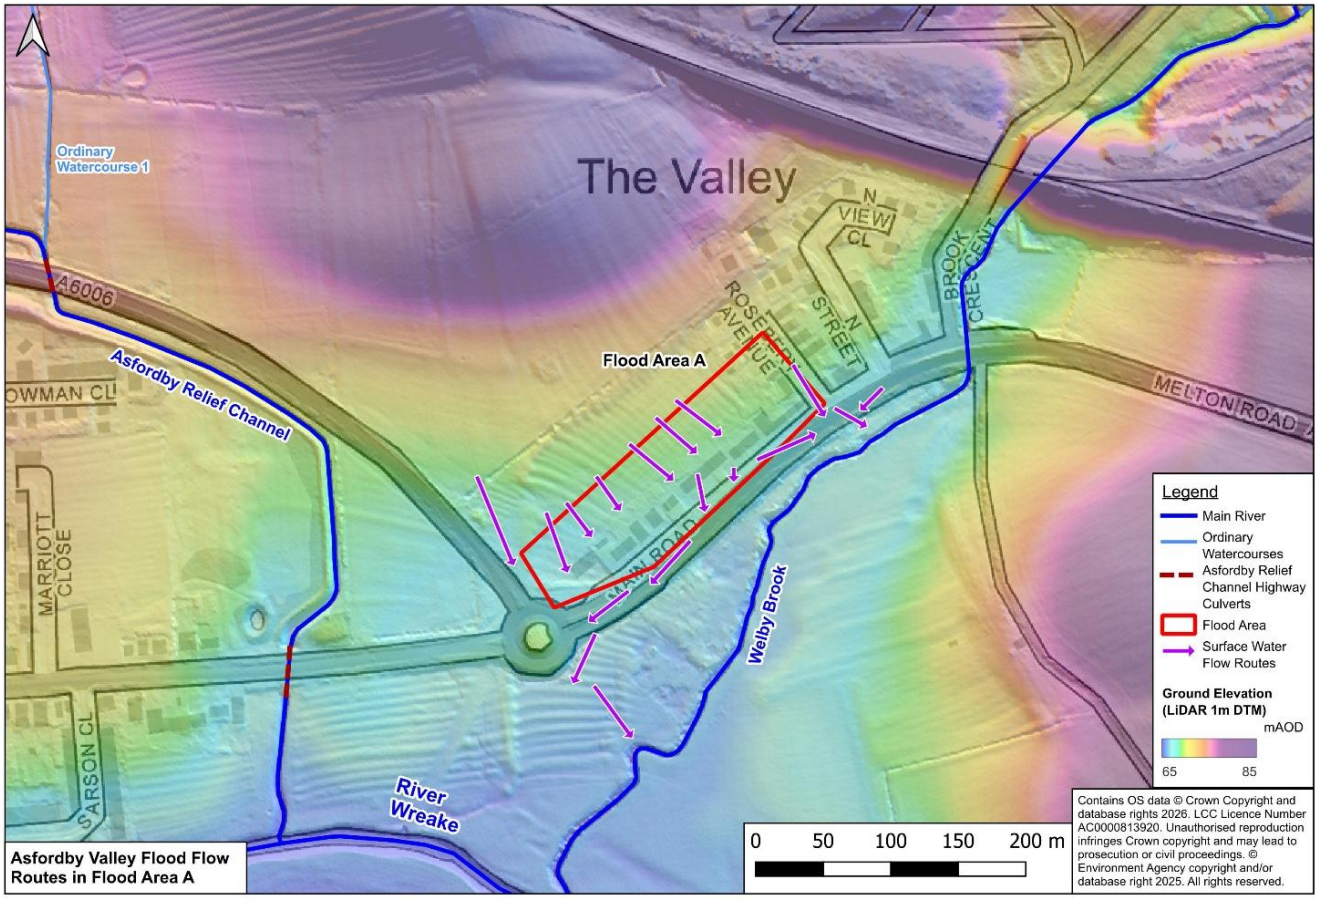
Figure 12-2: Asfordby Valley Flow Routes through Flood Area A (INSET 5)

Where these watercourses enter Asfordby, they were channelised eastwards alongside the A6006 Bypass and converge becoming the Asfordby Relief Channel which conveys flows beneath the Bypass within a culvert (Figure 12-2). Asfordby village has suffered from significant flooding in the past from overland flow generated in higher areas of land to the north, notably during Easter 1998. The Asfordby Relief Channel, constructed around the year 2000, has helped reduce the risk of flooding. This relief channel reappears as an open channel downstream of the Bypass and flows through the eastern edge of Asfordby. It passes beneath Main Street within a second culvert and continues southwards as an open channel discharging into the River Wreake approximately 235m downstream of Welby Brook/River Wreake confluence (Figure 12-2).

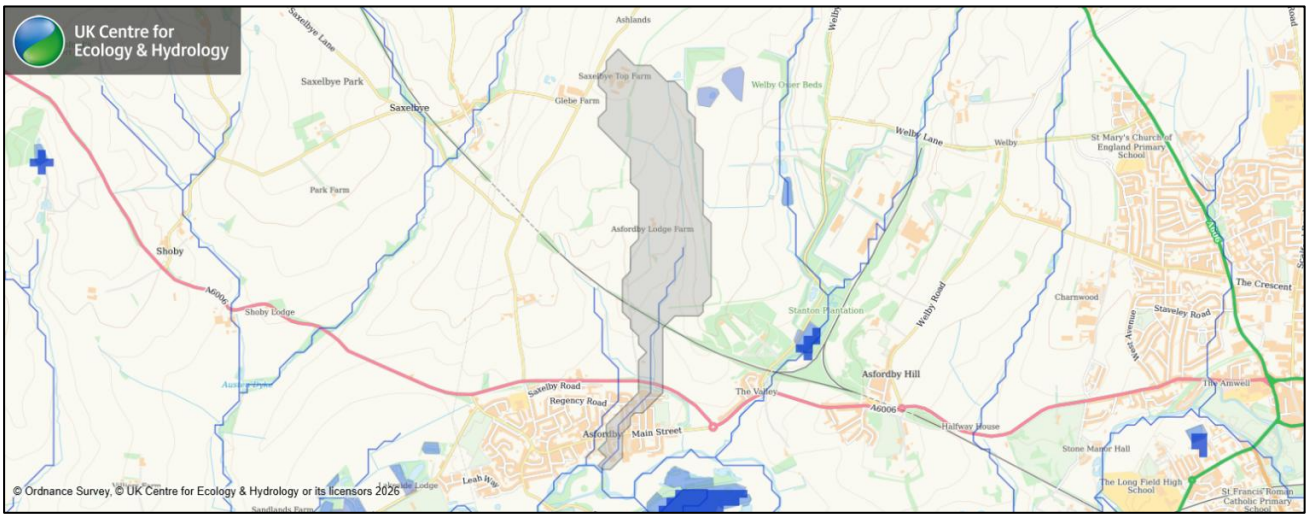
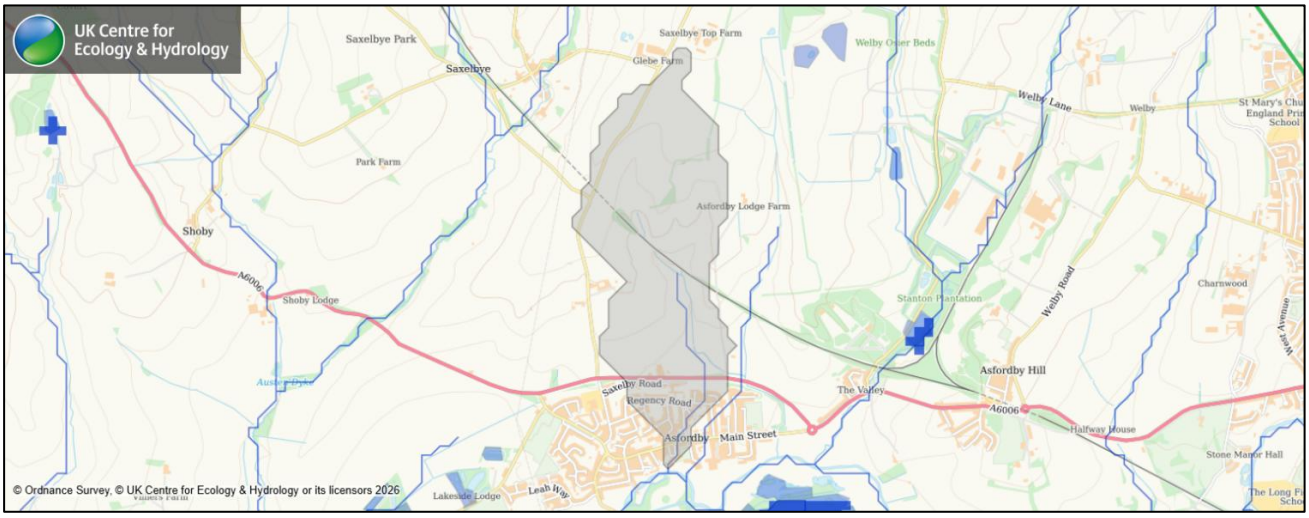
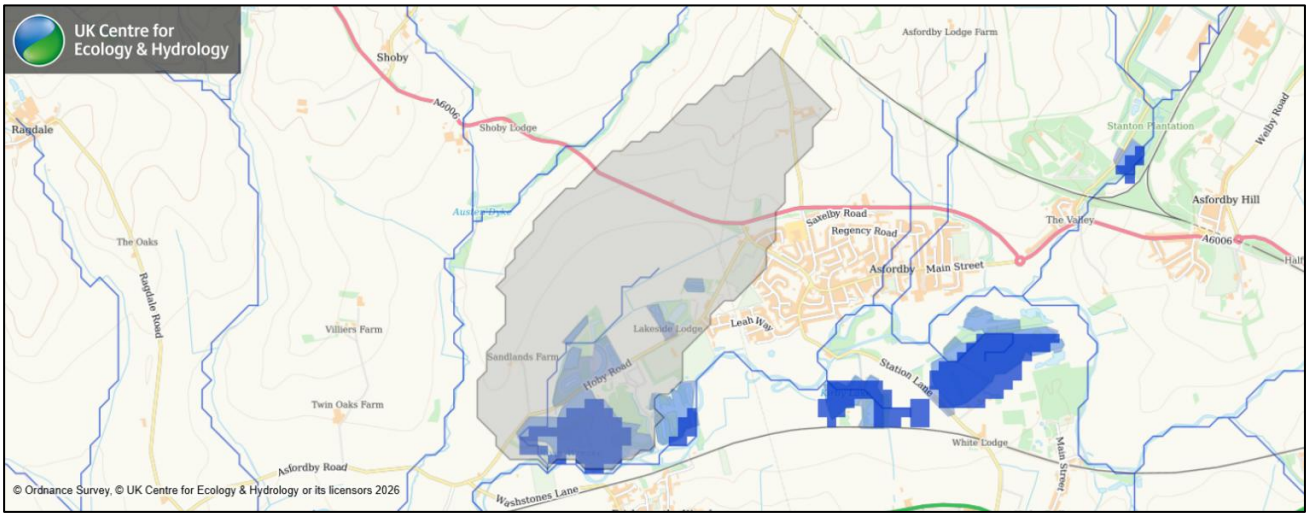
Figure 12-4: FEH Web Service Catchment Extents of Ordinary Watercourses 1 and 2 (1. and 2.) east of Asfordby, and Ordinary Watercourse 3 west of Asfordby (3.) upstream of A6006

The UK Centre for Ecology & Hydrology's Flood Estimate Handbook (FEH) Web Service[1] provides strategic level catchment mapping for the tributary watercourses of the River Wreake in the vicinity of Flood Areas A and B, as illustrated in Figure 12-4.

The two un-named ordinary watercourses north east of Asfordby drain rural catchment areas southwards to the A6066 bypass road (as illustrated in Figure 12-4). That to the east, Ordinary Watercourse 1 drains a catchment of 0.89km^2 to the River Wreake, and that to the west, Ordinary Watercourse 2 drains a catchment of 1.2km^2 to the River Wreake. However, these are not open channels flowing through Asfordby as illustrated by the FEH Web Service.

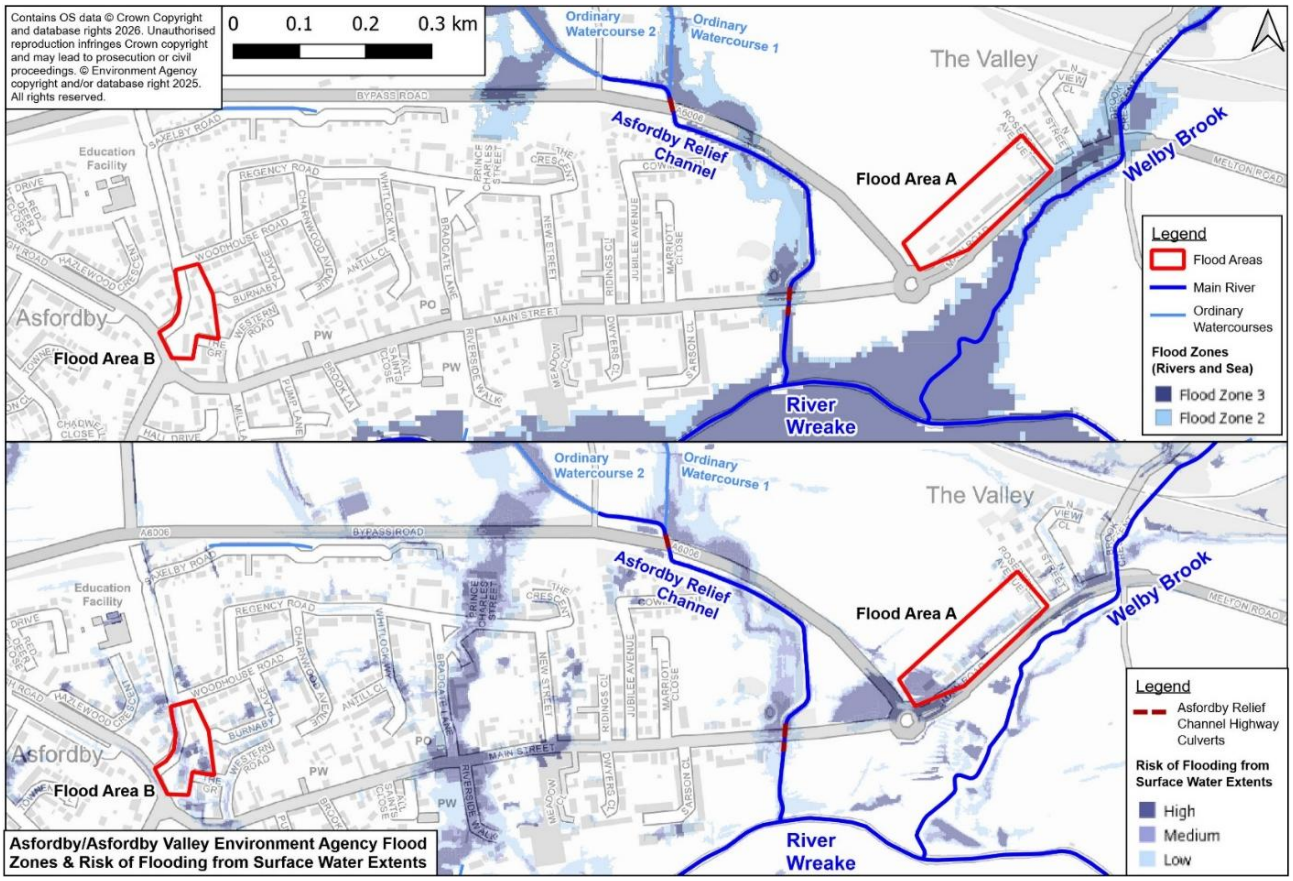
Figure 12-5: Asfordby and Asfordby Valley EA Flood Map for Planning Flood Zones[3] and Risk of Flooding from Surface Water Extents[4] in Flood Areas (INSET 5)

Flood Area A north of Main Road is entirely located within Flood Zone 1 (low risk of river flooding) from Welby Brook. However, the central and south-western extent of Flood Area A is located within an area identified as being at medium to high risk of surface water flooding.

Flood Area B at Saxelby Road is located within Flood Zone 1 from the River Wreake (low risk) of river flooding and within an area identified as being partially at a low, medium and high risk of surface water flooding, and within as illustrated in Figure 12-5.

During the high-intensity rainfall event on 2nd January 2024, the land drainage quickly became overwhelmed. Pre-existing soil saturation within agricultural land rapidly reduced infiltration capacity, resulting in accelerated surface runoff towards the River Wreake. The flooding which occurred in Flood Areas A and B closely matches the predicted outlines of the EA's RoFSW mapping, as shown in Figure 12-5.
