Flood Investigation Report

Storm Henk

2nd January 2024

Frisby on the Wreake

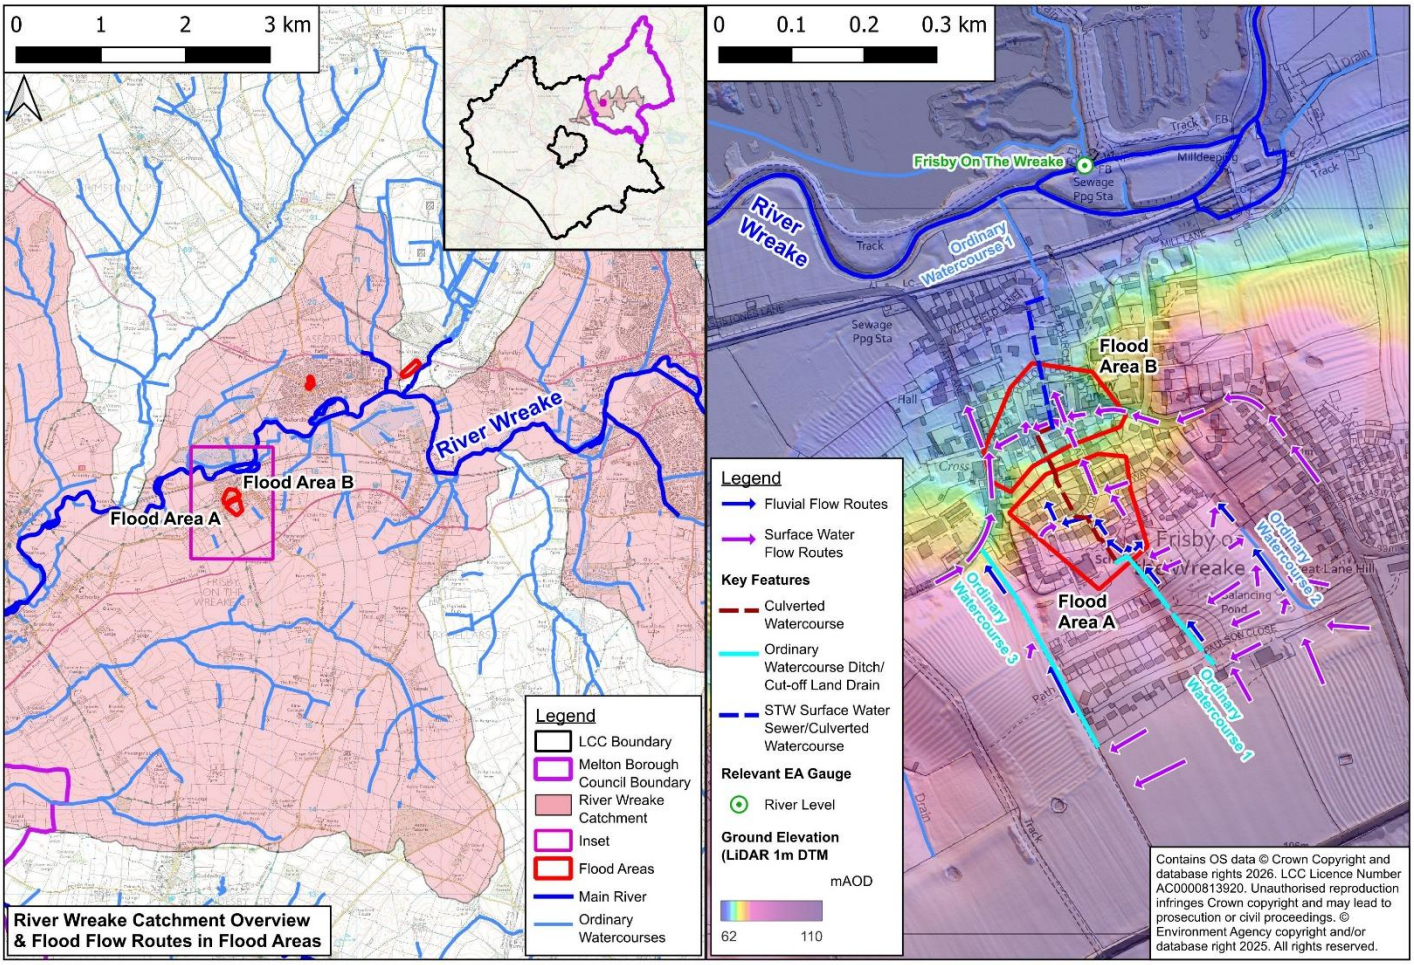
Figure 6-1: Frisby on the Wreake Location Plan, relevant Watercourse Catchment and Flow Routes through Flood Areas (INSET 4)

The high-intensity heavy rainfall from Storm Henk (see Section 2.3 of the main Storm Henk report) fell on an already saturated steep sided catchment resulting in significant surface water overland flow across agricultural fields, various sections of the highway and through gardens and private land converging at the centre of the village around Main Street (as illustrated on Figure 6-1). The volume of rainfall overwhelmed the entire local drainage network.

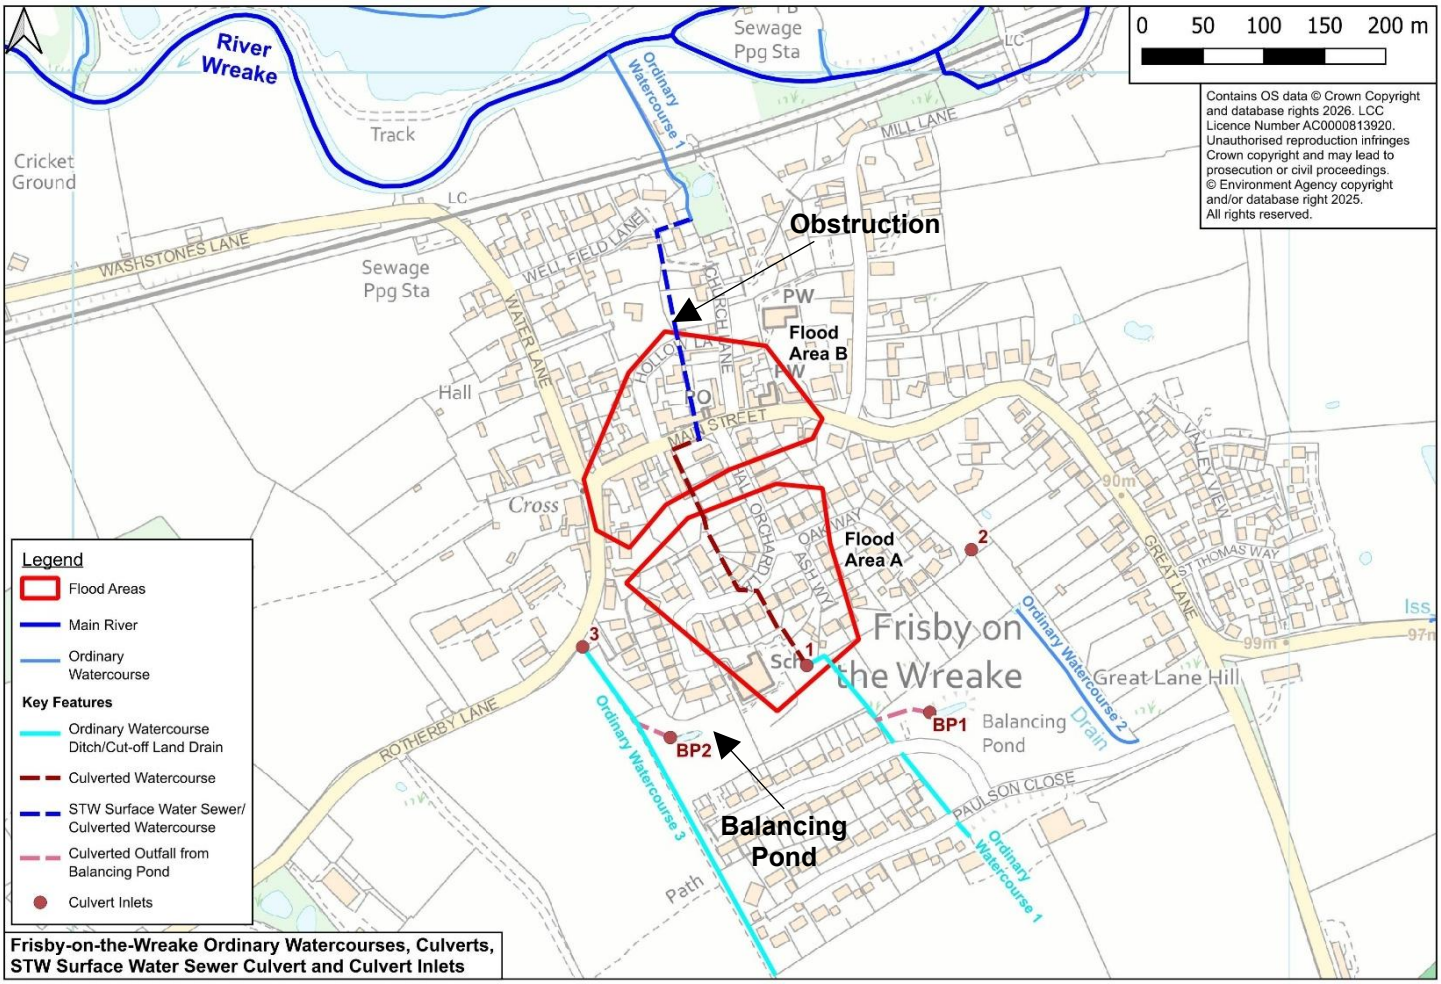
Figure 6-2: Frisby on the Wreake locations of culverted watercourse and key features (culvert inlets, balancing pond (BP) outfalls and obstruction in public surface water sewer)

As it flows through the school land it then takes a 90 degree bend west before entering a 225 dia surface water culvert adjacent to the rear of gardens of properties along Ash Way (at OSNGR SK 69602 17512) (identified as Inlet 1 on Figure 6-2 and depicted in Photograph 6-1). The inlet to the culverted section is protected by an informal trash screen which is owned and maintained by Frisby C of E Junior School and the riparian landowner.

Following the flood event, STW commissioned a camera and cleanse of the public sewer network in the village. This included the section of 600mm brick culvert flowing north from the centre of the village to its outfall. The survey could not be completed in its entirety due to a near complete obstruction of the 600mm brick culvert due to a root mass near Hollow Lane. This obstruction was later removed, with an access manhole installed in Hollow Lane to improve future maintenance access. STW were not aware of this obstruction prior to Storm Henk and had received no reports of any concerns relating to this culvert prior to the flood event. It is therefore not known how long the obstruction had been present or to what extent it covered the culvert before the flood event. No previous reports of flooding were made to either STW or LCC, suggesting there may not have been a complete obstruction.

It is believed that the obstruction in the 600mm brick culvert most likely caused the local drainage network upstream of this obstruction to surcharge, via existing manholes and the highway drainage system as the water could not get away quick enough. No evidence was found during the investigation of any further obstructions downstream and the outfall of the culvert was also found to be unimpeded.

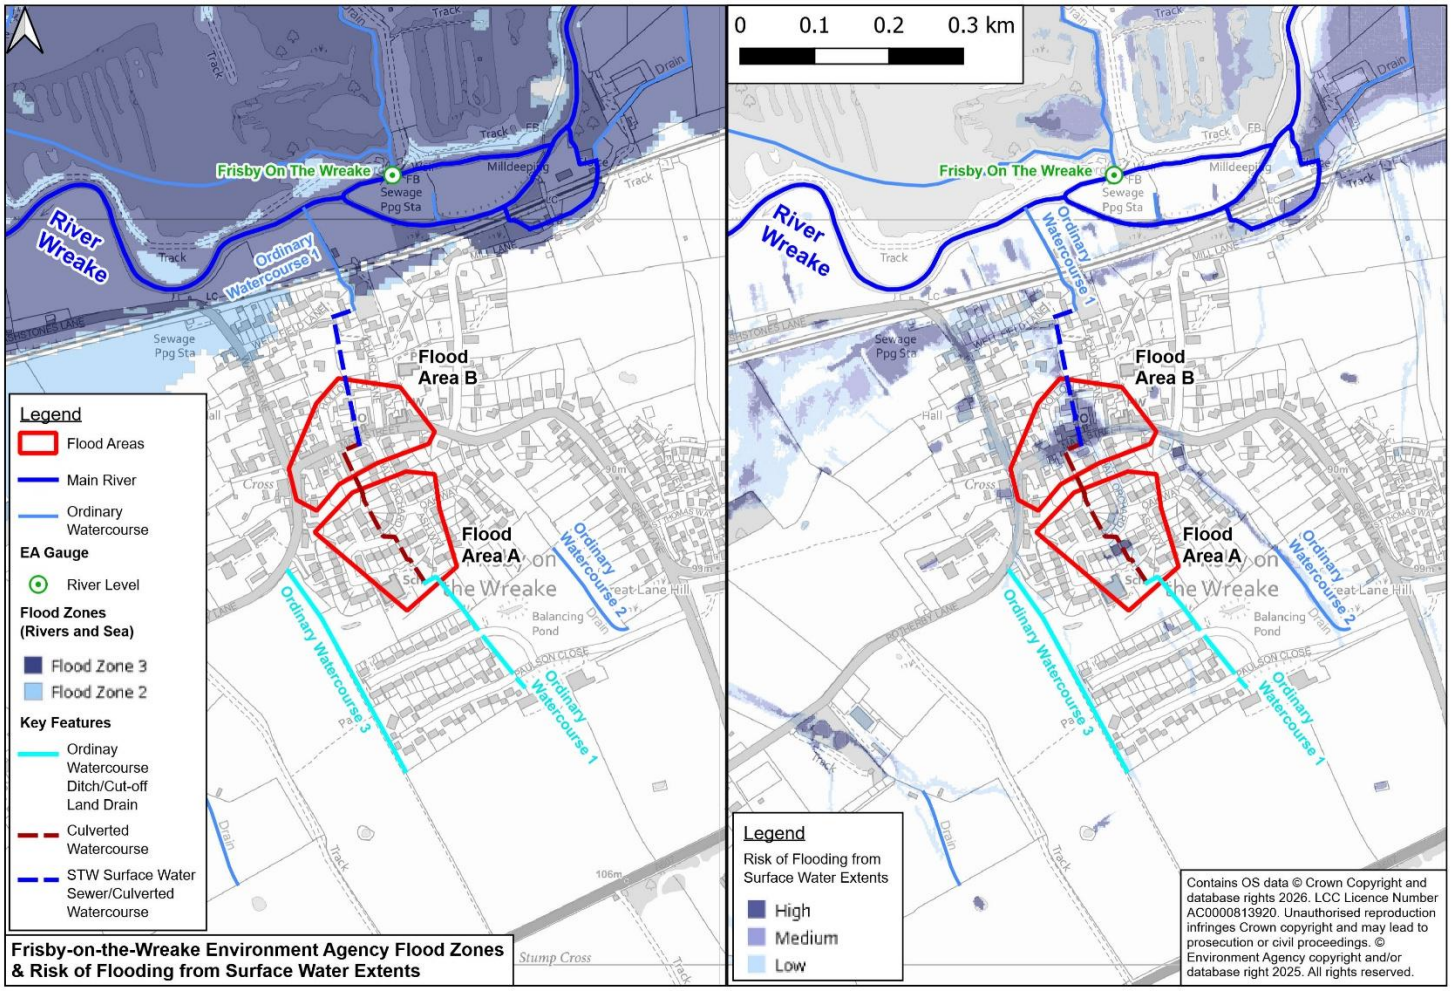
Figure 6-3: Frisby on the Wreake EA Flood Map for Planning Flood Zones[5] and Risk of Flooding from Surface Water[6] Extents in Flood Areas (INSET 4)

The EA provides flood risk mapping nationally for both rivers and surface water as detailed within Section 2.7.6 of the main Storm Henk report. The EA's Flood Map for Planning (NaFRA2) identifies that Flood Areas A and B are both entirely located within Flood Zone 1 (low risk, less than a 0.1% annual chance of flooding from rivers and the sea) as illustrated in Figure 6-3.

The EA's Risk of Flooding from Surface Water (RoFSW) map (NaFRA2) identifies that there is a high, medium and low risk of surface water flooding across the village, as illustrated in Figure 6-3. In particular, south of Orchard Lane (Flood Area A) and along Main Street northwards (Flood Area B). This risk however within the high level RoFSW mapping can be exacerbated by localised ground elevations, the presence of drainage infrastructure not included in the modelling, or drainage infrastructure limitations which are not always implicitly represented.

The flooding which occurred in Flood Area A closely matches the predicted surface water flooding as identified in the EA's RoFSW map illustrated in Figure 6-3.

The locations of internal flooding and flood extents which occurred in Flood Area B closely match the predicted surface water flooding as identified in the EA RoFSW, illustrated in Figure 6-3. The national RoFSW model (NaFRA2) does not provide detailed representation of below-ground drainage networks within the village, only an allowance for the losses for averaged infiltration rates they provide.
