Leicestershire County Council

Flood Investigation Report

Storm Henk

Quorn

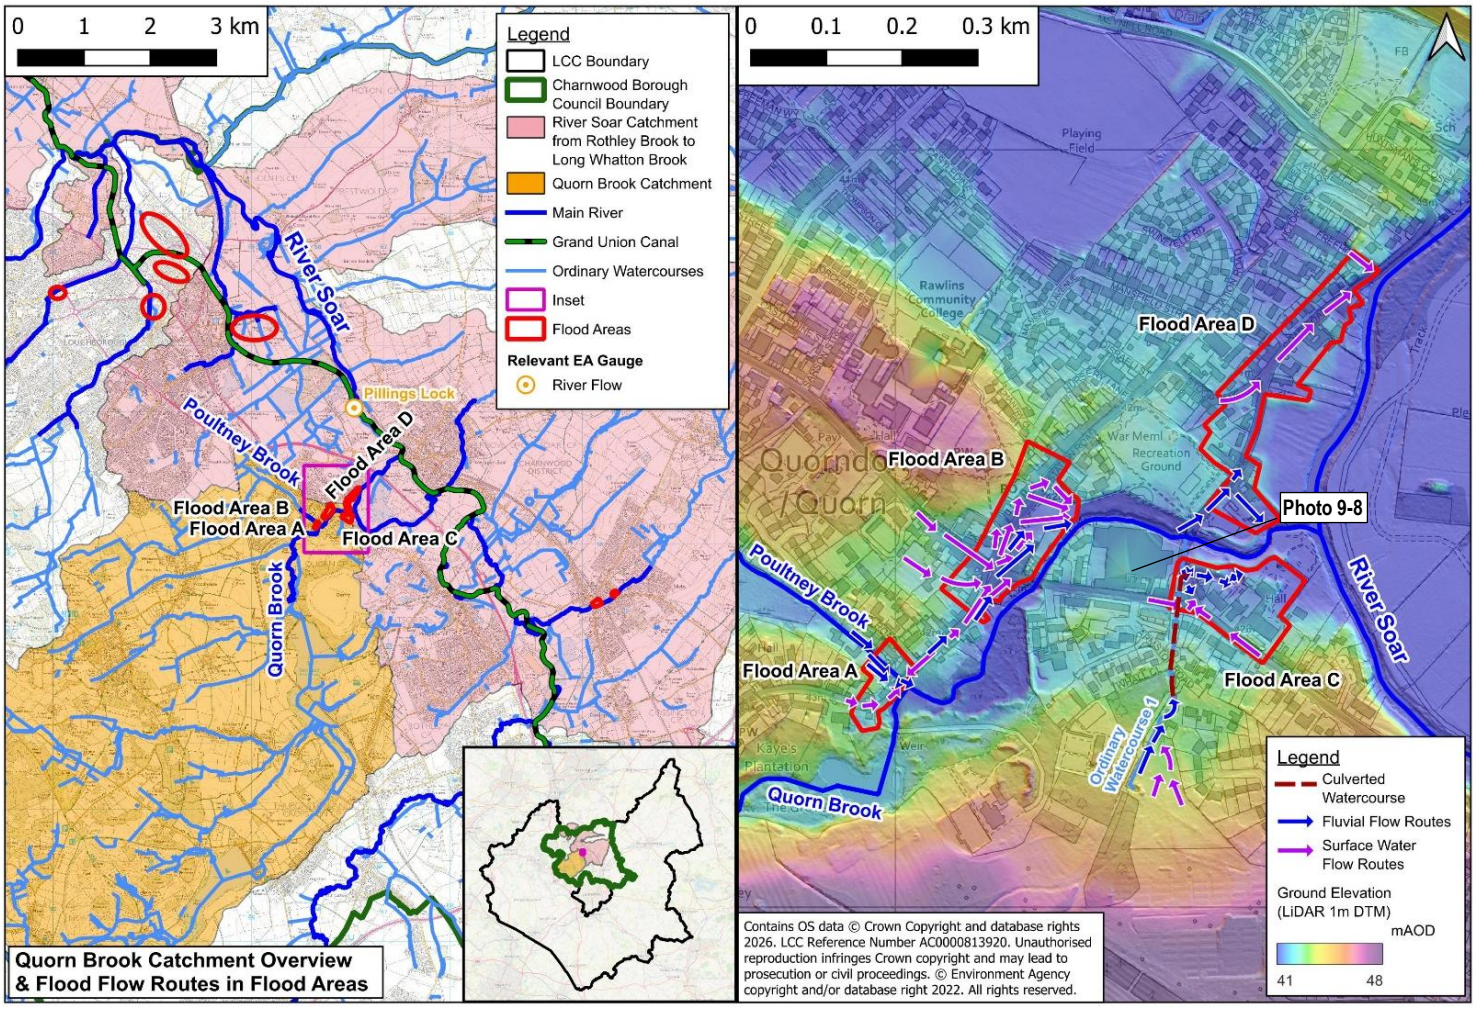
Figure 9-1: Quorn Location Plan, relevant Watercourse Catchments and Flow Routes through Flood Areas (INSET 2)

The following sub-sections of the report consider the local flood routing and impacts within each of the four Flood Areas A to D identified in Figure 9-1 within the town centre.

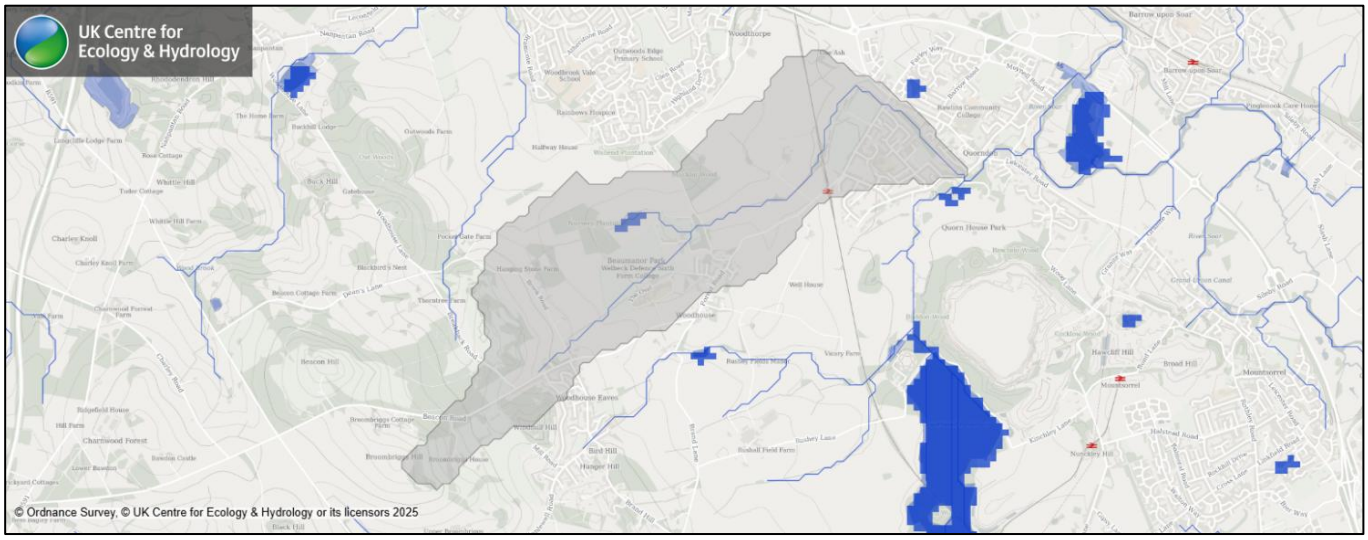
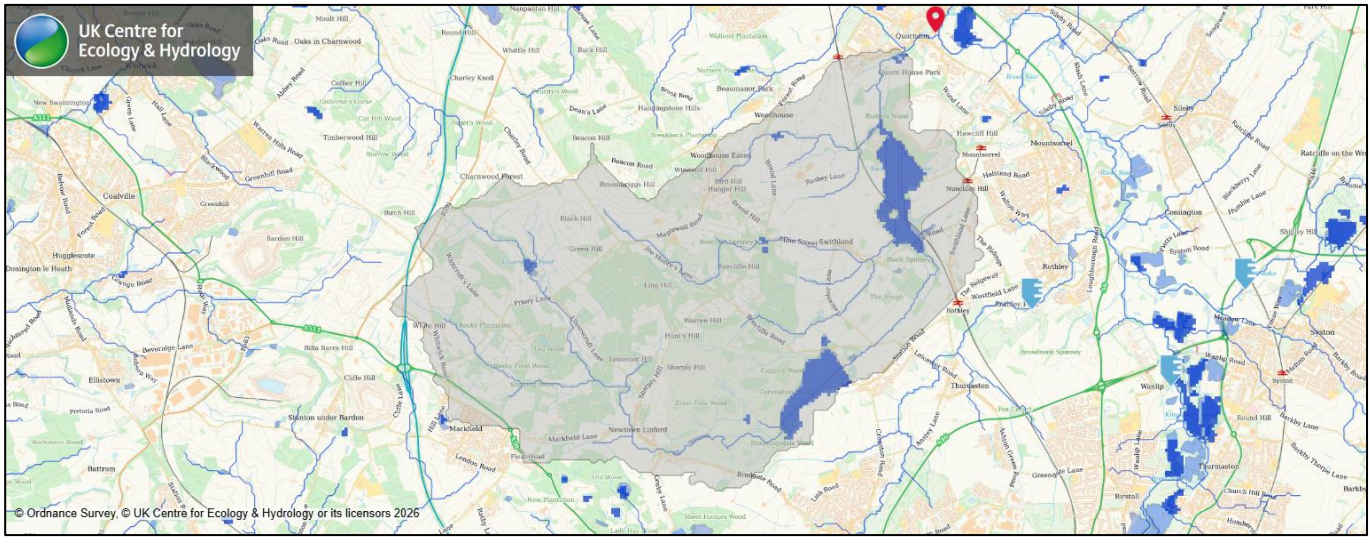
Figure 9-2: FEH Web Service Catchment Extents of Poultney Brook (1.) and Quorn Brook (2.) upstream of their Confluence

The UK Centre for Ecology & Hydrology’s Flood Estimate Handbook (FEH) Web Service[3] defines this catchment down to the River Soar as 45.6 km² as shown on Figure 9-2. The FEH Web Service estimates the catchment area at its confluence with Poultney Brook at OSNGR SK 56017 16294 to be 40 km².

Poultney Brook, an EA designated Main River, drains a predominantly agricultural catchment northwest of the village and flows south-east through northern Quorn. It joins Quorn Brook immediately downstream of Meeting Street. The FEH Web Service identifies this sub-catchment area as 4.82 km² (as illustrated in Figure 9-2). The brook is open for most of its length but becomes heavily constrained by garden boundaries and channelisation where it runs parallel to Sanders Road. The lower 350 m upstream of the confluence with Quorn Brook is classed as Main River; the remainder upstream is an ordinary watercourse.

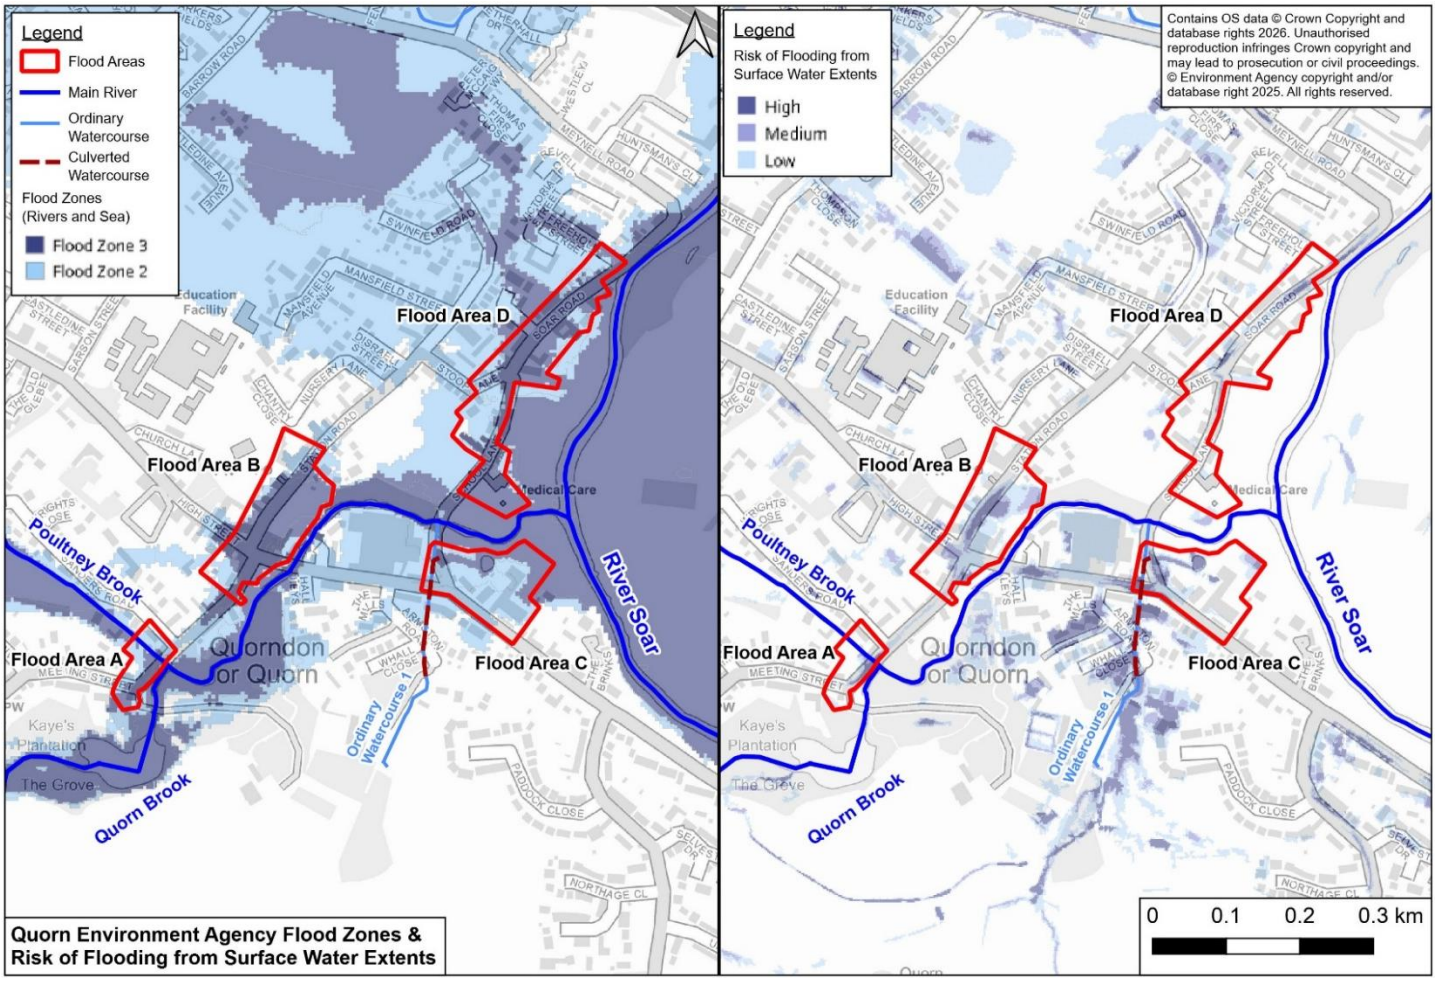
Figure 9-4: Quorn EA Flood Map for Planning Flood Zones[8] and Risk of Flooding from Surface Water Extents[9] in Flood Areas (INSET 2)

Parts of the Flood Areas defined in this investigation are also identified as being at a high, medium and low risks of flooding in the national EA Risk of Flooding from Surface Water (RoFSW) map (NaFRA2), as illustrated in Figure 9-4. These include high risk areas along Meeting Street, Station Road, School Lane and Soar Road.

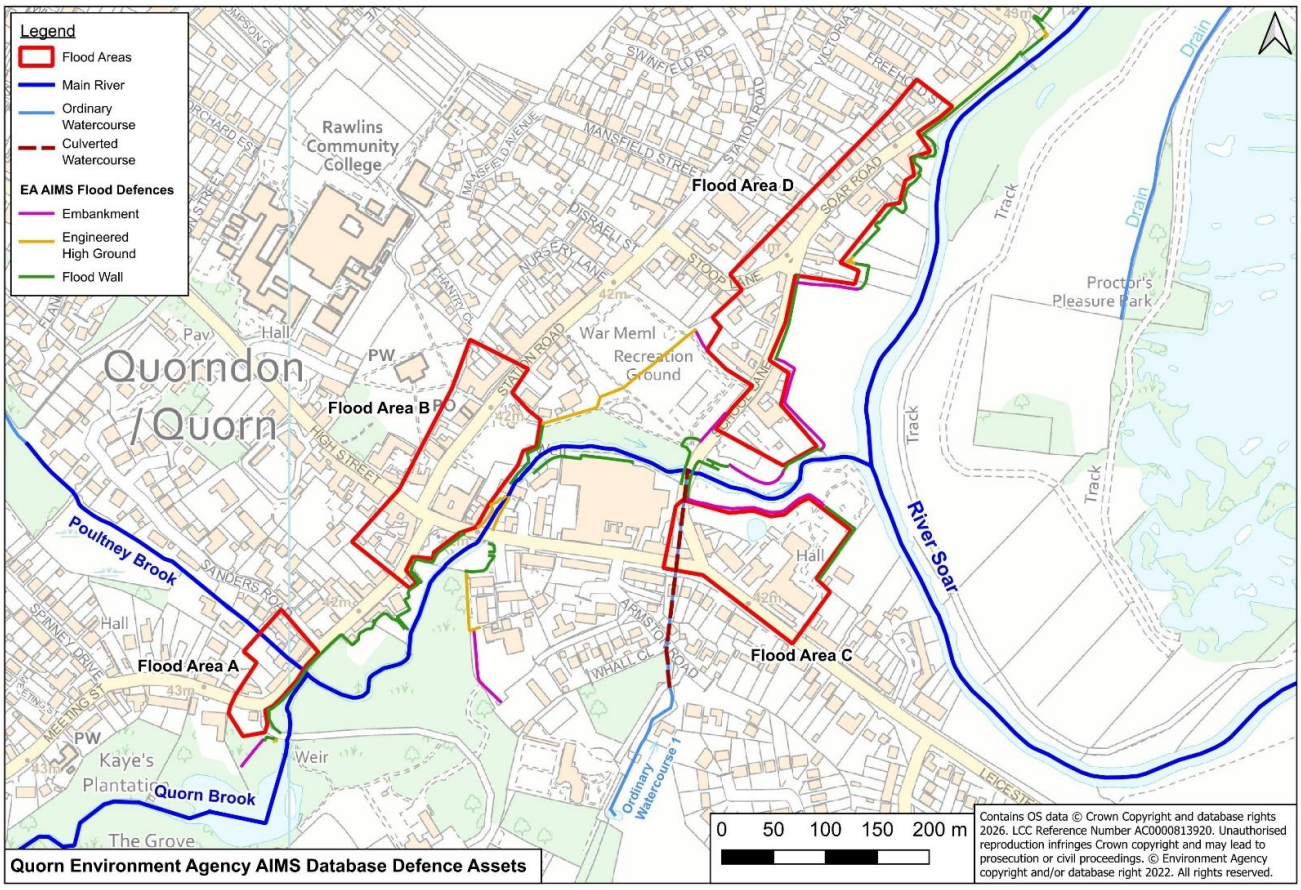
Figure 9-5: Flood Risk Management Assets in Quorn from the EA Asset Information Management (AIMS) Database

The flood risk management assets in Quorn, as illustrated in Figure 9-5, form part of the wider flood defence system along the River Soar, and their condition is recorded by the EA as ranging from 'Poor', 'Fair' and 'Good'. The current condition of the assets of interest for this investigation is detailed in Table 9-1 below. The EA confirm that those defences with classifications 'Poor' and 'Fair' have inspection records indicating ongoing maintenance and monitoring.

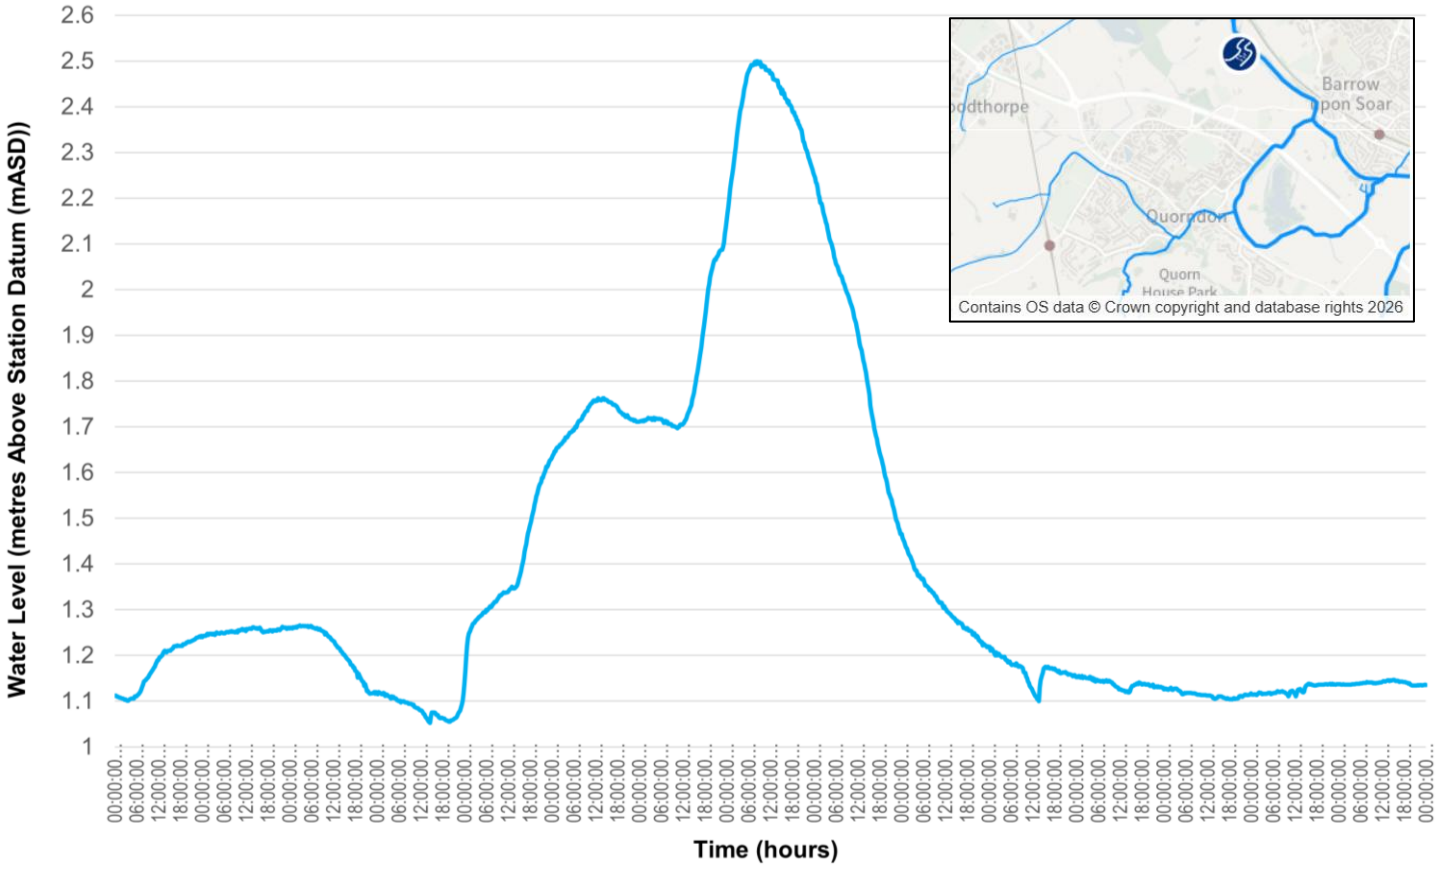
Figure 9-6: River Soar at Pillings Lock Gauge (Station ID 4093) - Water Levels from 00:00 hours on 27/12/2023 to 00:00 hours on 11/01/2024

The peak **river level** on the Soar at Pillings Lock during Storm Henk was recorded as 2.50 metres above the gauge station datum (mASD) at 08:15hrs on 3rd January 2024, as illustrated in Figure 9-6. The previous highest recorded river level was 2.25mASD on 11th April 1998, the same date as the record river flow.

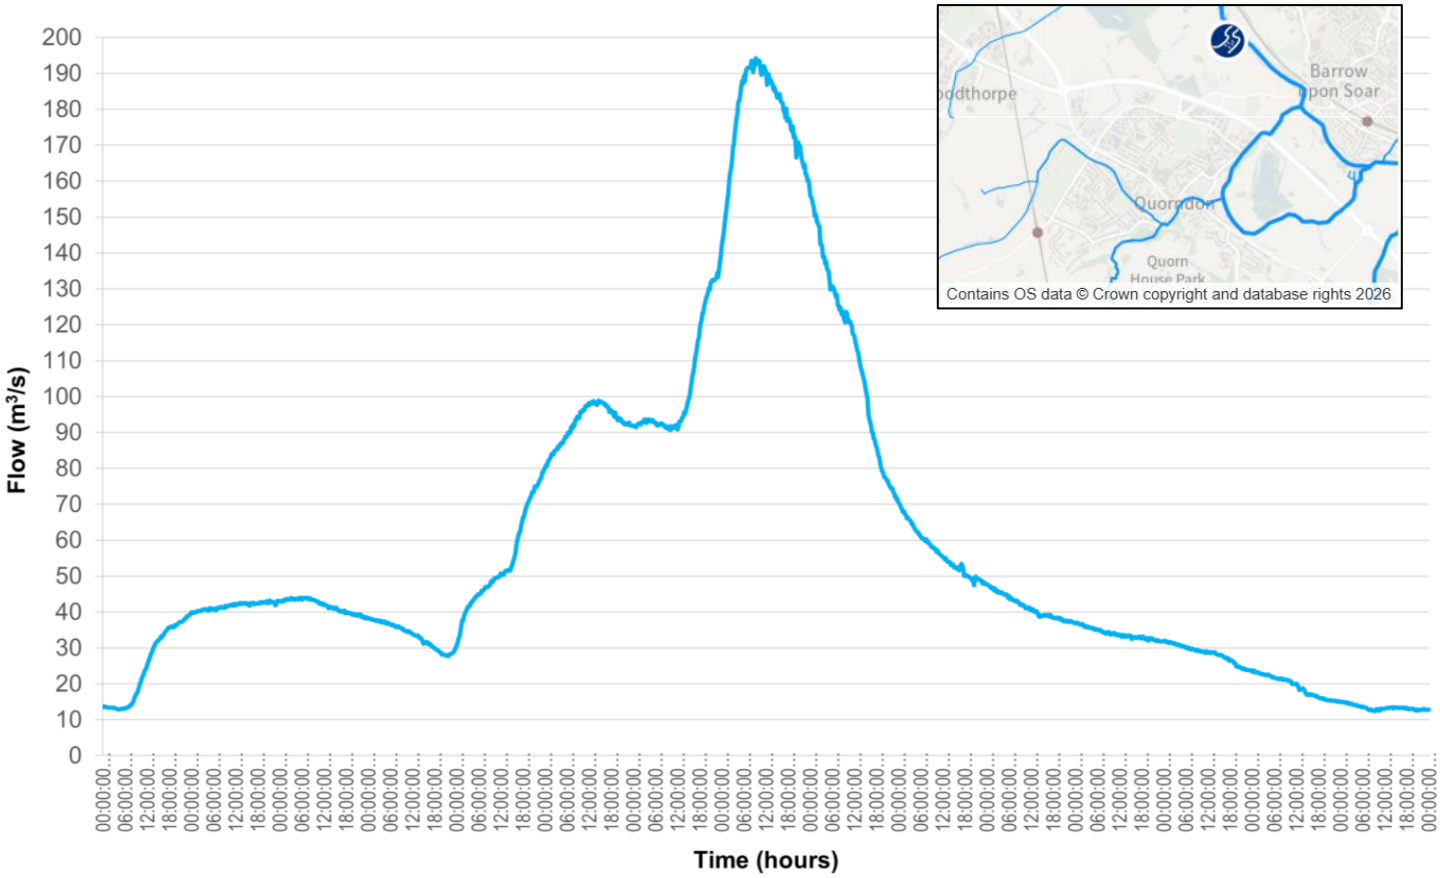
Figure 9-7: River Soar at Pillings Lock Gauge (Station ID 4093) - Flows from 00:00 hours on 27/12/2023 to 00:00 hours on 11/01/2024

The previous record **peak flow** was recorded during the Easter 1998 flood event (190.34m^3/s at 08:00hrs on 11th April). During Storm Henk, flows exceeded this at 06:30hrs on Wednesday morning, 3rd January 2024, peaking at an estimated 194.19 m^3/s at 09:15hrs as illustrated in Figure 9-7.
