Flood Investigation Report

Packington

18th September 2023

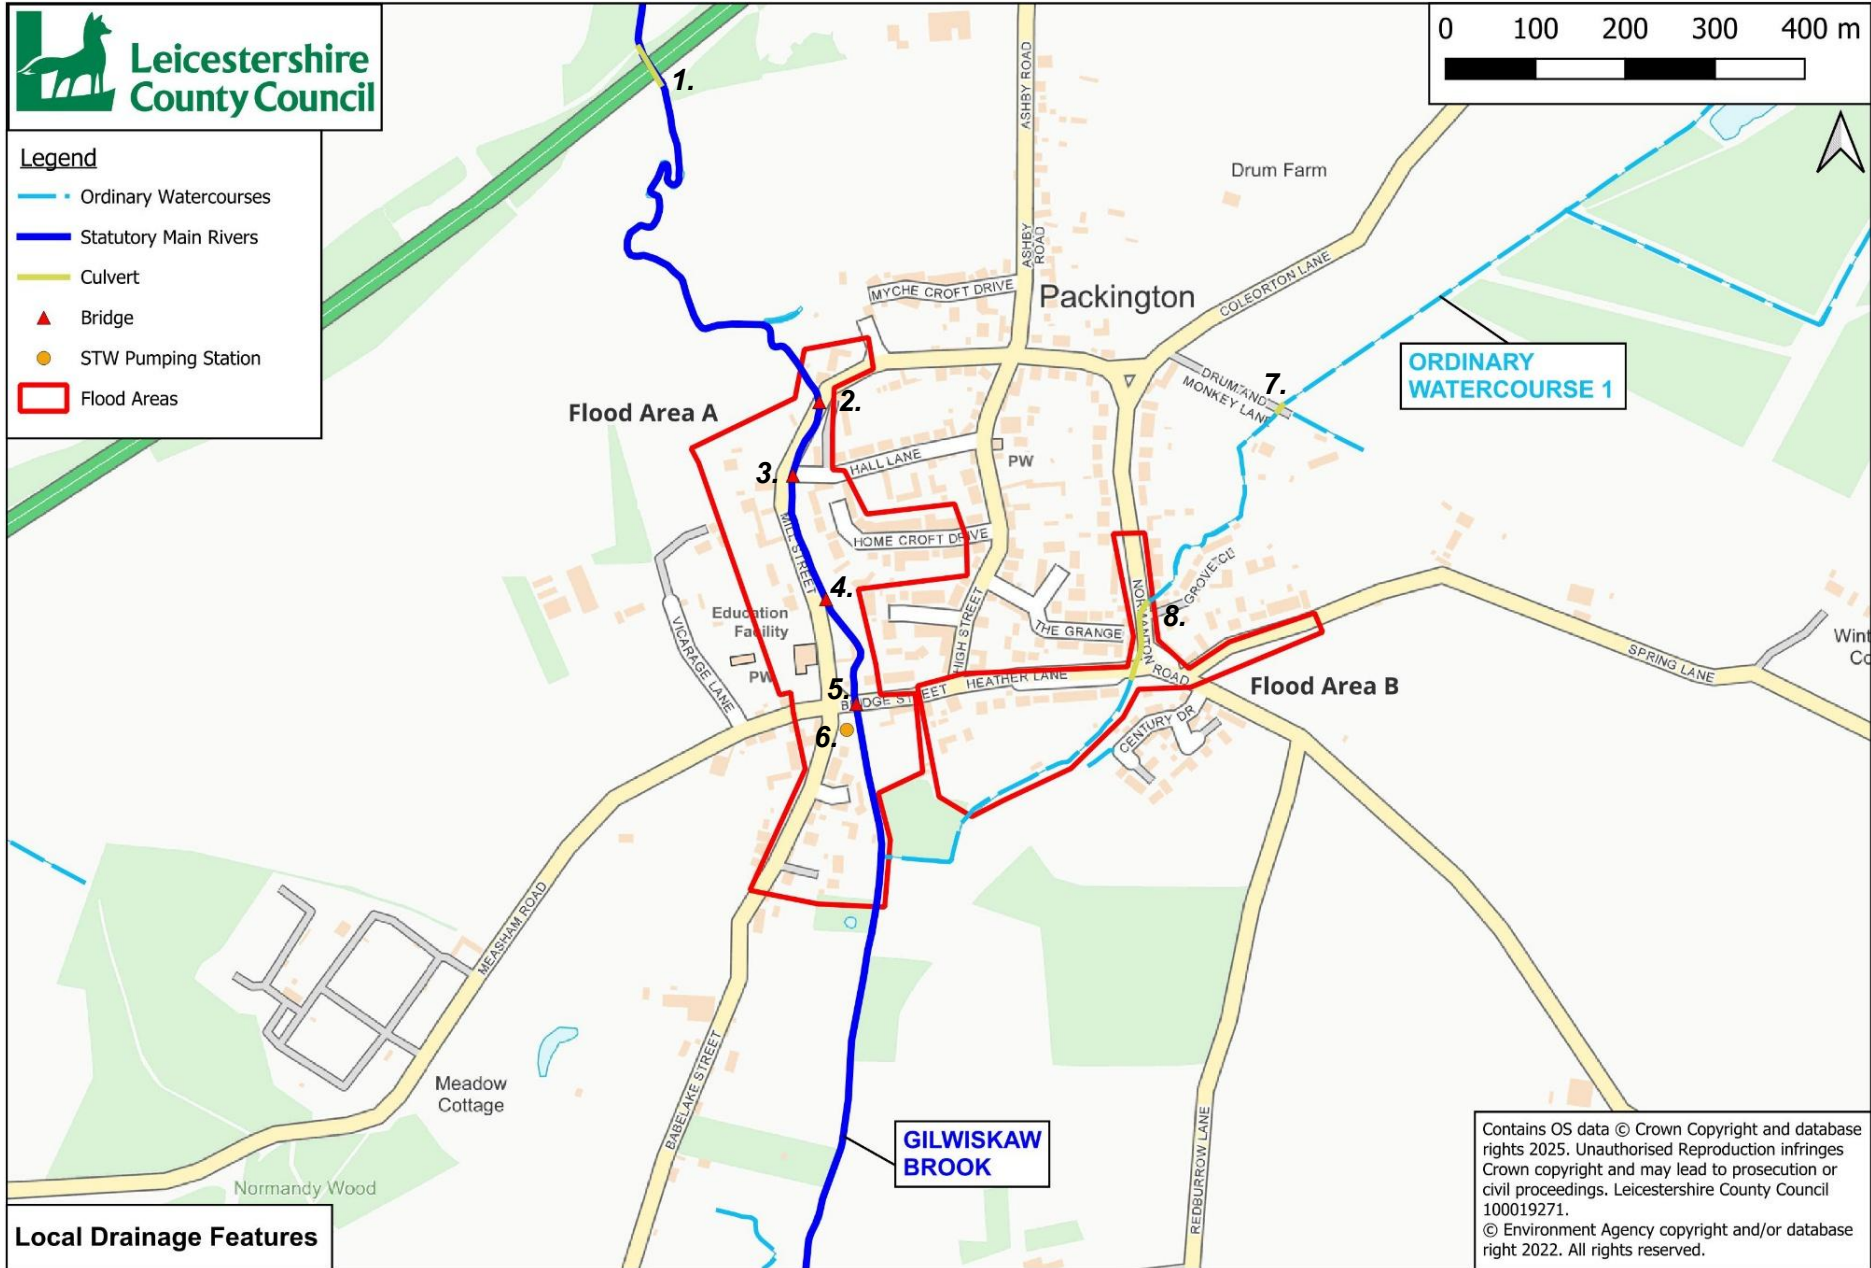
Figure 2: Local Drainage Features

Within Packington, the Gilwiskaw Brook passes beneath three road bridge structures: a single-span brick arch bridge on Mill Street (3.8m wide, identified as Feature 2 on Figure 2), a twin-arch bridge on Hall Lane (two 2.45m spans, Feature 3), and another twin-arch bridge on Bridge Street (two 2.9m spans, Feature 5). Additionally, there is at least one wooden footbridge located along Mill Street, just north of Packington Church of England Primary School (identified as Feature 4 on Figure 2).

The village is served by a public sewer network, which is made up mostly of 225mm-300mm combined sewers. These combined sewers generally follow the road network and converge at the STW pumping station near Babelake Street. The pumping station (identified as Feature 6 on Figure 2) then pumps the wastewater to the Packington Treatment Works. The treated water is then released into a culverted outfall and ordinary watercourse, which joins with the Gilwiskaw Brook approximately 1.5km downstream of Packington.

There were two key areas of the village impacted by the flooding and they are discussed separately below. The Flood Areas are indicated on Figure 2.

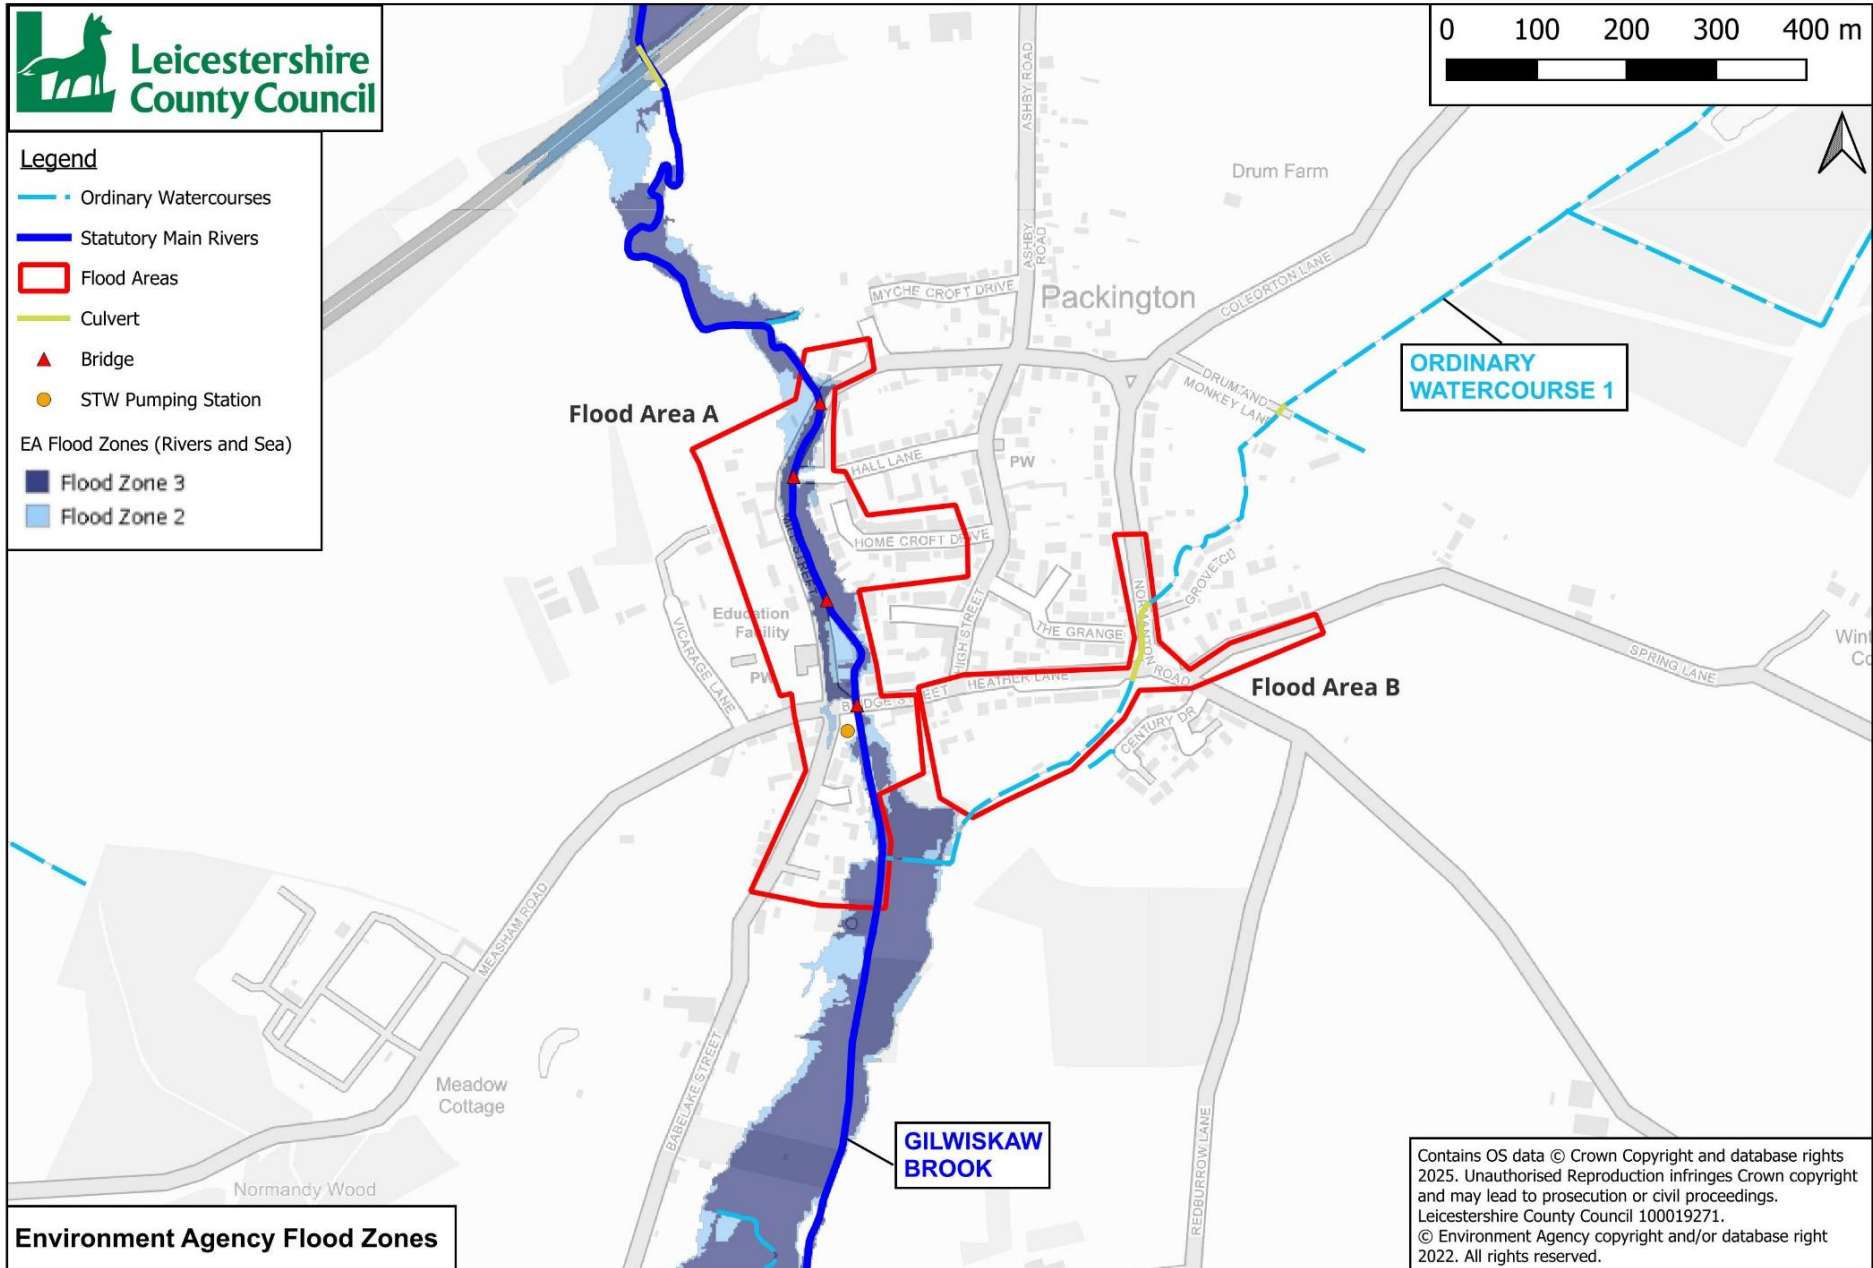
Figure 4: River (Fluvial) EA Flood Zone Extents (EA Flood Zones)

Figure 4 shows the EA's modelled Flood Zones associated with the Gilwiskaw Brook.

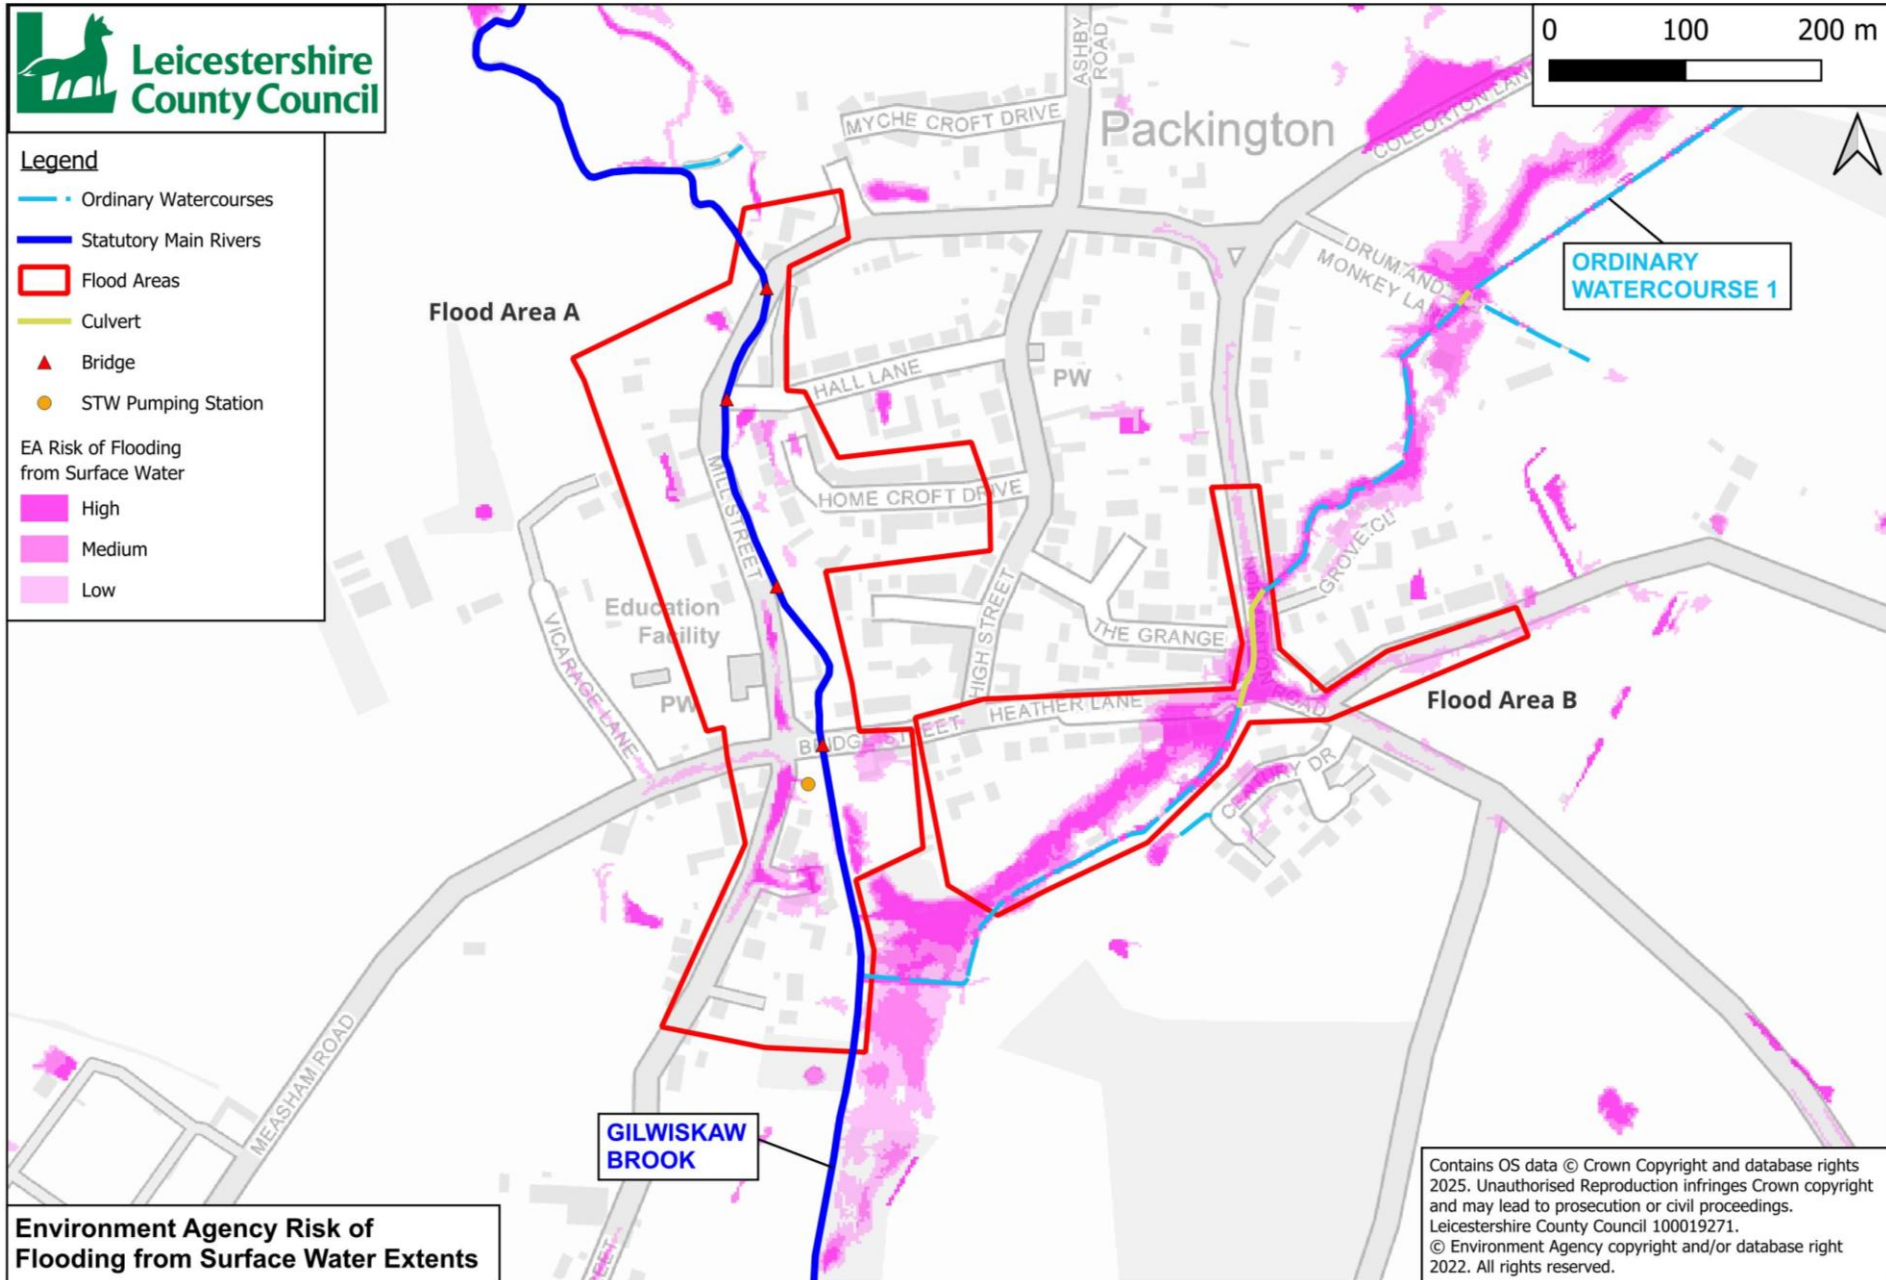
Figure 5: EA Risk of Flooding from Surface Water (Pluvial) Flood Extents

A map of the Risks of Flooding from Surface Water (RoFSW) (Figure 5) has been produced by the EA, published on www.gov.uk/check-long-term-flood-risk, using high level modelling which represents where water could flow and accumulate during certain rainfall events⁵. The modelling does not consider property threshold levels, and therefore cannot accurately predict internal flooding.

In the absence of or smaller watercourse modelling, surface water flood models are often good indicators of ordinary watercourse floodplain extents, as surface water models take into account rapid runoff from non-fluvial sources (such as roads, fields etc), from which smaller watercourses are more responsive. The surface water flooding outlines, as illustrated on Figure 4, clearly illustrate the flow path and likely flood extents of ordinary watercourse 1 and the extents of the high risk of surface water flooding closely match those that were observed during the 18th of September 2023 flood event. This therefore confirms that these properties are at high risk of flooding.

It must be noted however that the modelled rainfall magnitude/duration and spatial distribution of rainfall may vary substantially to what was experienced during the 18th September 2023 flood event, which explains why some of the areas identified in the EA's RoFSW map did not flood at that time
