# **Flood Investigation Report**

Oadby & Wigston  
22<sup>nd</sup> June 2023

Version	Published Date	Author	Approved By
Final 001	17/12/2025	Helen Burton, Consultant Senior Flood Risk Engineer	Victoria Coombes, Flood Risk Manager

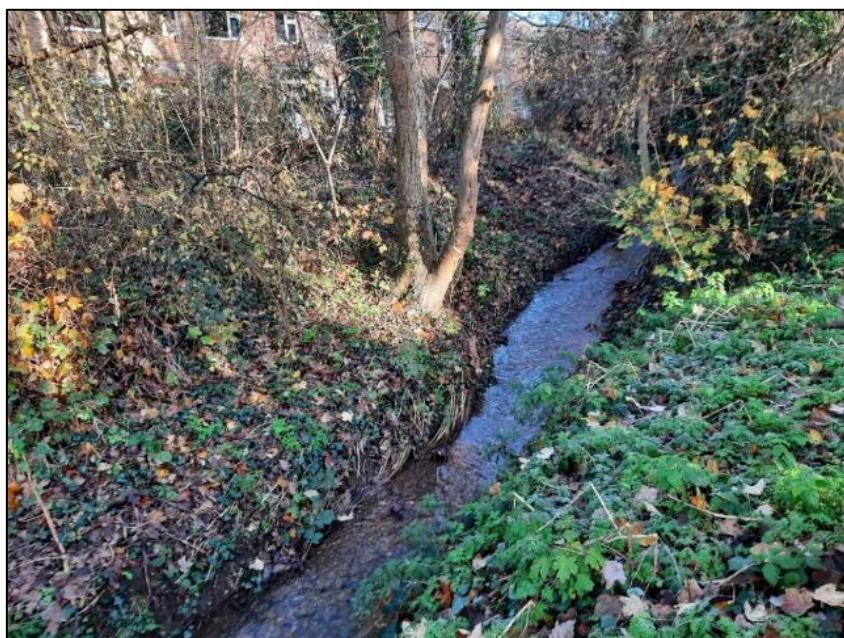
Photograph 1: Wash Brook alongside Nene Court, Oadby

Wash Brook, depicted in Photograph 1, is an ordinary watercourse for its extent within Leicestershire. The catchment area of Wash Brook is highly urbanised and many of the open channel reaches flow through residential back gardens. It becomes designated a Main River as it enters Leicester City where it is called Saffron Brook.

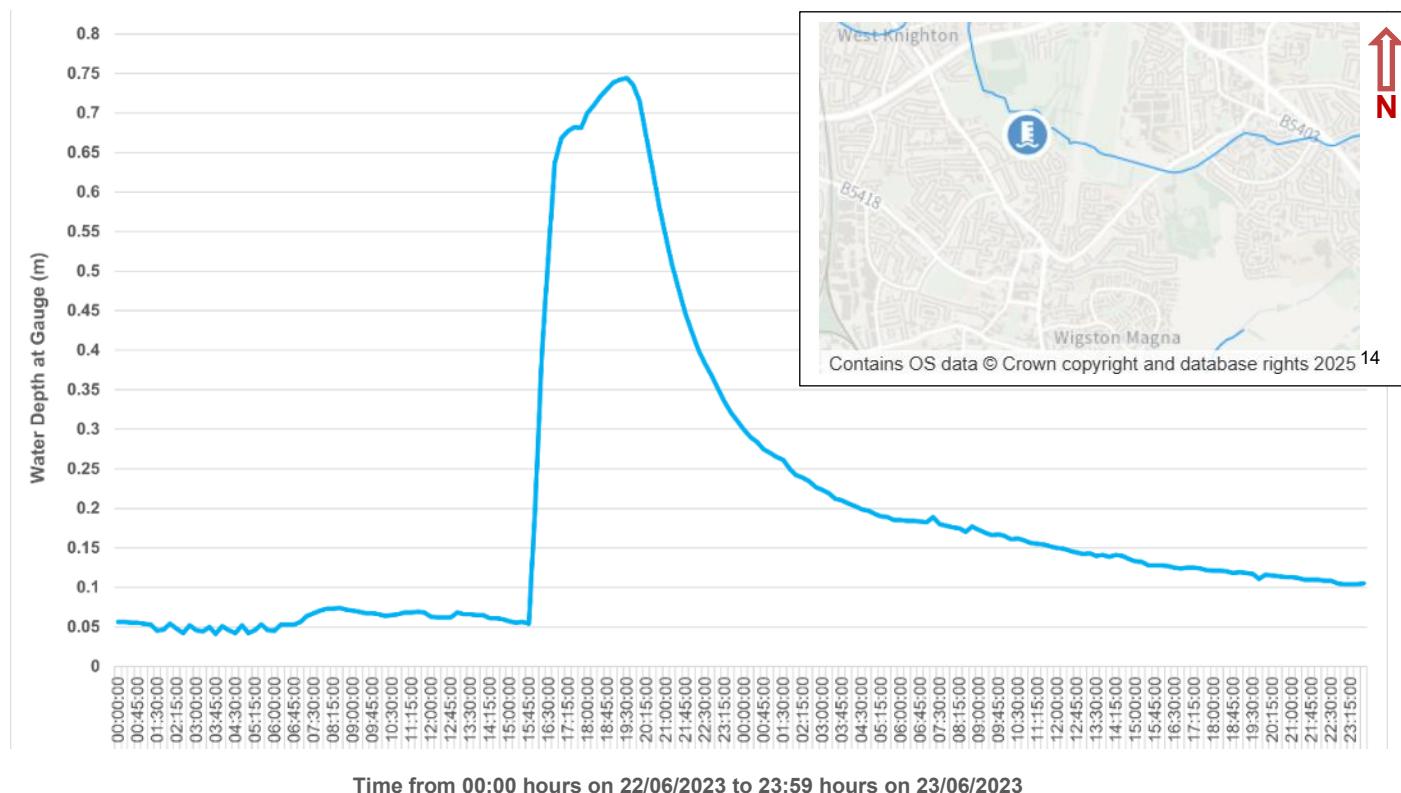
**Figure 6. Water Level profile at EA gauge on Saffron Brook at Knighton Park, Oadby on 22<sup>nd</sup> June-23<sup>rd</sup> June 2023**

The EA's monitor water levels along Saffron Brook at a hydrometry gauge located in Knighton Park<sup>14</sup>, Oadby (Ordnance Survey grid reference SK 60719 00357) which is further downstream along the Wash Brook. Observed water levels (depth in metres at the gauge) from 00:00 hours on 22<sup>nd</sup> June to 23:59 hours on 23<sup>rd</sup> June are illustrated in Figure 6.

The peak water level in the brook occurred at 19:30 hours on 22<sup>nd</sup> June, approximately 3.5 hours after the peak rainfall at Fleckney (at 16:00 hours). (*No rating curve currently exists for the gauge to convert the water levels to flows – m<sup>3</sup>/s.*)

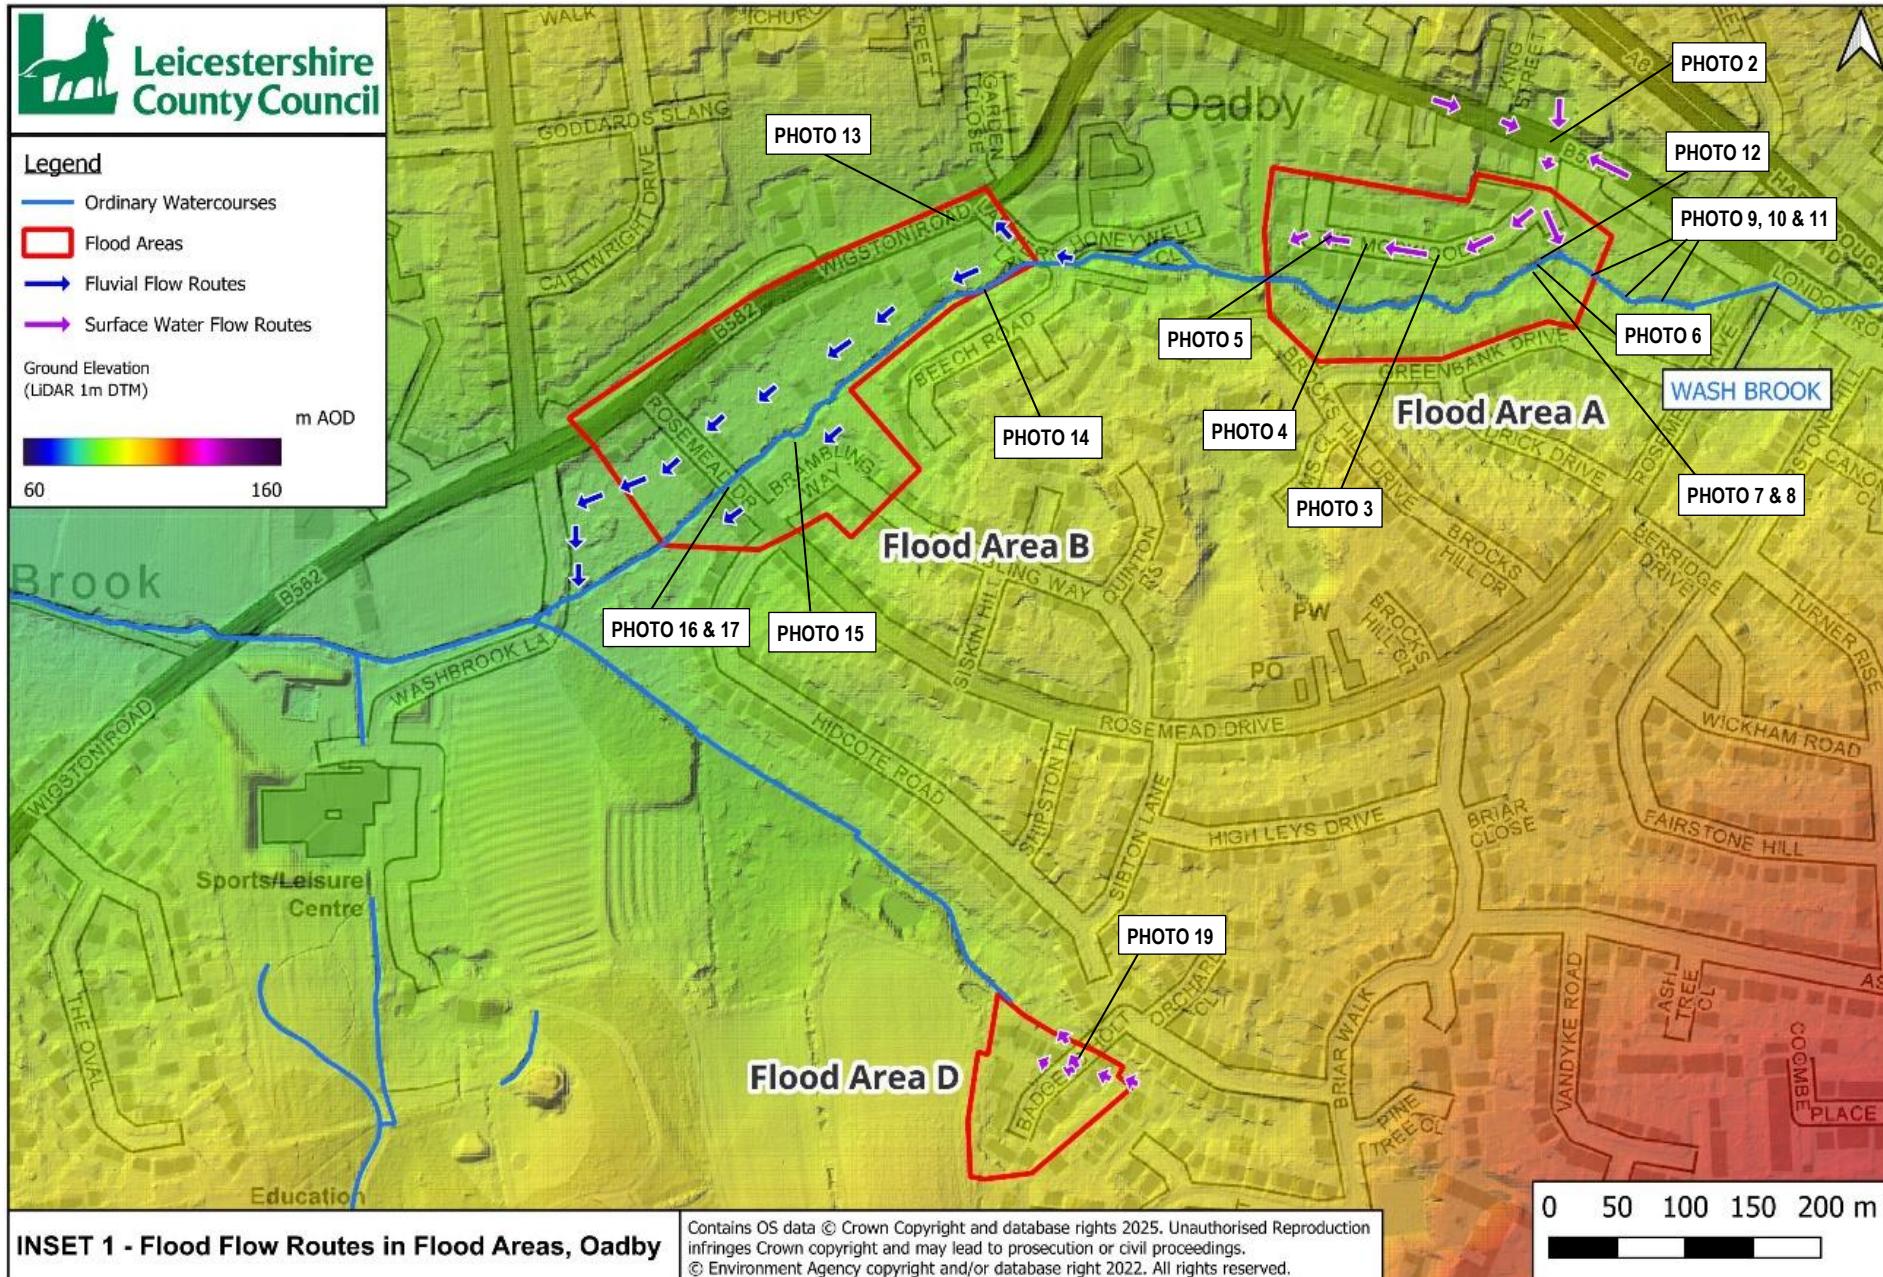
Figure 7: INSET 1: Flow routes through Flood Areas A, B and D, Oadby

In the afternoon of June 22<sup>nd</sup> 2023, surface water resulting from intense rainfall was reported to have initially flowed into The Morwoods from London Road (B582) in Oadby, as illustrated in Figure 7.

At the junction of London Road with The Morwoods, STW combined sewer systems became overwhelmed causing a sewer manhole cover to have lifted under hydraulic pressure (Photograph 2). The drainage network was overwhelmed by the quantity of water generated by such intense rainfall over such a short time-period and its design capacity was evidently exceeded.

A second STW combined sewer manhole also lifted towards the eastern end of The Morwoods. Figure 7 illustrates how overland flows (surface water contaminated with sewage) flowed southwards, accumulating at the lowest point at the western end of The Morwoods.

A private culverted watercourse flows in a southerly direction beneath London Road and the eastern extent of The Morwoods. The outfall, located along Wash Brook to the rear of number 3 The Morwoods, was observed on 22<sup>nd</sup> June to be submerged due to high water level in the brook. Flows were thus unable to discharge effectively at the downstream extent of the culvert. This resulted in a surcharged manhole and surcharging of several gullies along the eastern extent of The Morwoods that connect into this, due to its capacity being exceeded.

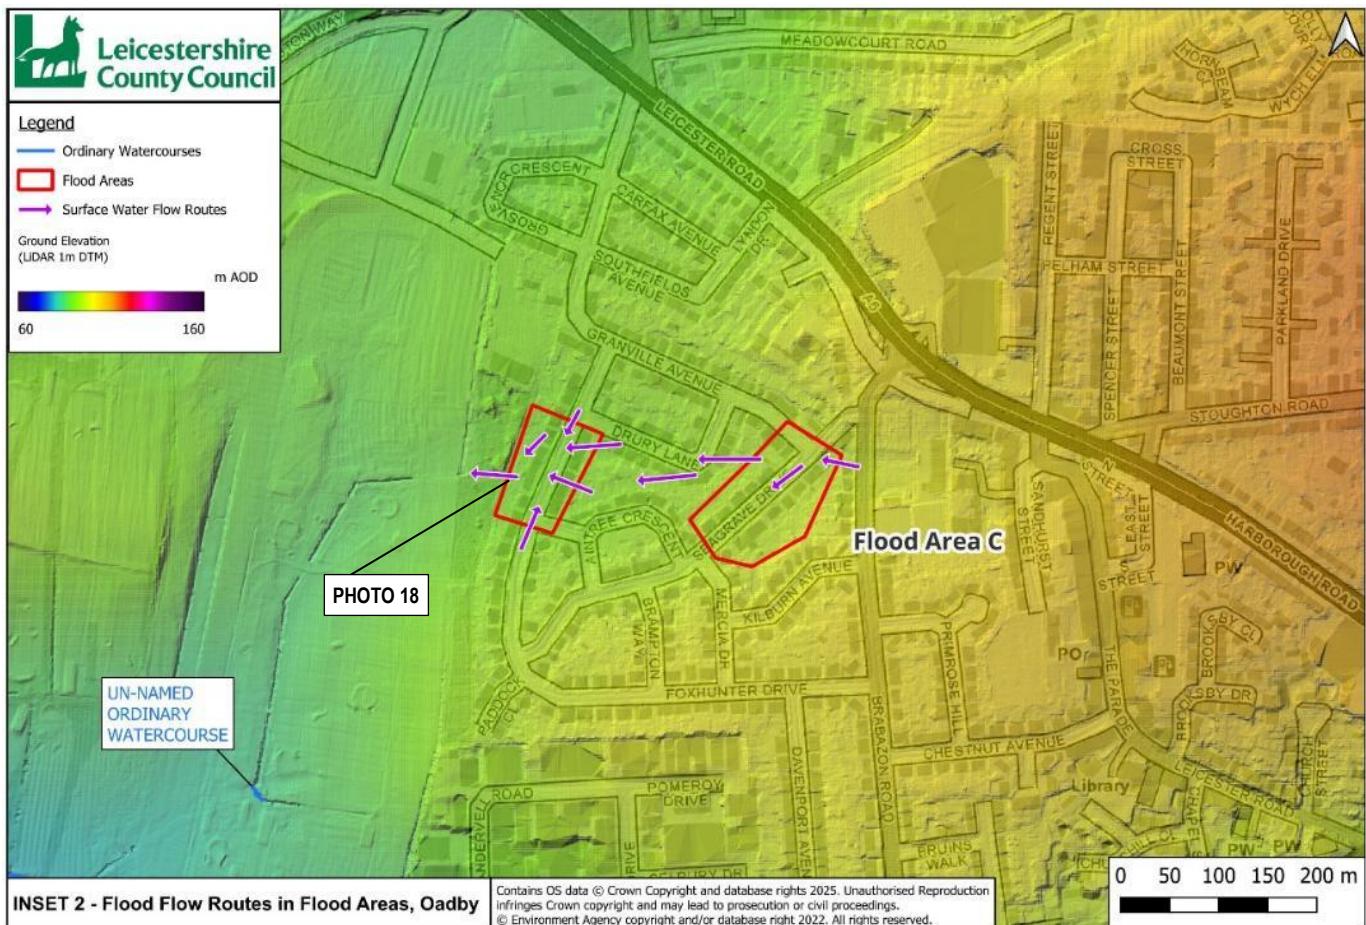
**Figure 8. INSET 2: Flow routes through Flood Area C, Oadby**

On 22<sup>nd</sup> June 2023 surface water was reported to have flowed down the highway along Segrave Drive and from both directions along Foxhunter Drive in Oadby, before accumulating in a dip in the road, as illustrated in Figure 8. It is understood that highway gullies were overwhelmed/surcharged by such intense rainfall over such a short time period as they could not convey the sheer volume of water away from the area quickly enough. The design capacity of the surface water drainage network into which they connect was evidently exceeded.

Surface water reportedly overtopped kerbs on the western side of both highways, resulting in internal property flooding via the frontage of three properties along Segrave Drive and external flooding of rear gardens at three additional properties. Flood water also overtopped the residential property thresholds of two properties along Foxhunter Drive, again from the front resulting in internal and external flooding; one rear garden of which is depicted in Photograph 18. Internal water levels here were described to have covered the carpet/floor. Two additional properties were externally flooded within gardens.

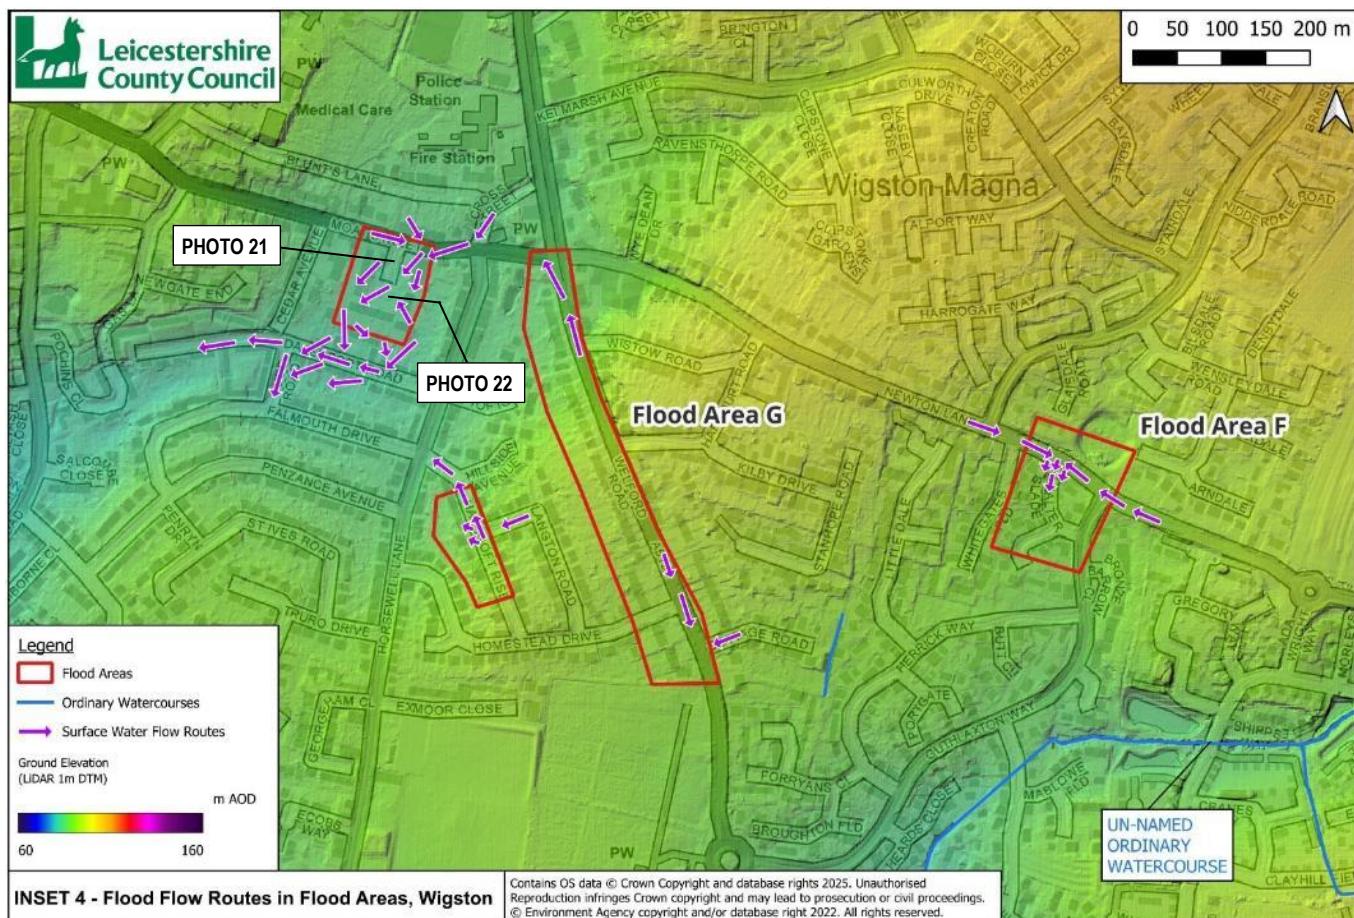
Figure 10. INSET 4: Flow routes through Flood Areas F and G, Wigston

Surface water was described as flowing down the highway on Welford Road, accumulating on the highway as illustrated in Figure 10. The local drainage network also became overwhelmed by the volume of water generated by such intense rainfall over such a short time-period and its design capacity was evidently exceeded. Surface water overtopped the kerb threshold. External property flooding affected two residential properties, and two residential properties experienced internal flooding. These properties were reportedly affected due to property thresholds being lower than or similar levels to the highway.

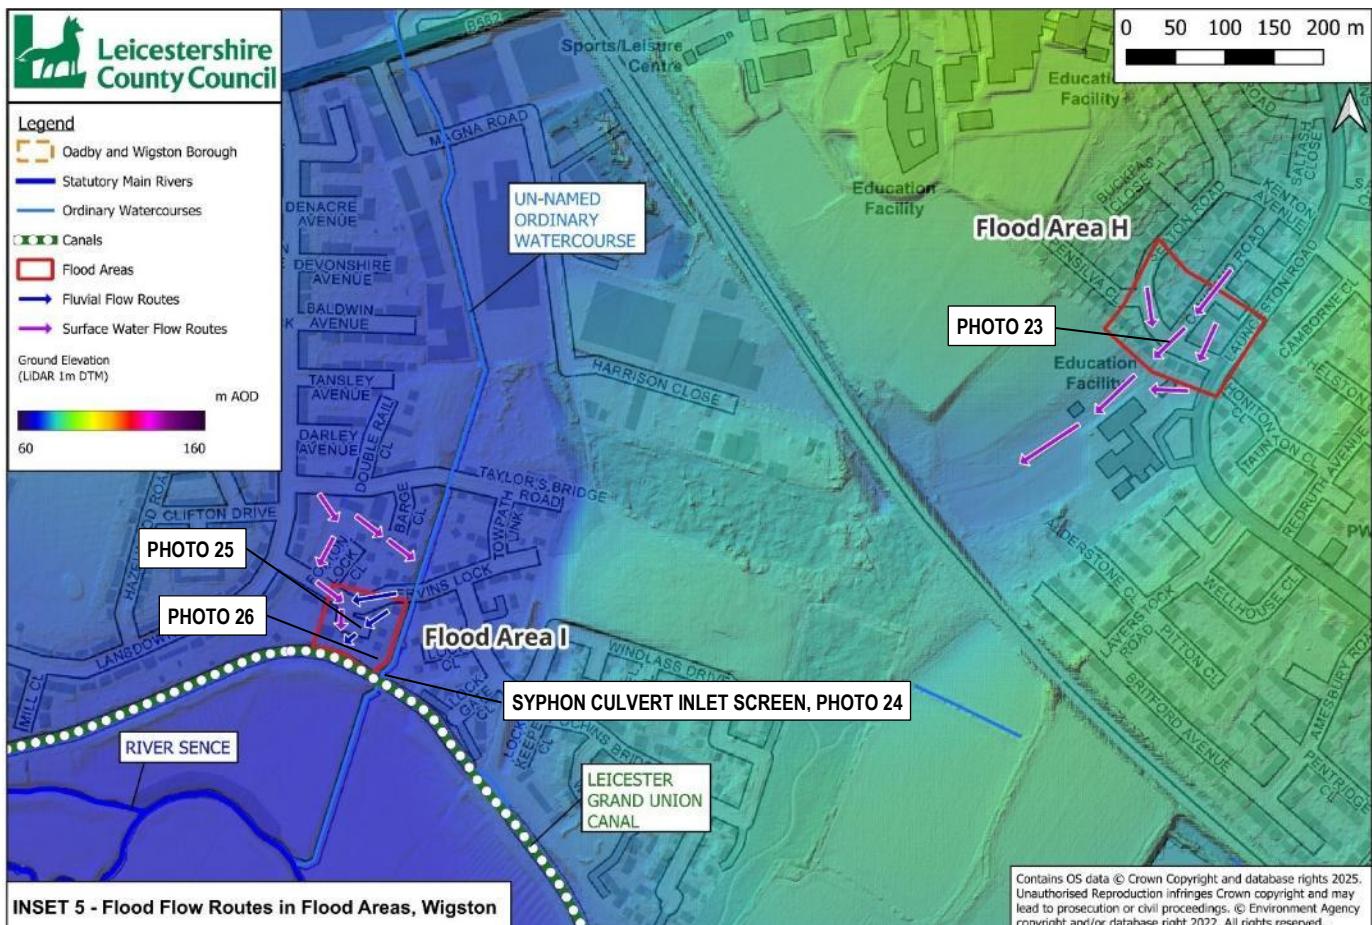
Figure 11. INSET 5: Flow routes through Flood Areas H and I, Wigston

Anecdotal reports from 22<sup>nd</sup> June 2023 described surface water flowing 'like a river' southwards along Launceston Road in Wigston. Water flowed along Pensilva Close and Cawsand Road, before converging on the lowest point at the southern end of Seaton Road, as illustrated in Figure 11 and as depicted in Photograph 23.

It was anecdotally reported that the local drainage network along Seaton Road was overwhelmed by the volume of water that fell during the prolonged, torrential rain. Several gullies were anecdotally reported as being partially blocked. No evidence however was found or submitted to substantiate the claim and confirm this. Debris remained on the road as it subsided which residents attempted to clear. This suggests that the highway gullies were working. However, the drainage network they connect into was overwhelmed by the volume of water generated by such intense rainfall over such a short time-period and its design capacity was evidently exceeded. The gullies surcharged as they could not convey the sheer volume of water away from the area quickly enough.

Floodwater accumulated on the highway and overtopped the kerb thresholds on both sides to ankle depths, resulting in external property flooding to seven residential properties and internal property flooding at one residential property. A resident described the floodwater on the road and within their garden as "almost knee deep". Another stated vehicles driving through the floodwater "*created ripples making it worse*".

In the afternoon of June 22<sup>nd</sup> 2023, surface water was reported to have flowed along the highway of Ervins Lock in both directions south eastwards and south westwards, before converging and flowing southwards along Narrow Boat Close, as illustrated by the purple arrows in Figure 11.

STW regularly inspect this screen and remove identified blockages. A site inspection confirm it was clear at the end of May 2023. Another site inspection conducted by STW shortly after the event identified a significant amount of new vegetation and urban debris mobilised by the floodwater blinding the screen, causing a partial/full blockage of the siphon inlet (Photograph 24). This caused raised water levels upstream of the screen as it reduced the capacity of the culvert inlet impacting the hydraulic performance of the culvert and slowed down the flow of water. High water levels observed around the River Sense confluence shortly downstream also overwhelmed this storm drain as water was unable to discharge. Subsequently, fluvial flooding was incurred to rear gardens along Narrow Boat Close due to overtopping of the east bank (illustrated by the blue flow arrows in Figure 11).

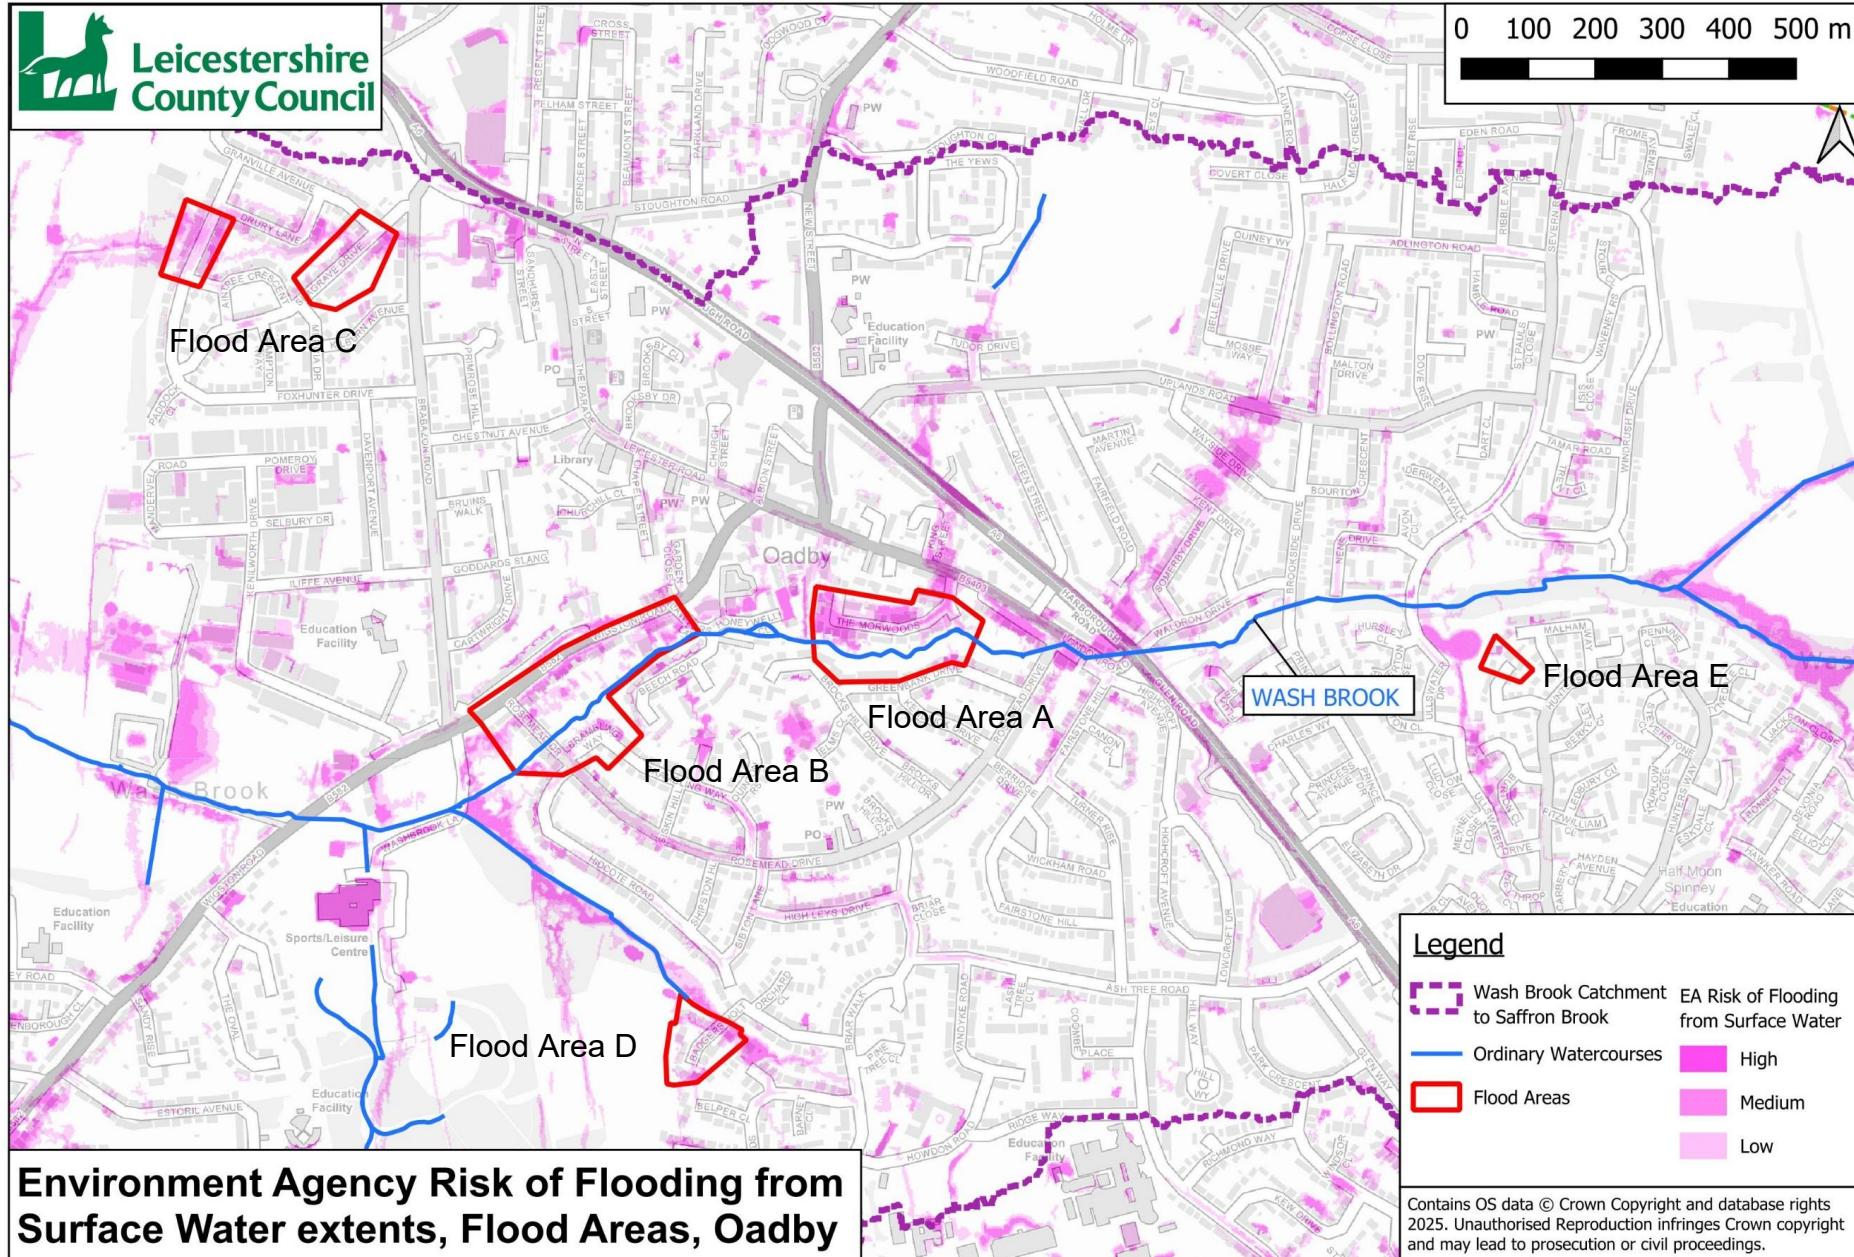
Figure 15. EA Risk of Flooding from Surface Water extents through Flood Areas in Oadby

As part of the initial desktop study, the Council also reviewed the Risk of Flooding from Surface Water (RoFSW) map (Oadby in Figure 15, Wigston in Figure 16) available online<sup>15</sup>. This data has been produced by the EA and is created using high level modelling which represents where water could flow and accumulate when rainwater does not drain away through the normal drainage systems or soak into the ground, but ponds or flows over the ground instead. The modelling does not consider property threshold levels, and therefore cannot accurately predict internal flooding. The map illustrates the flood extents during the following rainfall event probabilities/magnitudes.

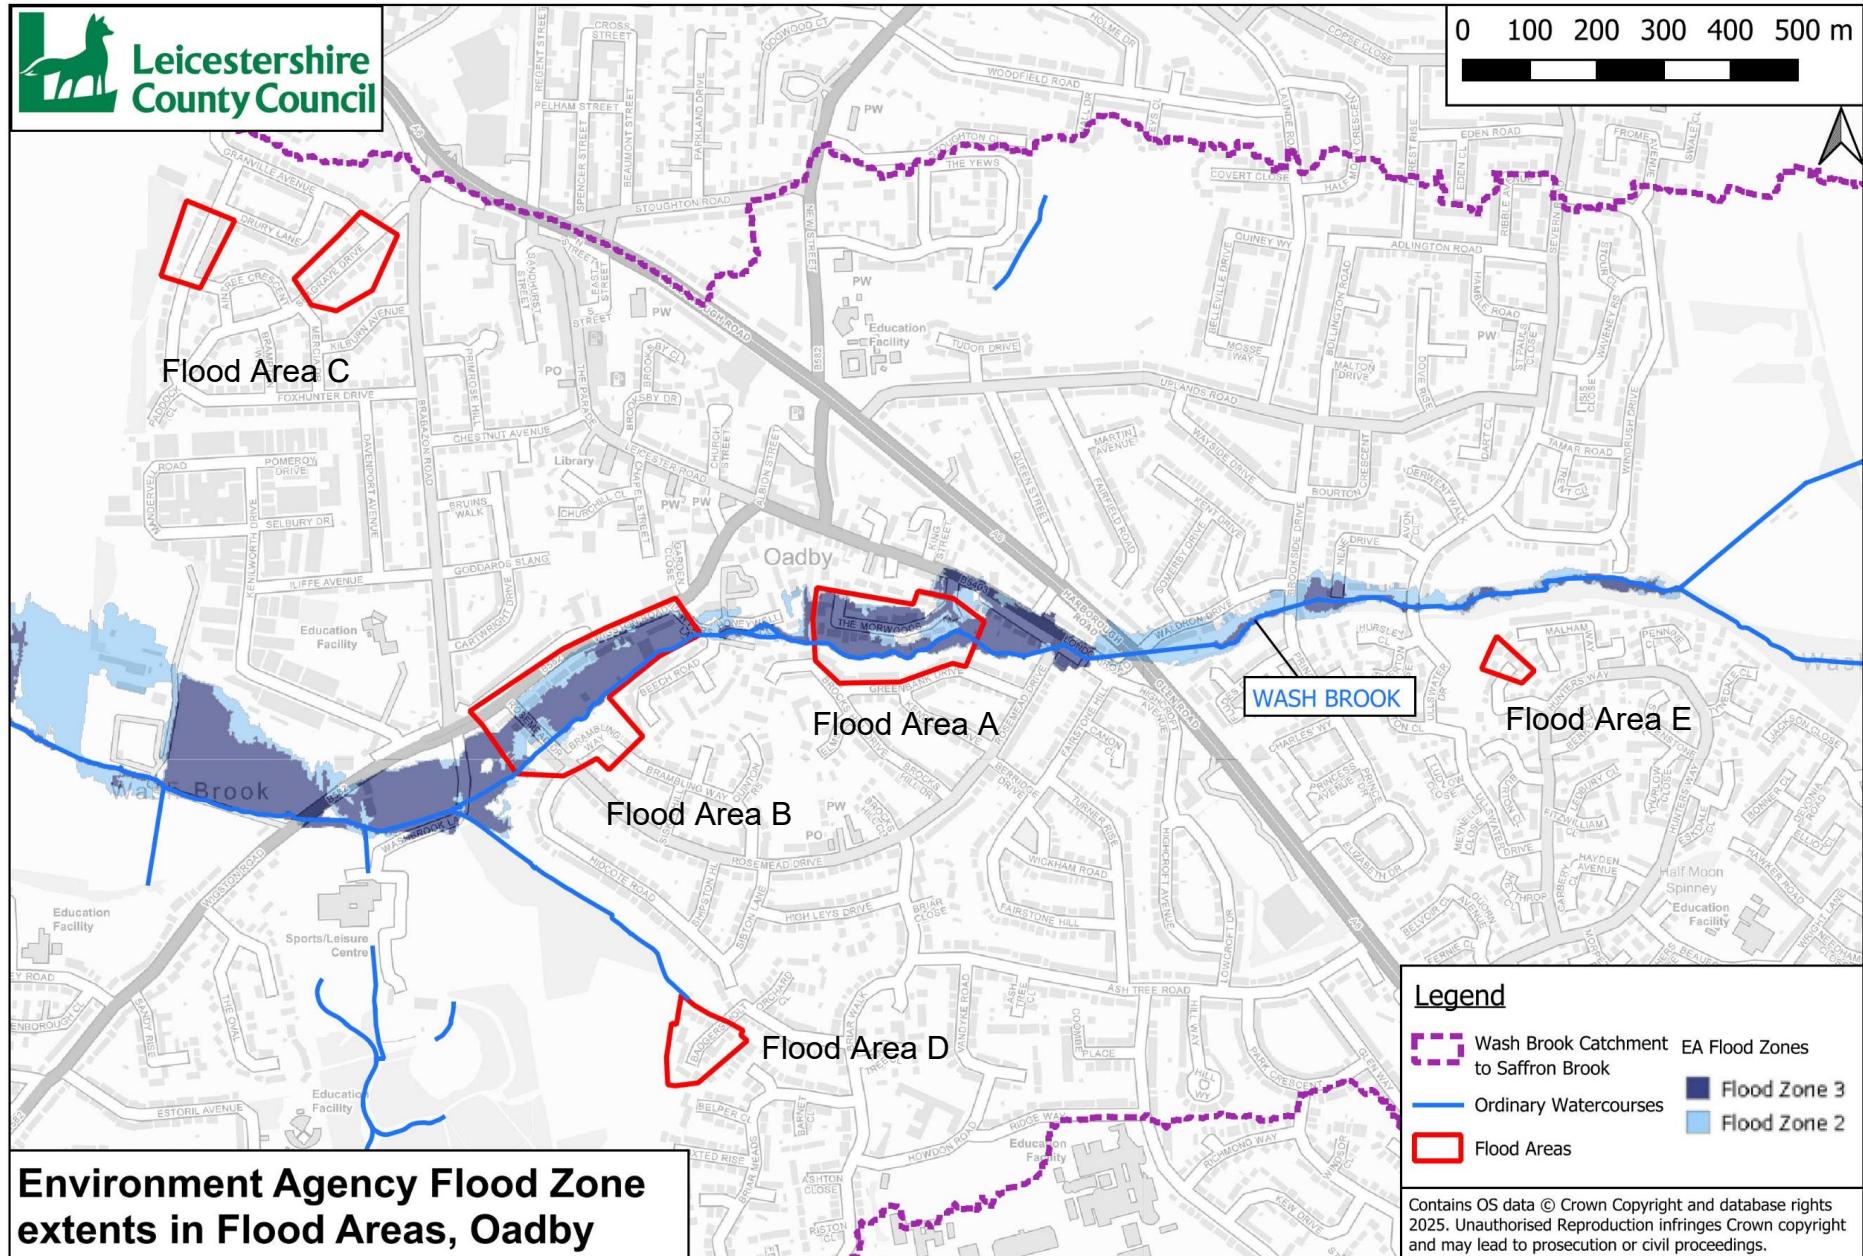
Figure 17. EA Flood Map for Planning Flood Zones (Undefended) extents through Flood Areas in Oadby

Figure 17 illustrates the modelled undefended Flood Zones and Figure 18 illustrates the modelled defended RoFRS extents associated with the Wash Brook.
