Flood Investigation Report

Storm Henk

2nd January 2024

Asfordby and Asfordby Valley

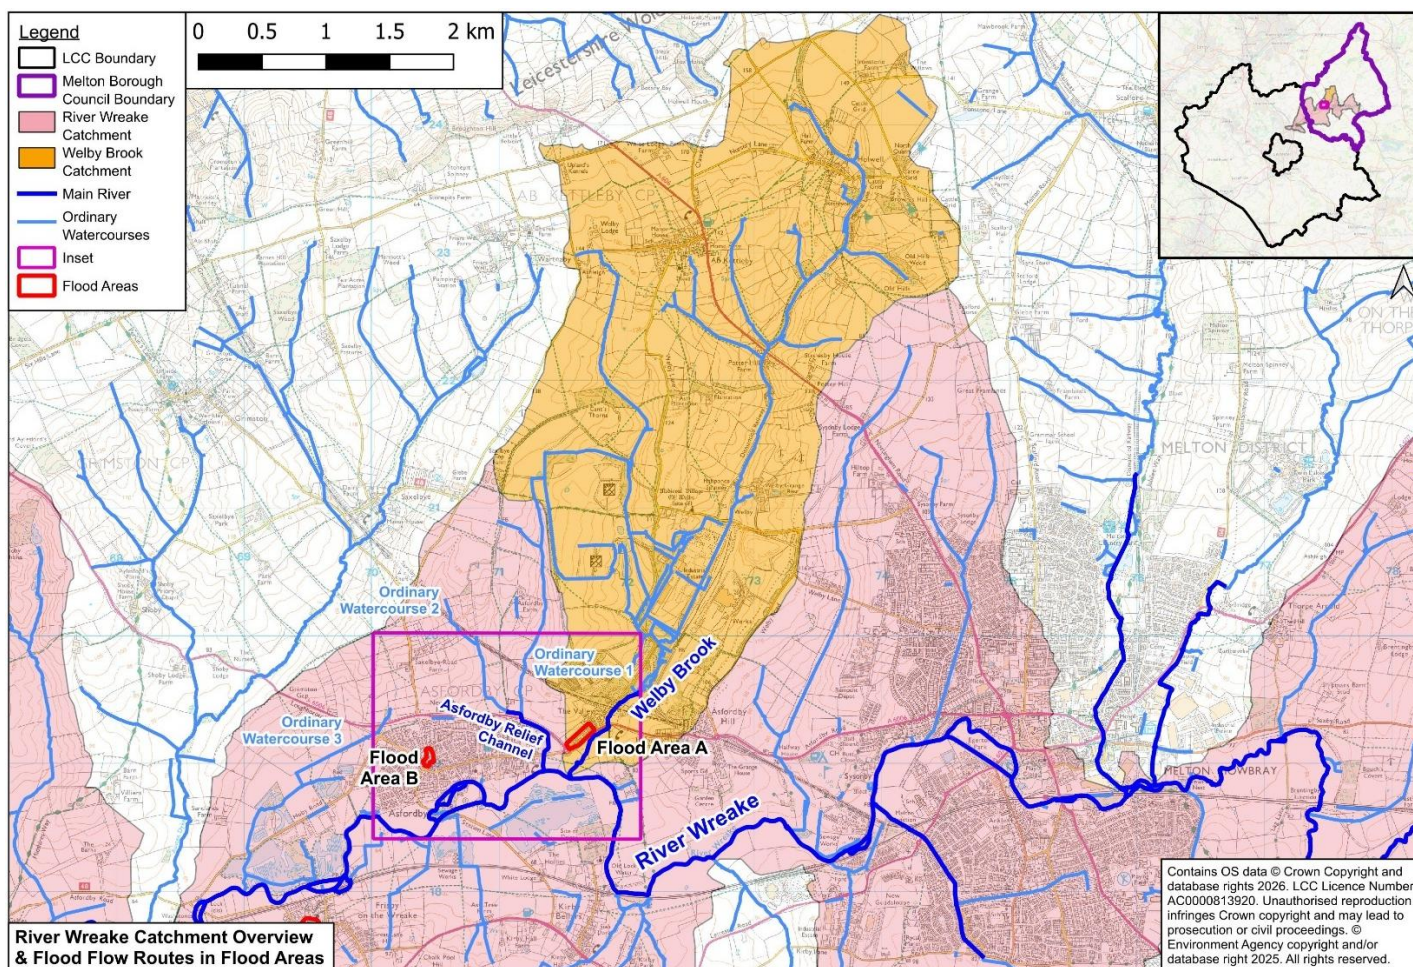
Figure 12-1: Asfordby and Asfordby Valley Location Plan, relevant Watercourse Catchment (INSET 5)

The River Wreake (an EA designated Main River) flows in a south-easterly direction to the south of Asfordby and Asfordby Valley as illustrated in Figure 12-1. Another Main River, Welby Brook, flows in a south-westerly direction alongside Welby Road and joins the River Wreake downstream of Asfordby Valley at Ordnance Survey national grid reference (OSNGR) SK 71565 18885. The responsible agency for managing the risk from Main Rivers is the EA. Details relating to RMA responsibilities can be found in Section 21 of the main Storm Henk report.

Flood Area A is located within the catchment area draining directly to Welby Brook (as illustrated in Figure 12-1), which is predominantly rural, but relatively steep, characteristic of flashy runoff. Its catchment area comprises 11.2km² at its confluence with the River Wreake.

It is therefore concluded that the intense rainfall event generated a large volume of overland flow of surface water on the highway that followed the local ground levels downhill southwards along the easiest route of the highway (as illustrated in Figure 12-1). It then ponded at the bottom of the hill where the limited highway drainage was overwhelmed, a gully became blocked, and was unable to drain the water away sufficiently. Ponded floodwater then accumulated and exceeded the threshold of one adjacent property, located at a low point, via their driveway flooding it internally. Two additional properties also flooded externally as a result of water flowing down Saxelby Road. The location of these coincides with the area at high risk along Saxelby Road identified in the RoFSW map (Figure 12-5).

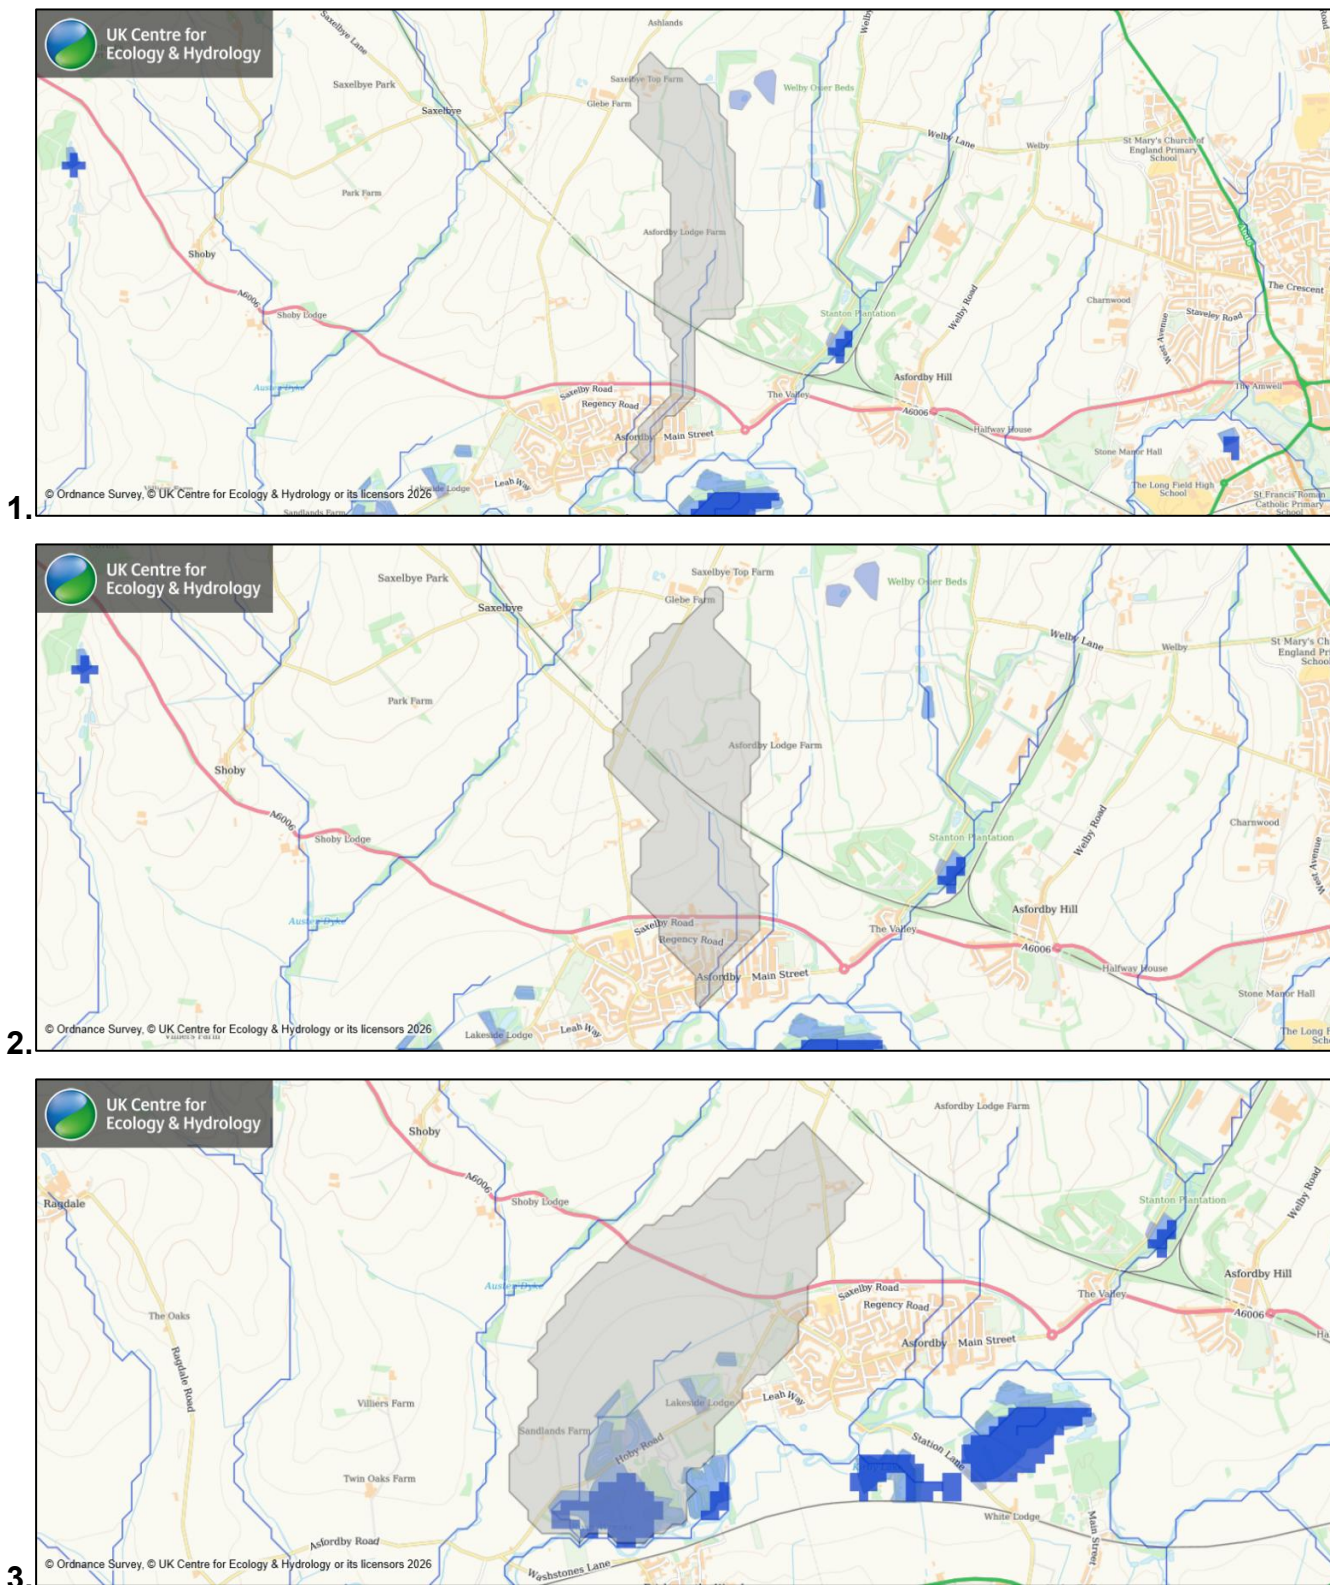
Figure 12-4: FEH Web Service Catchment Extents of Ordinary Watercourses 1 and 2 upstream of A6006 (1. and 2.), and Ordinary Watercourse 3 west of Asfordby (3.)

The UK Centre for Ecology & Hydrology’s Flood Estimate Handbook (FEH) Web Service¹ provides strategic level catchment mapping for the tributary watercourses of the River Wreake in the vicinity of Flood Areas A and B, as illustrated in Figure 12-4.

The two un-named ordinary watercourses north east of Asfordby drain rural catchment areas southwards to the A6066 bypass road (as illustrated in Figure 12-4). That to the east, Ordinary Watercourse 1 drains a catchment of 0.89km² to the River Wreake, and that to the west, Ordinary Watercourse 2 drains a catchment of 1.2km² to the River Wreake. However, these are not open channels flowing through Asfordby as illustrated by the FEH Web Service.
