# **Flood Investigation Report**

Storm Henk

2<sup>nd</sup> January 2024

**Frisby on the Wreake**

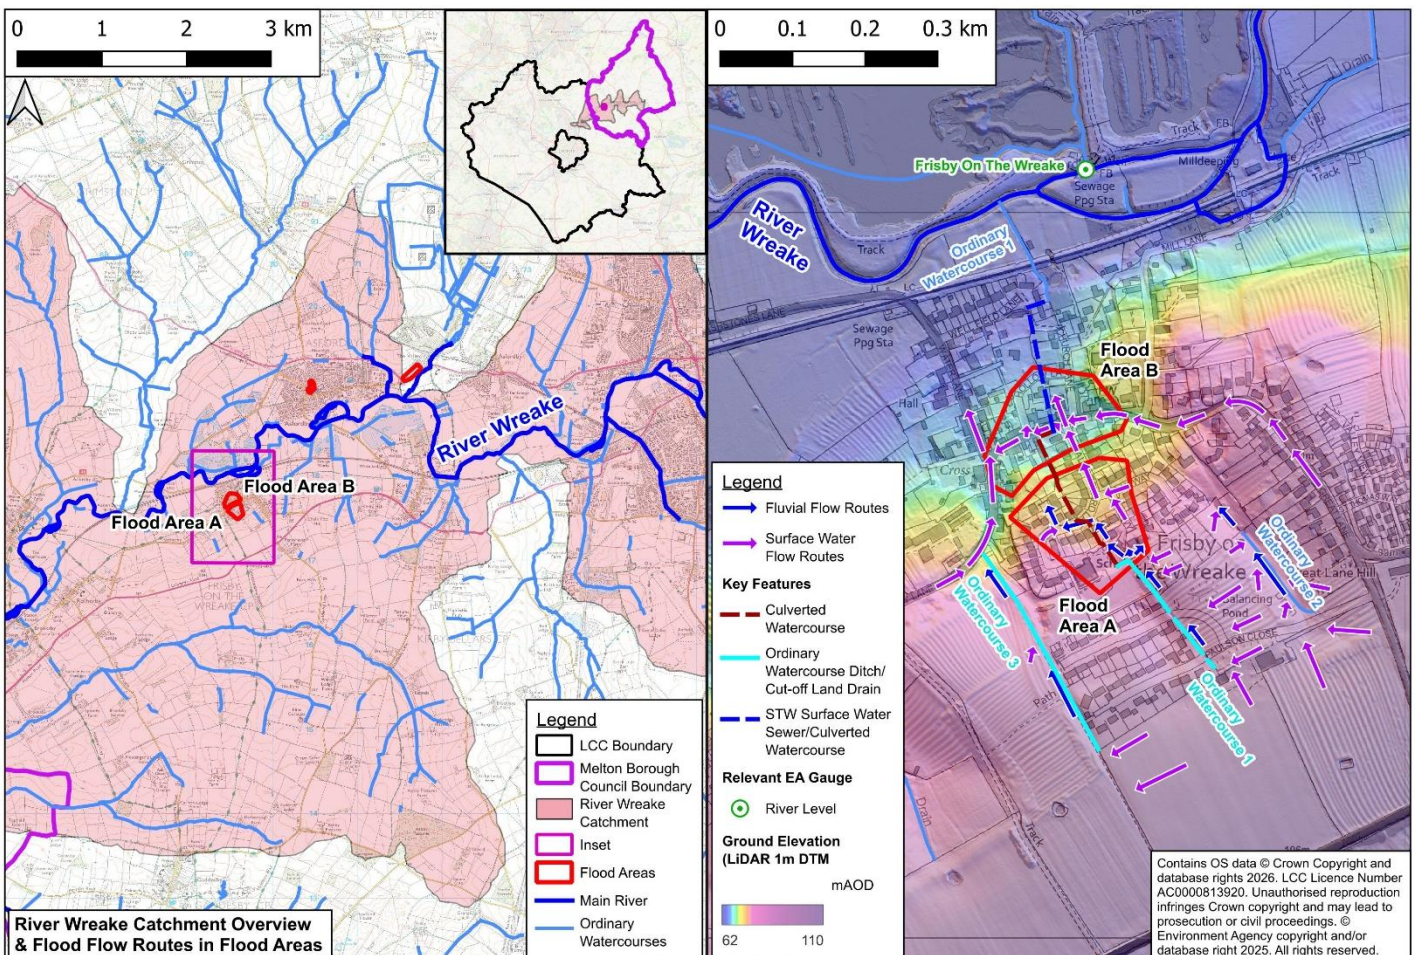
Figure 6-1: Frisby on the Wreake Location Plan, relevant Watercourse Catchment and Flow Routes through Flood Areas (INSET 4)

The high-intensity heavy rainfall from Storm Henk (see Section 2.3 of the main Storm Henk report) fell on an already saturated steep sided catchment resulting in significant surface water overland flow across agricultural fields, various sections of the highway and through gardens and private land converging at the centre of the village around Main Street (as illustrated on Figure 6-1). The volume of rainfall overwhelmed the entire local drainage network.
