Flood Investigation Report

Storm Henk

2nd January 2024

Glooston

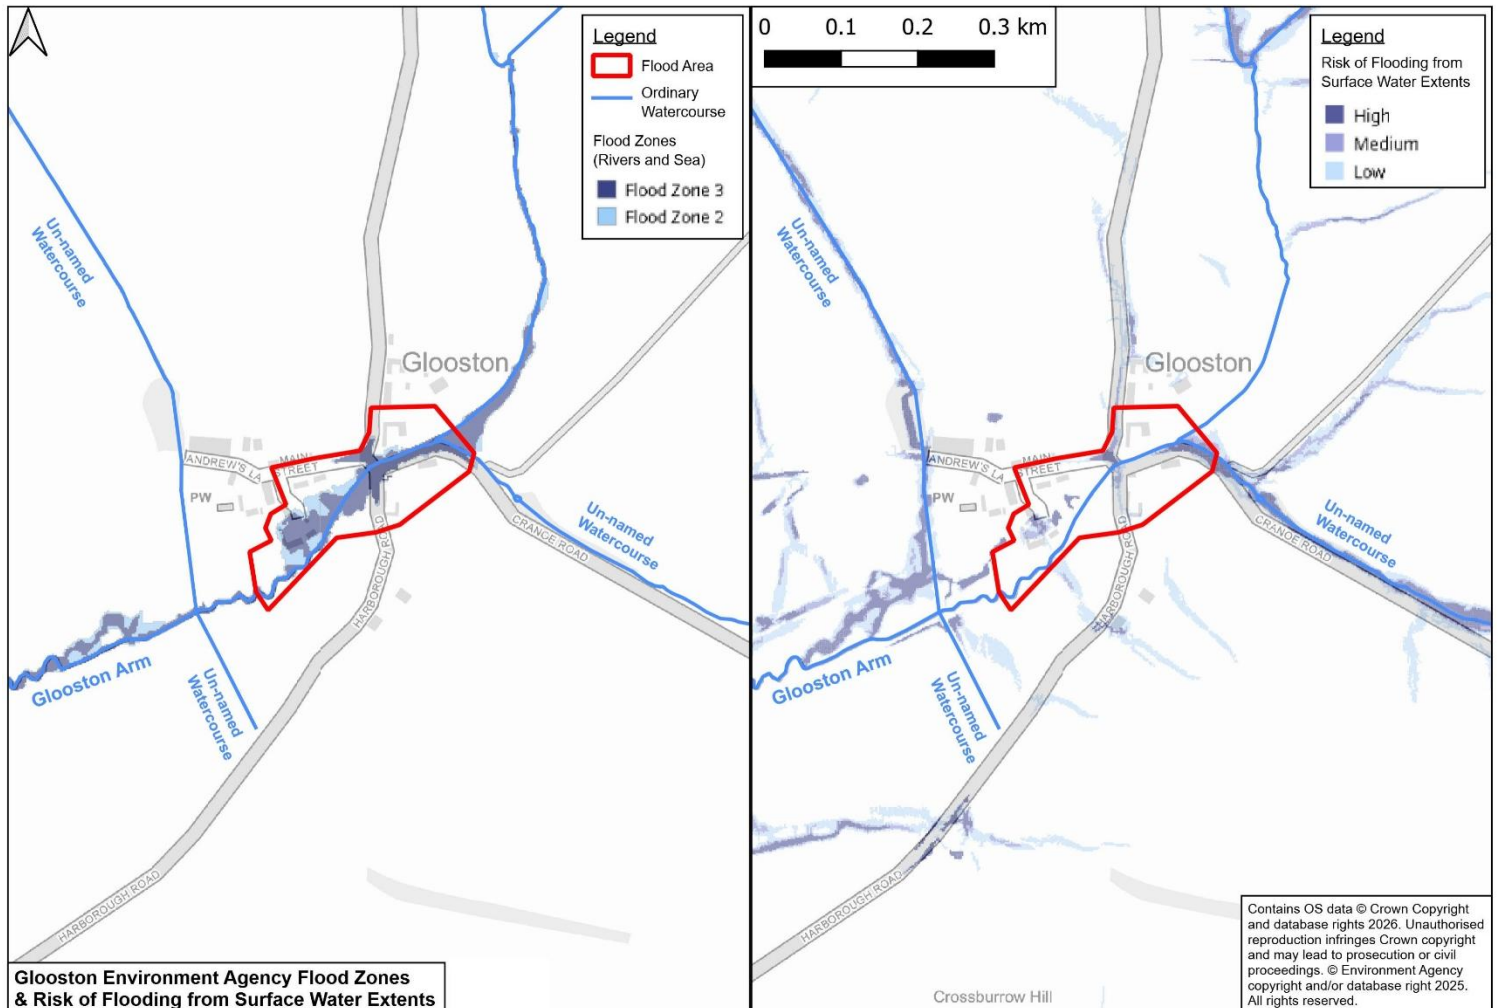
Figure 7-3: Glooston EA Flood Map for Planning Flood Zones⁴ and Risk of Flooding from Surface Water Extents⁵ in Flood Area (INSET 15)

The EA provides flood risk mapping nationally for both rivers and surface water as detailed within Section 2.7.6 of the main Storm Henk report. The extents of EA Flood Map for Planning (NaFRA2) Flood Zones 2 and 3 associated with the watercourses through the village (medium and high risk of river flooding respectively) are illustrated in Figure 7-3. These largely follow close to the river corridor of the Glooston Arm until the valley begins to widen and flatten downstream of its confluence with the Ordinary Watercourse tributary.

Areas of the village are also identified as being at a high, medium and low risks of flooding in the national EA Risk of Flooding from Surface Water (RoFSW) (NaFRA2) are illustrated in Figure 7-3. This illustrates a wider flood envelope along the tributary watercourse upstream of Cranoe Road, and near the confluence of the Glooston Arm with its northern tributary downstream of the St. John The Baptist Church.
