Flood Investigation Report

Storm Henk

2nd January 2024

Loughborough

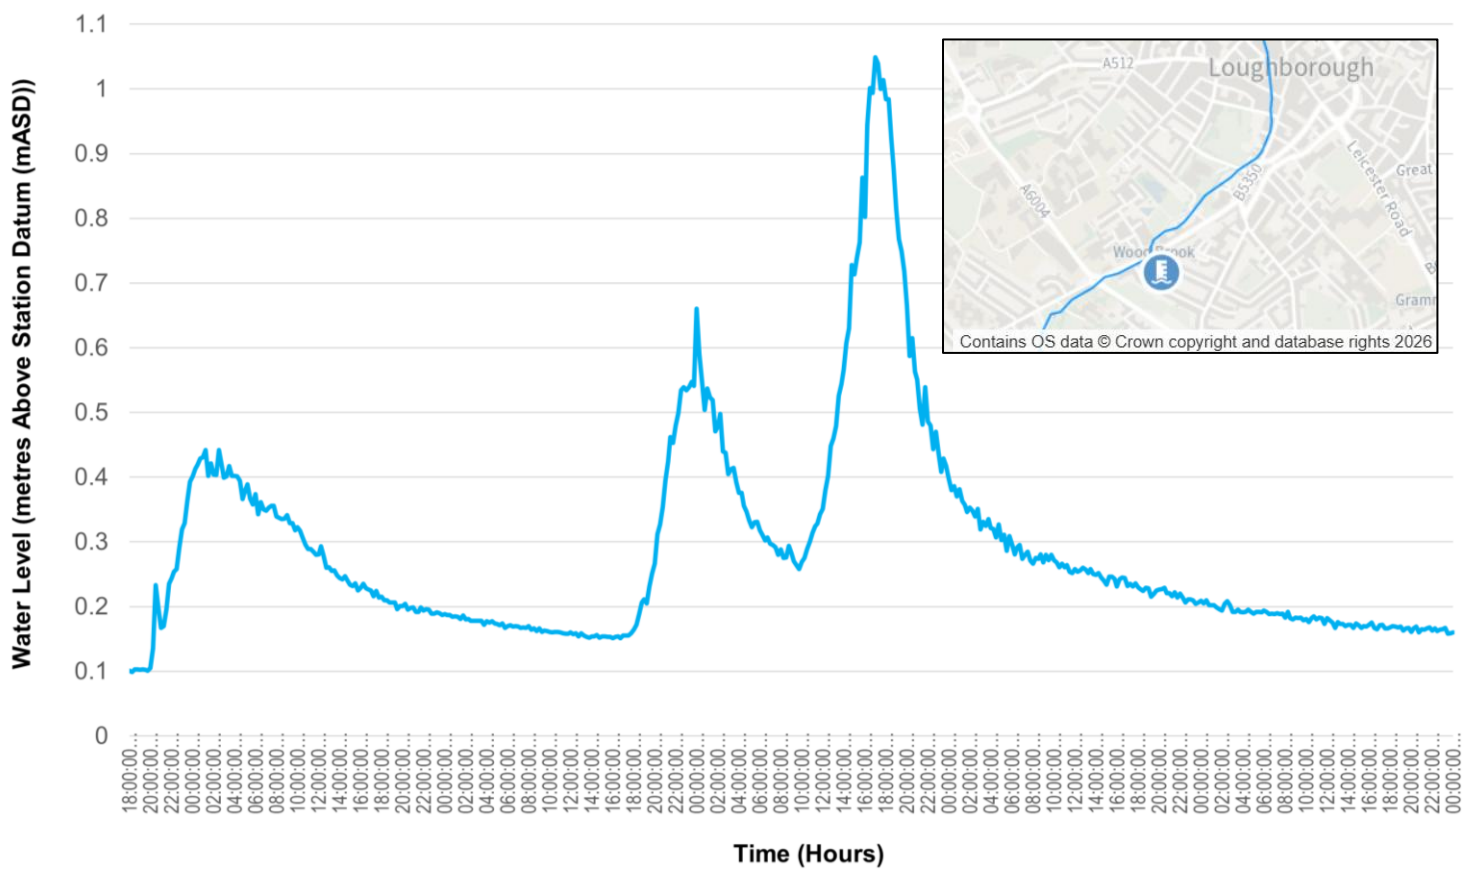
Figure 8-4: Wood Brook at Loughborough Gauge (Station ID 4205) - Water Level from 18:00 hours on 30/12/2023 to 00:00 hours on 05/01/2024

The EA monitor water levels within Wood Brook at the Loughborough River gauge⁹. During Storm Henk, river levels (metres above the gauge station datum (mASD)) peaked sharply at 1.049mASD at 17:00 hrs on Tuesday 2nd January 2024 as illustrated on Figure 8-4. This followed a smaller peak 17 hours prior during the previous night. At the time of Storm Henk, the record level at the gauge was 1.095mASD, recorded on 16th February 2020 (Storm Dennis).

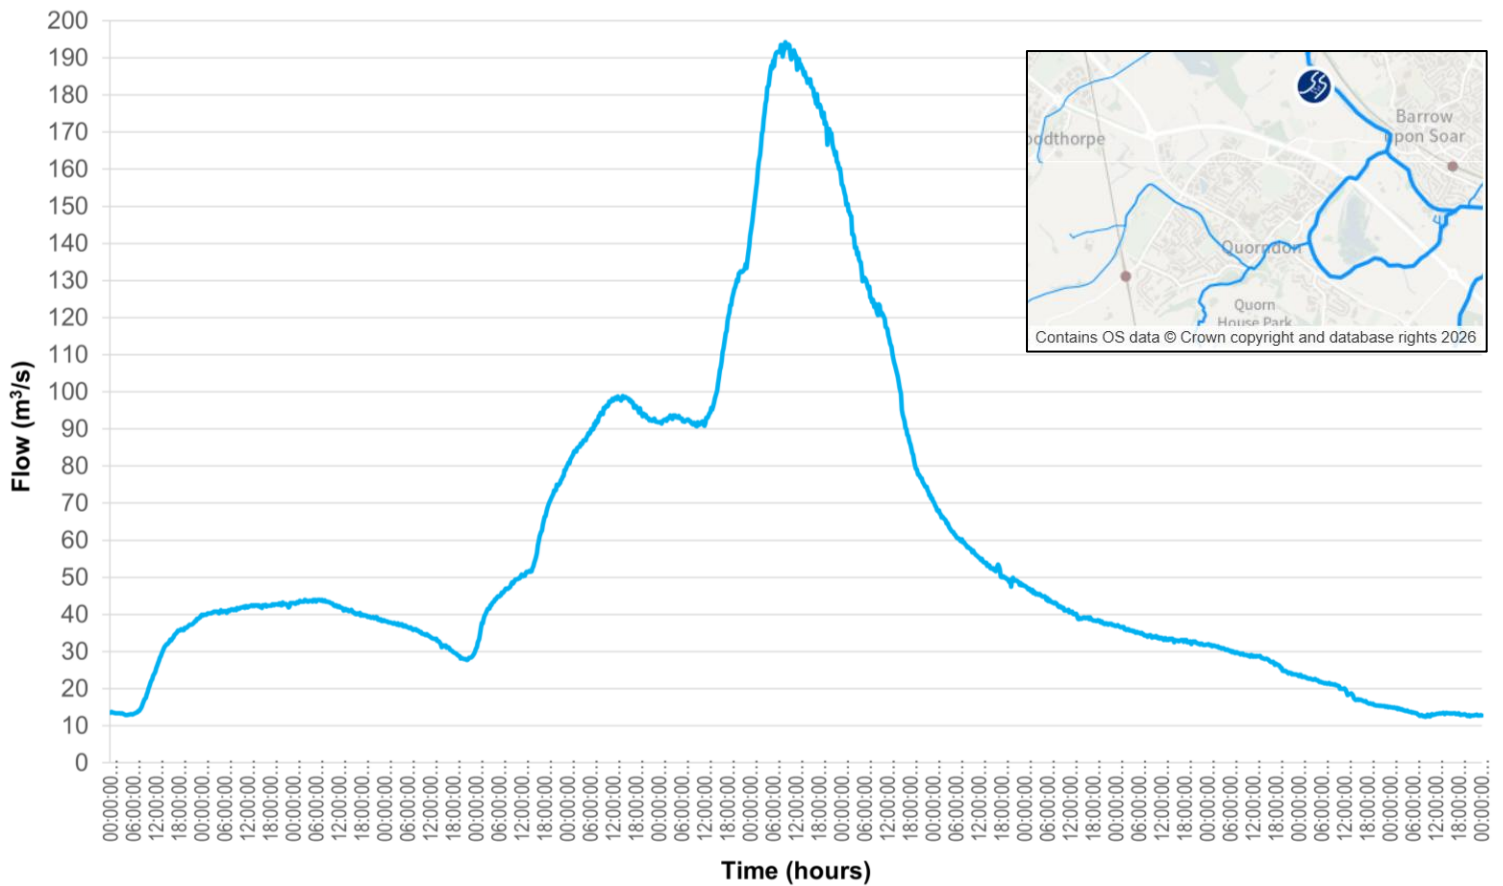
Figure 8-5: River Soar at Pillings Lock Gauge (Station ID 4093) - Flows from 00:00hrs on 27/12/2023 to 00:00hrs on 11/01/2024

The Pillings Lock gauge is one of approximately thirty gauging stations used to issue Flood Alerts and Flood Warnings within the River Soar catchment. The previous record **peak flow** was recorded during the Easter 1998 flood event (190.34 m³/s at 08:00hrs on 11th April). During Storm Henk, flows exceeded this at 06:30hrs on Wednesday morning, 3rd January 2024, peaking at an estimated 194.19 m³/s at 09:15hrs as illustrated in Figure 8-5.

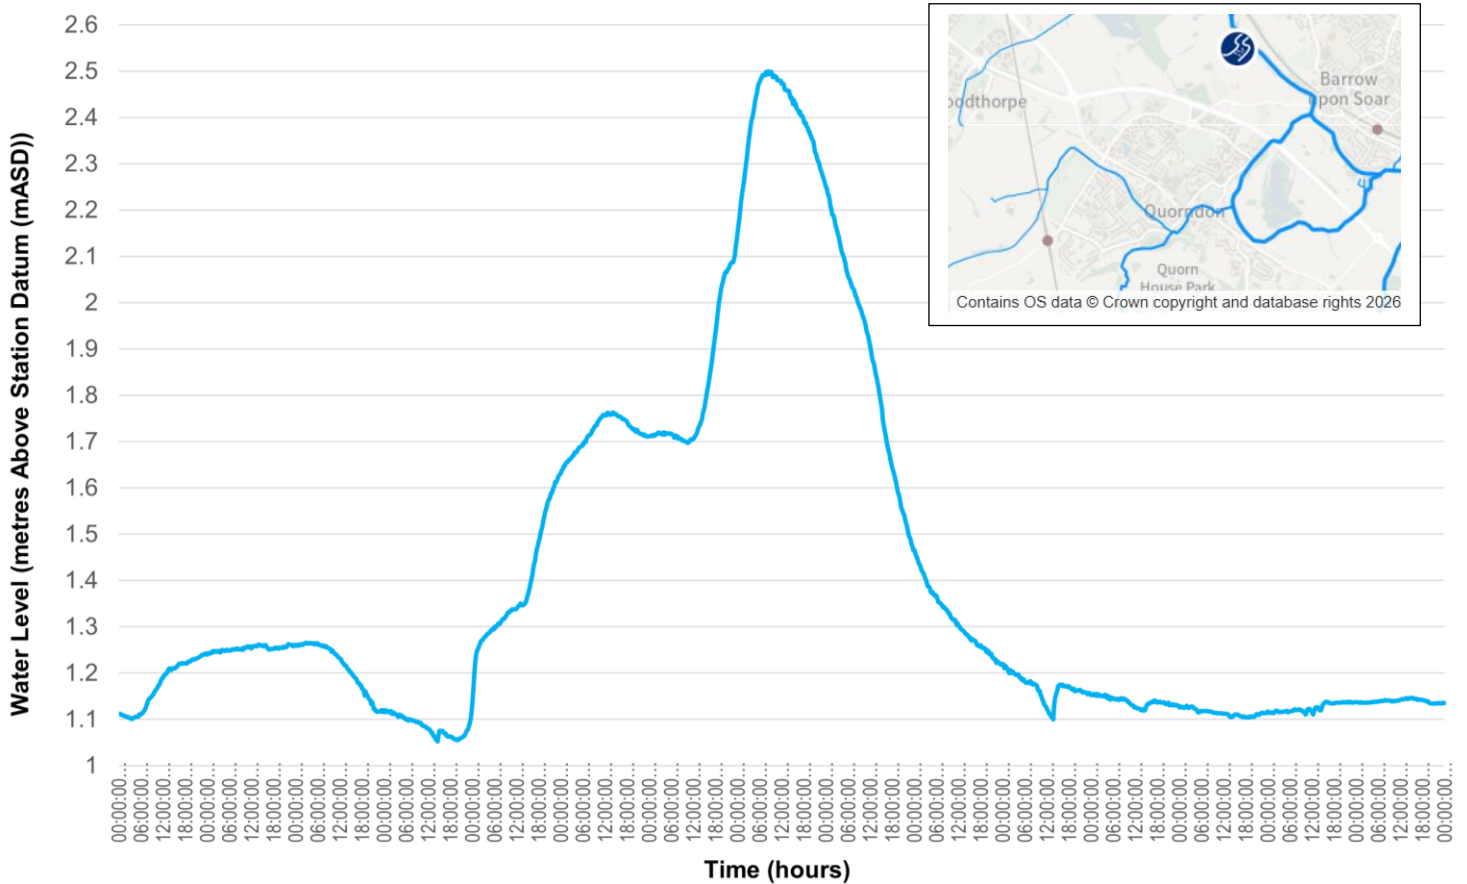
Figure 8-6: River Soar at Pillings Lock Gauge (Station ID 4093) - Water Levels from 00:00 hours on 27/12/2023 to 00:00 hours on 11/01/2024¹¹

The peak **river level** on the Soar at Pillings Lock during Storm Henk was recorded as 2.50mASD at 08:15hrs on 3rd January 2024, as illustrated in Figure 8-6. The previous highest recorded river level was 2.25mASD on 11th April 1998, the same date as the record river flow.

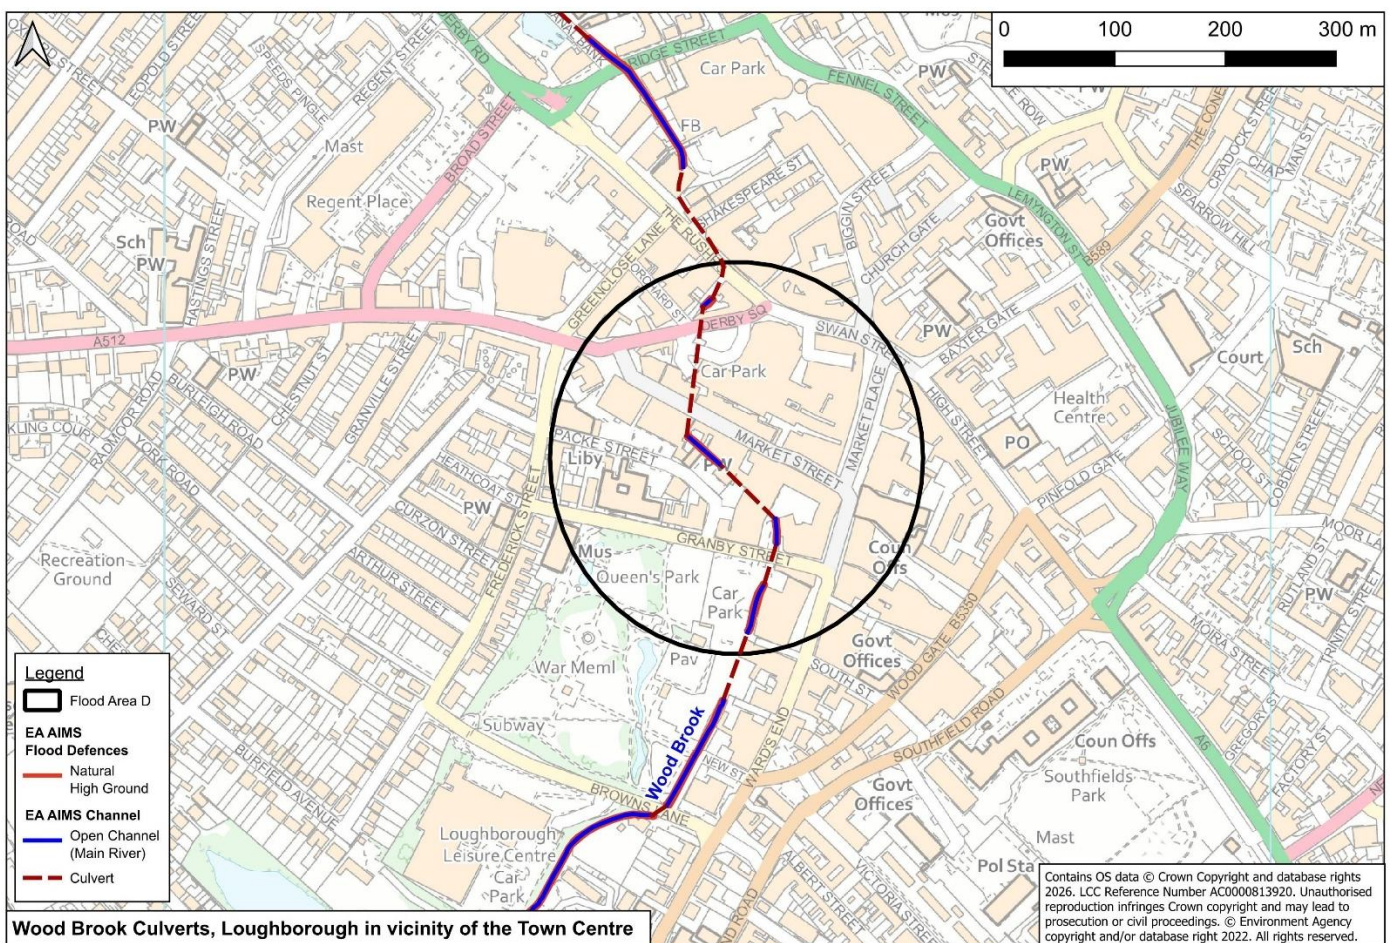
Figure 8-8: Culverted Reaches along Wood Brook through Loughborough Town Centre (Flood Area D)

There is a mixture of culverted (below ground), and open reaches of Wood Brook with natural high ground along the banksides, as illustrated in Figure 8-8. **(Note that the location of the Main River centreline through here between Queens Park south of Granby Street and the culvert outfall north of The Rushes is more accurately represented in this than on Figure 8-1, Figure 8-2 and Figure 8-3 which illustrate a simpler assumed route from connectivity).**
