Flood Investigation Report

Storm Henk

2nd January 2024

Quorn

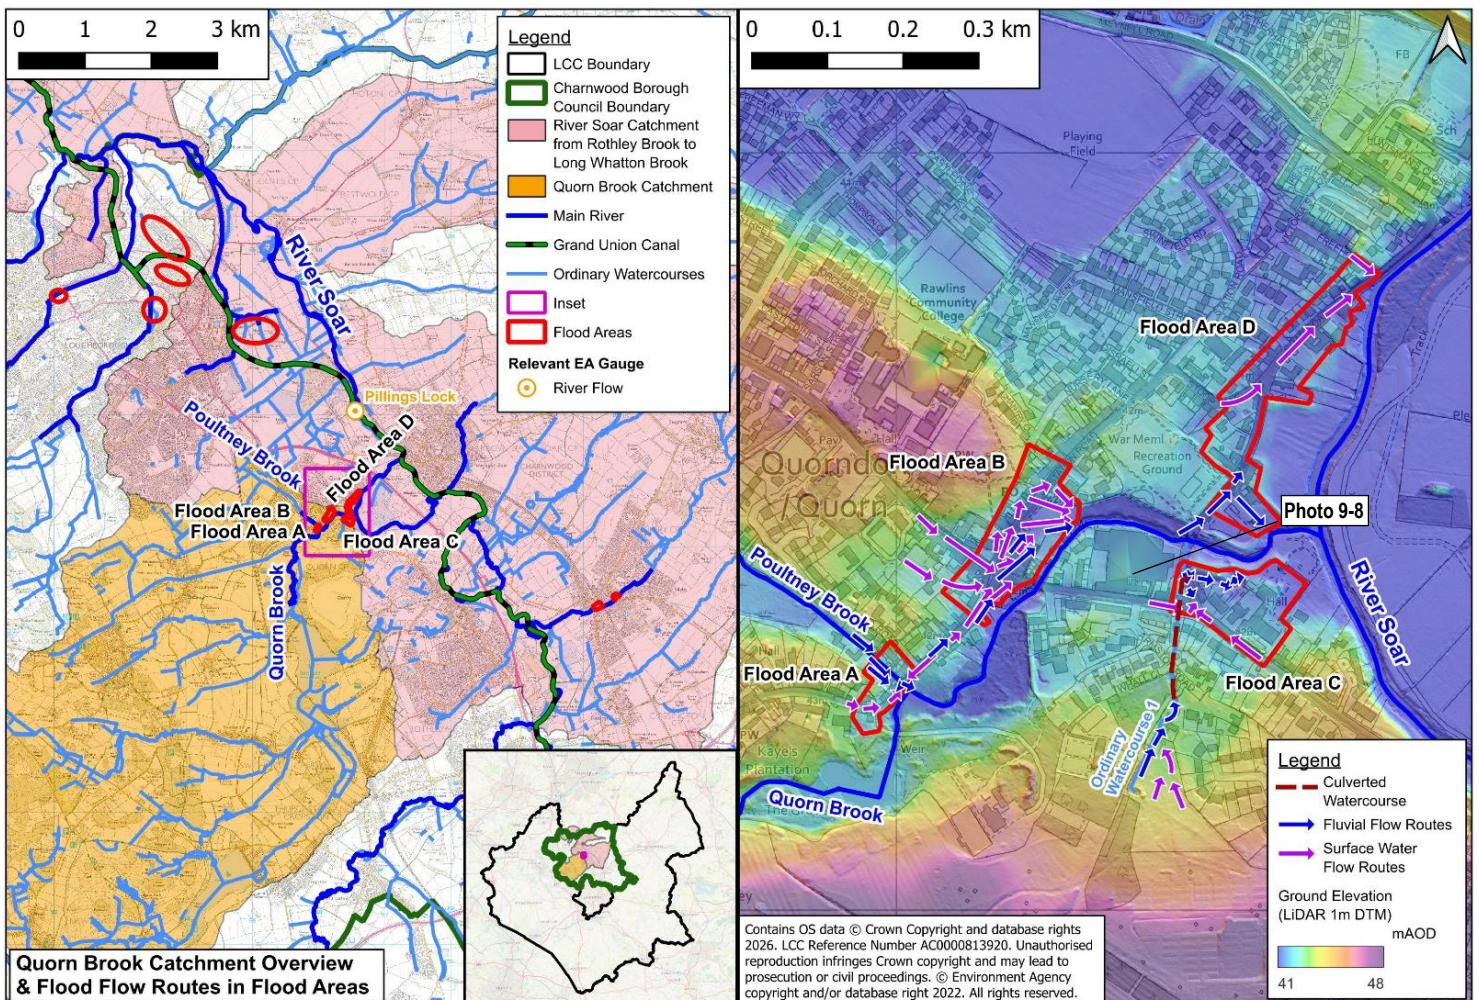
Figure 9-1: Quorn Location Plan, relevant Watercourse Catchments and Flow Routes through Flood Areas (INSET 2)

Quorn is served by a complex network of drainage systems that ultimately discharge to the River Soar to the east (an Environment Agency (EA) designated Main River). The responsible agency for managing the risk from Main Rivers is the EA. Details relating to RMA responsibilities can be found in Section 21 of the main Storm Henk report. During Storm Henk, four areas of the village experienced flooding (defined as Flood Areas A–D). The key drainage features associated with these Flood Areas are described below and are illustrated in Figure 9-1.

The Pillings Lock flow and level gauge¹⁰ located on the River Soar downstream of Quorn at Barrow Road (OSNGR SK 56550 18060) (as illustrated in Figure 9-1) has been in operation since August 1986.

The following sub-sections of the report consider the local flood routing and impacts within each of the four Flood Areas A to D identified in Figure 9-1 within the town centre.

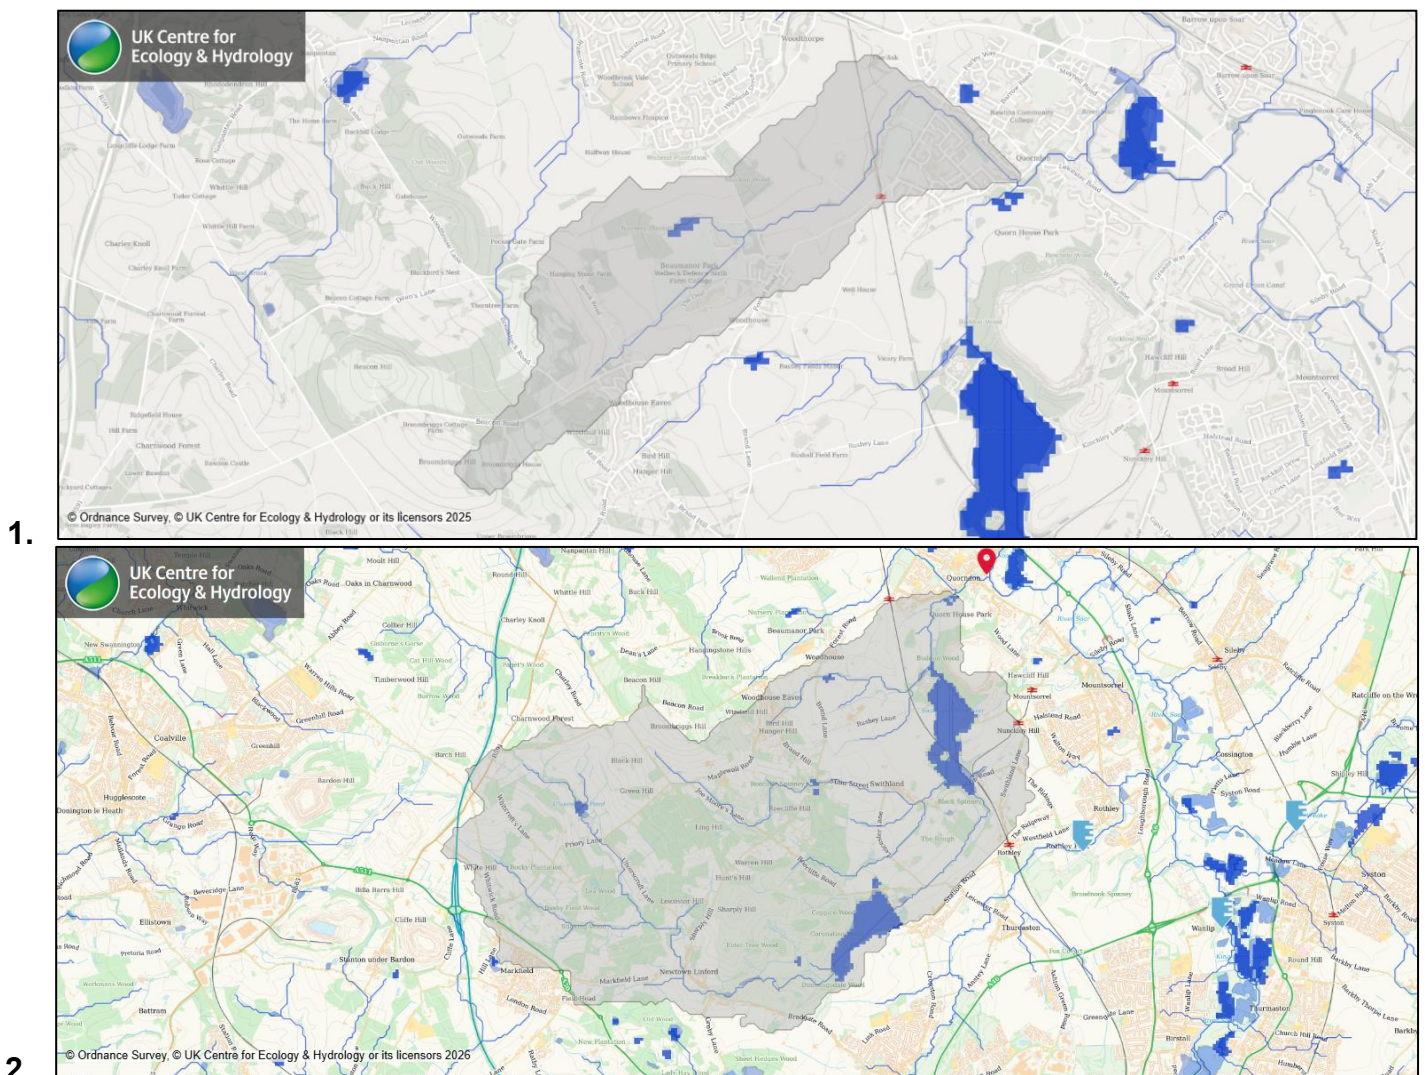
Figure 9-2: FEH Web Service Catchment Extents of Poultney Brook (1.) and Quorn Brook (2.) upstream of their Confluence

The UK Centre for Ecology & Hydrology’s Flood Estimate Handbook (FEH) Web Service³ defines this catchment down to the River Soar as 45.6 km² as shown on Figure 9-2. The FEH Web Service estimates the catchment area at its confluence with Poultney Brook at OSNGR SK 56017 16294 to be 40 km².

Poultney Brook, an EA designated Main River, drains a predominantly agricultural catchment northwest of the village and flows south-east through northern Quorn. It joins Quorn Brook immediately downstream of Meeting Street. The FEH Web Service identifies this sub-catchment area as 4.82 km² (as illustrated in Figure 9-2). The brook is open for most of its length but becomes heavily constrained by garden boundaries and channelisation where it runs parallel to Sanders Road. The lower 350 m upstream of the confluence with Quorn Brook is classed as Main River; the remainder upstream is an ordinary watercourse.

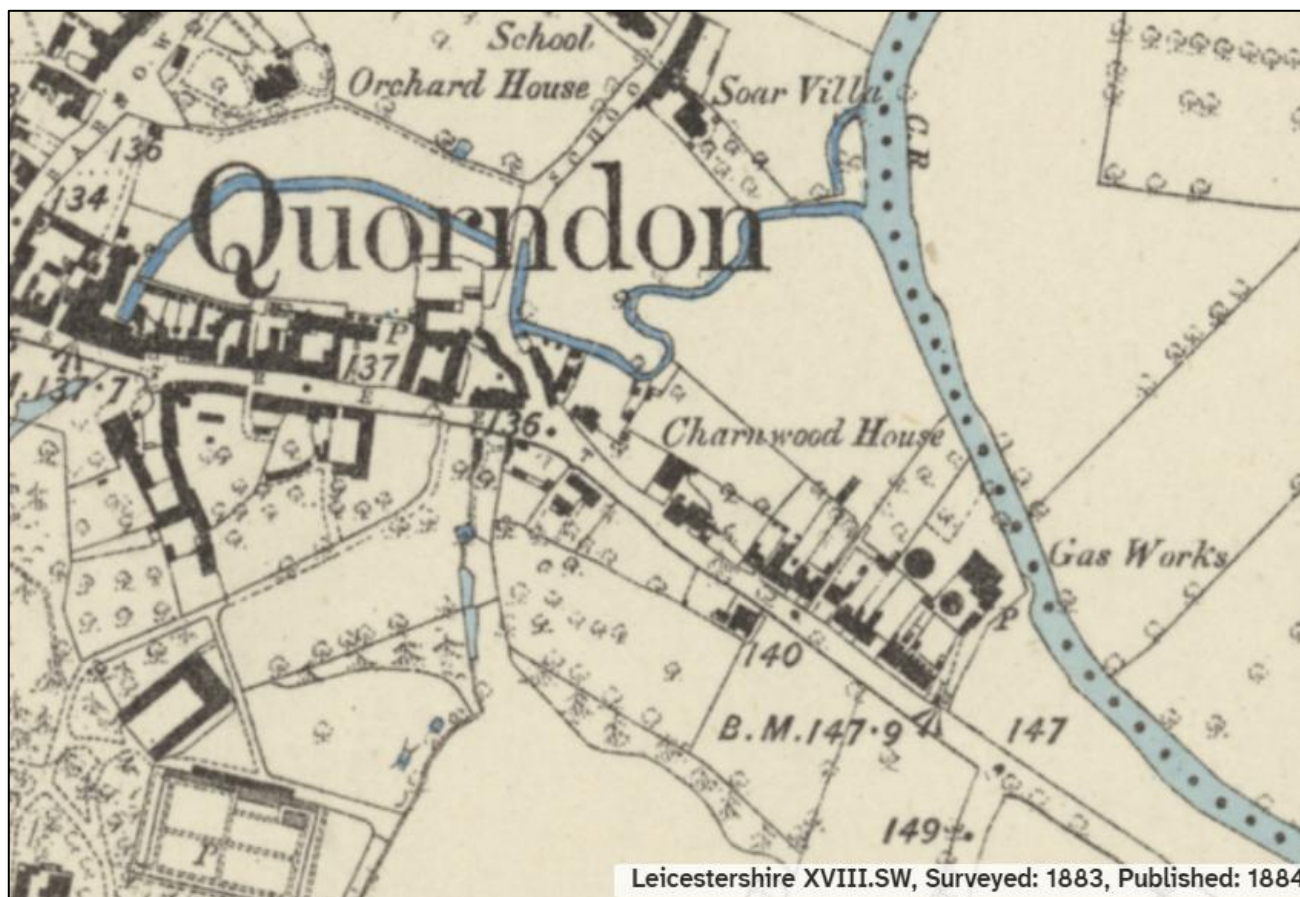
Figure 9-3: Historic map of Quorndon⁴ illustrating the old alignment of Quorn Brook (including old meander downstream of School Lane) and the source and historic alignment of Ordinary Watercourse 1

It is believed that Ordinary Watercourse 1 may become open channel again adjacent to 9 School Lane shortly before it connects back into a redundant meander bend channel of the Quorn Brook, very close to the confluence with the Soar (refer to Figure 9-3). It may also discharge directly into the Quorn Brook upstream of the School Lane bridge. The alignment is not fully understood or confirmed. The FEH Web Service does not define a distinct sub-catchment for this watercourse; but its contributing area is included within the lateral intervening catchment area of Quorn Brook.

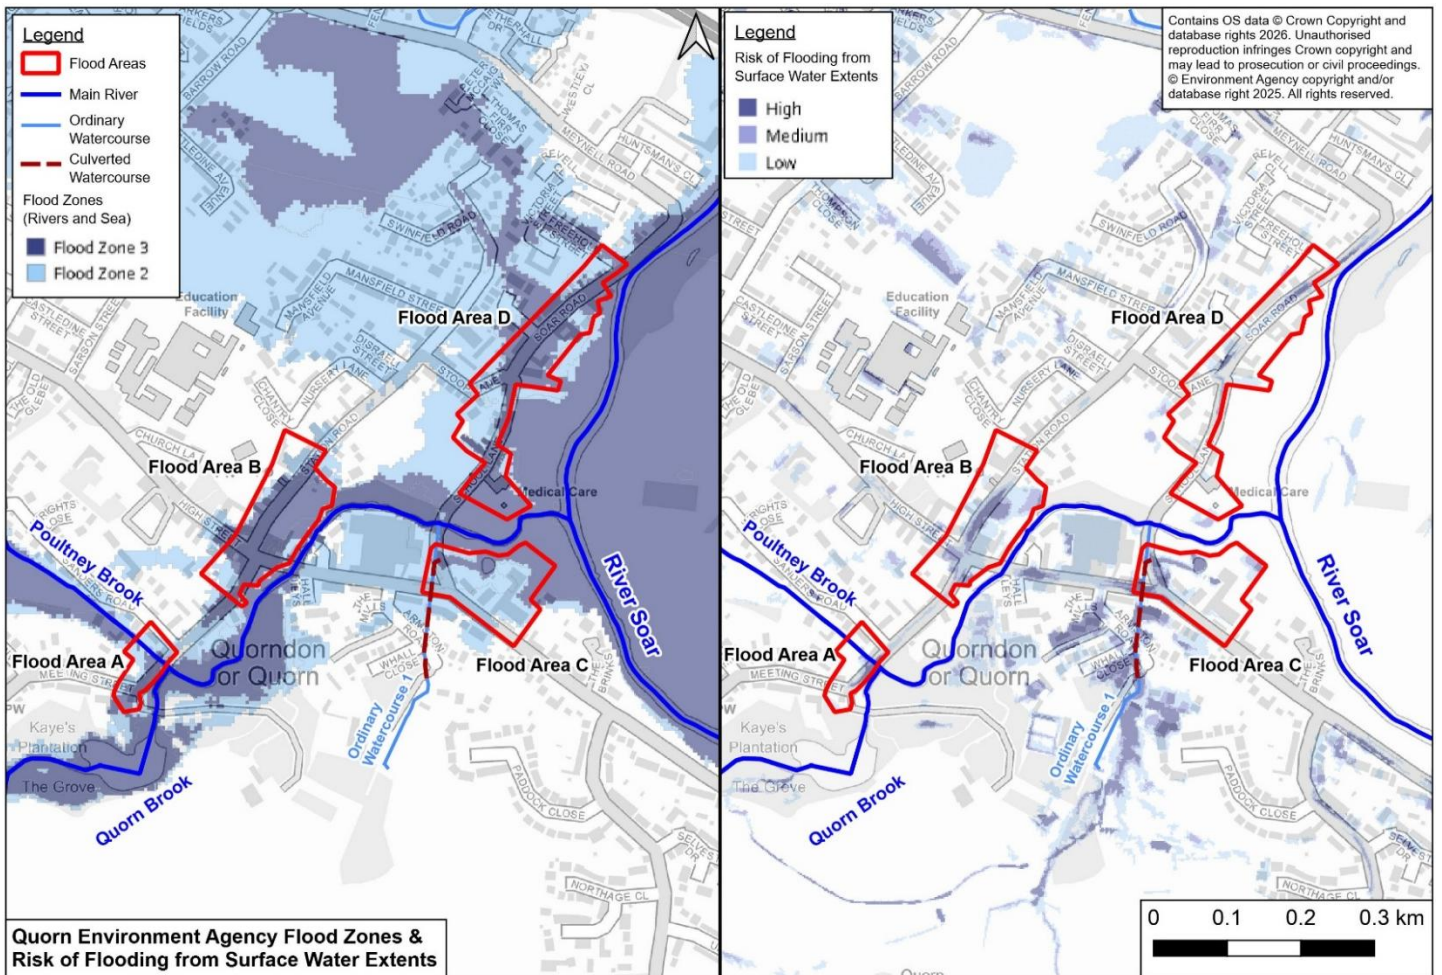
Figure 9-4: Quorn EA Flood Map for Planning Flood Zones⁸ and Risk of Flooding from Surface Water Extents⁹ in Flood Areas (INSET 2)

EA Flood Map for Planning (NaFRA2) Flood Zones 2 and 3 associated with the key watercourses through the village (medium and high risk of river flooding respectively) are illustrated in Figure 9-4.

Parts of the Flood Areas defined in this investigation are also identified as being at a high, medium and low risks of flooding in the national EA Risk of Flooding from Surface Water (RoFSW) map (NaFRA2), as illustrated in Figure 9-4. These include high risk areas along Meeting Street, Station Road, School Lane and Soar Road.

Water which fell on the local highway network was unable to discharge effectively into Quorn Brook due to the high river levels and therefore pooled on the highway at the Meeting Street and Sanders Street junction (closely matching the predicted surface water flooding as shown in Figure 9-4).

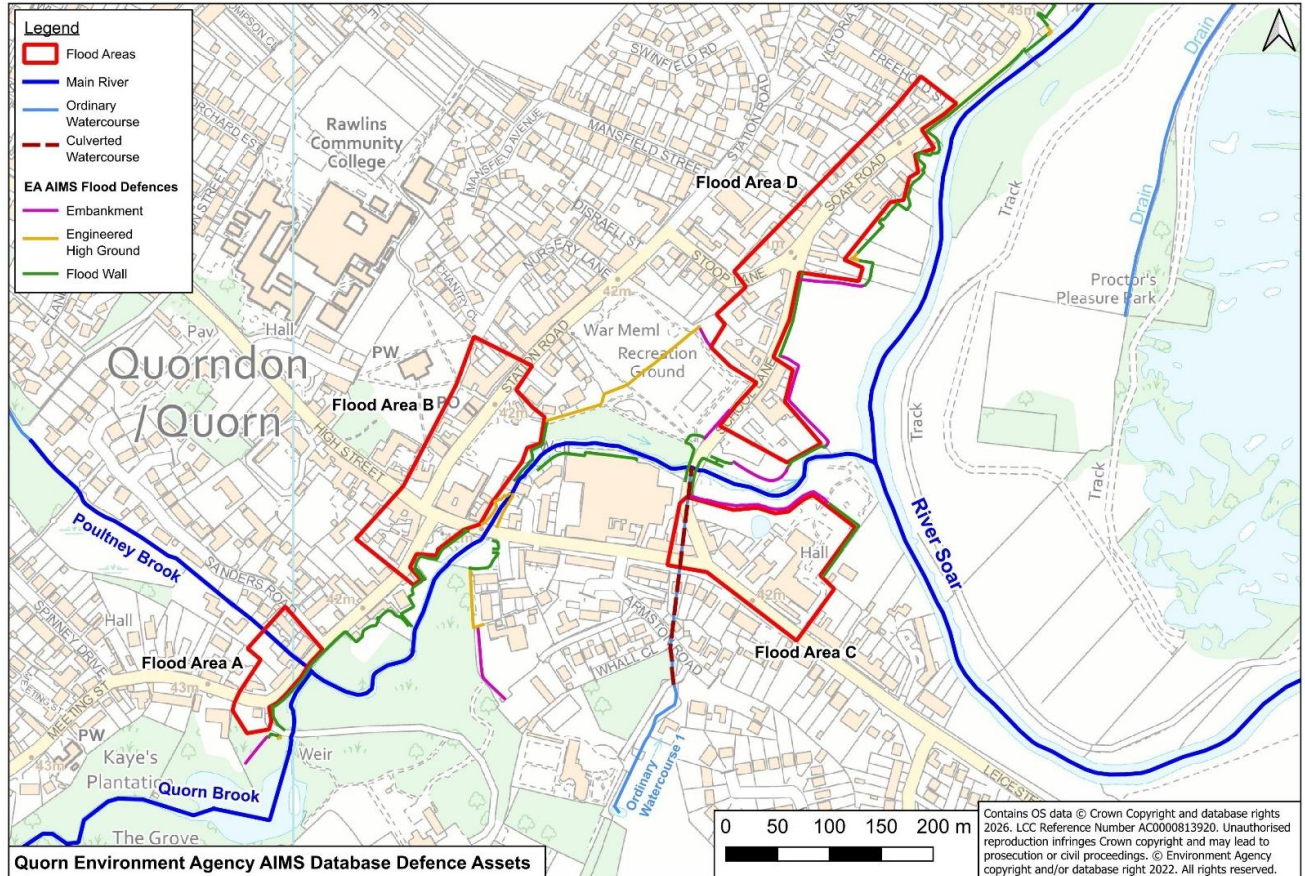
Figure 9-5: Flood Risk Management Assets in Quorn from the EA Asset Information Management (AIMS) Database

Quorn benefits from flood protection provided by EA maintained raised defence assets on the left bank of the River Soar, and along both banks of Quorn Brook, as illustrated in **Error! Reference source not found.** The defences comprise a series of Flood Walls, engineered high ground and Flood Embankments as detailed in Table 9-1, and illustrated in Photograph 9-1, Photograph 9-2, Photograph 9-3, Photograph 9-4 and Photograph 9-5. These were constructed around 1992-1994 as part of the Lower Soar Flood Alleviation scheme (SVIS).

The flood risk management assets in Quorn, as illustrated in **Error! Reference source not found.**, form part of the wider flood defence system along the River Soar, and their condition is recorded by the EA as ranging from ‘Poor’, ‘Fair’ and ‘Good’. The current condition of the assets of interest for this investigation is detailed in Table 9-1 below. The EA confirm that those defences with classifications ‘Poor’ and ‘Fair’ have inspection records indicating ongoing maintenance and monitoring.

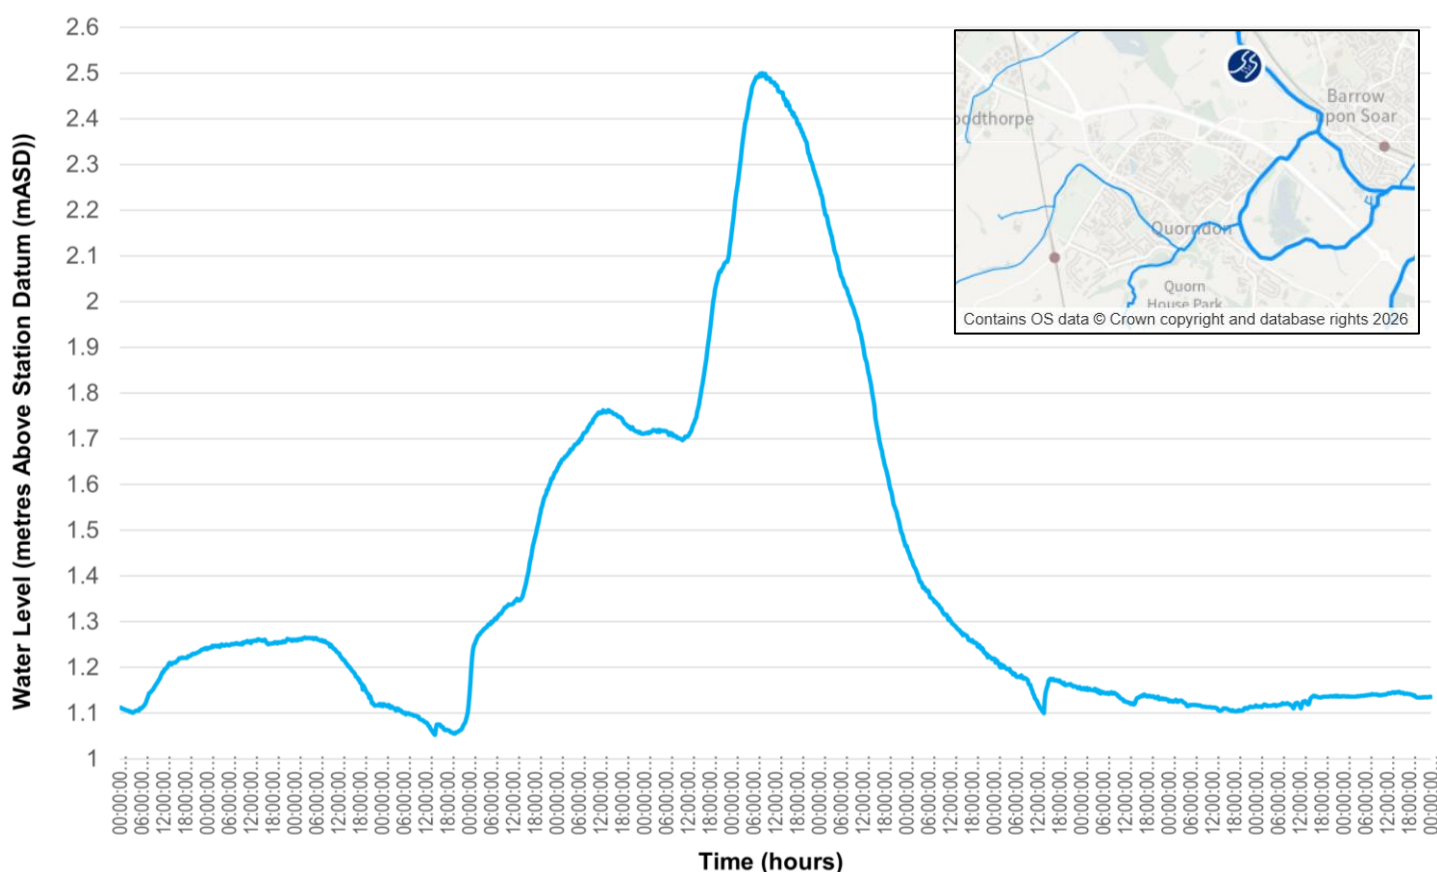
Figure 9-6: River Soar at Pillings Lock Gauge (Station ID 4093) - Water Levels from 00:00 hours on 27/12/2023 to 00:00 hours on 11/01/2024

The Pillings Lock gauge is one of approximately thirty gauging stations used to issue Flood Alerts and Flood Warnings within the River Soar catchment. The levels and flows measured at Pillings Lock during the Storm Henk flood event are provided in Figure 9-6 and Figure 9-7 respectively, with more detail provided in Section 2.4 of the main Storm Henk report.

The peak **river level** on the Soar at Pillings Lock during Storm Henk was recorded as 2.50 metres above the gauge station datum (mASD) at 08:15hrs on 3rd January 2024, as illustrated in Figure 9-6. The previous highest recorded river level was 2.25mASD on 11th April 1998, the same date as the record river flow.

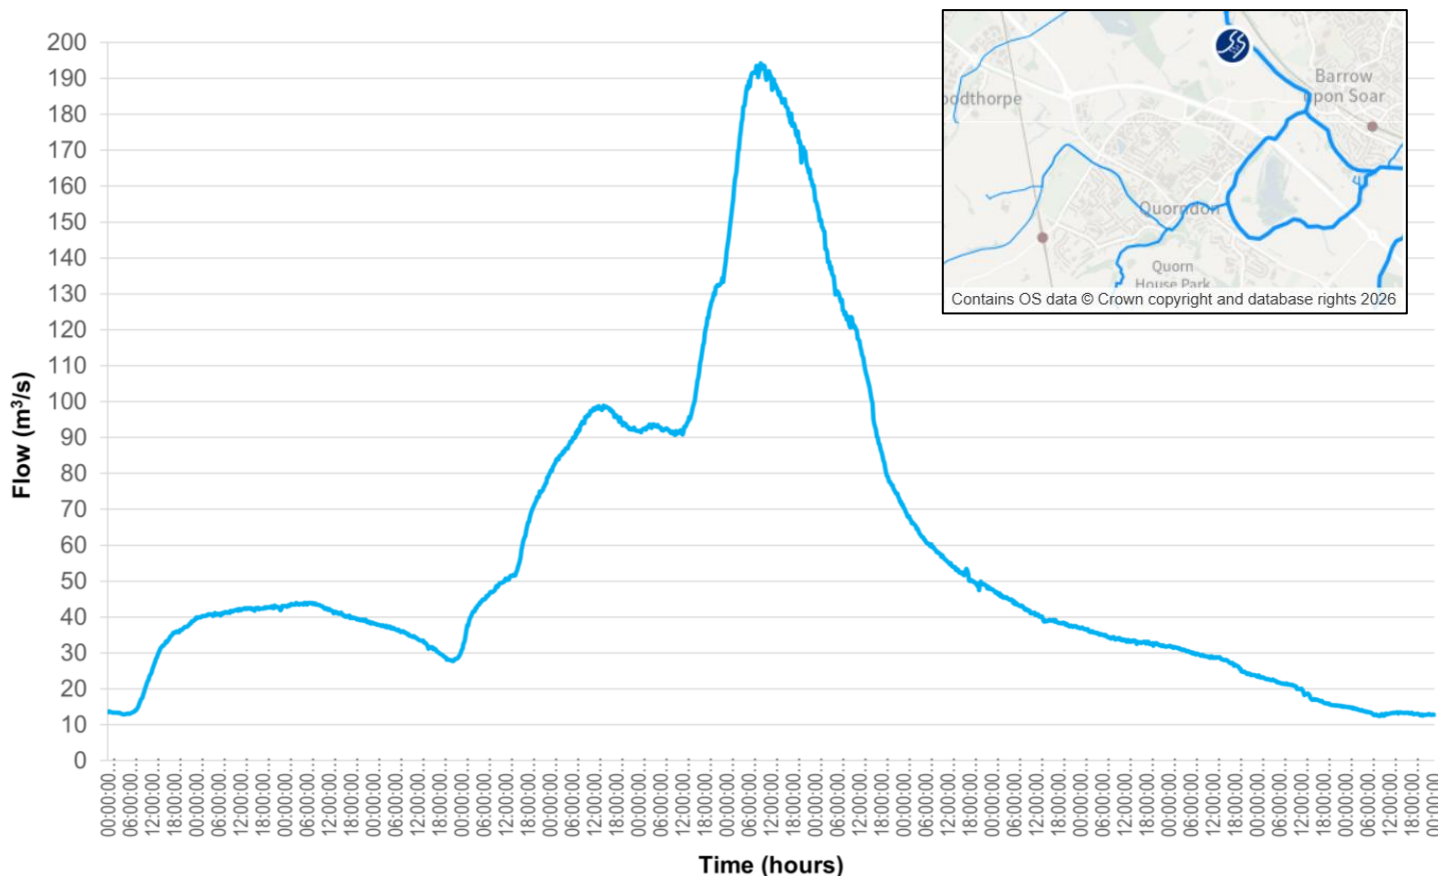
Figure 9-7: River Soar at Pillings Lock Gauge (Station ID 4093) - Flows from 00:00 hours on 27/12/2023 to 00:00 hours on 11/01/2024

The previous record **peak flow** was recorded during the Easter 1998 flood event (190.34m³/s at 08:00hrs on 11th April). During Storm Henk, flows exceeded this at 06:30hrs on Wednesday morning, 3rd January 2024, peaking at an estimated 194.19 m³/s at 09:15hrs as illustrated in Figure 9-7.
