# Flood Investigation Report

Storm Henk

2<sup>nd</sup> January 2024

**Sharnford**

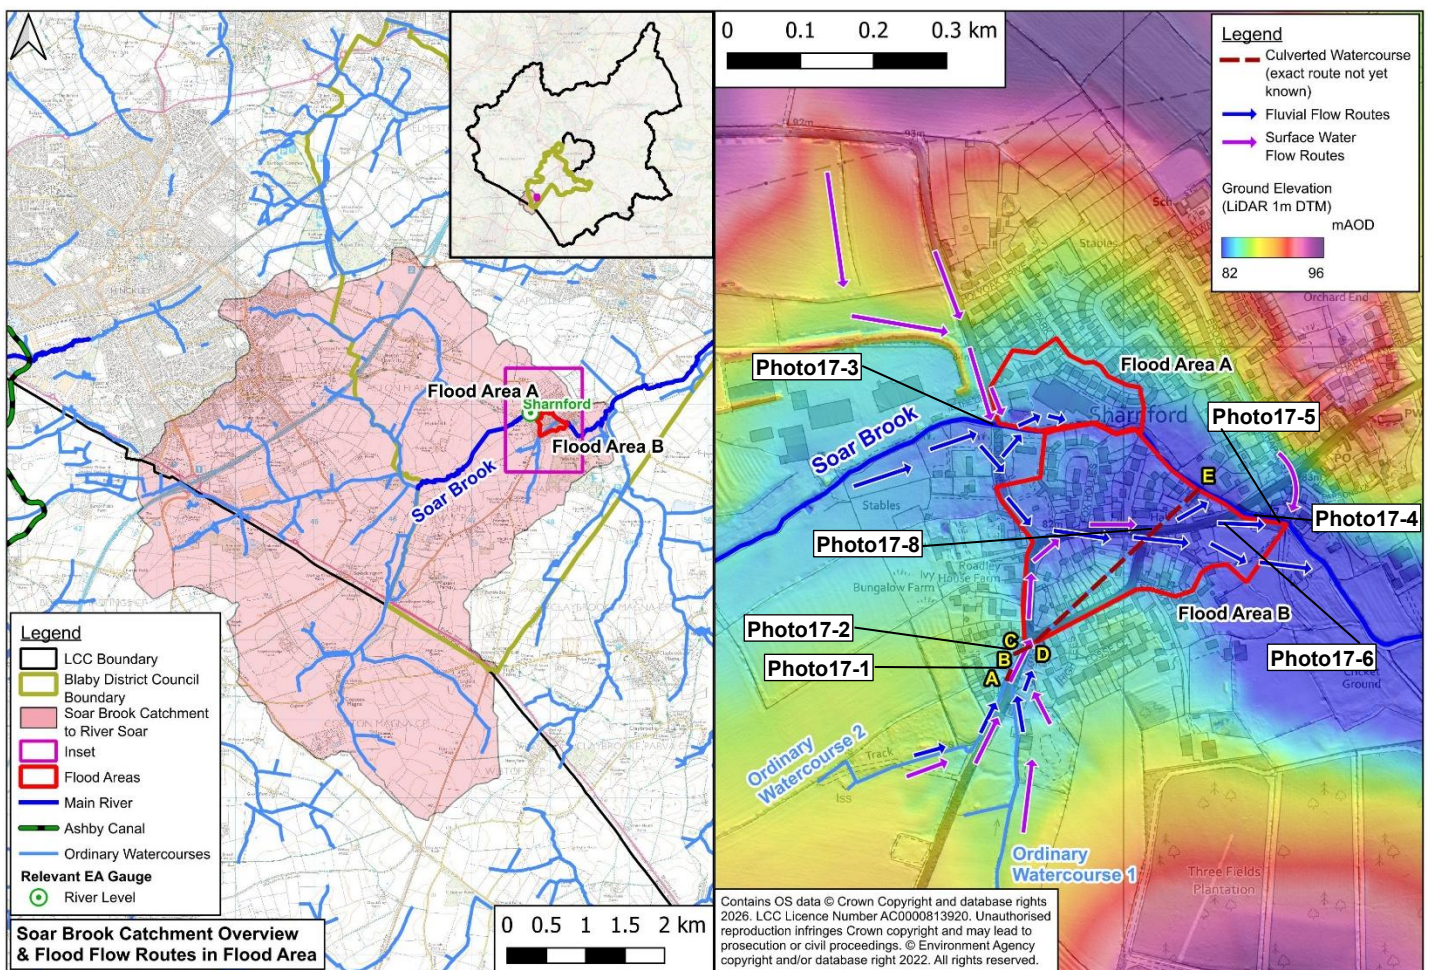
Figure 17-1: Sharnford Location Plan, relevant Watercourse Catchment and Flow Routes through Flood Areas (INSET 16)

An un-named Ordinary Watercourse 1 enters Sharnford from the south, draining rural land, flowing adjacent to the eastern side of the B4114 Leicester Road as illustrated in Figure 17-1 towards Coventry Road.

A second un-named Ordinary Watercourse 2 enters Sharnford from the south-west draining a smaller rural catchment, running adjacent to the western side of the B4114 Leicester Road. This is known to enter a 450mm diameter circular concrete highway culvert on the western side of Leicester Road and southern side of Butler Close at OSNGR SP 47840 91544 illustrated as Location A in Figure 17-1. It reappears as an open channel on the northern side of Butler Close (illustrated as Location B in Figure 17-1 and depicted in Photograph 17-1). This continues as an open channel for approximately 30m then falls into a 450mm dia culvert inlet (illustrated as Location C in Figure 17-1 and depicted in Photograph 17-2) and is conveyed under the B4114 highway at OSNGR SP 47848 91565. The watercourse reemerges as an open channel discharging into Ordinary Watercourse 1 on the eastern side of the B4114, south of the Coventry Road junction. Ordinary Watercourse 1 then sinks into what is understood to be a 600mm dia culvert inlet illustrated as Location D in Figure 17-1.

The main source of flooding affecting Sharnford was from the Soar Brook which overspilled its banks during the hours of 18:00 on 2<sup>nd</sup> January 2024 and 10:00 on 3<sup>rd</sup> January 2024 as the channel capacity was exceeded, particularly at the two key bridges; one located along Aston Lane (Photograph 17-3), and one along Leicester Road (Photograph 17-4). Water flowed across adjacent land into the industrial estate north of the river, and primarily to the south of the river (Flood Area A and Flood Area B respectively as illustrated in Figure 17-1).

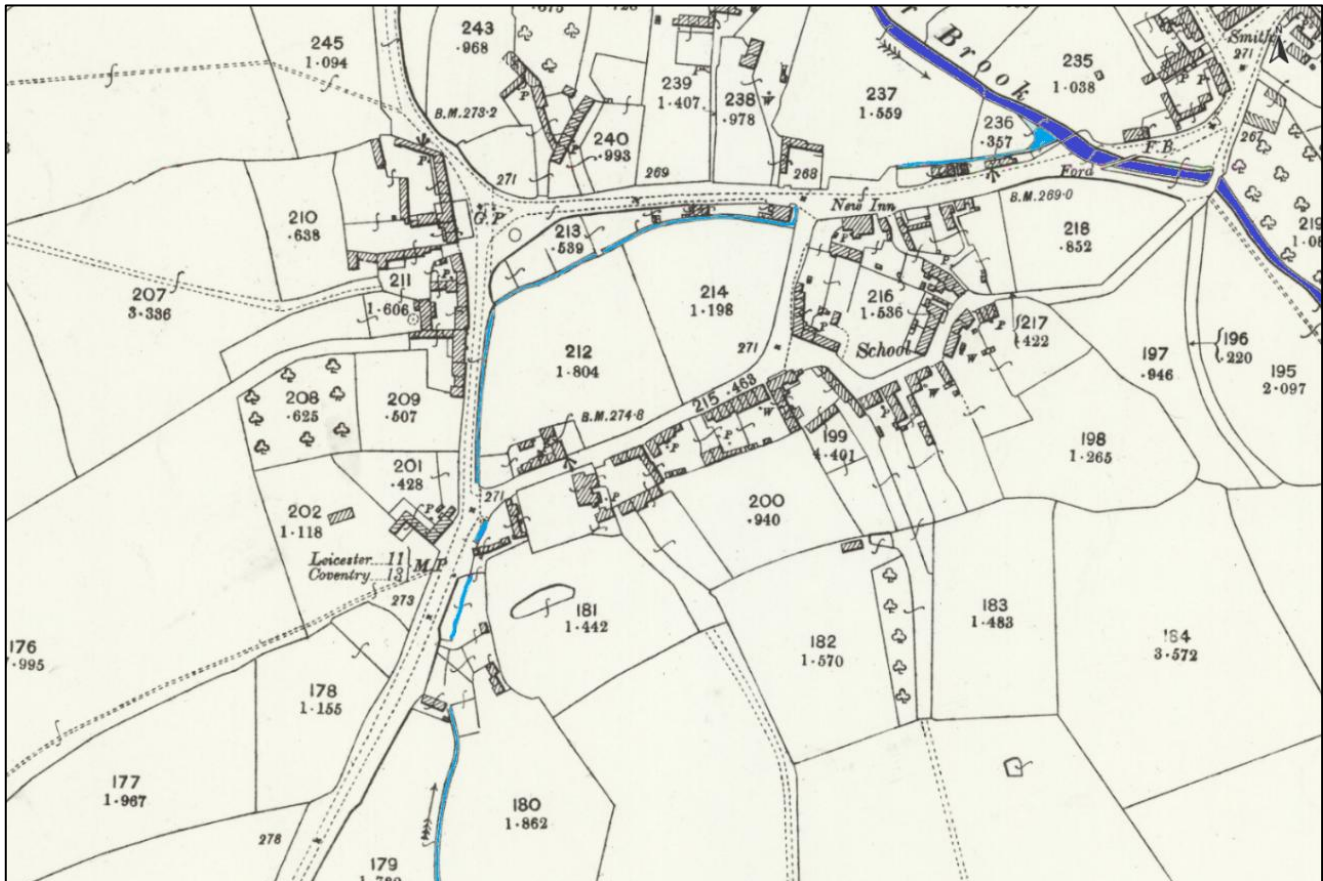
**Figure 17-2: Known historic un-named Ordinary Watercourse 1 route - 1886 OS Survey Map (1:2 5inch)**

Originally, Ordinary Watercourse 1 comprised an open watercourse that flowed along the length of Leicester Road before entering the Soar Brook adjacent to the Leicester Road ford, its length has been culverted and straightened over the years as properties were built on the former Sharnford 'green' and the road network was widened and upgraded. The historic route of Ordinary watercourse 1 is shown in Figure 17-2.

Note that the route between Locations D and E presented in Figure 17-1 is assumed/straight-lined between the two points in the current OS MasterMap watercourse mapping. It is more likely, based upon this historic mapping and investigations to date, that it follows the route northwards from Location D beneath Coventry Road, then through private land south of Leicester Road and outfalls into Soar Brook between the Leicester Road bridge and Sharnbrook Gardens at Location E, as indicated in Figure 17-3. But the exact route along the whole length of the culvert has not been confirmed.

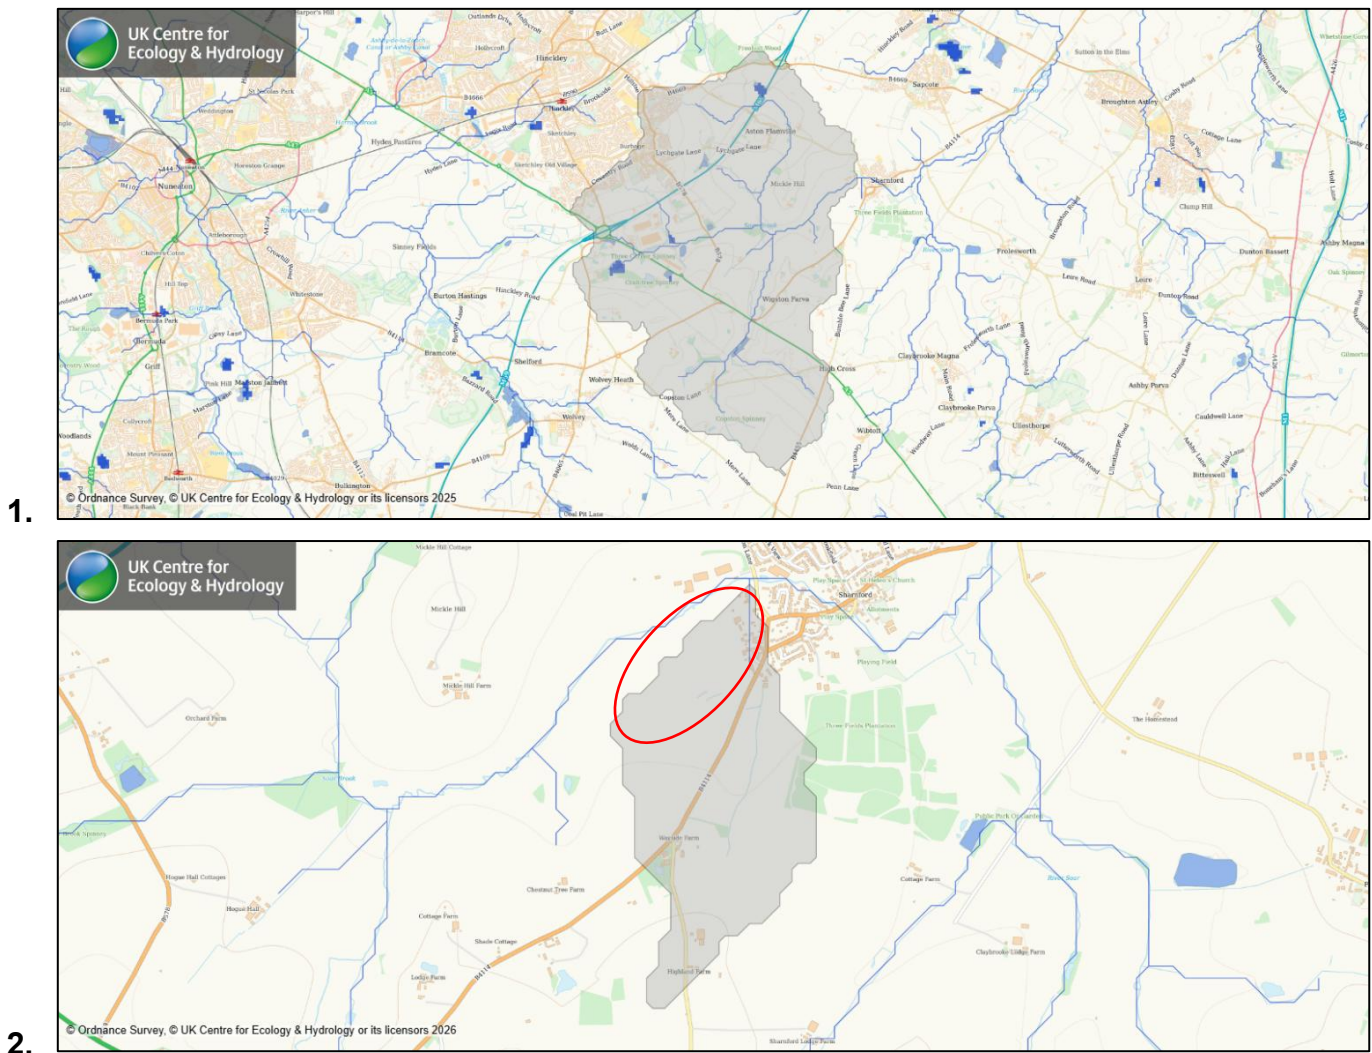
**Figure 17-4: FEH Web Service Catchment Extents of Soar Brook at Aston Lane (1.) and combined unnamed Tributary catchments (Ordinary Watercourses 1 and 2) (2.)**

The UKCEH FEH Web Service<sup>1</sup> provides strategic level catchment mapping for the area as illustrated in Figure 17-4. This identifies that Soar Brook drains a sub-catchment area of approximately 22.8km<sup>2</sup> to Aston Lane. The catchment includes Hinckley Park, the edge of Burbage and the rural catchment around Wigston Parva and Copston Magna. The catchment area further downstream at the River Soar increases to 23.7km<sup>2</sup>.

The combined tributary catchment area of Ordinary Watercourses 1 and 2 is defined as joining the channel of Soar Brook at Aston Lane and has an area of 0.86km<sup>2</sup>. However, the FEH Web Service is based upon a terrain model that does not account for modified channels resulting from culverting or integration into drainage networks. Interrogation of ground elevation data identified that the boundary between these two catchments west of Coventry Road is likely to reflect the actual routing mechanisms towards the culvert inlet at the southern side Coventry Road, with the north western region of the tributary catchment (circled in red) actually being part of the intervening lateral catchment of Soar Brook to the north.

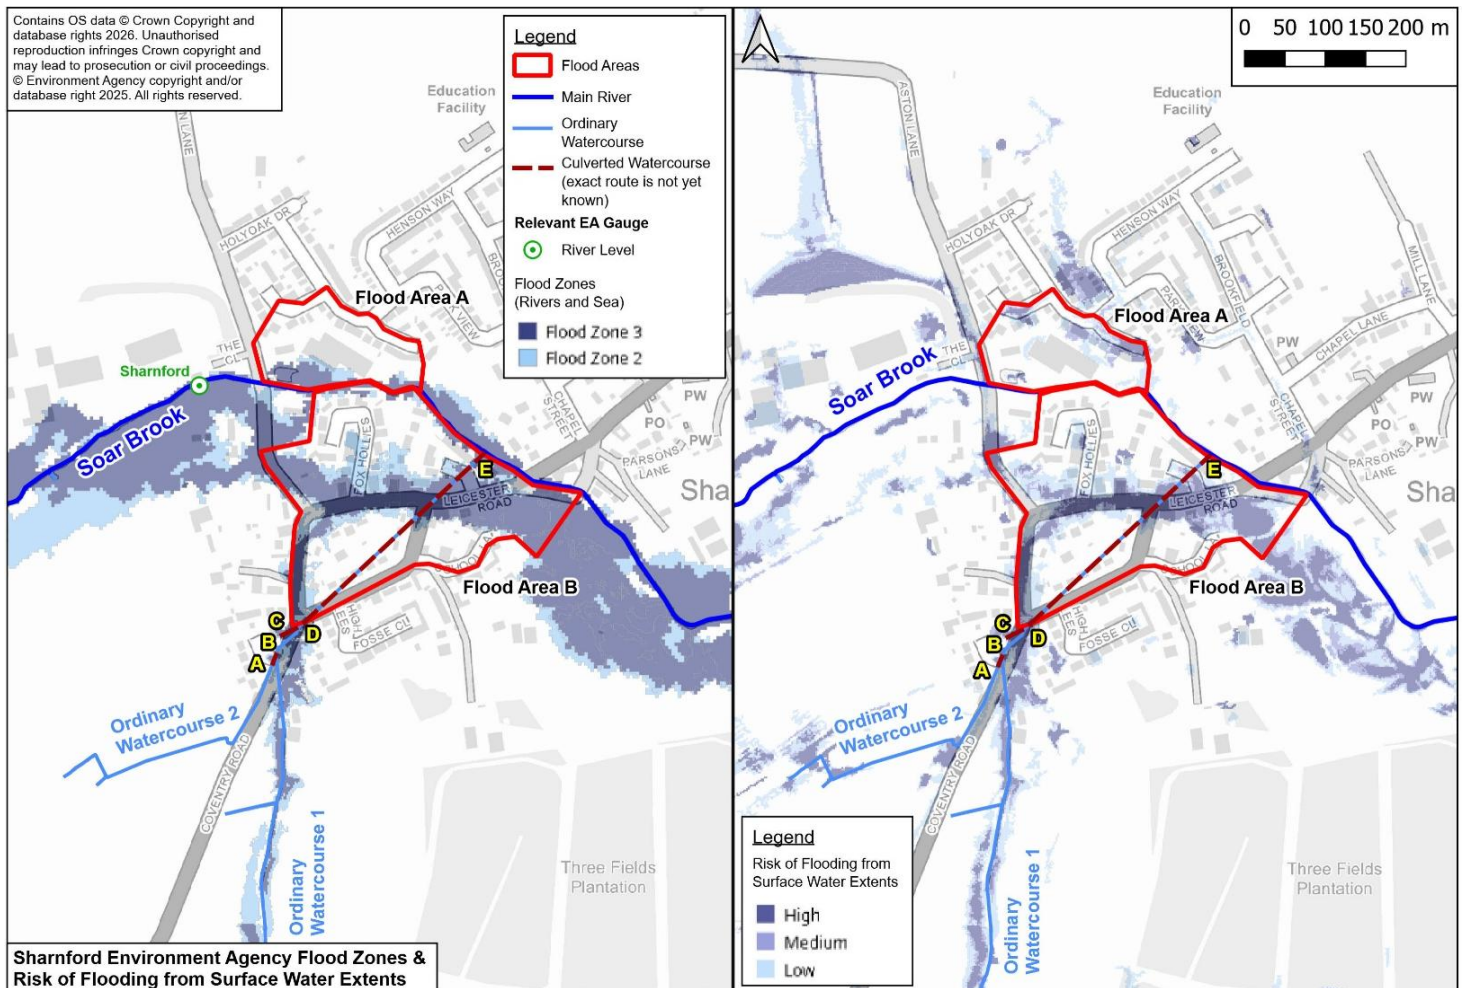
Figure 17-5: Sharnford EA Flood Map for Planning Flood Zones<sup>3</sup> and Risk of Flooding from Surface Water Extents<sup>4</sup> in Flood Areas (INSET 16)

The EA provides flood risk mapping nationally for both rivers and surface water as detailed within Section 2.7.6 of the main Storm Henk report. The extents of EA Flood Map for Planning Flood Zones 2 and 3 (NaFRA2) associated with Soar Brook within the village (medium and high risk of river flooding respectively) are illustrated in Figure 17-5.

There are also areas of the village shown as having a high and medium and low risk of flooding on the strategic level Risk of Flooding from Surface Water (RoFSW) (NaFRA2) mapping as illustrated in Figure 17-5.

The reports received also detailed that surface water flow was flowing downhill from the first bend north of the village along Aston Lane, and flowing southwards over fields to the west, which is similar to that illustrated in the EA's RoFSW map (Figure 17-5). Anecdotal reports were also made of cars and lorries from the industrial development in Brindleys Yard driving through knee-deep water which created bow waves and exacerbated internal flooding to the businesses. This flood water was conveyed south following the local ground levels along Aston Lane into Flood Area B.

The culverted Ordinary Watercourse 1 (illustrated as between Locations D and E in Figure 17-1) was anecdotally reported as being overwhelmed as the capacity was exceeded, causing water to flood out at the inlet (Photograph 17-2). Floodwater from this culvert was reported to have followed the lowest ground levels along Leicester Road, matching its historical route shown in Figure 17-2 and coinciding with areas of high risk illustrated in the EA's modelled Flood Zones and flow routes on the EA's RoFSW map shown in Figure 17-5.

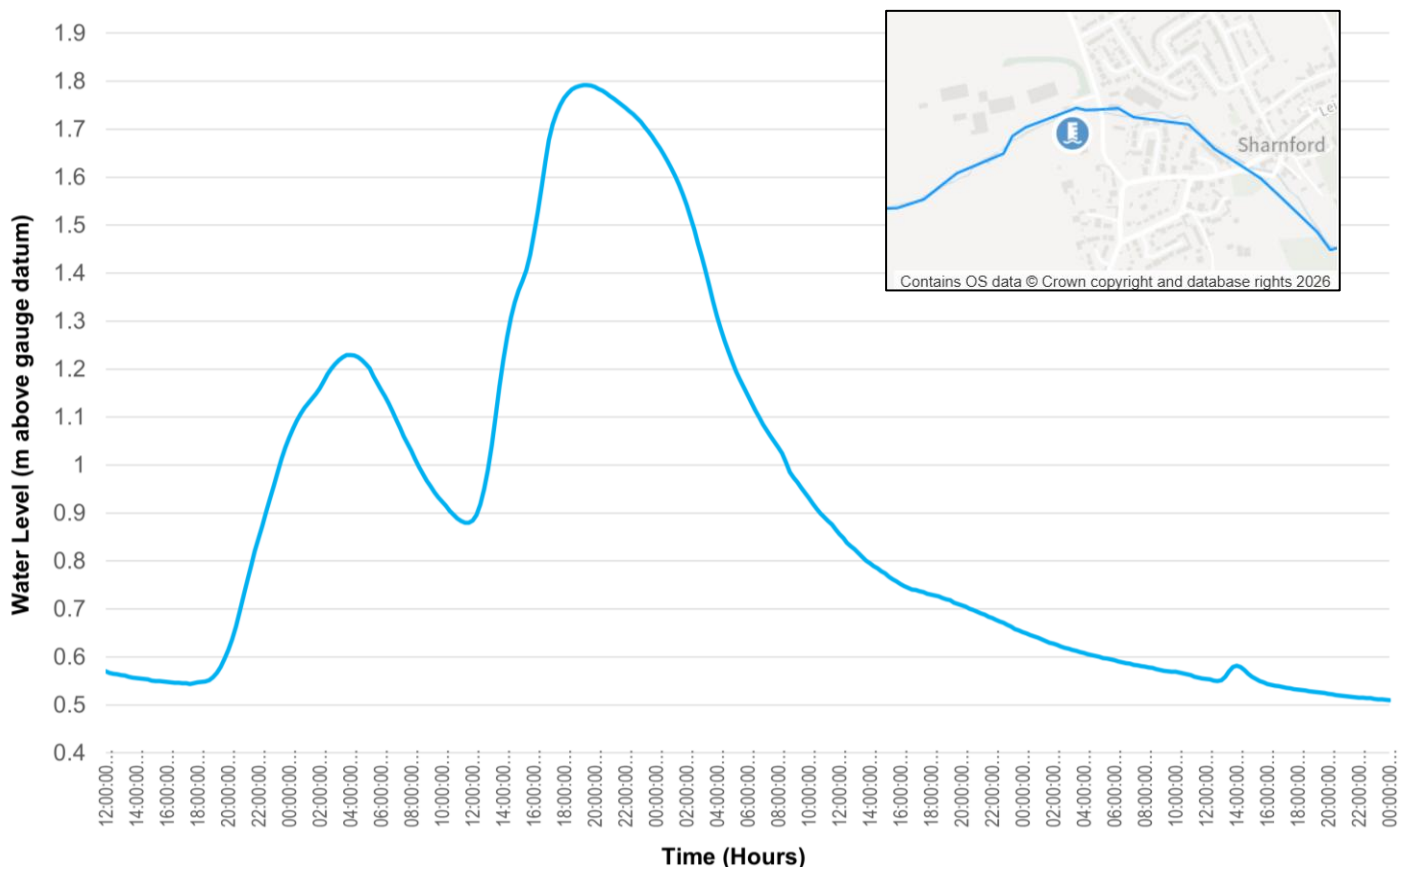
**Figure 17-6: River Soar (Soar Brook) Sharnford Gauge (Station ID 4145<sup>5</sup>) Water Level from 12:00 hours on 01/01/2024 to 00:00 hours on 05/01/2024**

The EA monitors river levels along Soar Brook at a hydrometry gauge (Station Reference 4145 and named ‘River Soar’) located upstream of Aston Lane (OSNGR SP 47750 91890), as illustrated in Figure 17-5. Observed river levels (water level in metres above the gauge station datum (mASD)) from 12:00hrs on 1<sup>st</sup> January 2024 to 00:00hrs on 5<sup>th</sup> January 2024 are illustrated in Figure 17-6.

During Storm Henk, this gauge recorded its highest ever level. The peak river level in the brook, recorded as 1.79mASD, occurred at 19:15hrs on 2<sup>nd</sup> January 2024. The previous highest recorded river level was 1.75mASD which occurred in November 2012.
