Flood Investigation Report

Flooding at Watling Street, Hinckley –
27th December 2017

Final Report
October 2020

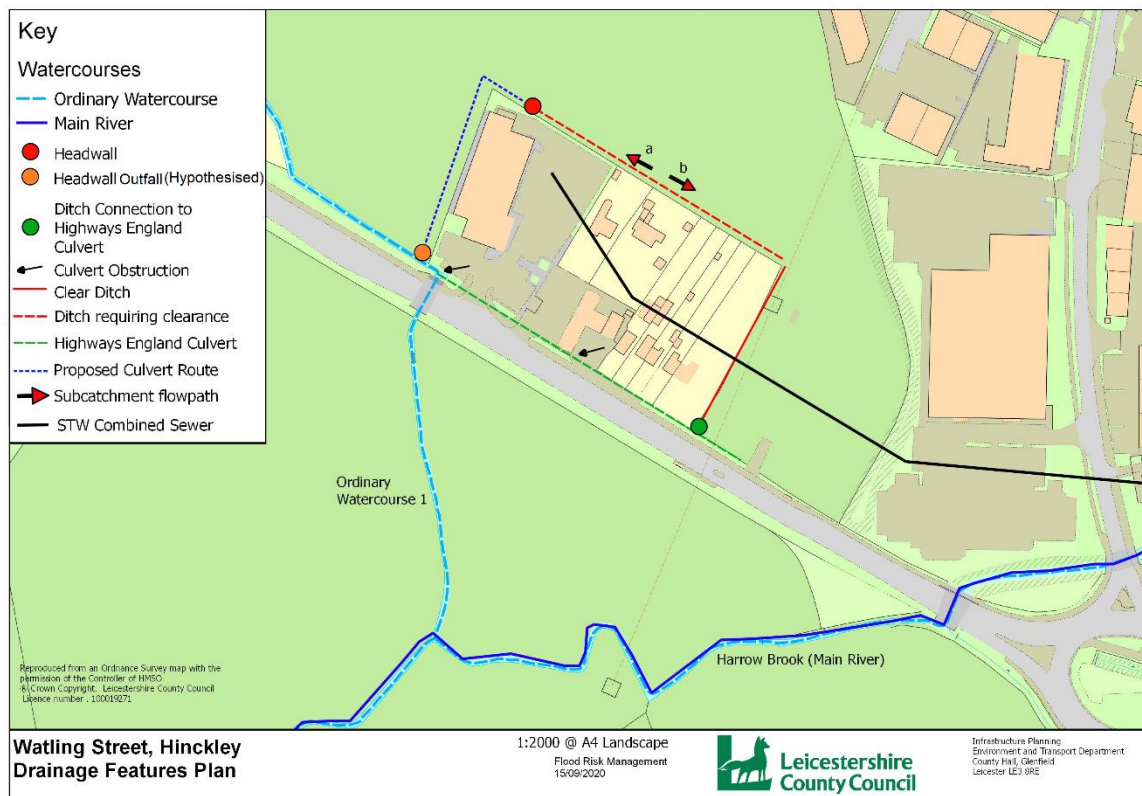
Figure 2: Watercourse features

As shown in Figure 2, an unnamed ordinary watercourse (labelled ordinary watercourse 1) flows from land to the North of Watling Street in a southerly direction. At the location marked with a red circle (Figure 2), the ordinary watercourse converges with a 225mm diameter surface water culvert (labelled as a green dotted line on Figure 2) before entering a 1300mm brick arch culvert and passing beneath the Watling Street. The ordinary watercourse continues in a southerly direction before reaching a confluence with the Harrow Brook (labelled on Figure 2 as Harrow Brook (Main River)) immediately to the South-West of Hinckley. The unnamed

A localised ridge runs through the middle of the fields behind the properties, this causes surface water to run off into two separate micro catchments. Water draining to the east (annotated as 'b' on Figure 2) makes its way towards a drainage ditch forming the boundary between the properties on Watling Street and the field behind (shown as a solid red line on Figure 2). The drainage ditch serves to convey surface water around the backs of the property towards formal drainage located within Watling Street. The condition and capacity of the ditch varies along its length with some sections approximately 1m deep and 1.5m wide. Other sections such have silted up or been filled in and are only observable as slight linear depressions in the ground.

Water draining to the west (annotated as 'a' on Figure 2) makes its way into either a headwall located immediately to the North of the Aldi supermarket or bypasses this and drains across the fields towards the unnamed ordinary watercourse. The headwall appears older and anecdotal evidence suggested that this predates the Aldi store and was unaffected by the construction of the store. The condition and exact route could not be confirmed following site investigations however it is believed that it eventually discharges into ordinary watercourse 1 adjacent to Watling Street (annotated as a blue hashed line and orange dot on Figure 2).

During a site walk over, conducted by the Council on 9th March 2018 it was identified that a section of the drainage ditch (highlighted red on Figure 2) located behind the affected residential properties, had not been maintained and had consequentially become silted and been filled with garden debris such as grass cuttings and soil (Figure 7).

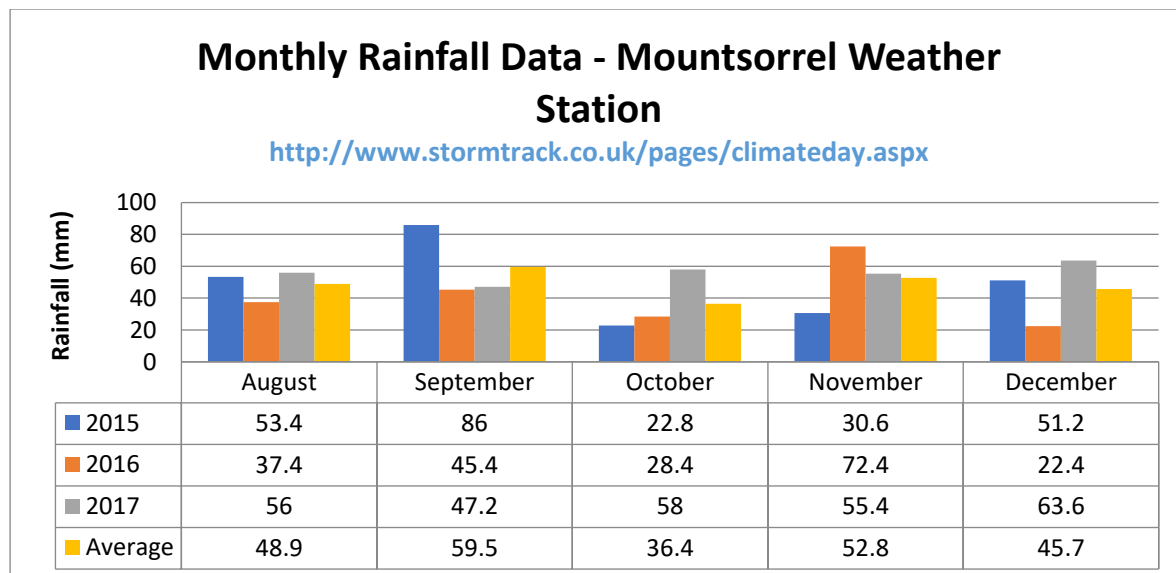
Figure 4: Annual rainfall data – August to December 2015-2017

Above average rainfall was experienced in the East Midlands in the Autumn/Winter of 2017. In December 2017, approx. 63.4 mm rainfall was recorded at a nearby weather station in Mountsorrel. Figure 4 depicts the rainfall at the Mountsorrel weather station from August to December (Autumn/Winter) for the years 2015 – 2017. Rainfall during December 2017 was higher than the rainfall recorded in the same month for the previous two years and significantly higher than 2016. This increase in rainfall throughout December would have contributed to the saturation of the ground, thus reducing the ground's ability to absorb water during the flood event of 27 December 2017.
