Leicester Road, Loughborough

Flood Report

DETAILED FLOOD INVESTIGATION

County Council Investigation Ref.:	2016-INV-115
Investigation:	Leicester Road, Loughborough
Date of Flooding:	7 th May 2016
Revision	Final

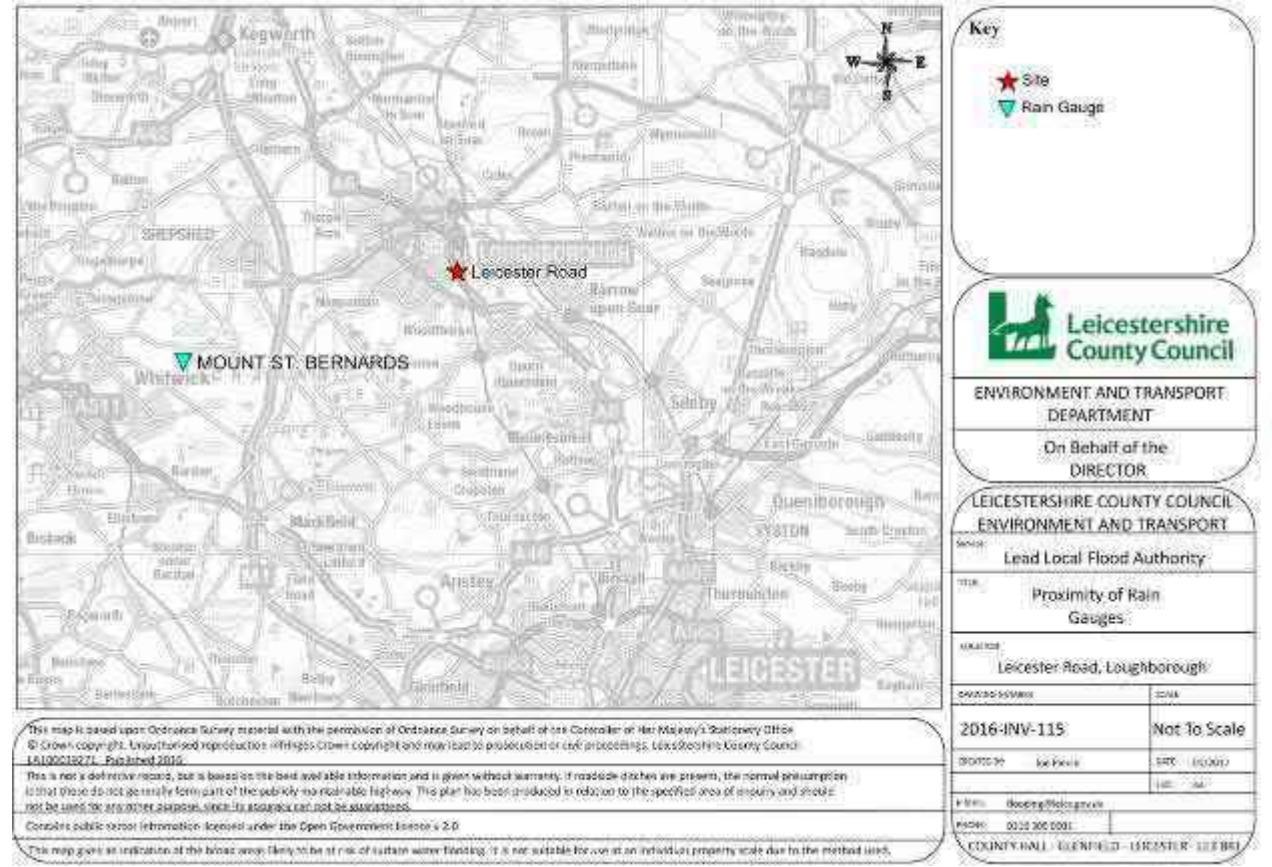
Figure 2 Location of the rainfall gauge and the flooding site location

Table 4-1 below provides a summary of the relevant Environment Agency rainfall gauge within the study area that was used for data analysis purposes i.e. Mount St Bernards. This rainfall gauge was chosen because it is located in close proximity to the flooding site (see Figure 2). The rainfall gauge at Burton-on-the-Wolds is located closest to the flood incident at Leicester Road in Loughborough. Analysis of rainfall data from the Burton-on-the-Wolds gauge indicates that the rainfall event was not recorded by the gauge on or around 7th May.

However the rainfall event on 7th May was recorded by the Mount St Bernards rainfall gauge, which is the next nearest gauge to the flooding incident. Therefore rainfall data from the Mount St Bernards gauge was used for data analysis purposes for this site.
